Asset #06143(Routine, Underwater type 2)

SH 35-07 LM 4.17 over Hundley Creek

Team Lead: Sharon Hooks, Inspection Date: 06/14/2022

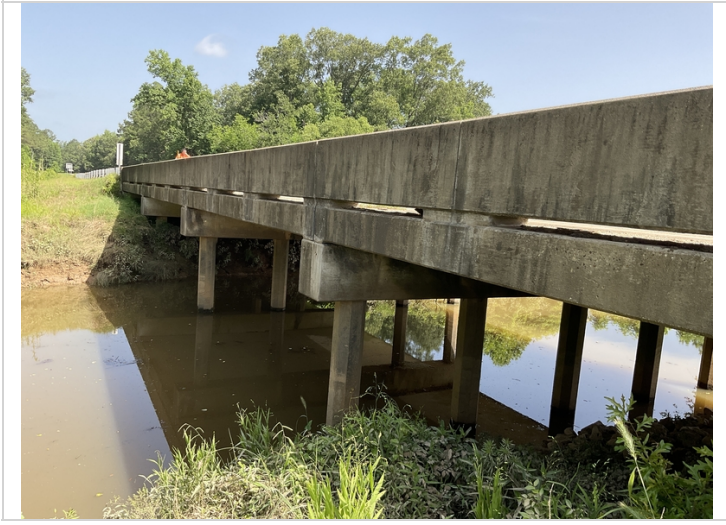
Elevation.

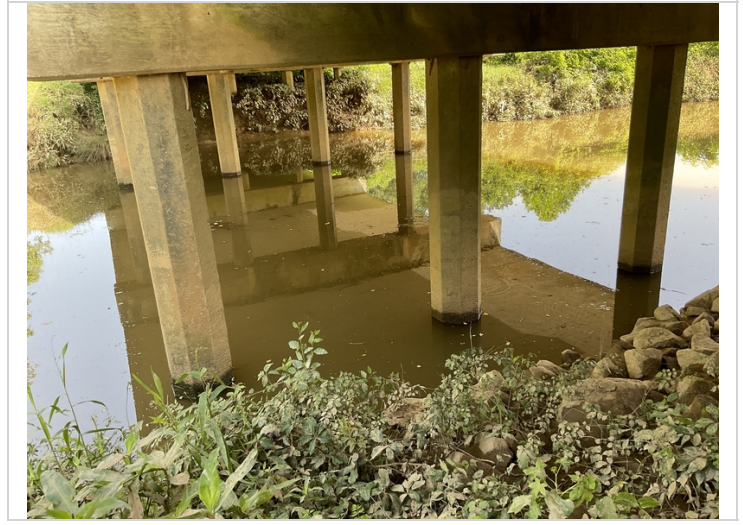
Substructure view.

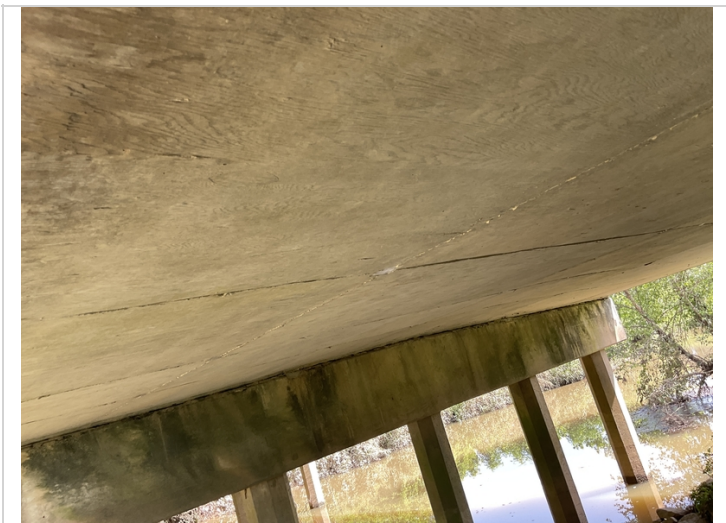
Under view.

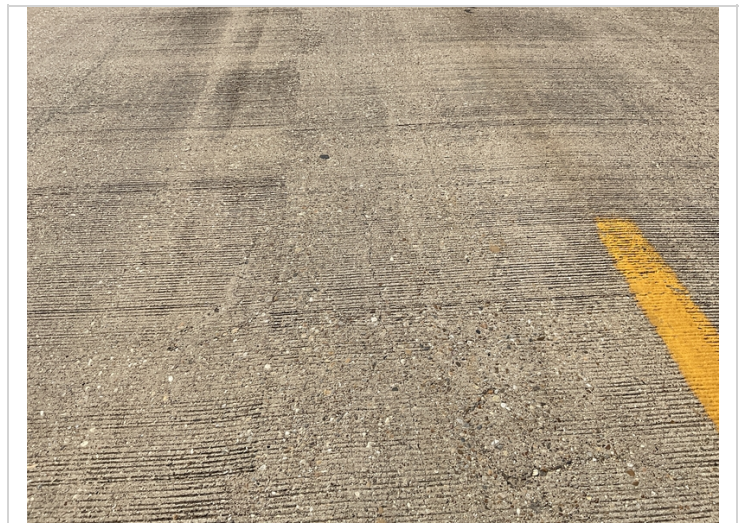
ELEMENTS	DESCRIPTION	UNITS	TOTAL	CS1	CS2	CS3	CS4
38	RC Slab	SF	3936	3756	160	20	0
1130	Cracking (RC and Other)	SF	180	0	160	20	0
(38) Deck: 32.8' wide x 120' long. Scattered longitudinal cracks in all spans. Span 4: Tightly-spaced cracking along centerline - 20 sqft CS3.

Deck cracking span 1 left.

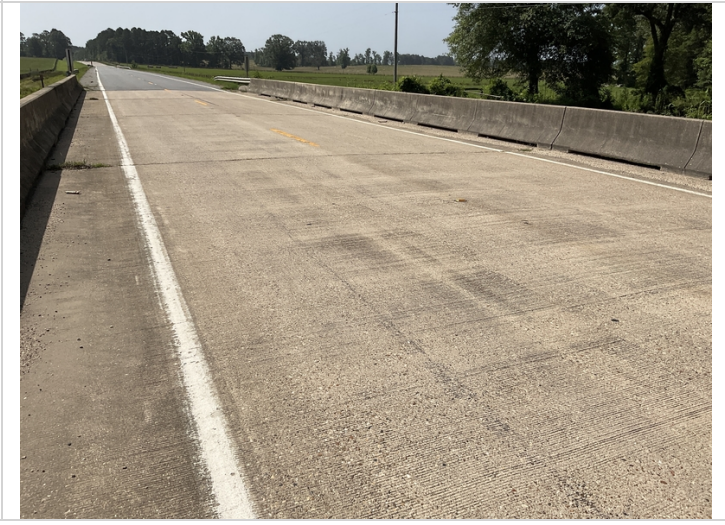
Deck over view.

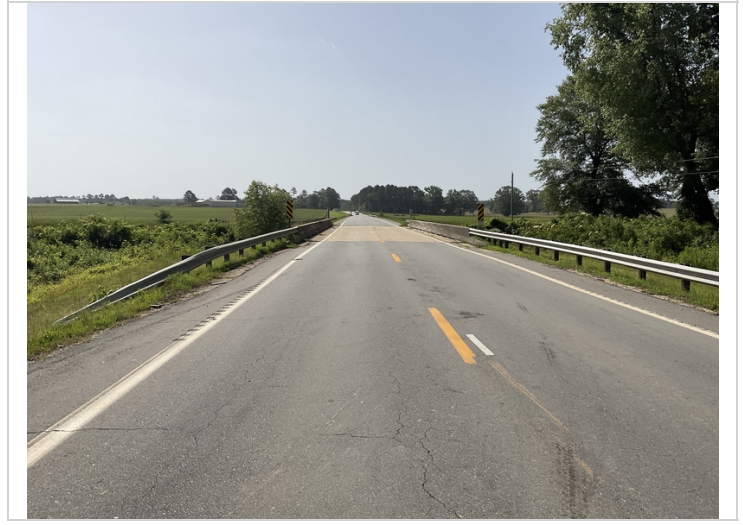
Approach.

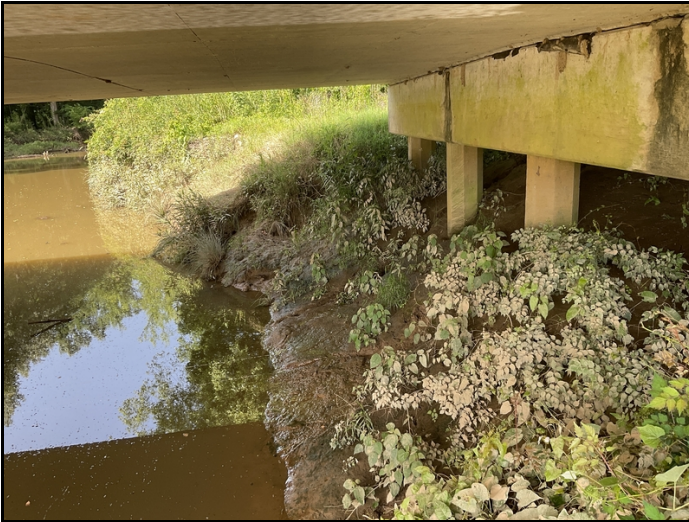
Endslope - Bent 2: Erosion of channel/slope material between Piles 3-4.

Bent 2 endslope erosion.

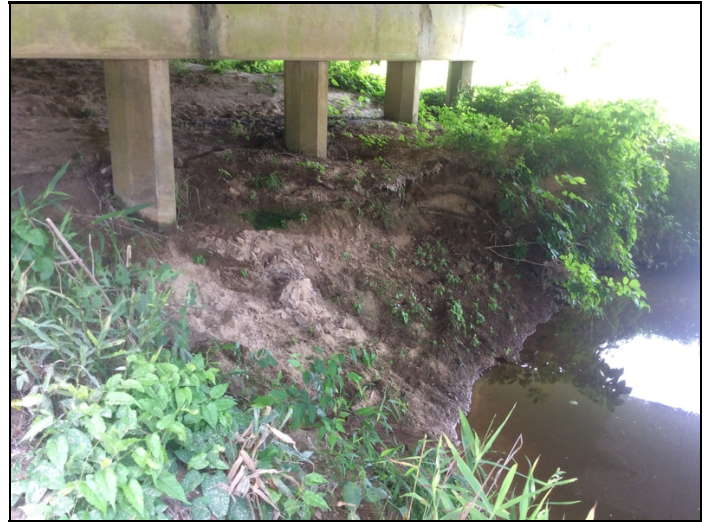
Endslope - Bent 2: Erosion / Scouring

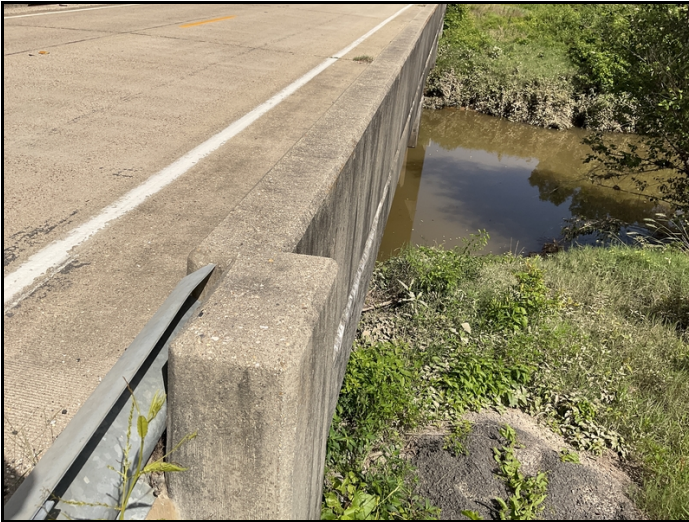
Both ends of bridge, Trees vines and vegetation impeding inspection.

Trees, vines and vegetation.

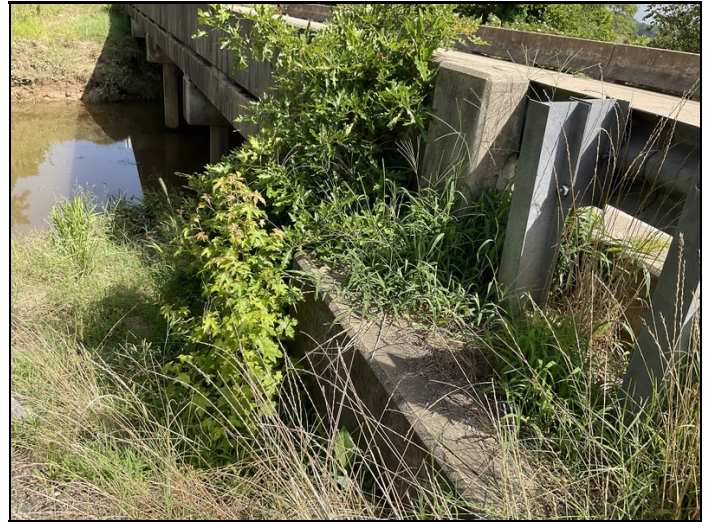
Trees, vines and vegetation tree growing at Bent 5 right side of abutment.

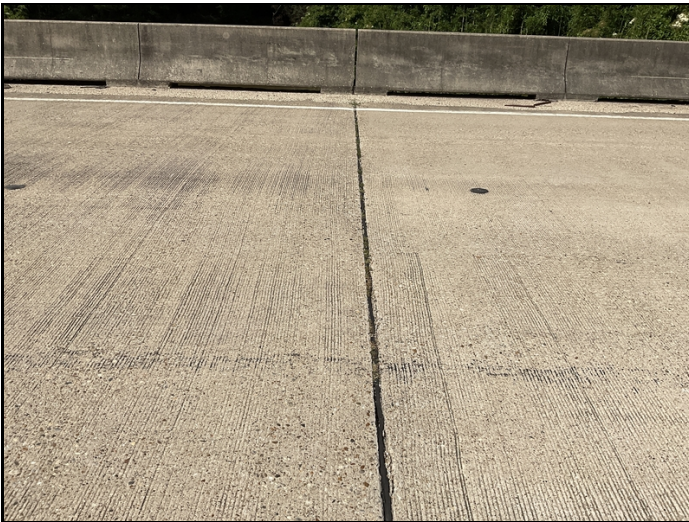
Joints - Bents 2-4: Pourable joint material is intact but has lost adhesion in most places with some very light spalling of adjacent concrete.

Bent 3 joint seals have loss of adhesion.

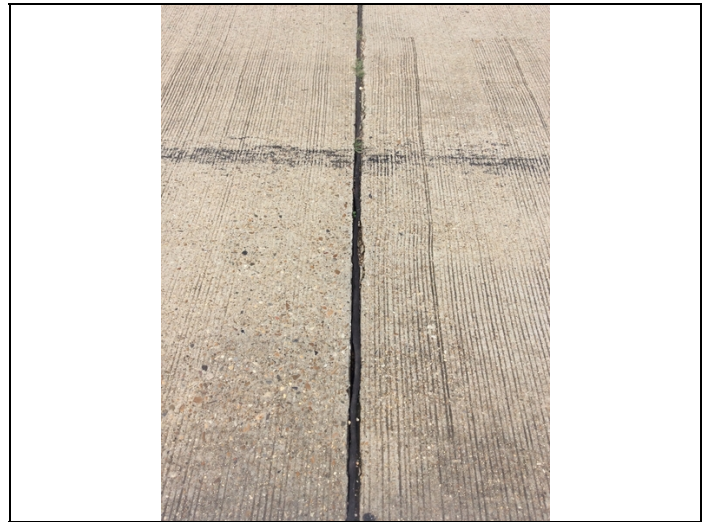
Joint - Bent 3: Loss of adhesion

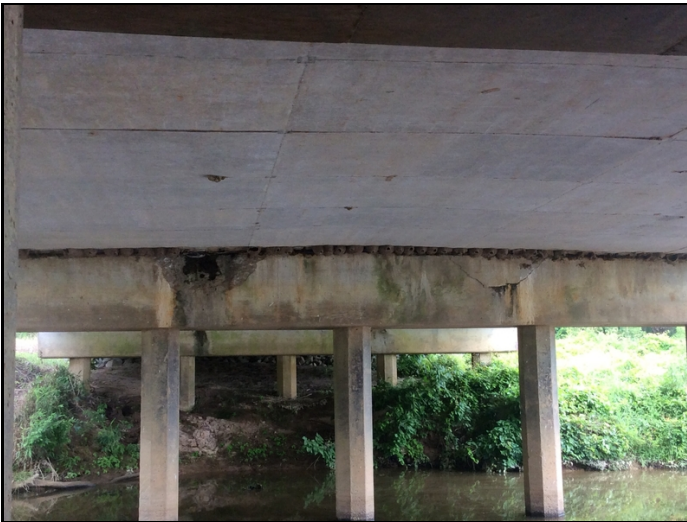
Cap - Bent 3 ahead face: Large spall with exposed rebar @ key-way between Piles 3 & 4 / delamination @ key-way between Piles 2 & 3.

Cap - Bent 3 : Spalls and delaminations

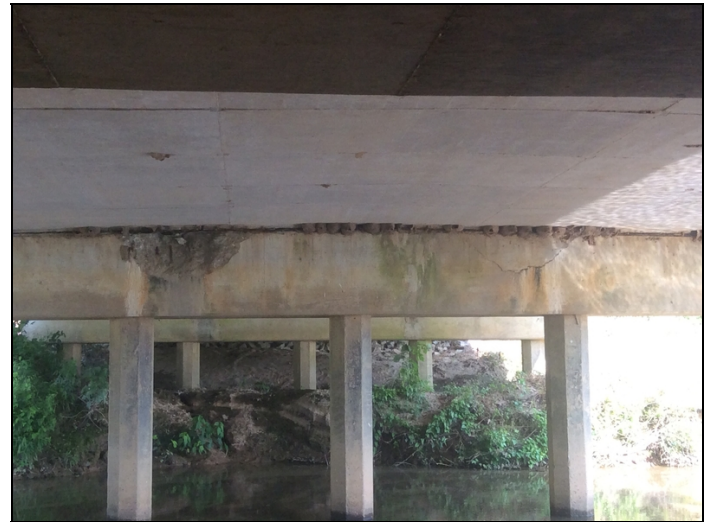
Bent 3 ahead spall with exposed rebar and delamination.
