Asset #06144(Routine)

SH 35-07 LM 4.33 over Hundley Creek Relief

Location: 4.33 Mi E ClevelandCo-Rye

Team Lead: Greg Loomis, Inspection Date: 05/24/2023

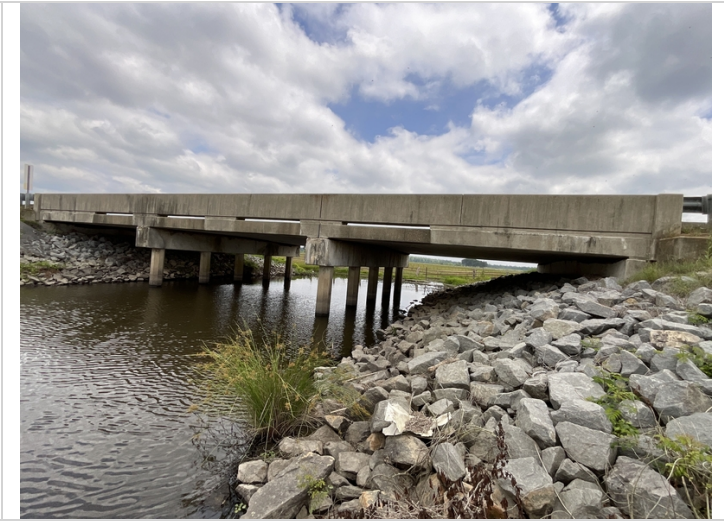
Right side view

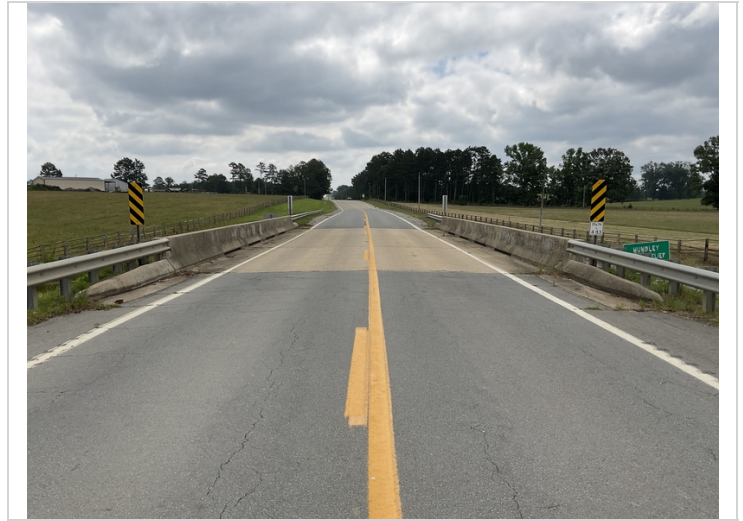
Roadway view

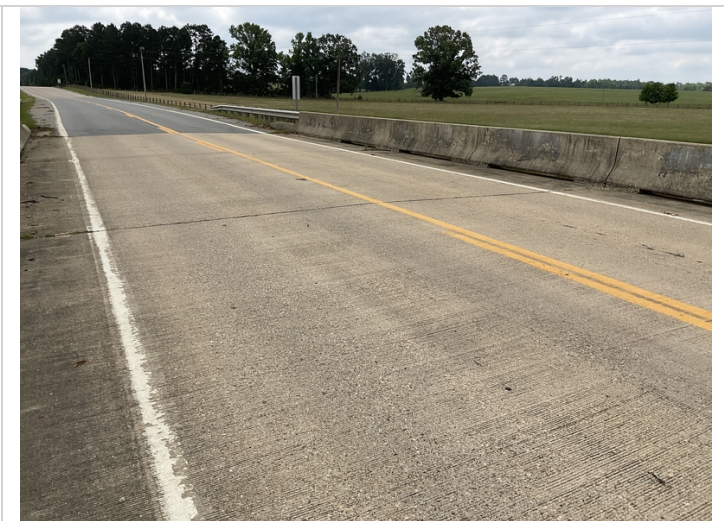
(38) Deck: 32'-10" wide x 75' long = 2462 sqft. Some hairline- to minor-sized longitudinal and diagonal (corner) cracks, with very little reflective efflorescence on soffit - 25 sqft CS2 cracking. Light abrasive wear in driving lanes - (2' wide x 75' long) x 3 ruts = 450 sqft CS2 abrasive wear. Side of slabs: Some minor vertical cracking with efflorescence near bents at beginning of drain-slots - 7 sqft CS2 efflorescence.							
215	Reinforced Concrete Abutment	LF	95	95	0	0	0

Deck - Spans 1-3: Typical

A-61 - Polymer Overlay Advised (Yes)

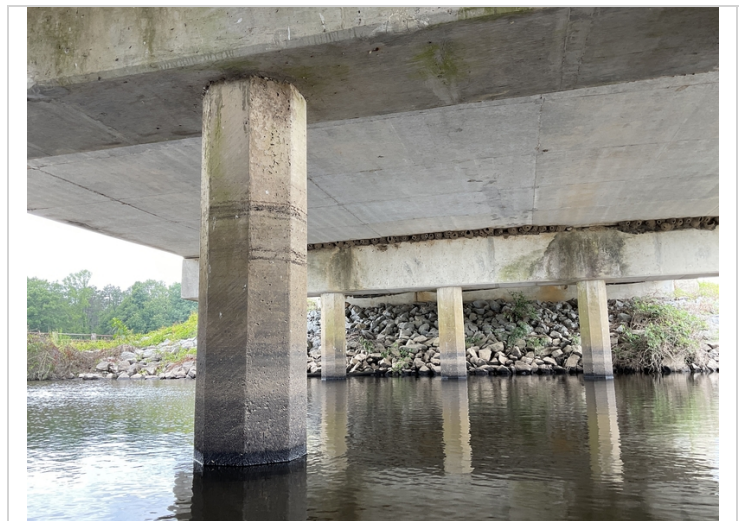
Soffit - Span 2: Typical
