Asset #06145(Routine)

SH 35-07 LM 6.76 over Hungerrun Creek

Team Lead: Sharon Hooks, Inspection Date: 06/09/2020

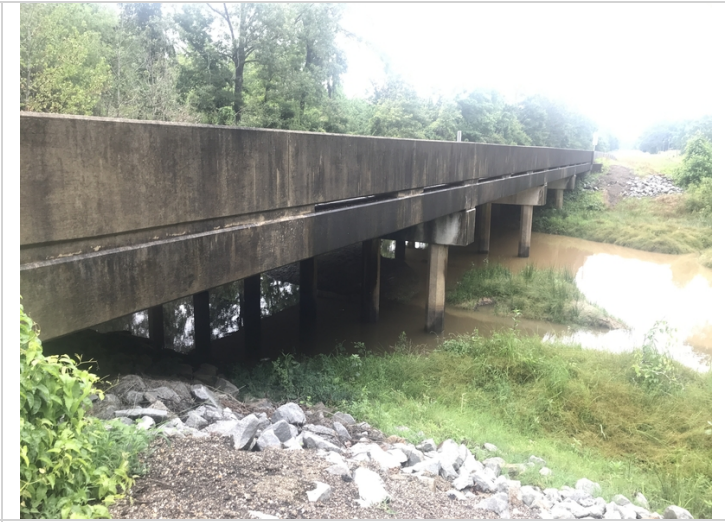
Elevation.

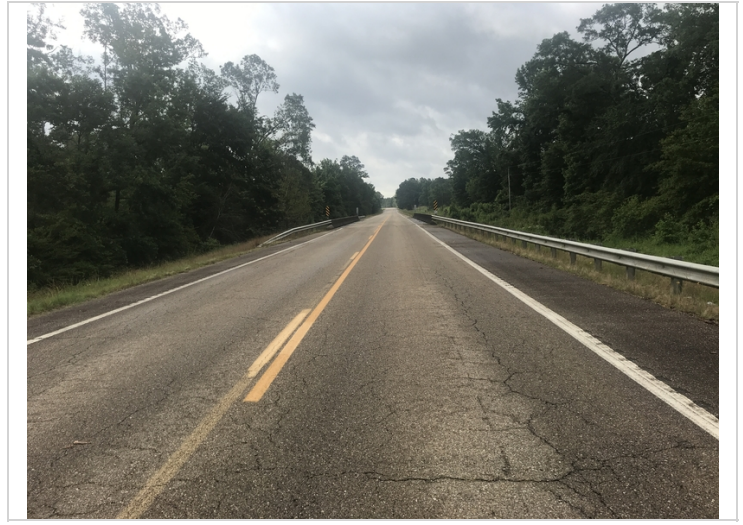
Approach.

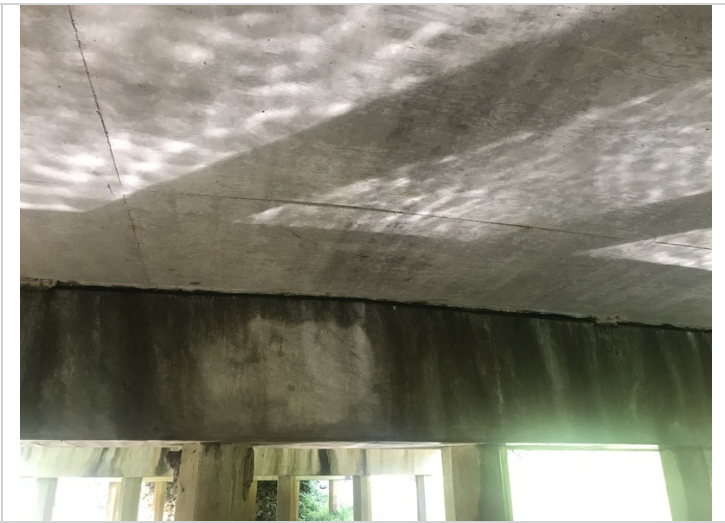
Overview of soffit.

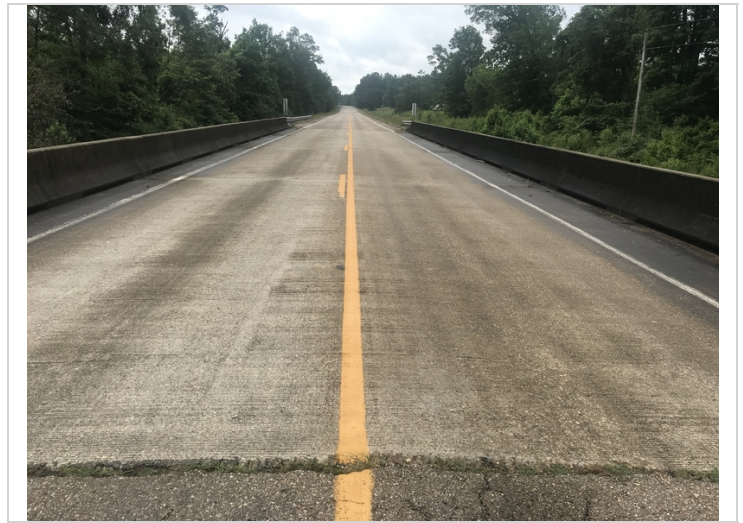
Deck overview.

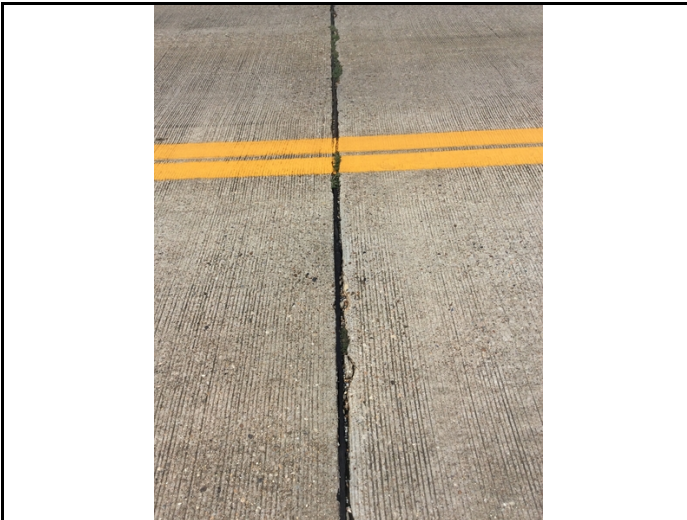
(301) Joints: 30' each / Bents 2-4. Bents 2-4: Pourable joint material is intact but has lost adhesion in most places with some very light spalling of adjacent concrete.							
331	Reinforced Concrete Bridge Railing	LF	280	280	0	0	0

Joints - Bents 2-4: Pourable joint material is intact but has lost adhesion in most places with some very light spalling of adjacent concrete.

Joint - Bent 2 : Loss of adhesion
