Asset #M0804(Routine)

SH 35 S-5 LM 16.23 over DITCH

Location: 1.04 MI W JCT SH 15

Team Lead: Rickie Bratton, Inspection Date: 09/11/2023

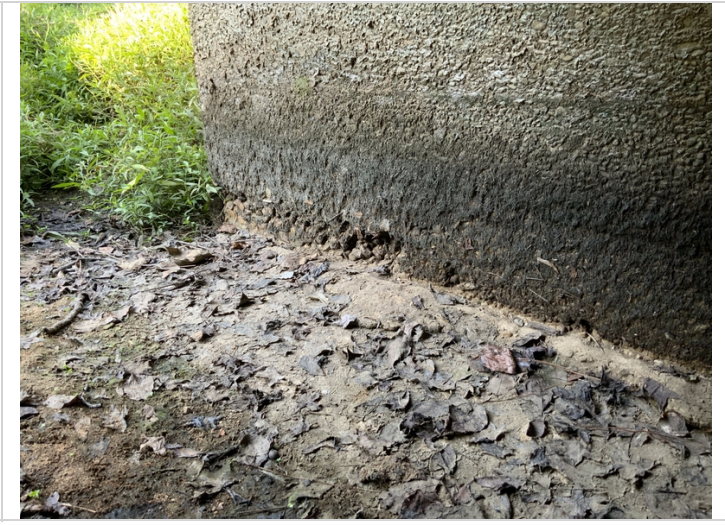
Barrels have a few minor vertical cracks, with coarse abrasion at bottom of walls.

Moderate abrasion at bottom of divider wall.

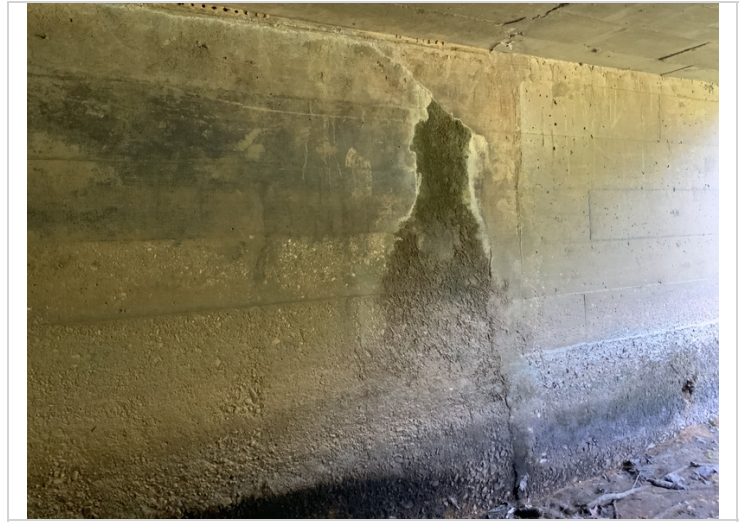
| ELEMENTS | DESCRIPTION | UNITS | TOTAL | <div> <div></div> <div></div> <div></div> <div></div> </div> | | | |
|--|---|---|---|--|---|---|---|
| (241) Barrels have a few minor vertical cracks, with coarse abrasion at bottom of walls. | | | | | | | |

Barrel 2 cracks
