Bridge #02712(Routine, Underwater type 2)

State Highway 45 over Brush Creek-Washington

Team Lead: Eric West Inspection Date: August 22, 2022

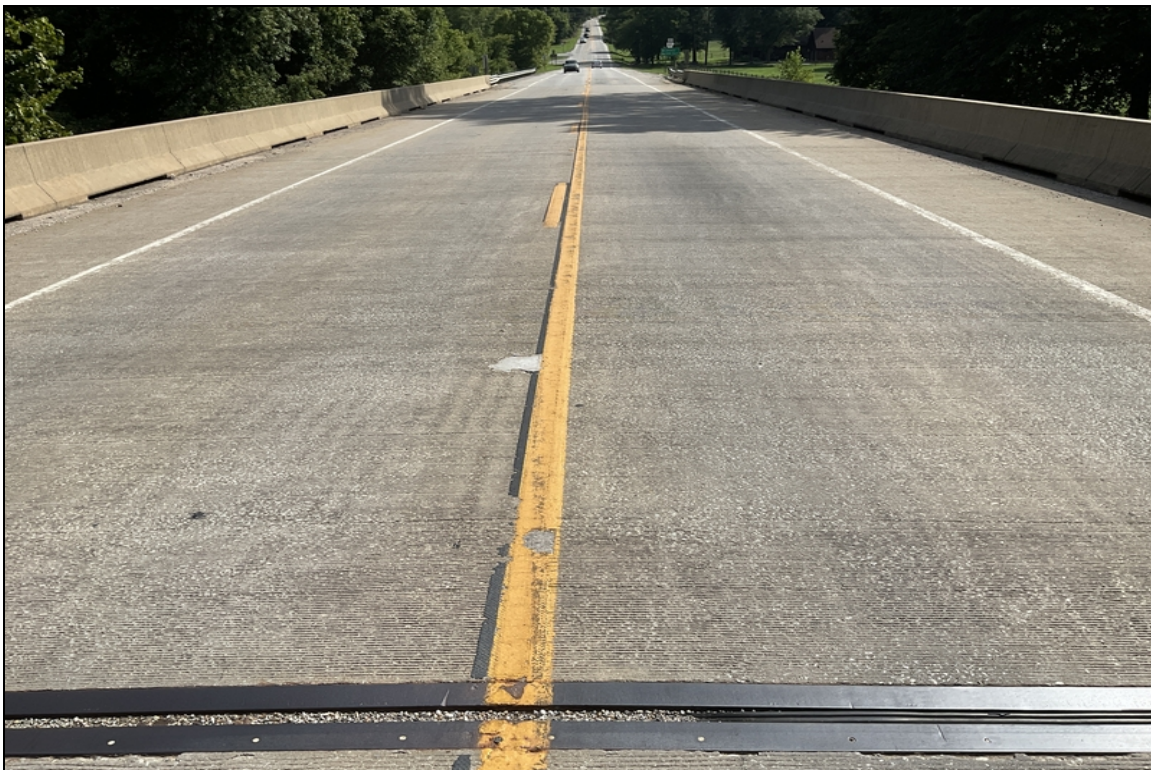
Typical driving surface of the deck.

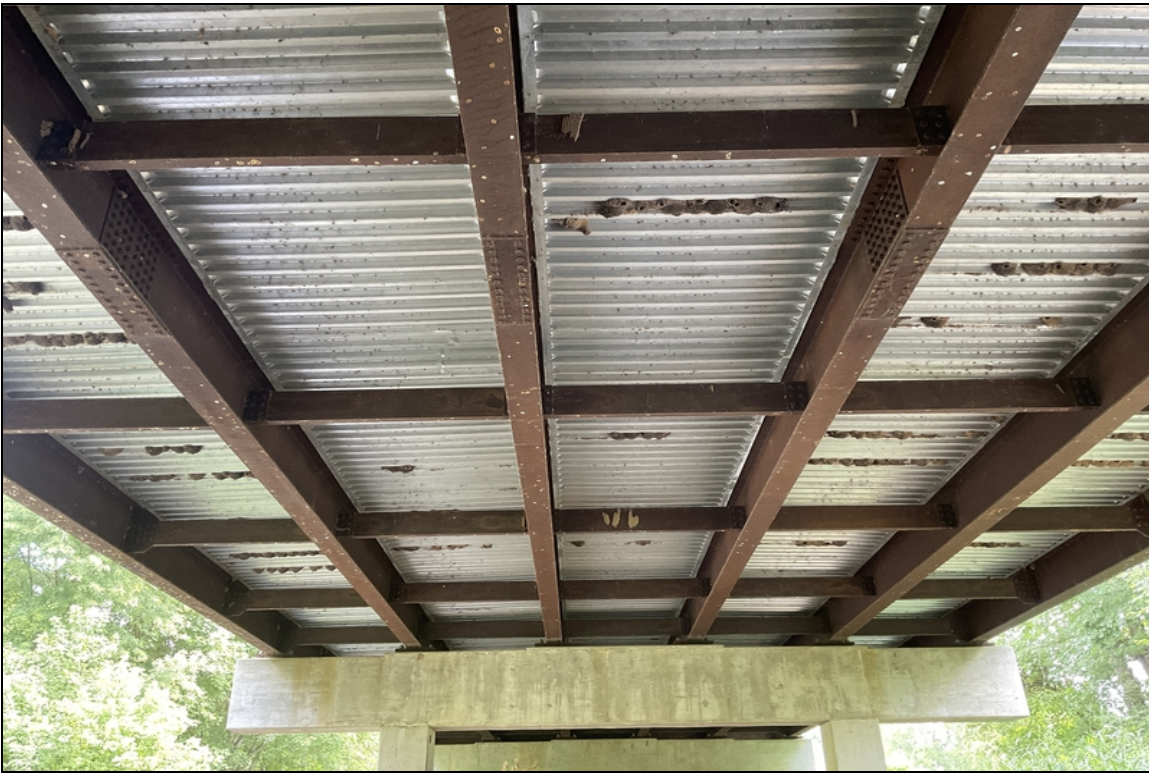
Typical undersurface of the deck.

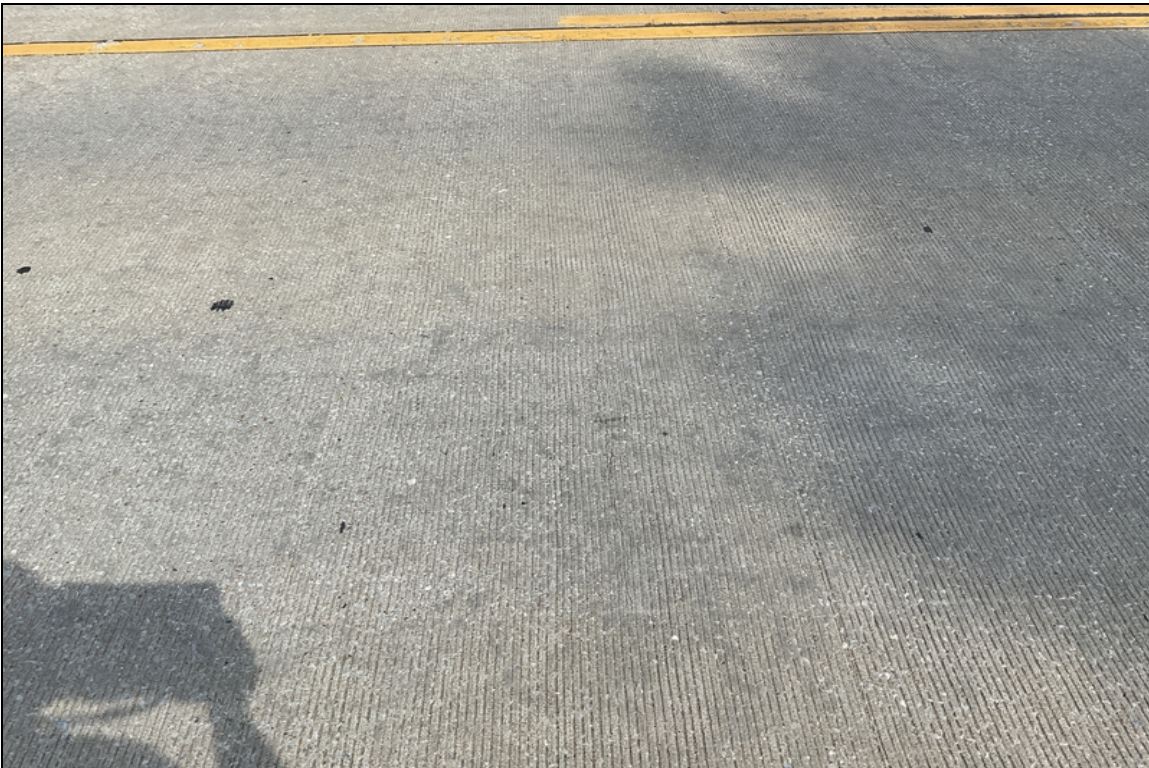
Sealable deck cracking.

Deck-
There are sealable transverse and longitudinal cracks in the driving surface of the deck.

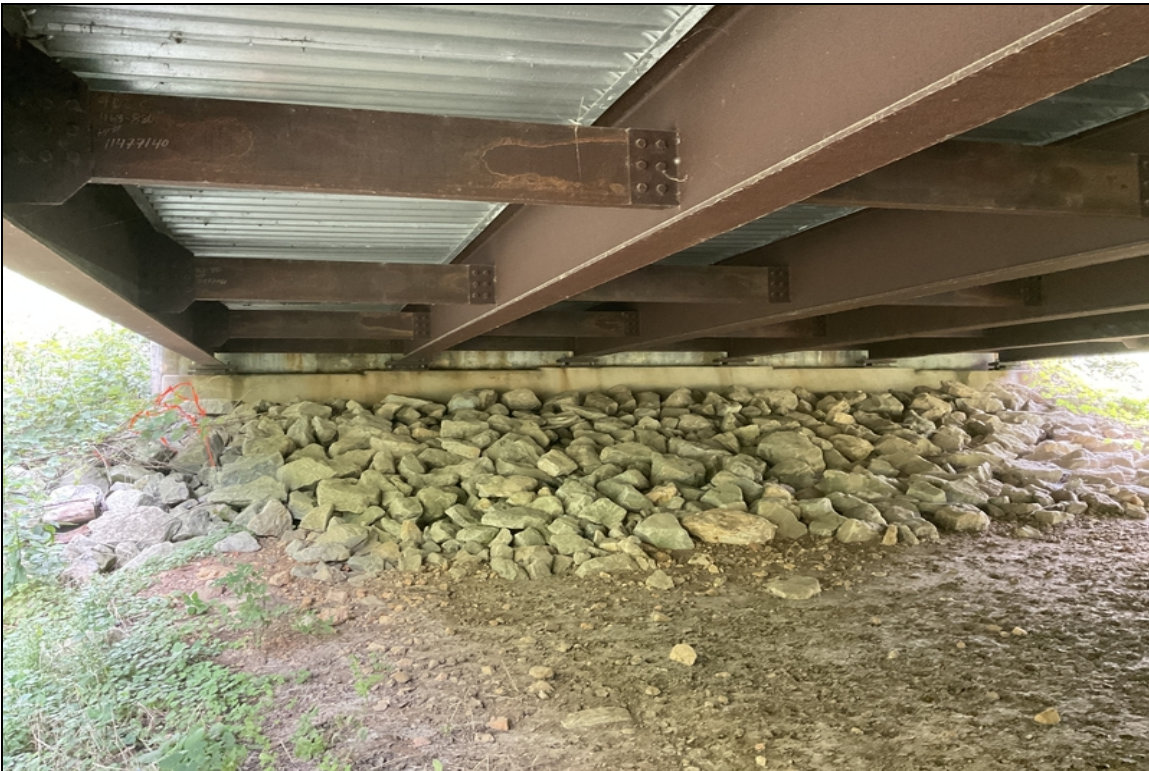
Abutment #2 typical.

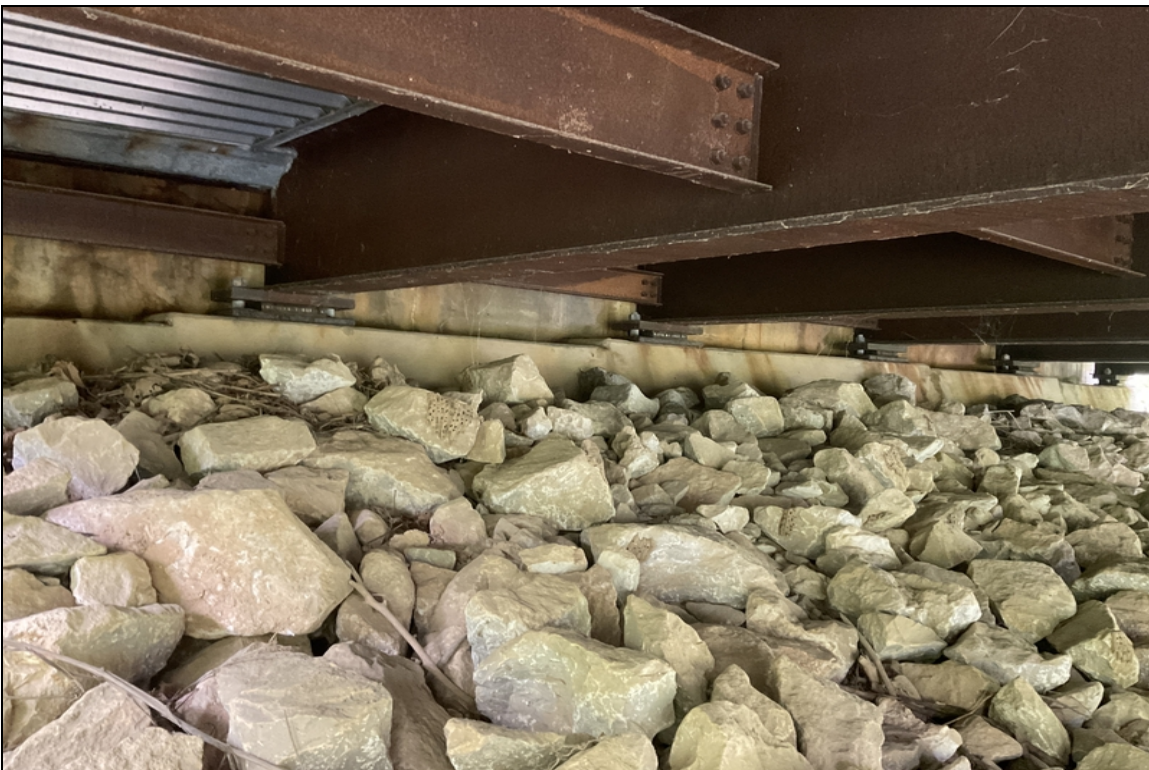
Abutment #1 typical.

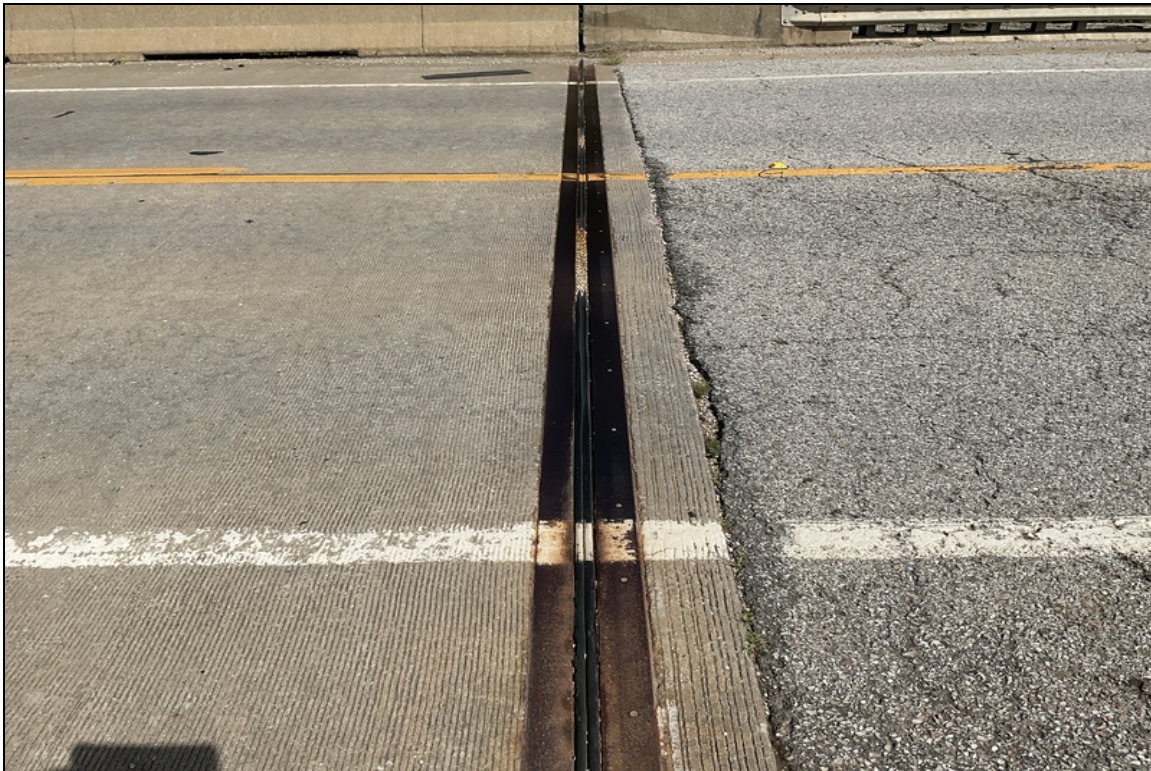
Abutment #2 compression joint seal.

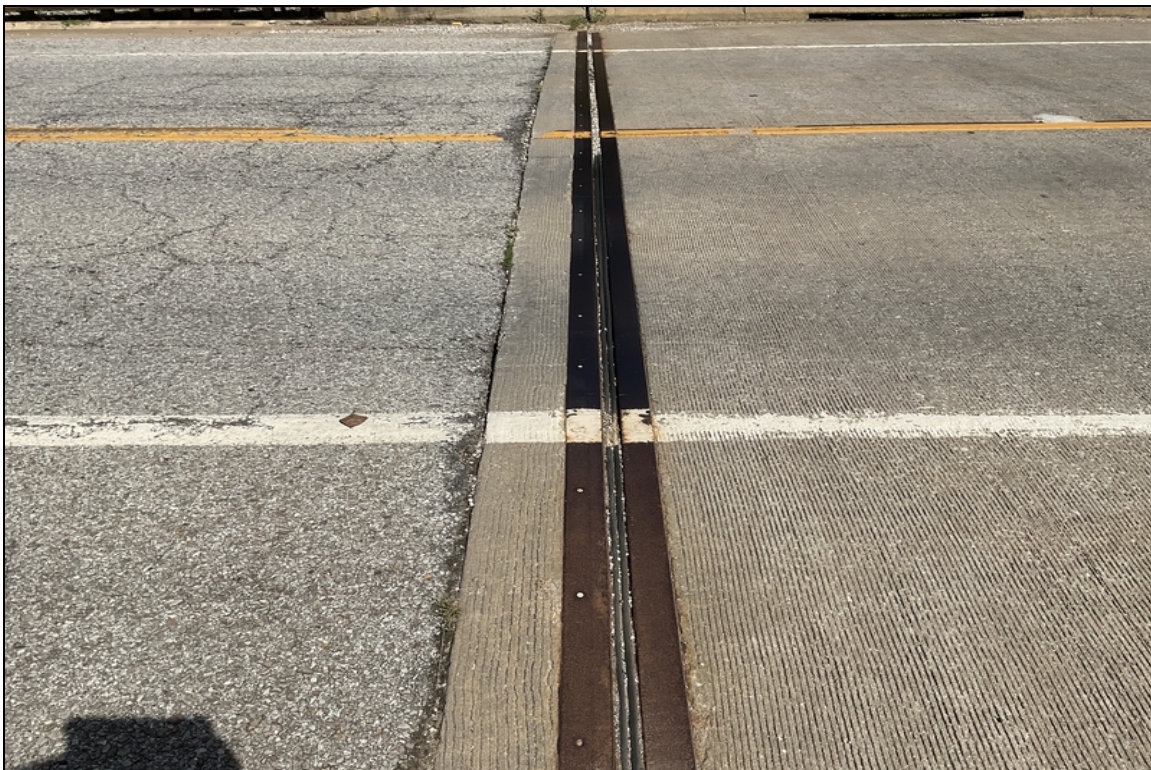
Abutment #1 compression joint seal.

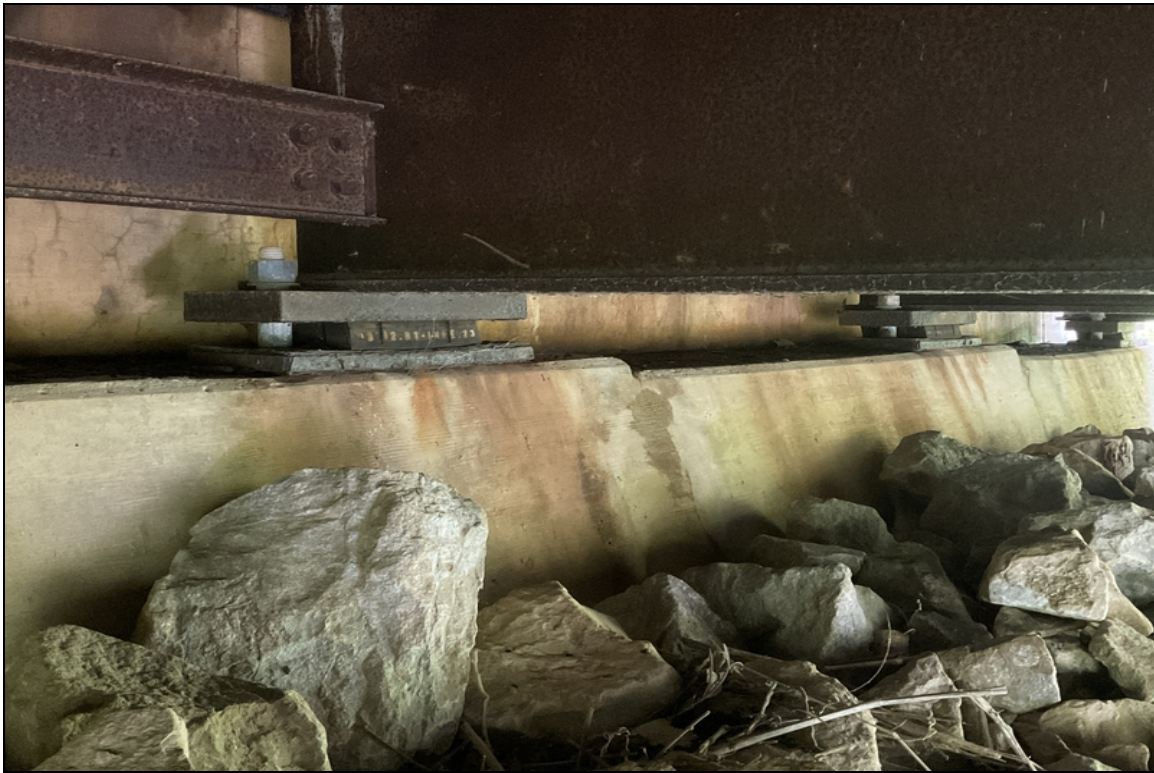
Abutment #1 typical elastomeric bearings.

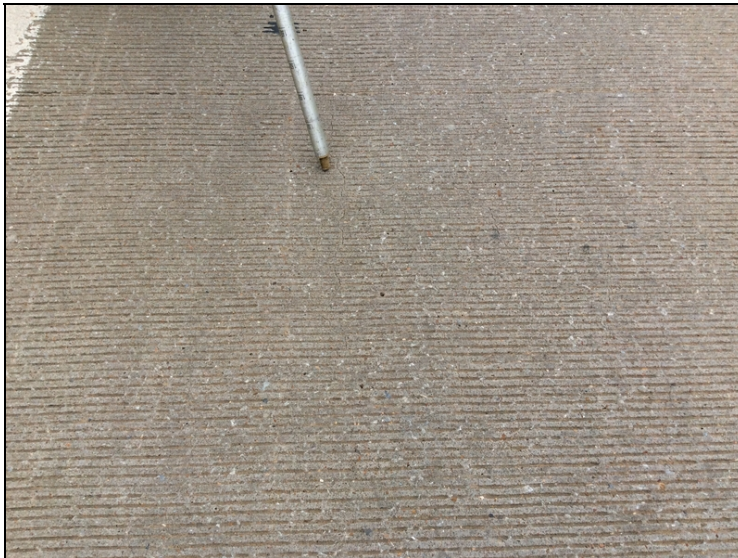
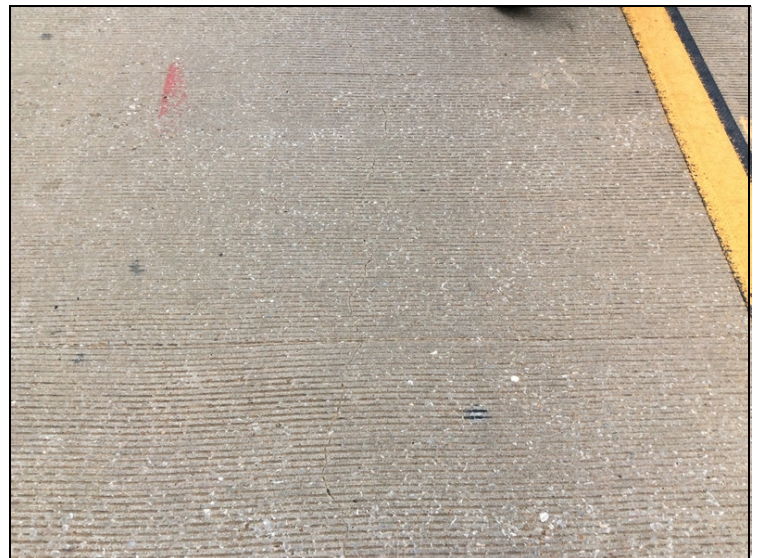
Deck. Sealable longitudinal crack.

Sealable longitudinal crack.

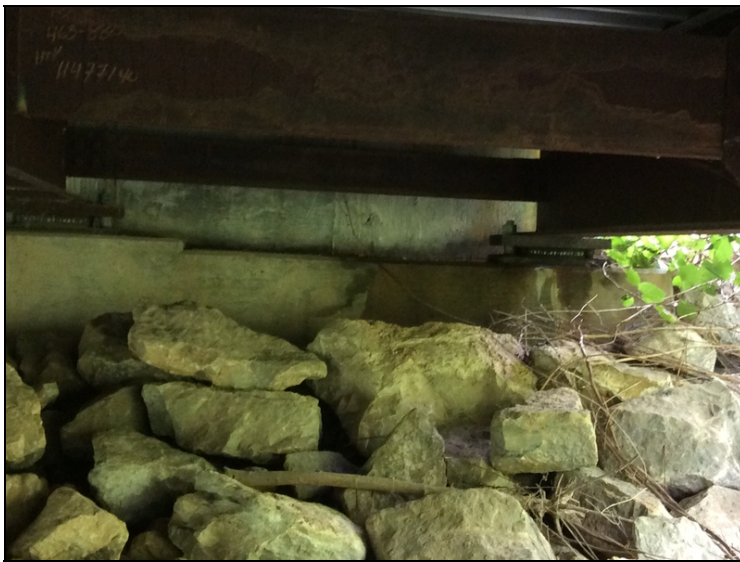
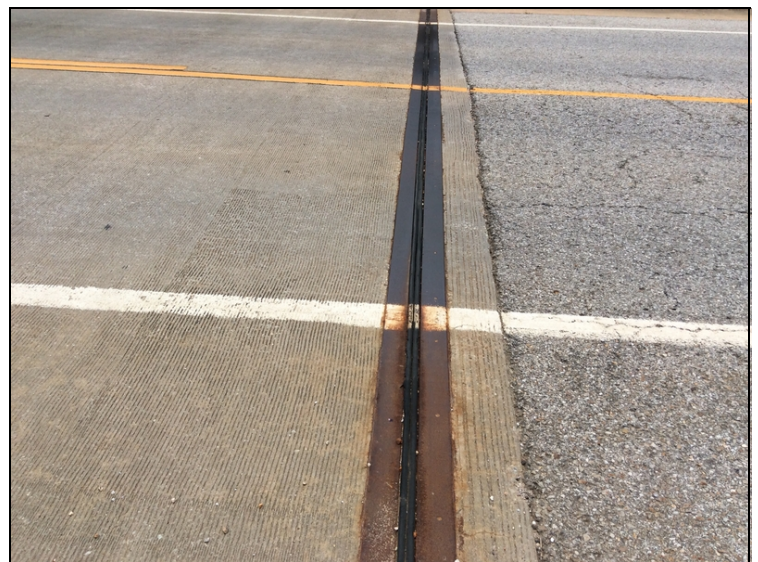
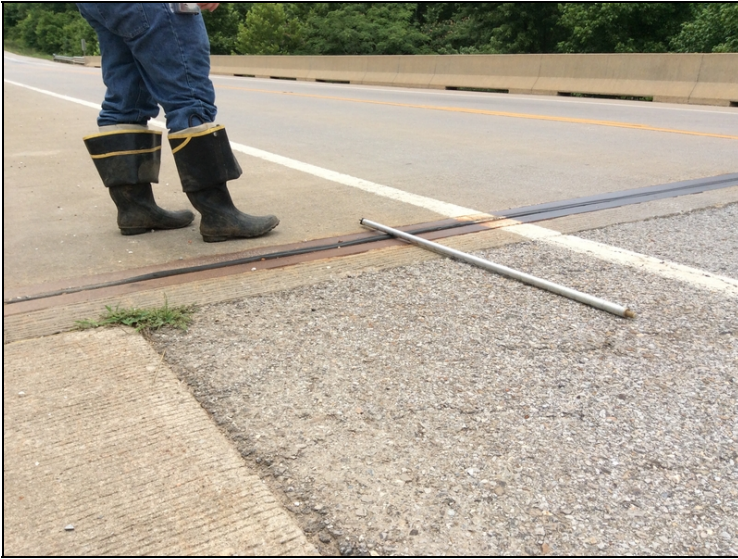
Compression Joint Seals-
The compression joint seals leak water on the bearings and substructure.

Right side of Bent # 5. Leaking expansion joint seal.

Bent # 5 expansion joint.

Expansion joint seal. Right side of Bent # 5.

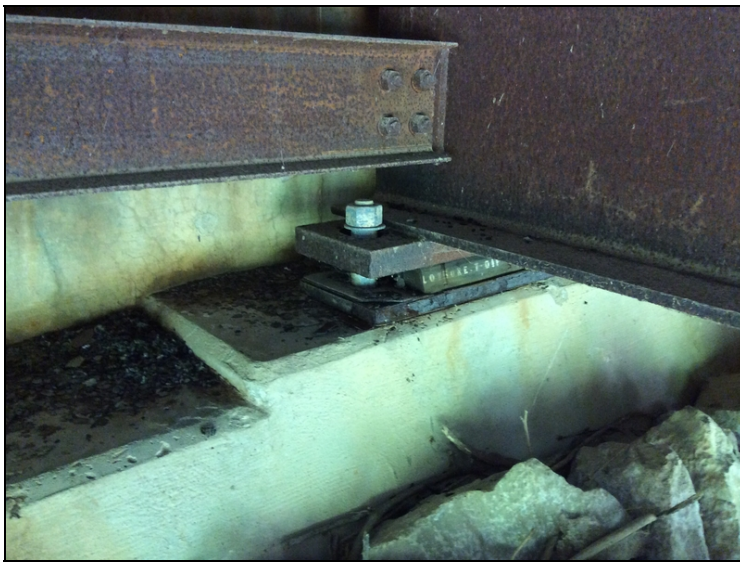
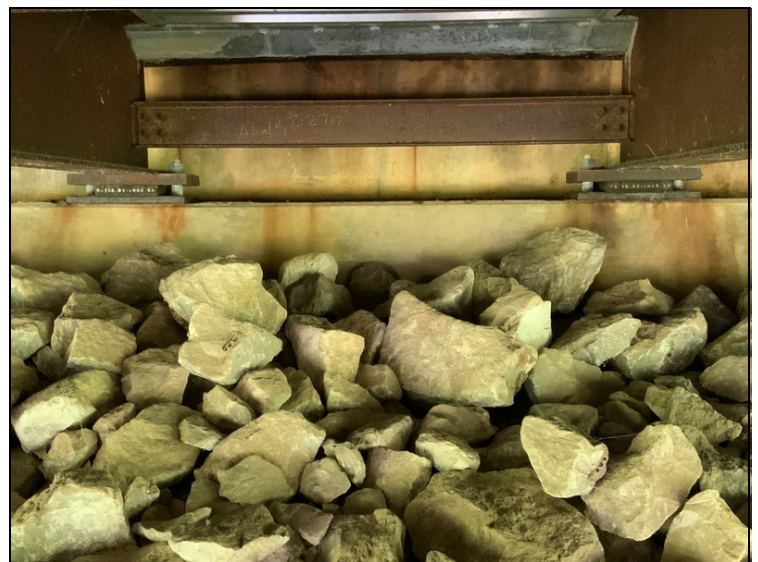
The masonry plates have active corrosion with flaking rust at the abutments where the expansion joint seals leak.

Bent # 1. Beam # 5. Active corrosion in the masonry plate.

Bent 1 Girder 3 & 4 Flaking rust

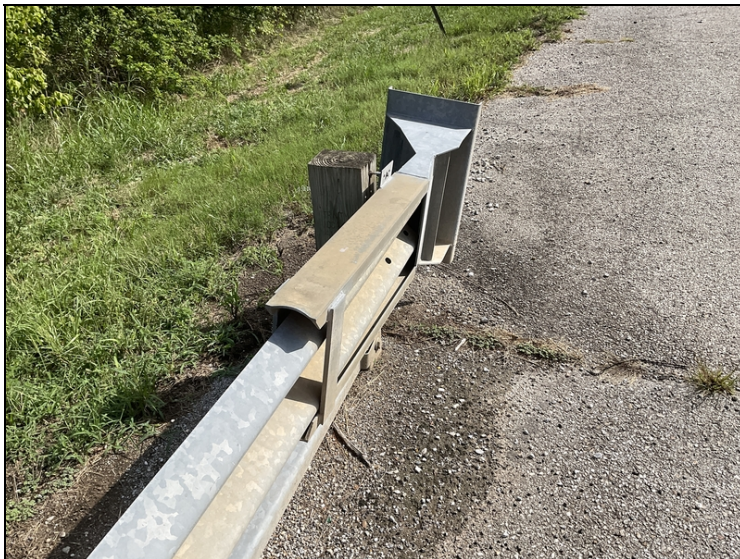
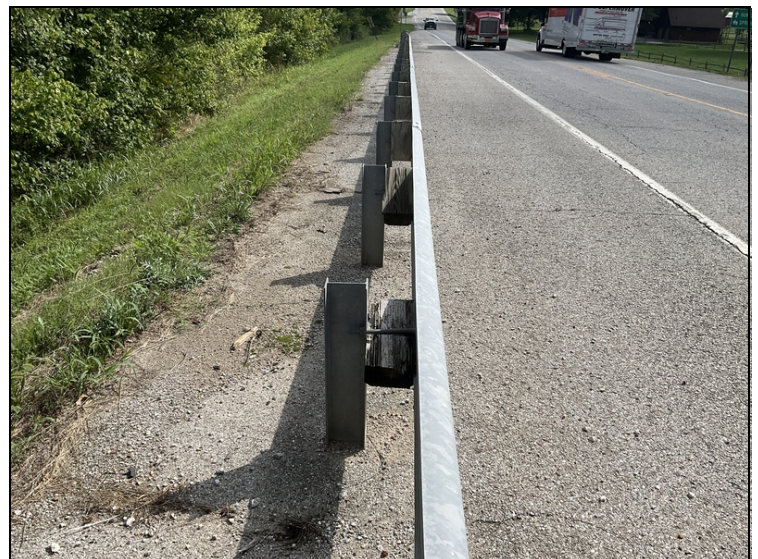
- The northeast and northwest approach guardrail end terminals have loose anchorage attaching the end terminal to the wood posts.
- The northeast approach guardrail has fractured wood blocks between the guardrail and the rail posts.

Northeast approach guardrail end terminal.

Northeast approach guardrail with fractured wood spacer blocks.

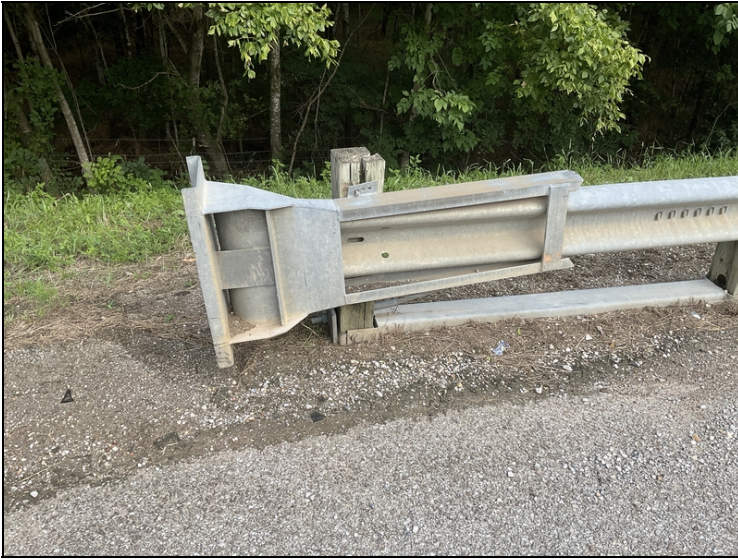
Northwest approach guardrail collision with a damaged post.

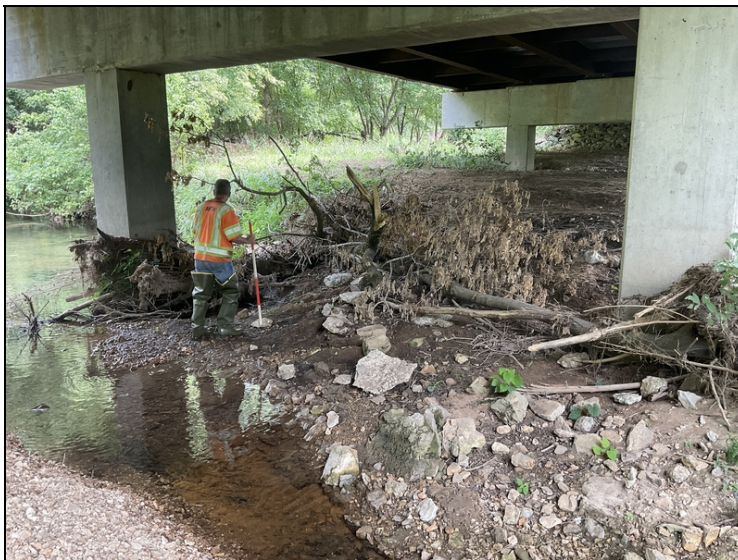
Channel-
Drift accumulation at bent # 3.

Bent #3 drift accumulation.
