Bridge #06789(Routine)

SH 45 over White River-Washington

Team Lead: Eric West Inspection Date: September 08, 2022

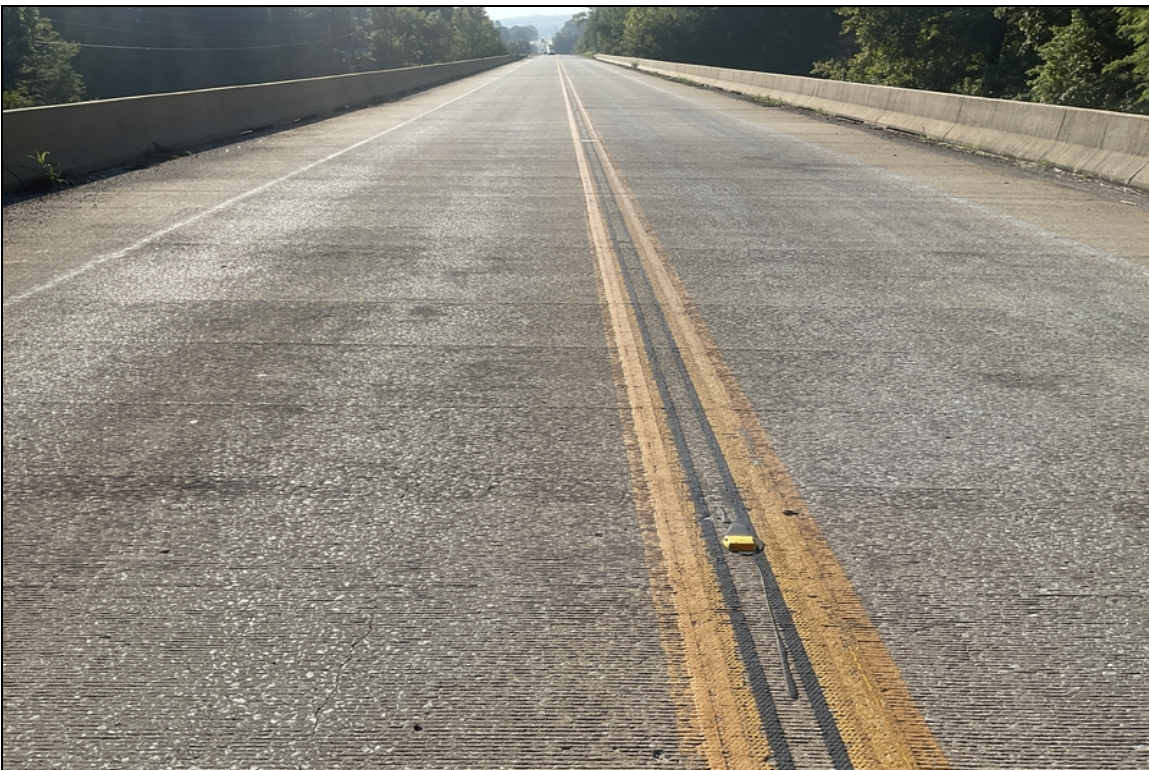
Typical driving surface of the deck.

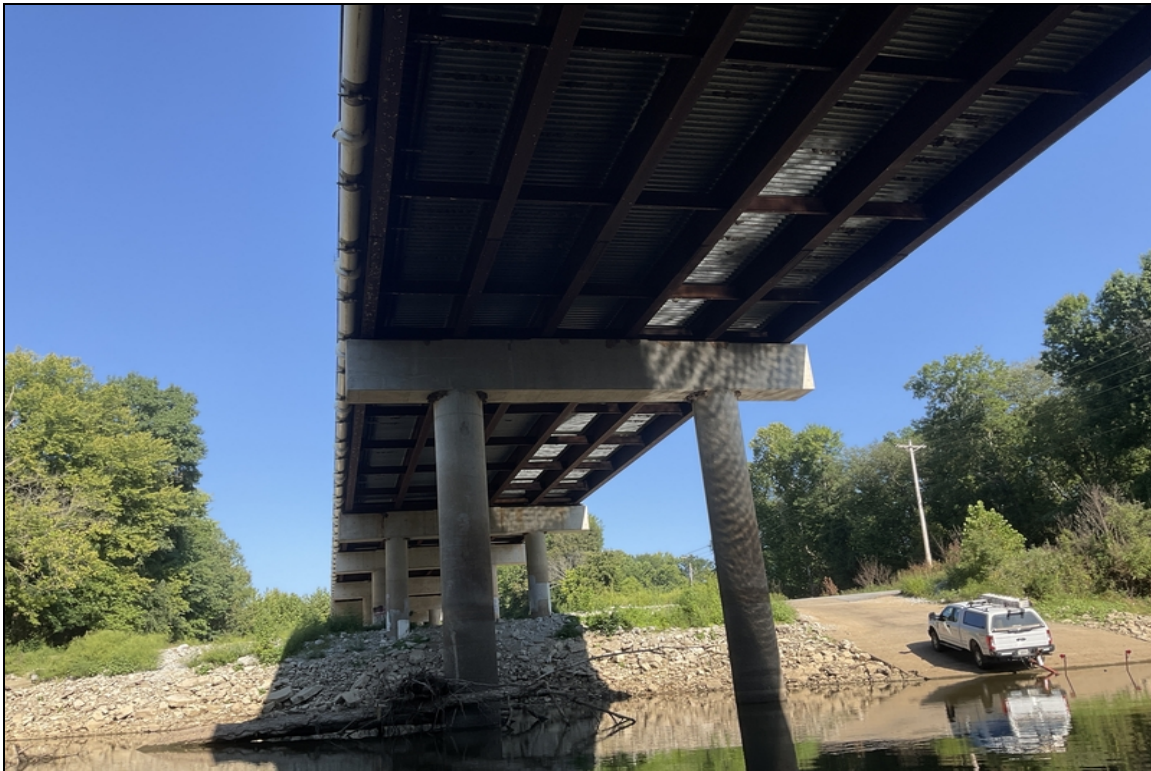
Typical undersurface of the deck.

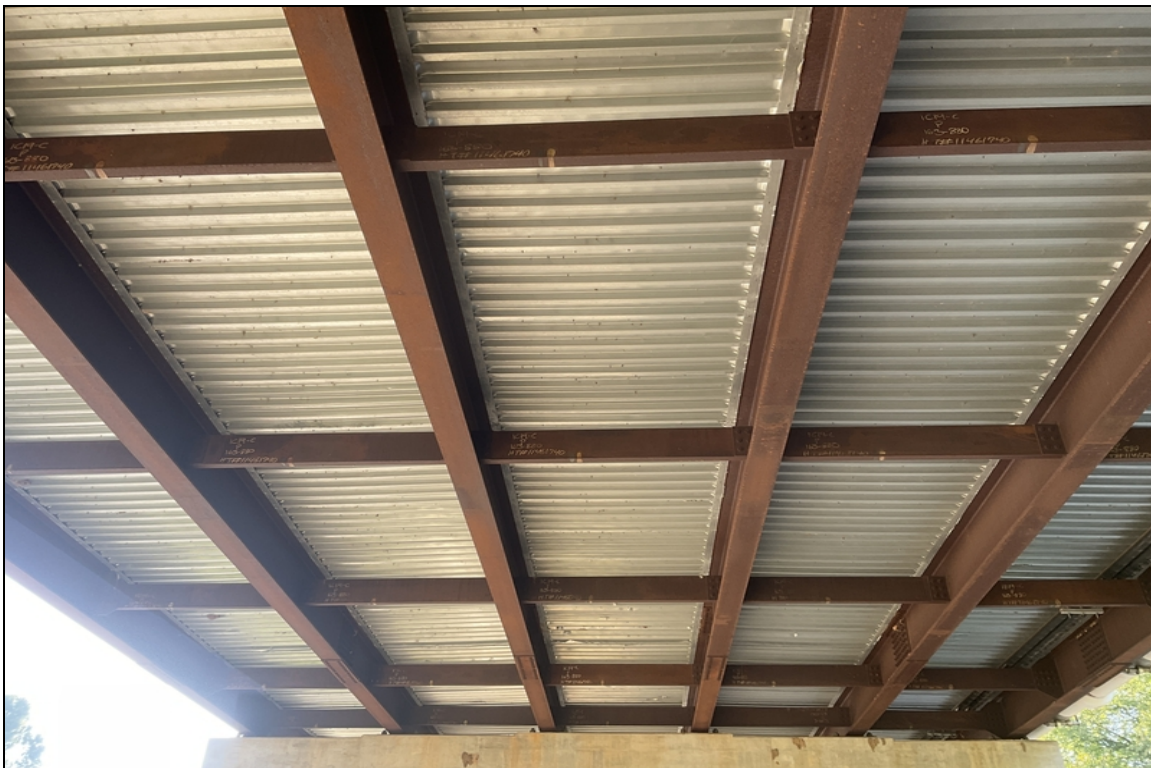
Typical undersurface of the deck.

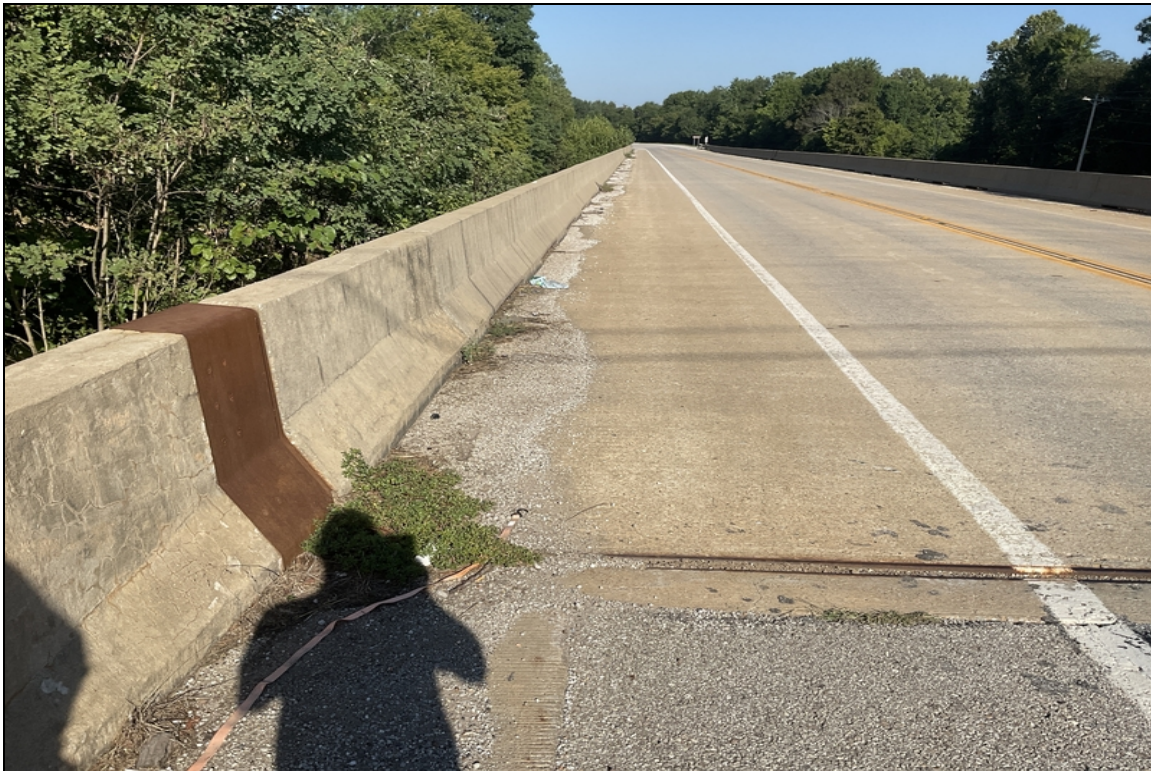
Debris accumulation in the gutters.

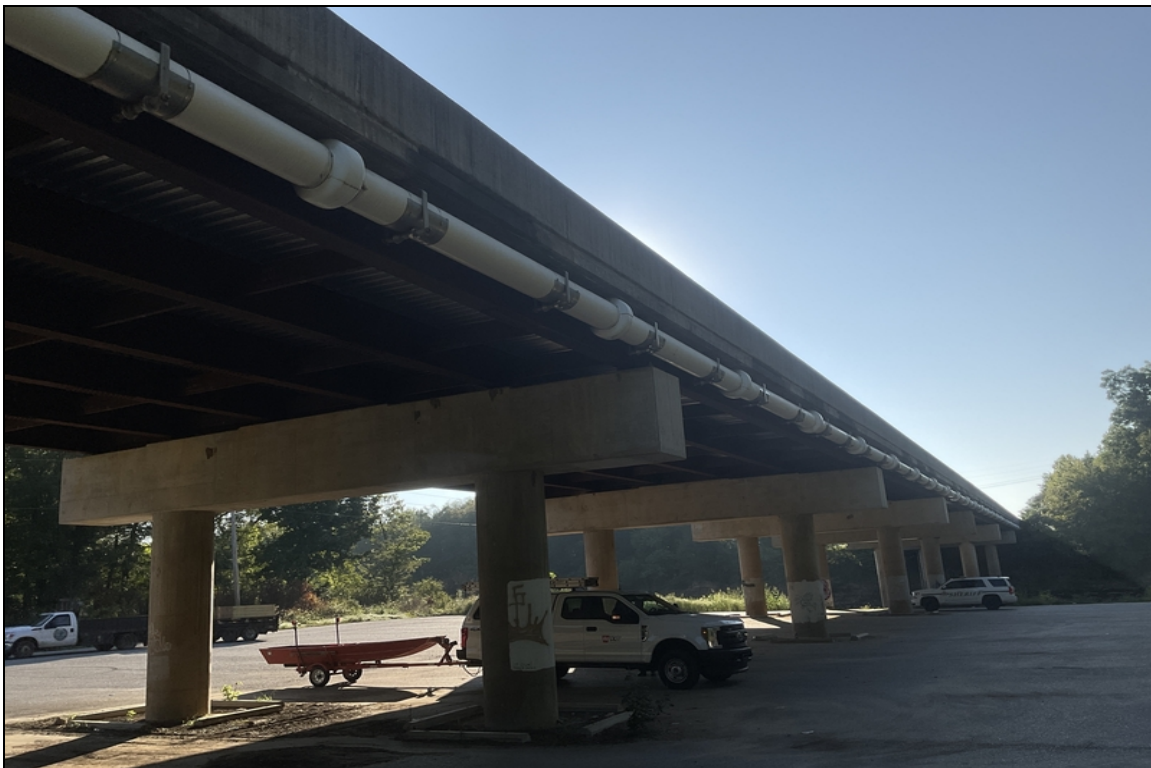
Utility attachment.

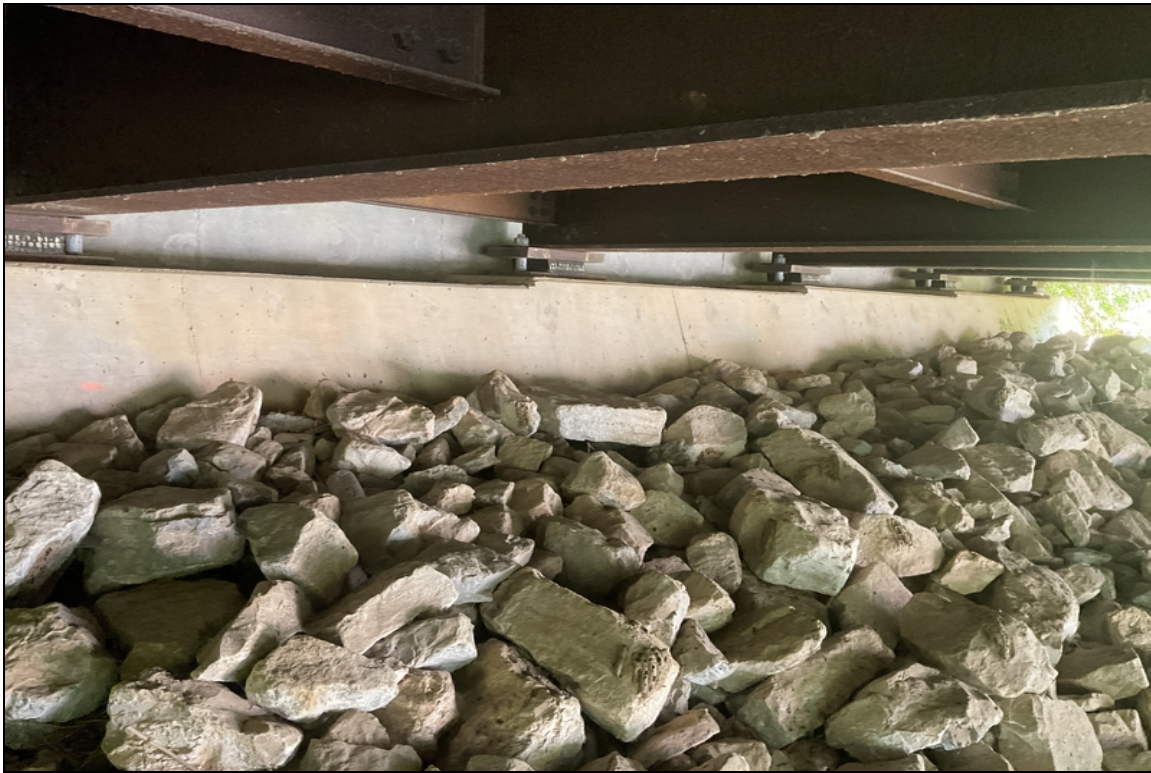
Abutment #1 typical.

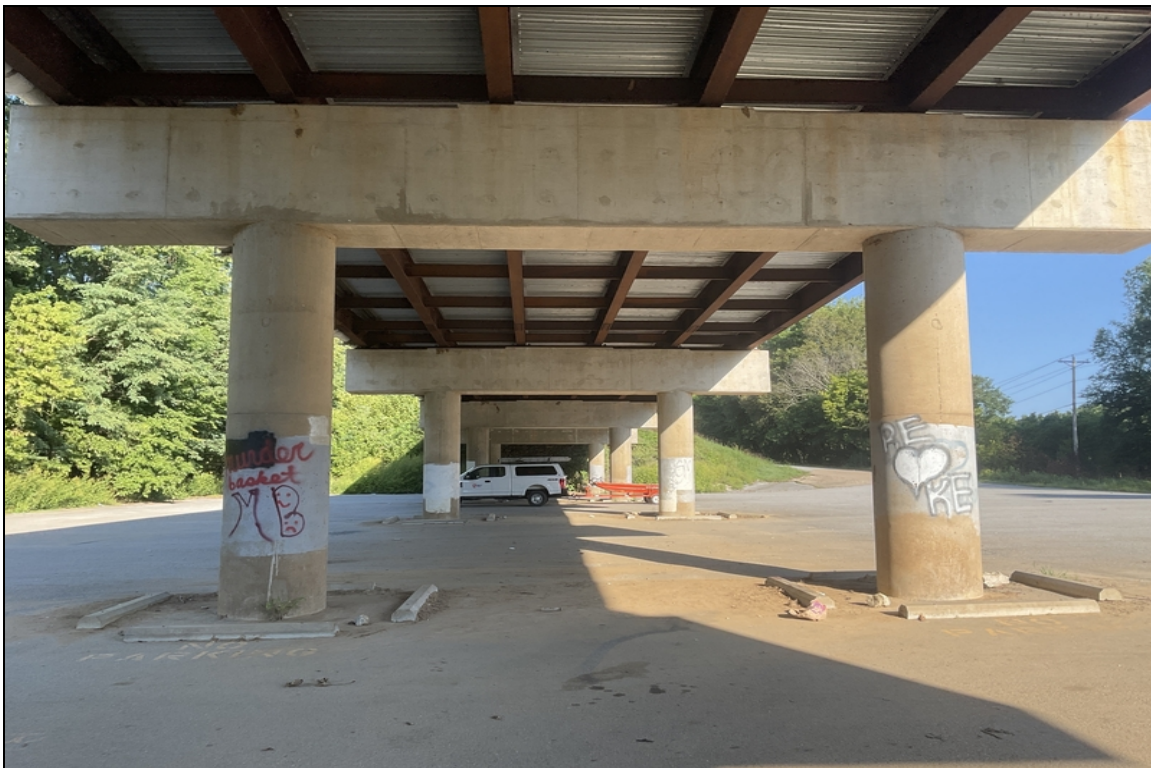
Bents # 2 - 5 typical.

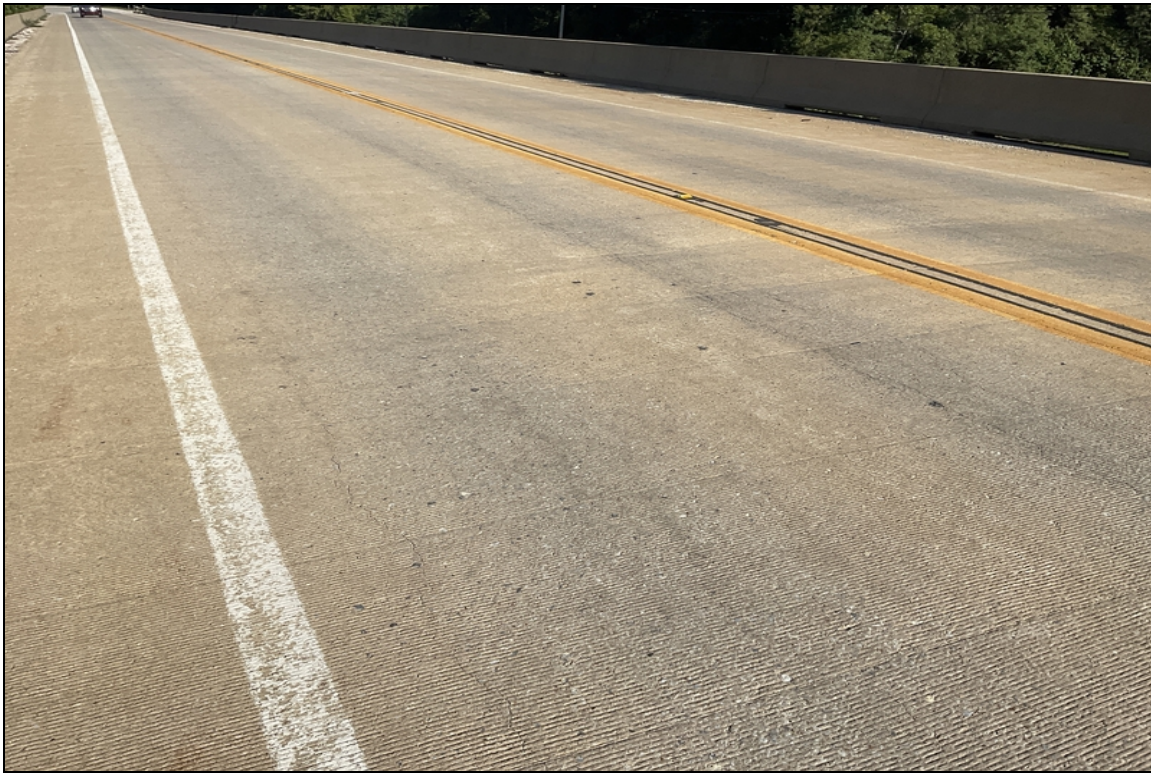
(12)							
-Transverse cracks with light efflorescence at variable spacing in the overhangs are visible from the undersurface of the deck. -Light wear in the wheel paths. -Sealable longitudinal cracks over the top flanges of Beams # 2, 3, 4, and 5. Cracks are full length of structure. -There are isolated areas where map cracking is beginning to propagate from the longitudinal cracks. -Transverse cracks that appear to correspond with the joints in the parapet walls. -There are sealable transverse cracks approximately 6 inches from the expansion joints at abutments # 1 and # 2.							
107	Steel Open Girder/Beam	LF	3229	3229	0	0	0
515	Steel Protective Coating	SF	34286	34286	0	0	0

Typical longitudinal deck cracking over the beams.

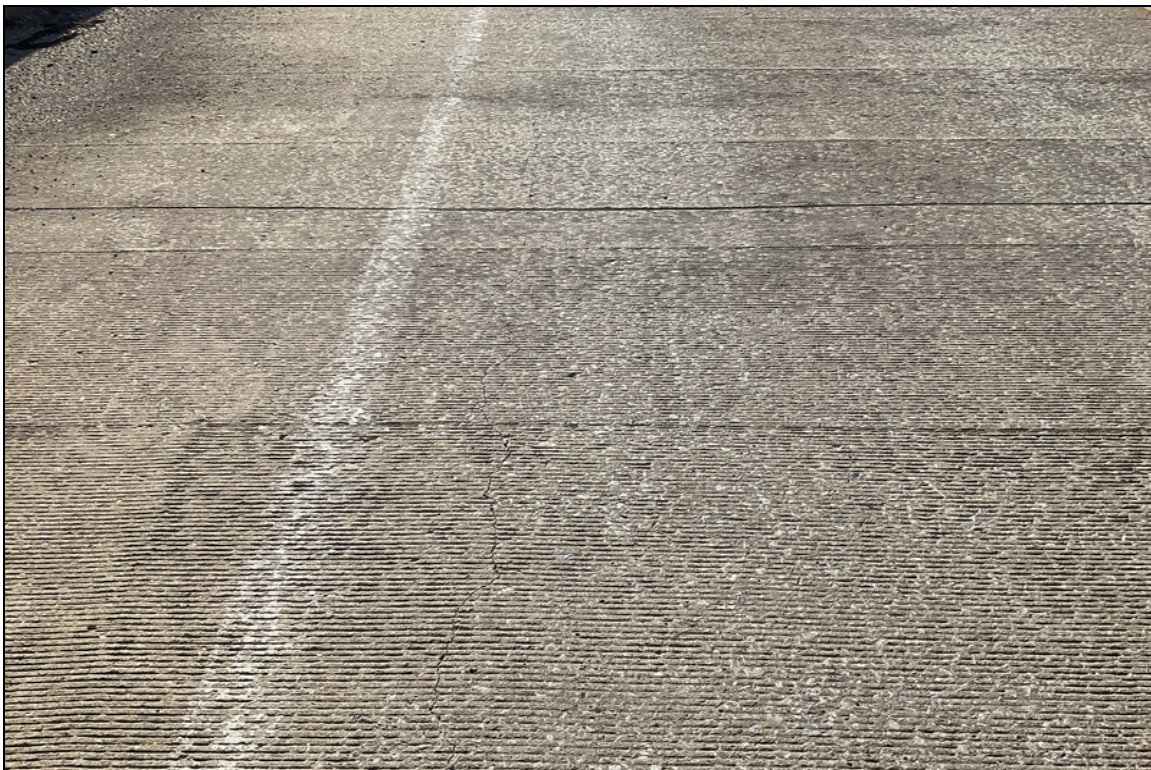
Sealable deck cracking.

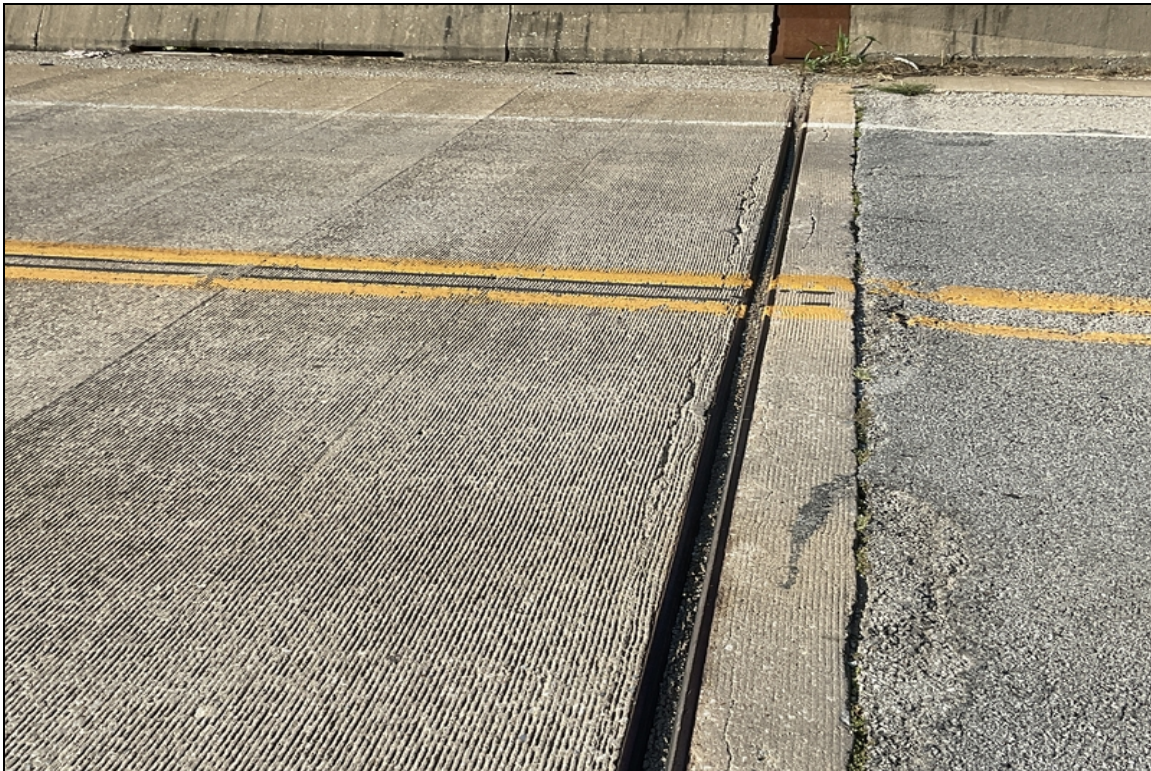
(300)							
-Expansion joints are located at Bents # 1, 6, & 9. -Transverse cracking in the deck located approximately 6 inches from the expansion joints at abutments # 1 and # 2. -There are no apparent changes to the transverse cracks in the deck adjacent to the expansion joints. -Strip seal joints are in place with a few areas of where the rubber bead is torn / partially pulled out of its track with no apparent leakage. -The expansion joint assemblies at all locations have dirt and debris accumulation the full width of assemblies.							
310	Elastomeric Bearing	EA	54	51	1	2	0
1000	Corrosion	EA	3	0	1	2	0
515	Steel Protective Coating	SF	216	203	4	3	6
3430	Oxide Film Degradation Color/Texture Adherence(Steel Protective Coatings)	SF	13	0	4	3	6

Span #1 wide cracking adjacent to the strip seal expansion joint.

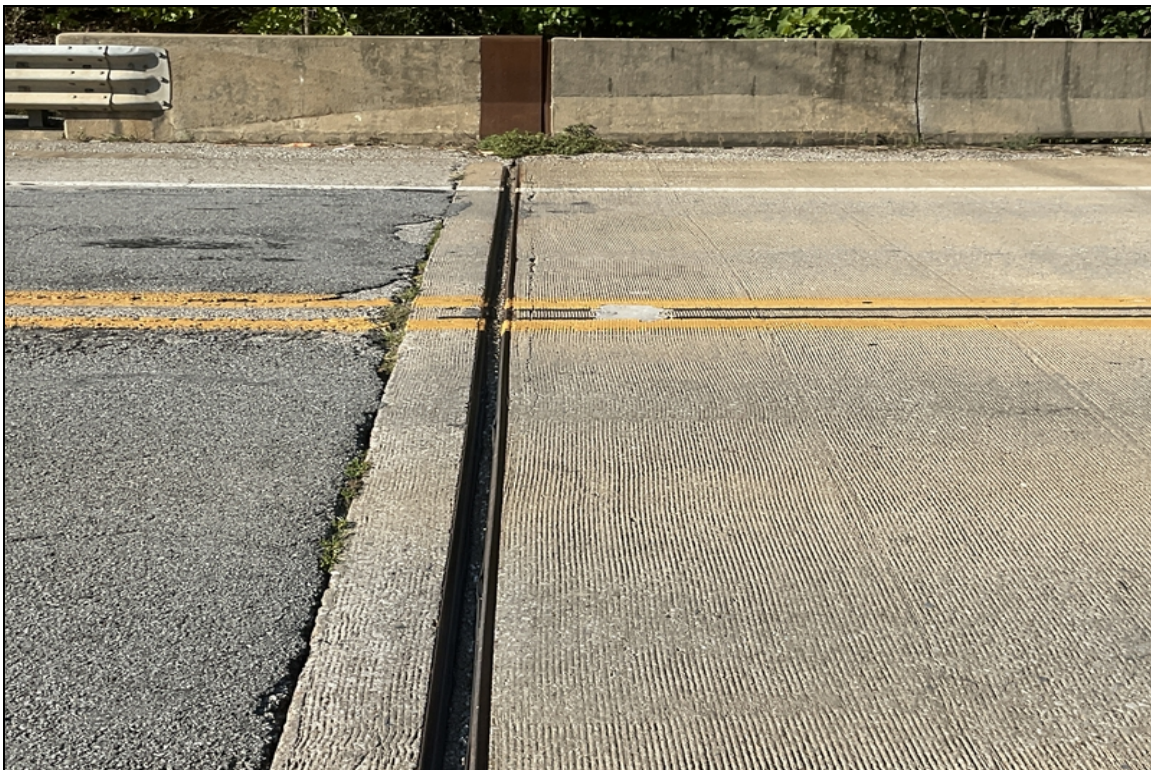
Span #8 cracking adjacent to the strip seal expansion.

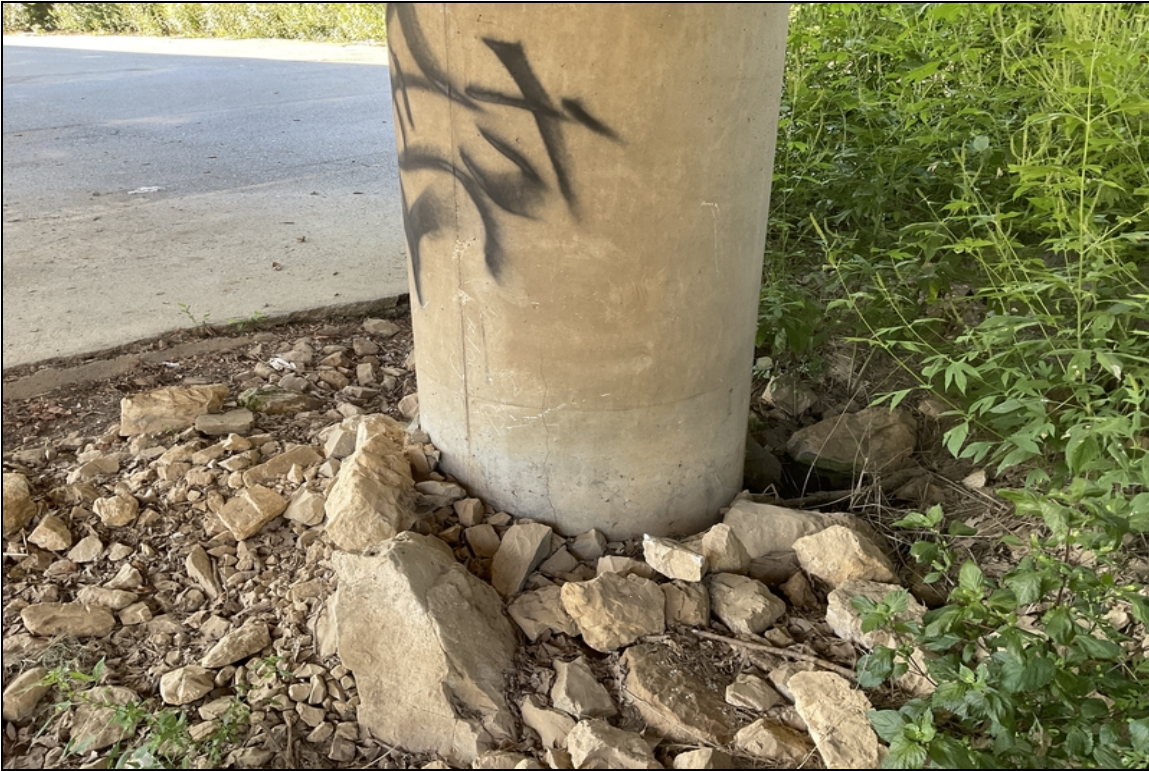
(205)							
-Bent # 2 Columns have multiple vertical cracks that range in width from hairline up to 0.04" wide. -Bent # 3, column # 1 has several short duration vertical cracks near the base. -Bents # 4 & 5 Left Columns have vertical hairline cracks. -Both columns of Bent # 7 have short duration vertical cracks at the water elevation that range in width from hairline up to approximately 1/16" which is located in the Left column. The previously documented cracking in the left column up to 3/16" wide could not be verified this inspection and may be below the water elevation.  2022 - UWI - Both columns at Bent 7 have multiple CS3 cracks running vertical. The cracks extend vertically from 2 feet above current water elevation to the mud line. Cracks are widest approximately 5 feet below the water elevation at this inspection. All 4 columns in bents 7 and 8 have minor pop outs and abrasion near the water surface elevation.

Bent #2 column #2 vertical cracking.

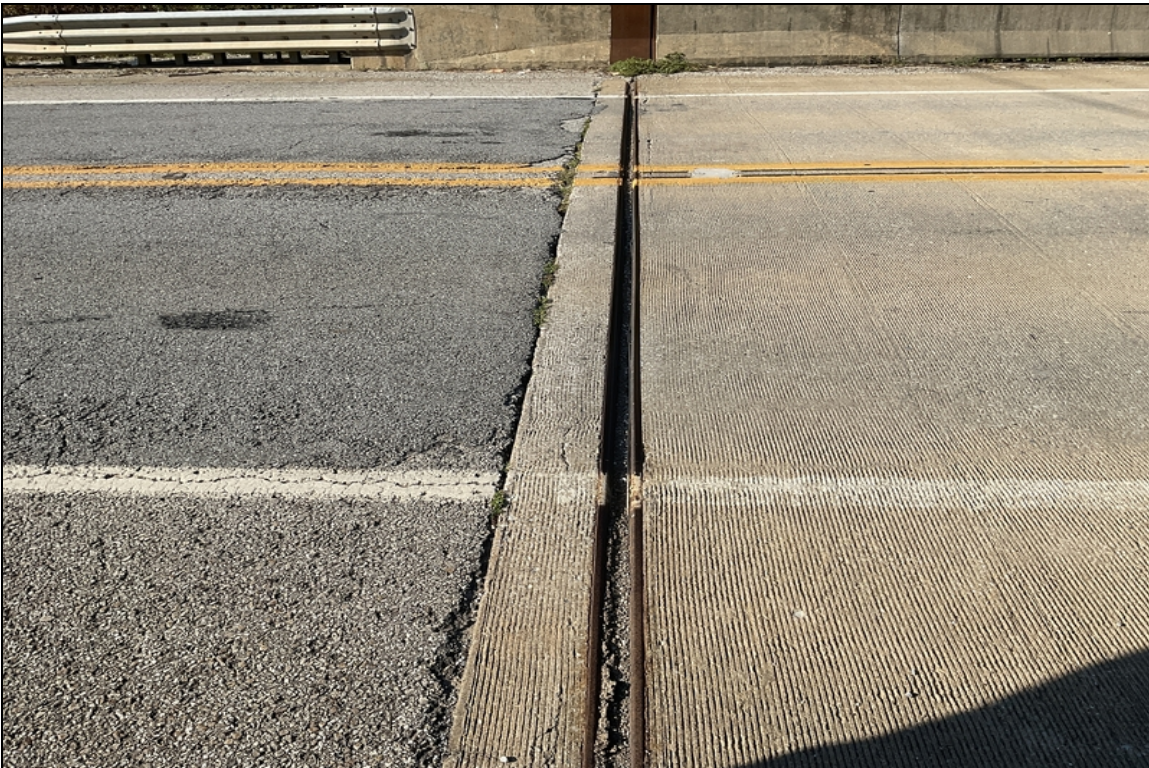
Abutment #2 typical.

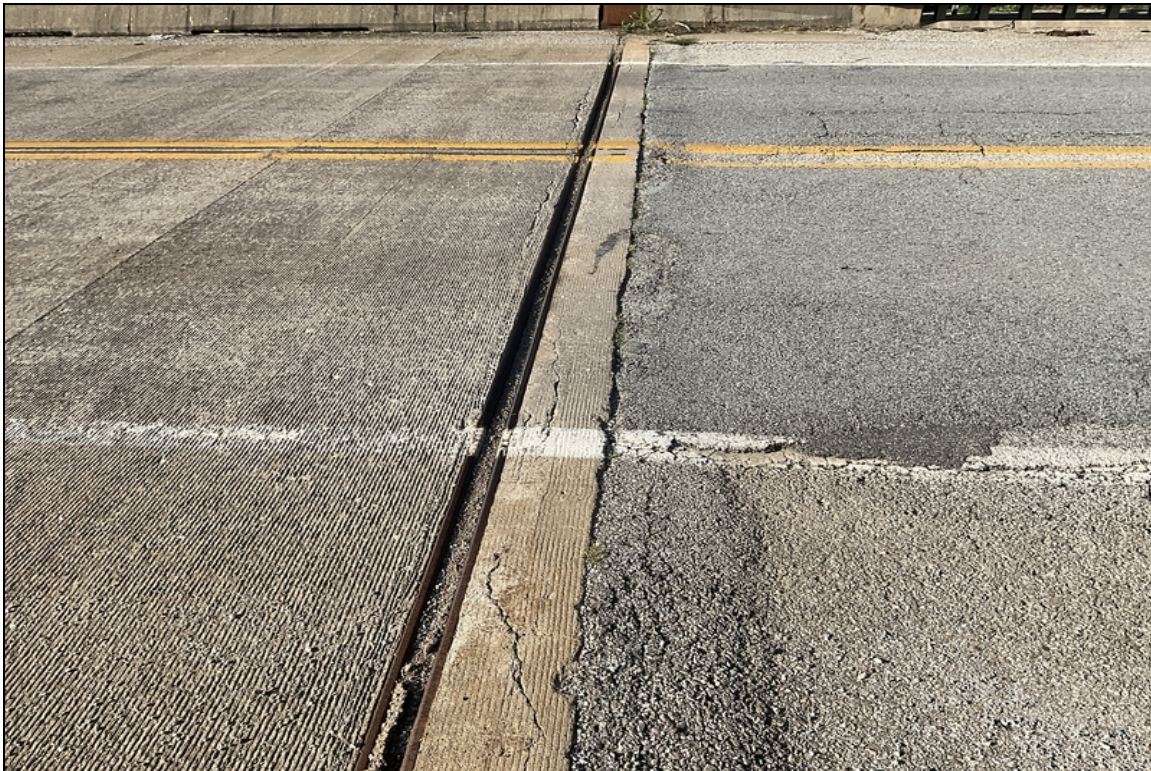
215	Reinforced Concrete Abutment	LF	126	64	39	23	0
1120	Efflorescence/Rust Staining	LF	7	0	7	0	0
1130	Cracking (RC and Other)	LF	55	0	32	23	0
(215)							
-The top of both abutment backwalls have sealable longitudinal wide cracking for the majority of the length of backwall that is visible from the driving surface of the deck. -The top of both back walls have short duration transverse hairline cracks that are visible from the driving surface of the deck. -There are vertical hairline cracks with light efflorescence in the face of the backwalls. -Both abutments have diagonal hairline cracking in the face of the backwalls.

Abutment #1 wide cracking in the top of the backwall.

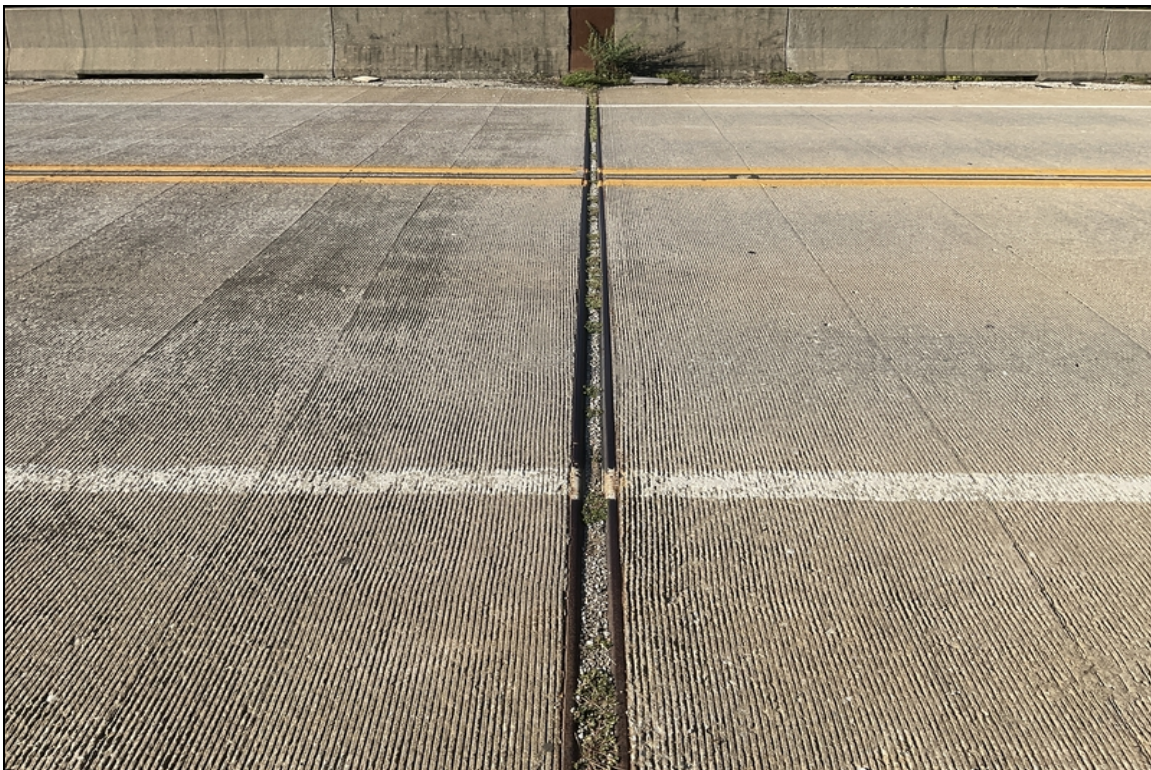
Bent #6 strip seal expansion joint.

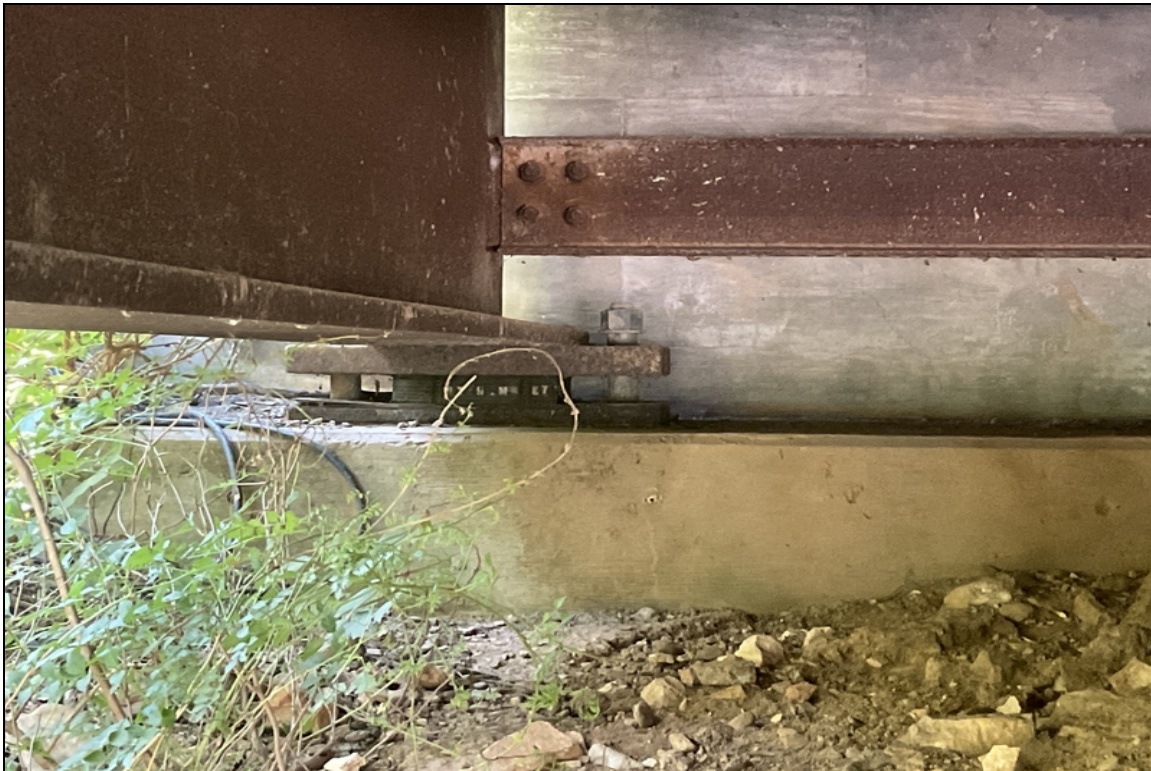
(310)							
-The bearing at abutment # 1, beam # 6 has light flaking rust on the masonry plate. -Bearing # 6 over bent # 6 has flaking rust on the sole and masonry plates. -The exterior bearings at abutment # 2 have active corrosion with flaking rust in the external loading plate - masonry plate. -All other Bearings appear to be functioning as intended with no apparent noteworthy deficiencies at this inspection.							
331	Reinforced Concrete Bridge Railing	LF	1076	843	221	12	0
1080	Delamination/Spall/Patched Area	LF	4	0	4	0	0
1090	Exposed Rebar	LF	1	0	1	0	0
1130	Cracking (RC and Other)	LF	228	0	216	12	0
1234	ASR	LF	1	1	0	0	0

Abutment #2 exterior bearings with active corrosion and pack rust.

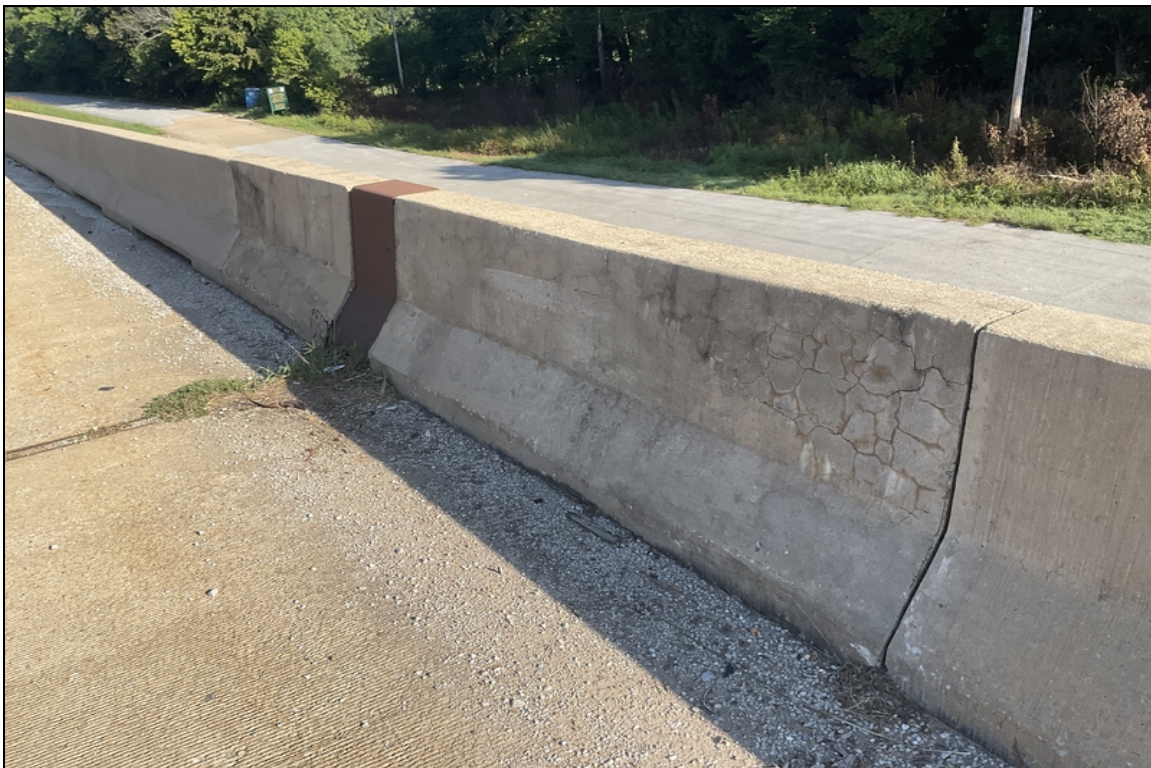
(331)							
-Minor spall with exposed reinforcing steel in the Left side of Span # 1 bridge railing. -Bridge railing has minor hairline map cracking in various locations. -Bridge railing has vertical cracks at variable spacing. -The bridge railing has a few isolated areas with condition state 3 map cracking during this inspection.

Bridge rail map cracking.

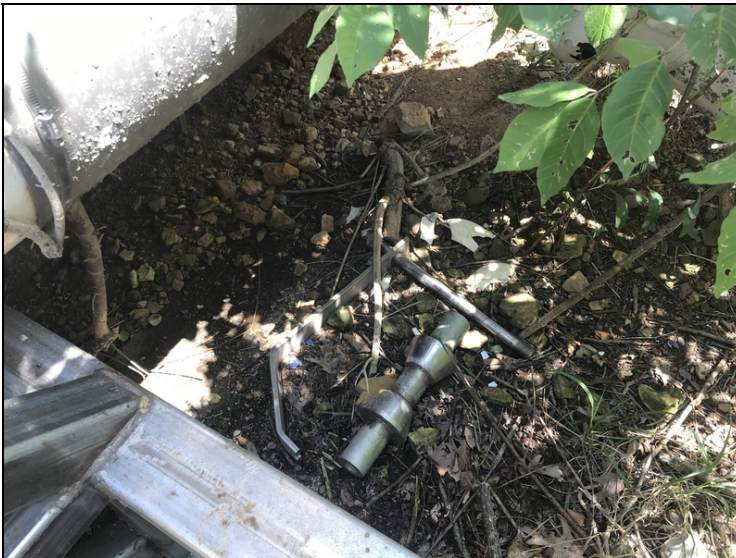
The utility attached to the South side of the structure has a fractured support bracket located at the East abutment.

The utility attached to the South side of the structure has a fractured / displaced support bracket located at the East abutment.

**Date Reported:** 08/30/2018  
**Priority:** C - Important  
**Type of Work:** Repair  
**Status:** Monitor  
**Inspection Direction** W to E  
**Component:** Miscellaneous

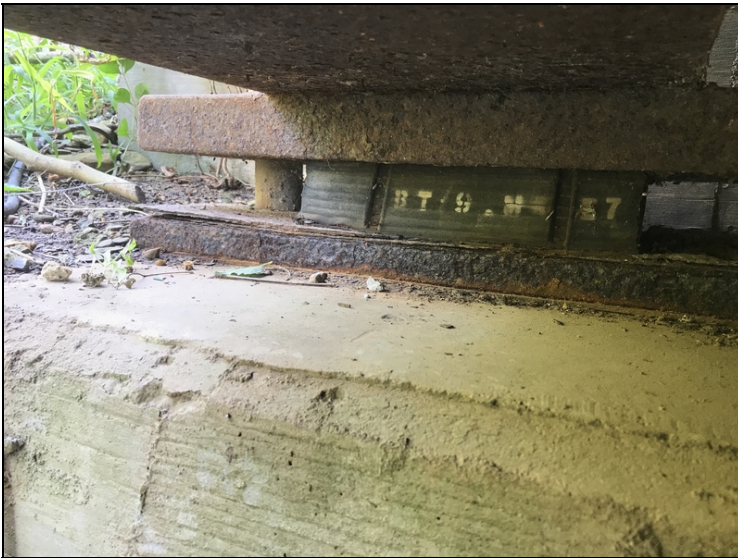
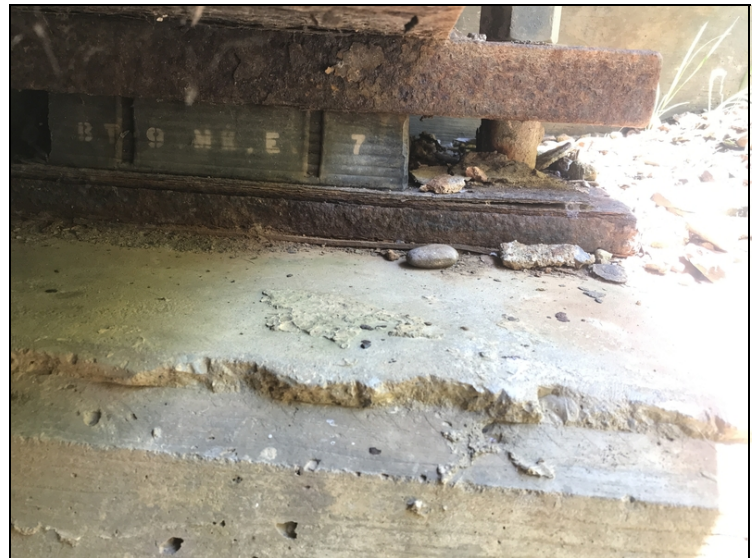
The masonry plates for bearing # 6 at abutment # 1, and both exterior bearings at abutment # 2 have active corrosion with flaking rust.

**Date Reported:** 08/30/2018  
**Priority:** D- Routine  
**Type of Work:** Repair  
**Status:** Monitor  
**Inspection Direction** W to E  
**Component:** 310 - Elastomeric Bearing

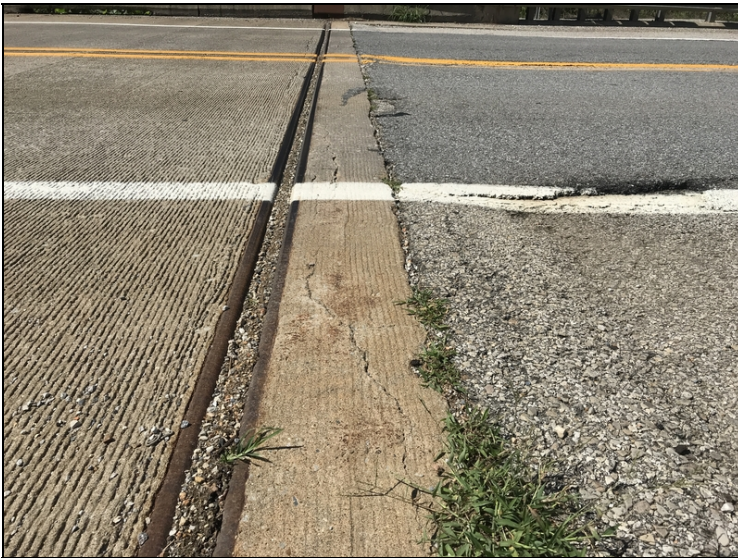
The top of the abutment backwalls have sealable longitudinal cracks that are visible from the driving surface of the deck.

**Type of Work:** Repair

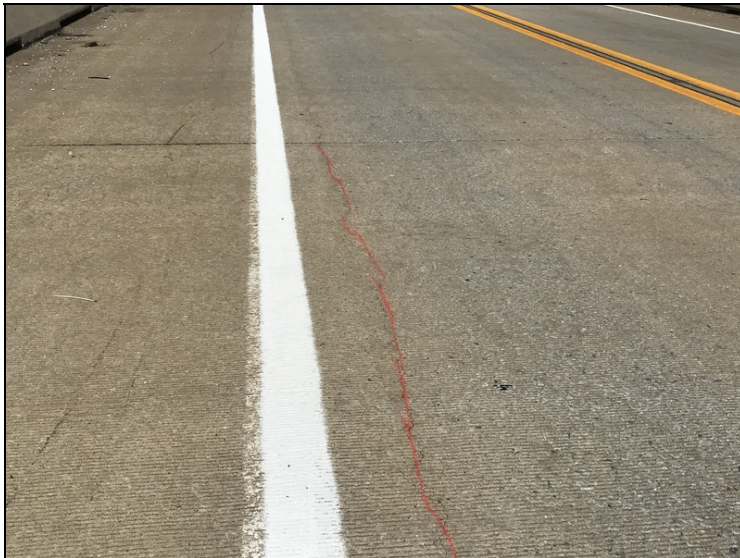
Sealable longitudinal cracks over the top flanges of Beams # 2, 3, 4, and 5. Cracks are approximately full length of structure. There are isolated areas where map cracking is beginning to propagate from the longitudinal cracks. Transverse cracks that appear to correspond with the joints in the parapet walls. There is sealable transverse cracking located approximately 6 inches from the expansion joints at abutments # 1 and # 2.

Span 7, right lane-Longitudinal cracking.

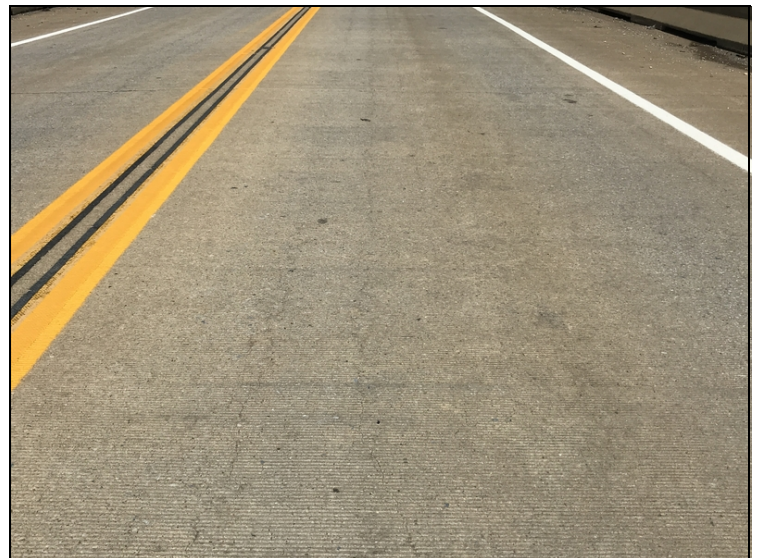
Span 6, left lane longitudinal cracking.

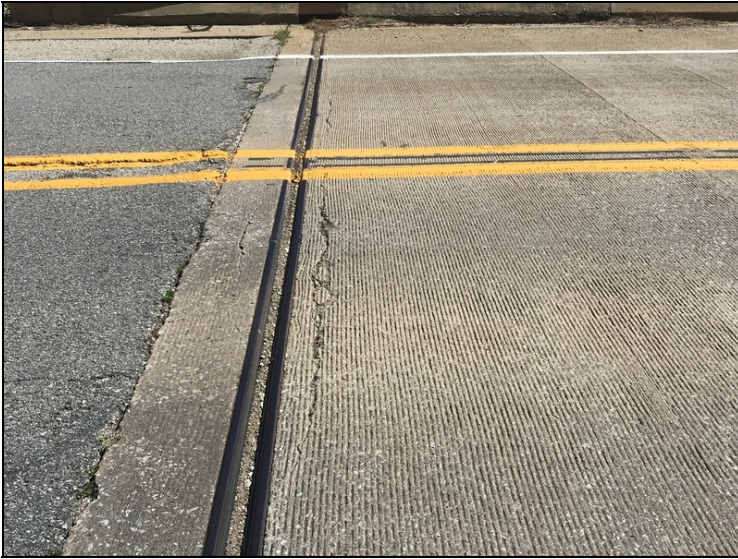
Span 1-Transverse cracking / spalling adjacent to abutment # 1 expansion joint assembly.

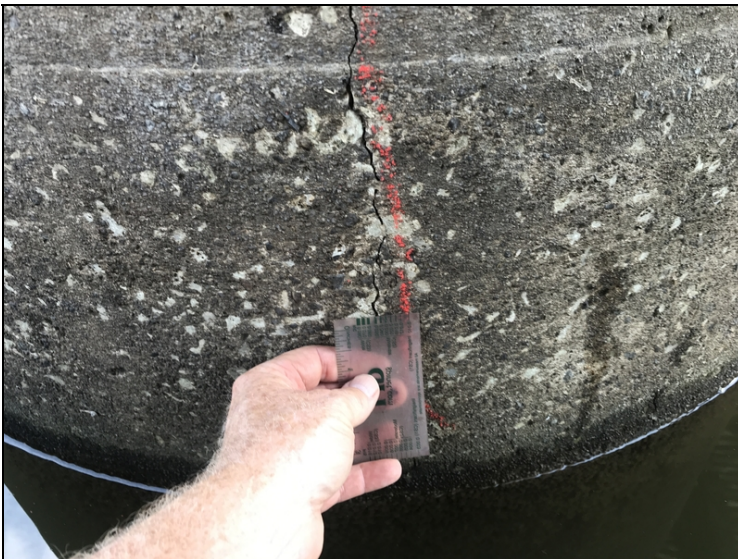
The columns in Bent # 7 have short duration vertical cracks at the water elevation that range in width from hairline up to 3/16".

2022 UWI - Both columns at Bent 7 have CS3 cracks that extend from water elevation to the mud line.

Bent 7, left column-Vertical cracking.

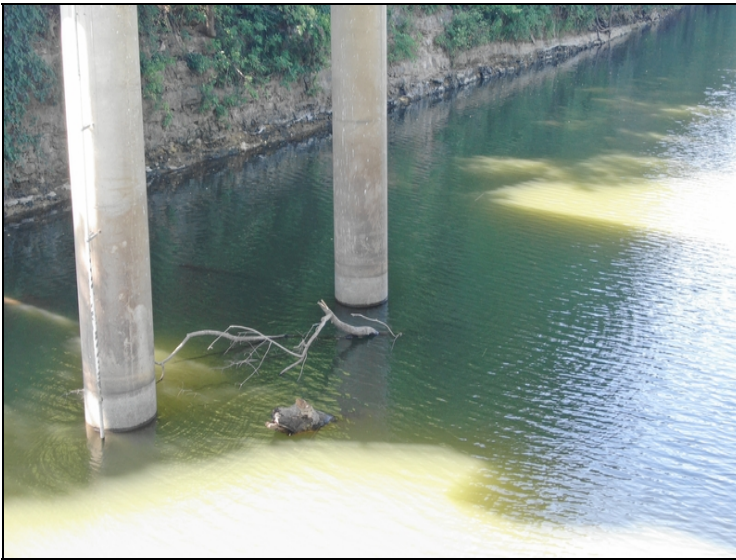
2022 - UWI - Both bents 7 and 8 have large amounts of drift accumulation primarily on the upstream side.

Drift and debris at bent 8.

**Date Reported:** 07/18/2022  
**Priority:** D- Routine  
**Type of Work:** Clean  
**Status:** Monitor  
**Inspection Direction** W to E  
**Component:** Channel

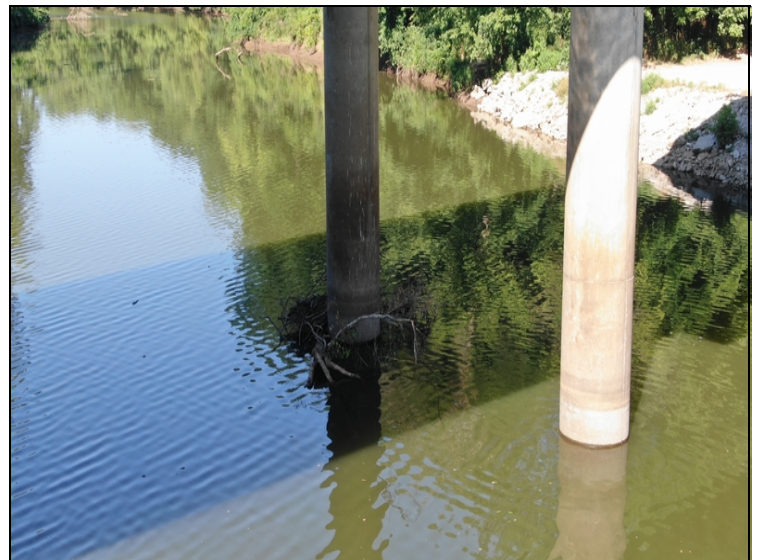
Drift and debris at bent 7.

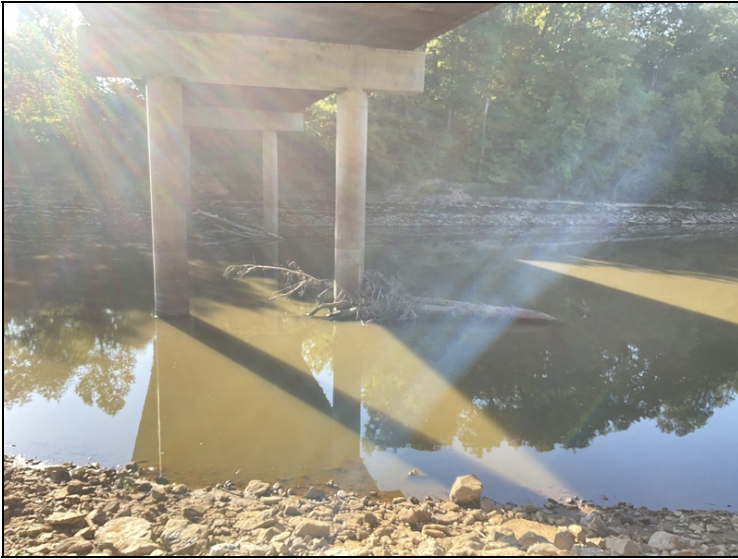
Bent # 7 & 8 drift accumulation.

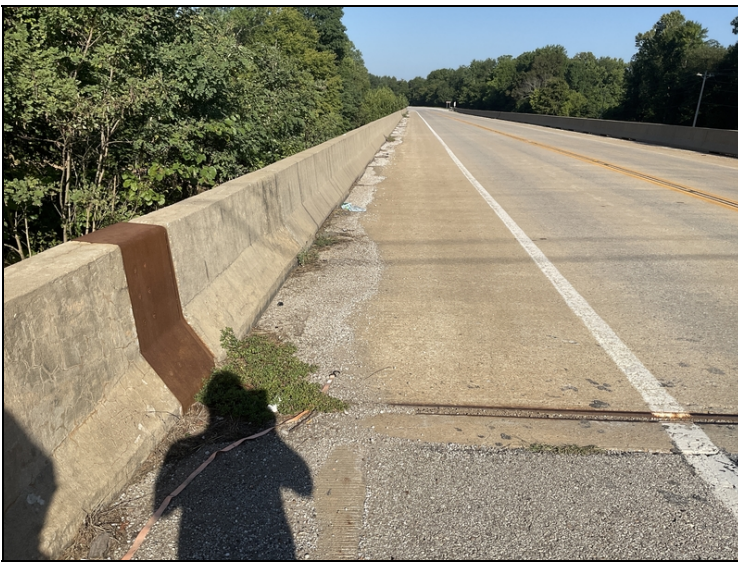
R.C. Deck-  
The deck gutters have heavy gravel and debris accumulation.

Debris accumulation in the gutters.

Date Reported: 09/08/2022  
Priority: D- Routine  
Type of Work: Clean  
Status: Open  
Inspection Direction W to E  
Component: Deck

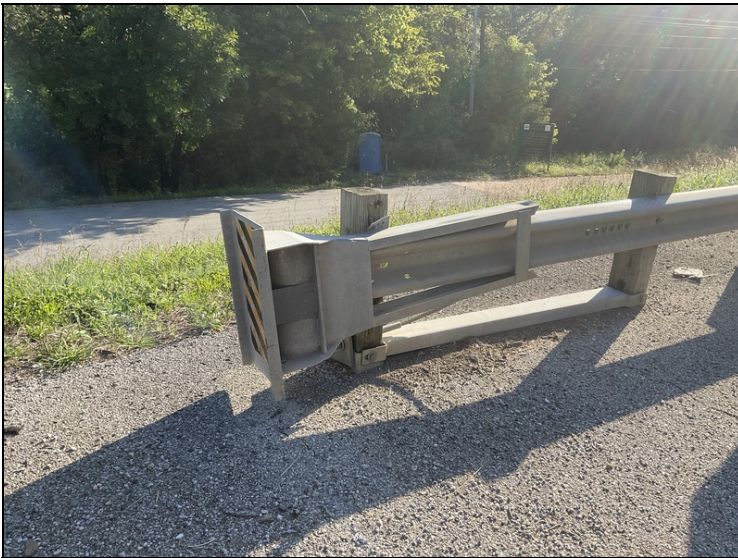
The approach guardrail end terminal at the Northwest approach has loose hardware attaching the end terminal to the wood post.

Northwest approach guardrail end terminal loose.

**Date Reported:** 09/08/2022  
**Priority:** C - Important  
**Type of Work:** Repair  
**Status:** Open  
**Inspection Direction** W to E  
**Component:** Approach

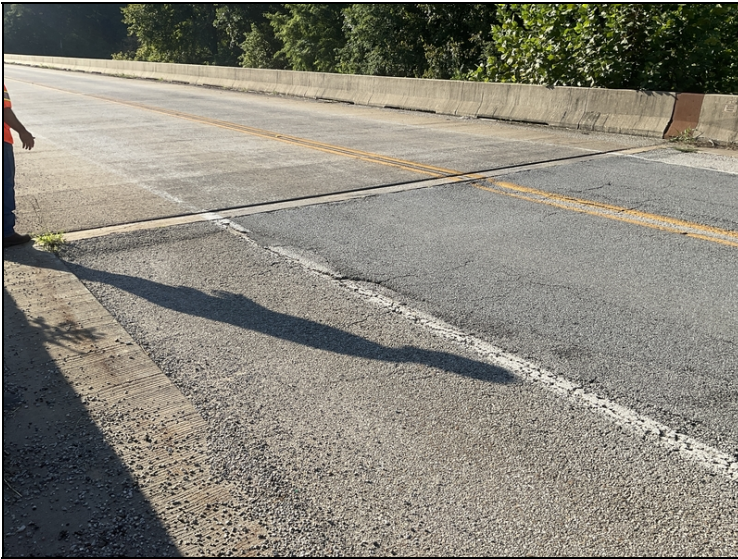
Approach Roadway-  
The west approach roadway has asphalt settlement at the bridge end.

West approach roadway asphalt settlement at  
abutment #1.

Date Reported: 09/12/2022  
Priority: D- Routine  
Type of Work: Repair  
Status: Open  
Inspection Direction W to E  
Component: Approach
