**Bridge #06790**(Routine, Underwater type 2)

**State Highway 45 over Richland Creek**

**Team Lead: Eric West Inspection Date: August 22, 2022**

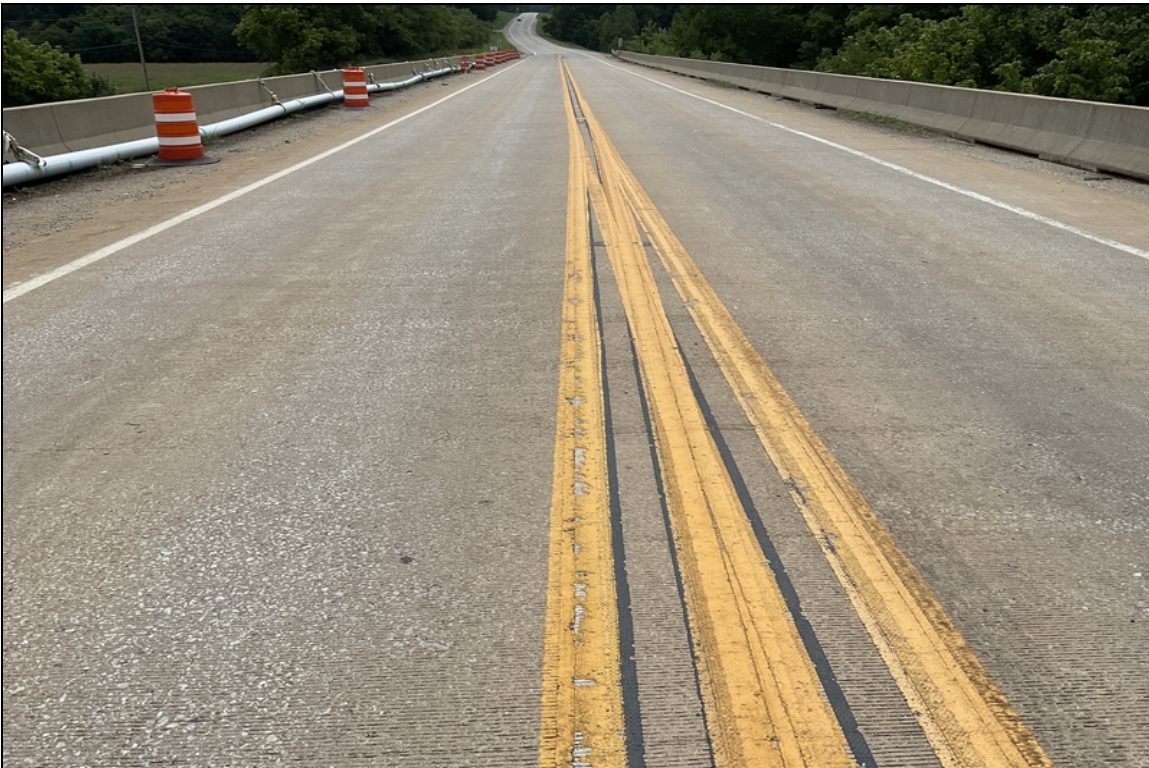
Typical driving surface of the deck.

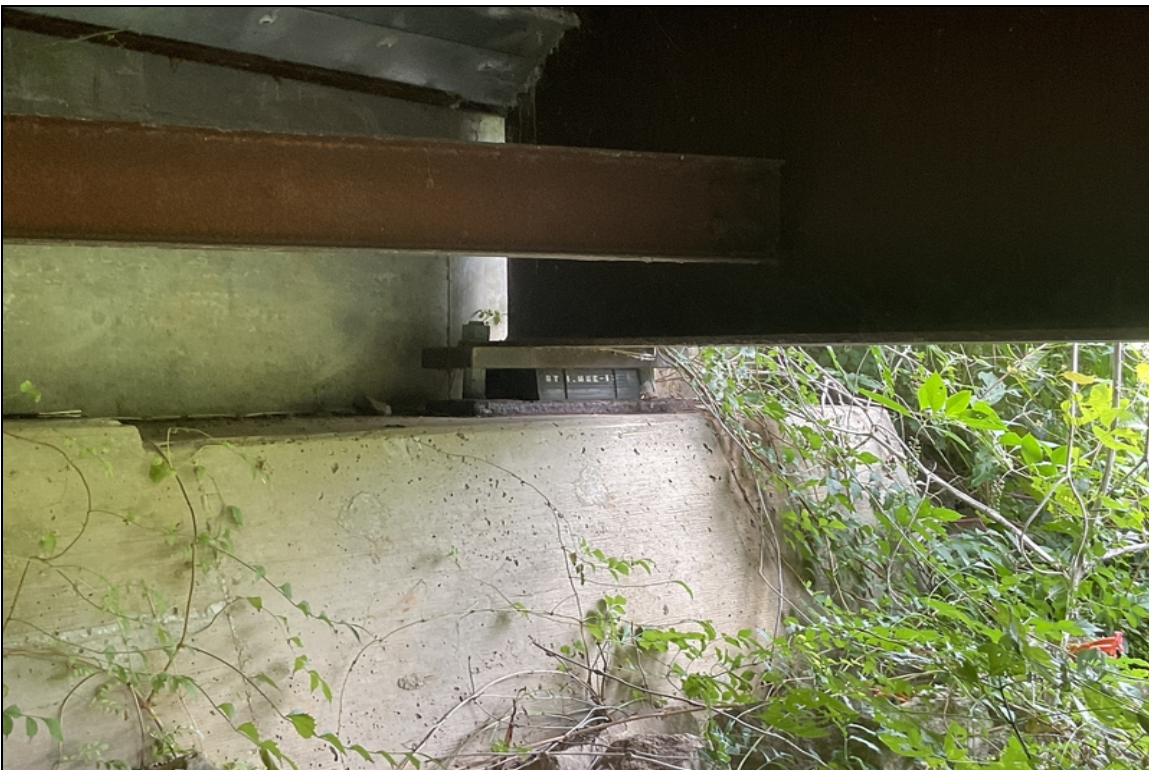
(310)							
-Bent # 1, Beam # 3 has one missing anchor bolt nut.							
-Abutment # 1 bearing #1 & 6 have active corrosion on the masonry plate.							
-Abutment # 2 bearing # 1 has active corrosion with pack rust in the masonry plate.							
331	Reinforced Concrete Bridge Railing	LF	702	564	138	0	0
1080	Delamination/Spall/Patched Area	LF	2	0	2	0	0
1130	Cracking (RC and Other)	LF	136	0	136	0	0

Abutment #1 bearing #1 active corrosion with pack rust.

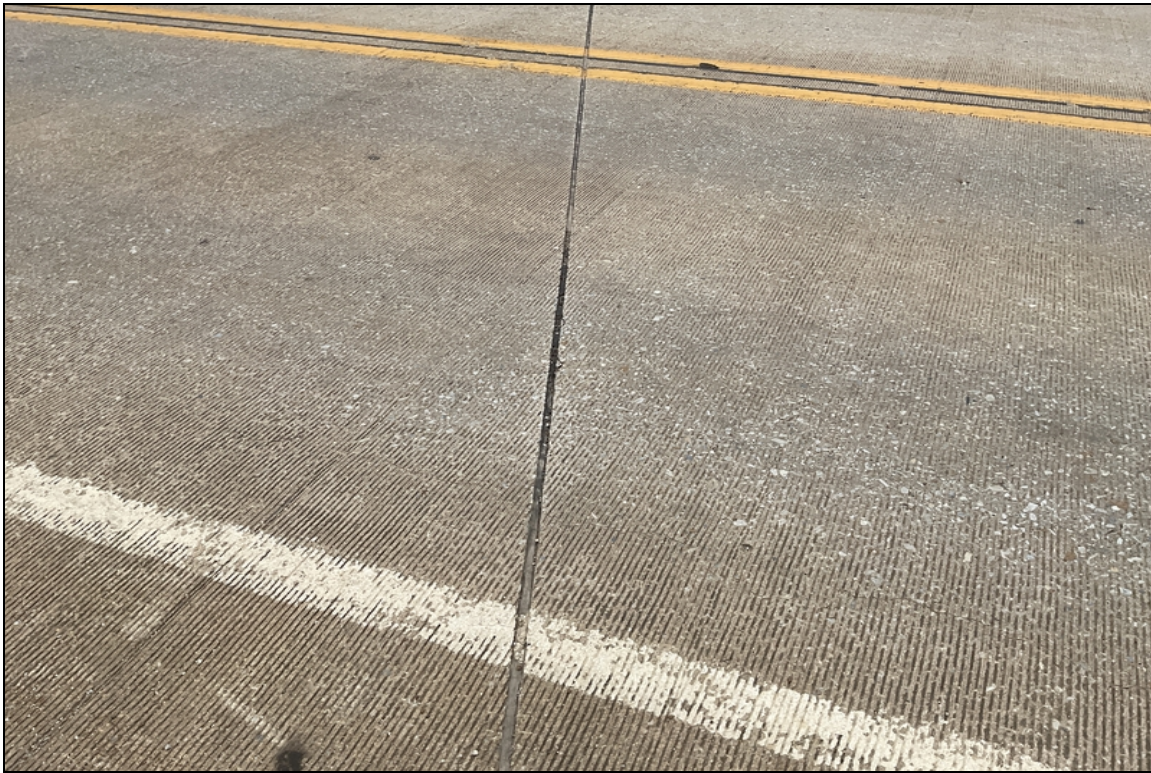
Deteriorating saw joint sealant.

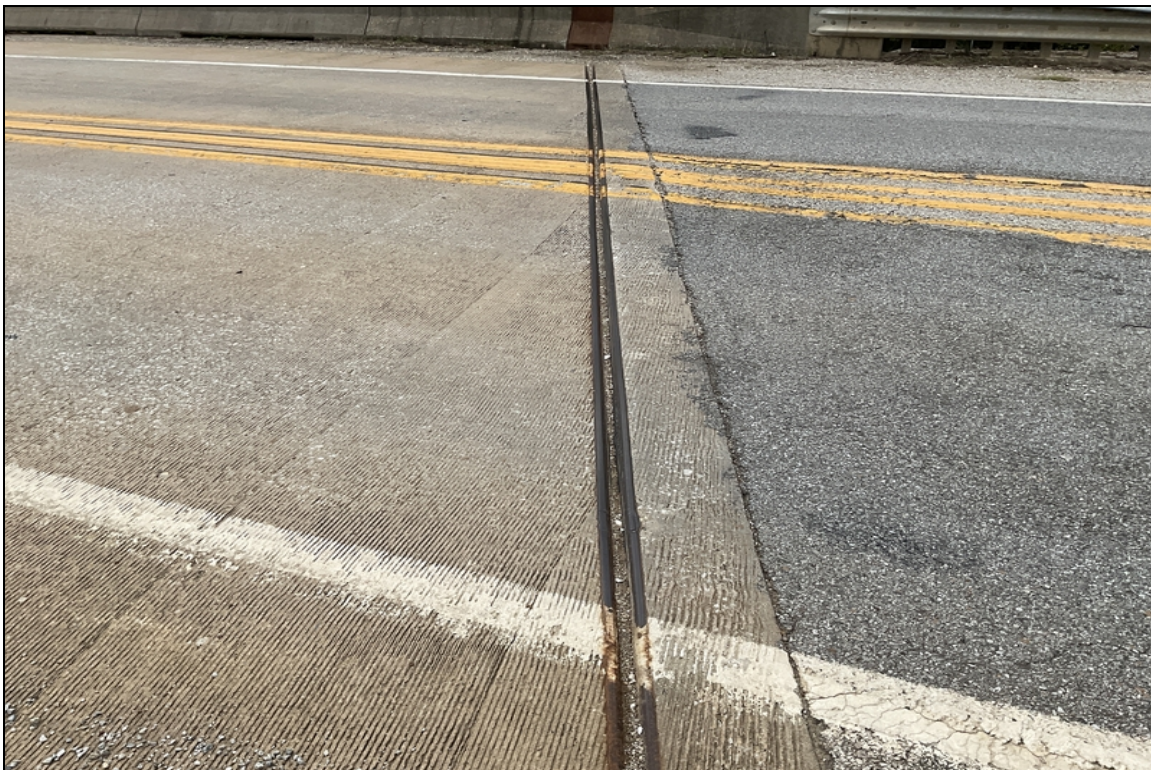
Abutment #1 strip seal.

ELEM	DESCRIPTION	UNITS	TOTAL	CS1	CS2	CS3	CS4
300	Strip Seal Expansion Joint	LF	90	45	45	0	0
2350	Debris Impaction	LF	45	0	45	0	0
(300)							
-Deck joint seals are in place and appear to be functioning as intended.							
-Joint seals have debris impaction in the gutter lines.							
310	Elastomeric Bearing	EA	36	32	0	4	0
1000	Corrosion	EA	3	0	0	3	0
1020	Connection	EA	1	0	0	1	0

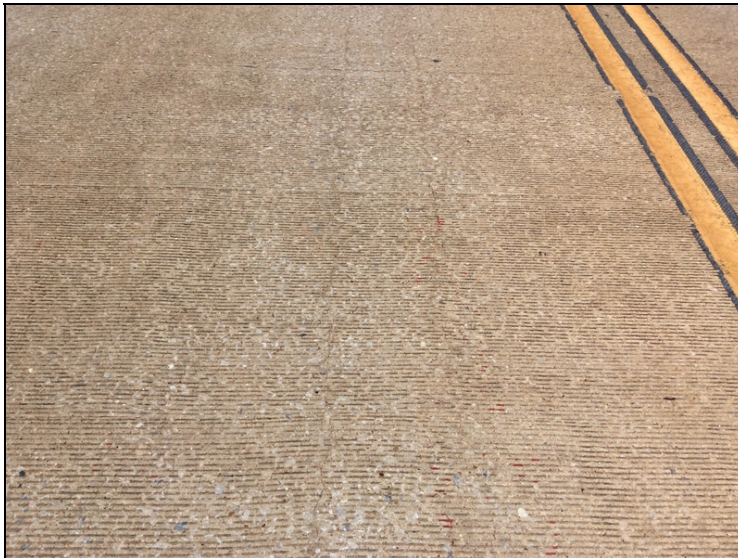
Deck  
Sealable longitudinal cracks are visible on the driving surface of deck. Cracks are located on the Right side of Beam # 2, Both sides of Beams # 3 and # 4, and the Left side of Beam # 5. Longitudinal cracks appear to be for the entire length of structure. There are transverse hairline cracks that appear to correspond with the joints in the parapet walls.

Longitudinal crack in the Right lane of Span # 3.

**Date Reported:** 08/23/2012  
**Priority:** D- Routine  
**Type of Work:** Repair  
**Status:** Monitor  
**Inspection Direction** W to E  
**Component:** 12 - Reinforced Concrete Deck

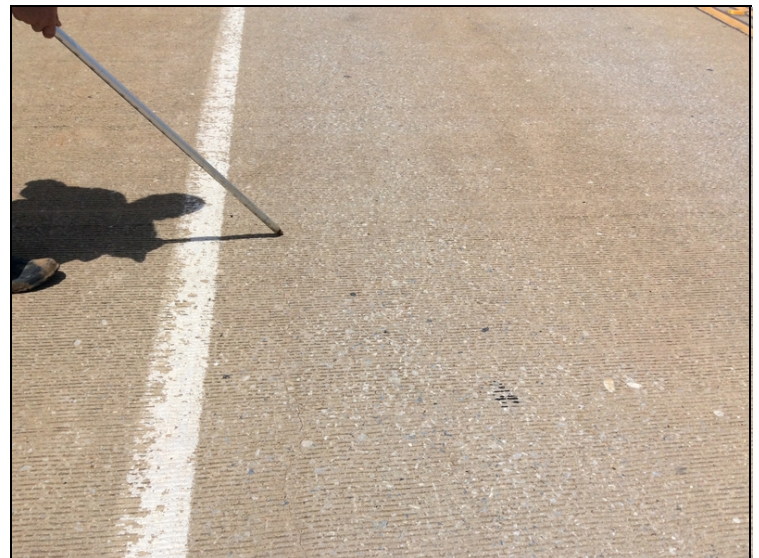
Longitudinal crack in the Right lane of Span # 4.

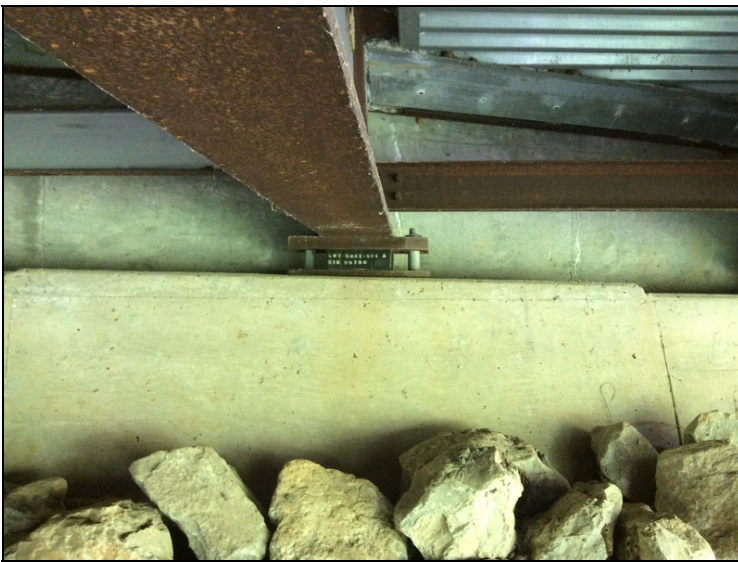
Bearings  
Bent # 1, Beam # 3 anchor bolt nut is missing.

Bent # 1, Beam # 3. Missing anchor bolt nut.

**Date Reported:** 07/23/2014  
**Priority:** G - General/ Preventive maintenance  
**Type of Work:** Replace  
**Status:** Monitor  
**Inspection Direction** W to E  
**Component:** 310 - Elastomeric Bearing

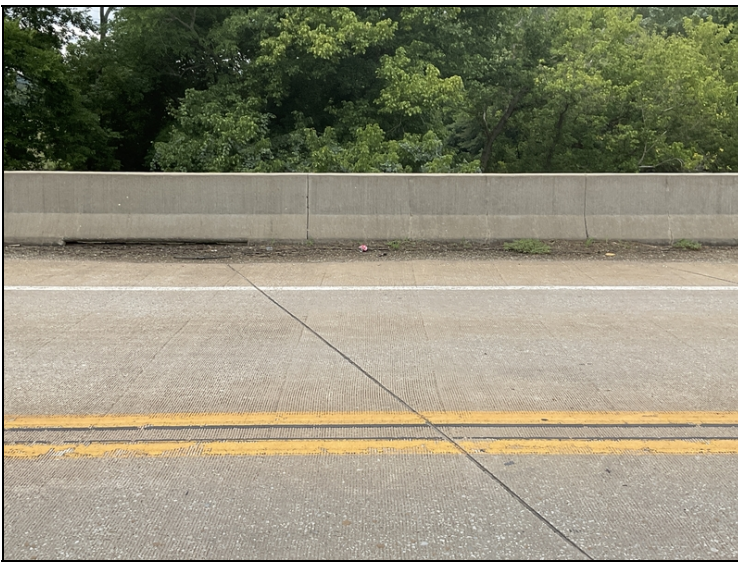
The deck gutters have dirt and debris accumulation that partially restricts the deck drains.

Dirt and debris accumulation in the gutters.

**Type of Work:** Clean

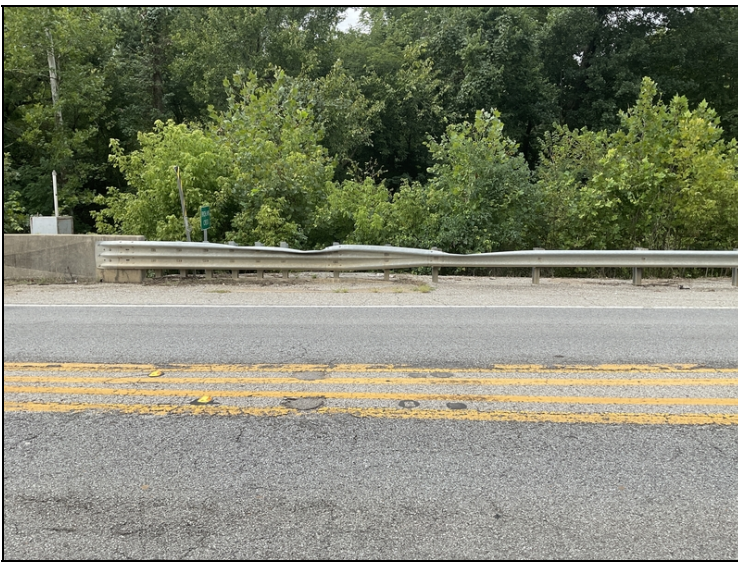
Approach Guardrail-  
The approach guardrail has collision damage and loose anchorage at the end terminals.

Southwest approach guardrail collision damage.

**Date Reported:** 08/24/2022  
**Priority:** C - Important  
**Type of Work:** Repair  
**Status:** Open  
**Inspection Direction** W to E  
**Component:** Approach

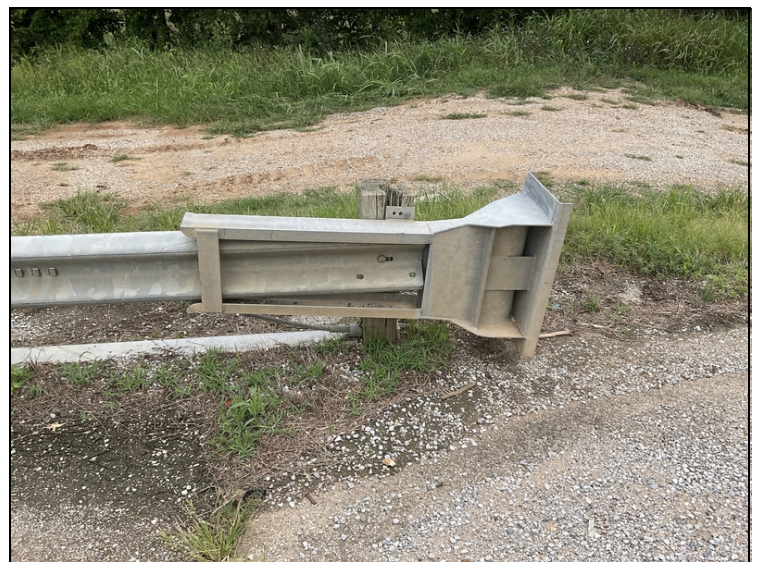
Northeast approach guardrail fractured post.

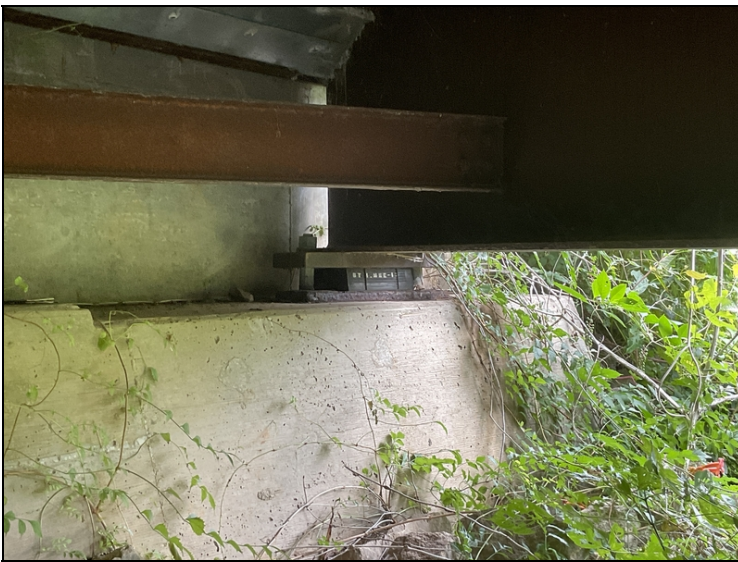
The masonry plates on the exterior bearings at the abutments have active corrosion with areas of pack rust.

Abutment #1 bearing #1 active corrosion with pack rust.

**Date Reported:** 08/24/2022  
**Priority:** D- Routine  
**Type of Work:** Repair  
**Status:** Open  
**Inspection Direction** W to E  
**Component:** 310 - Elastomeric Bearing
