Asset #M0912(Routine)

SH 45-Wash. Co. over Creek

Location: 2.6 MI SW JCT SH 303 & 45

Team Lead: Eric West, Inspection Date: 12/11/2023

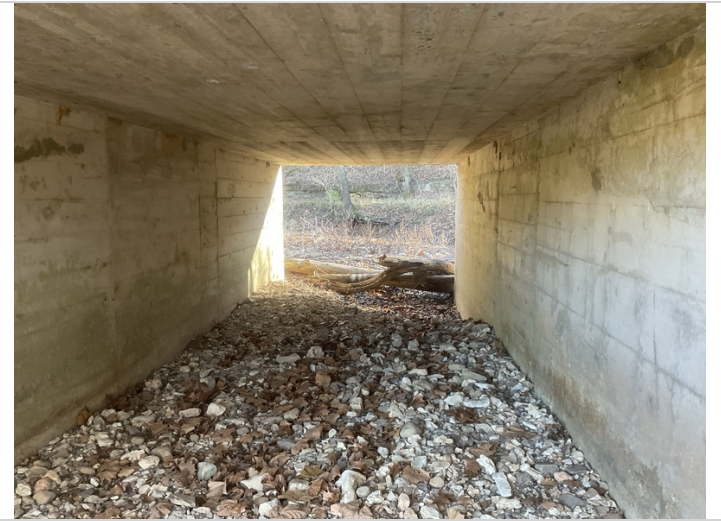
Barrel # 2 typical.

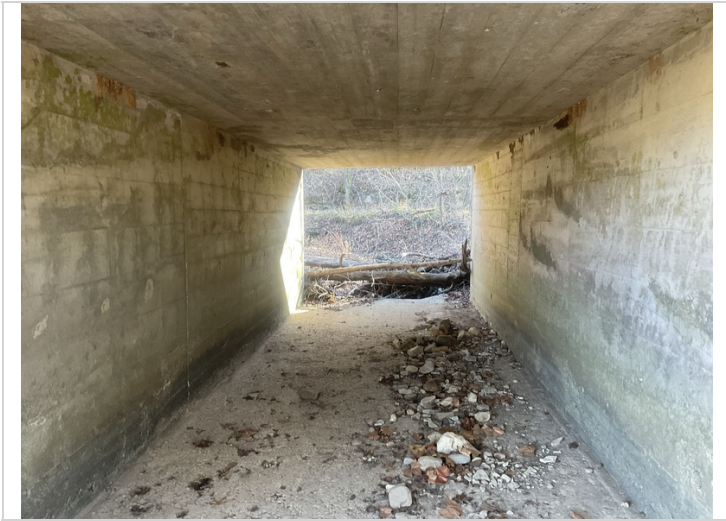
Barrel # 1 typical.

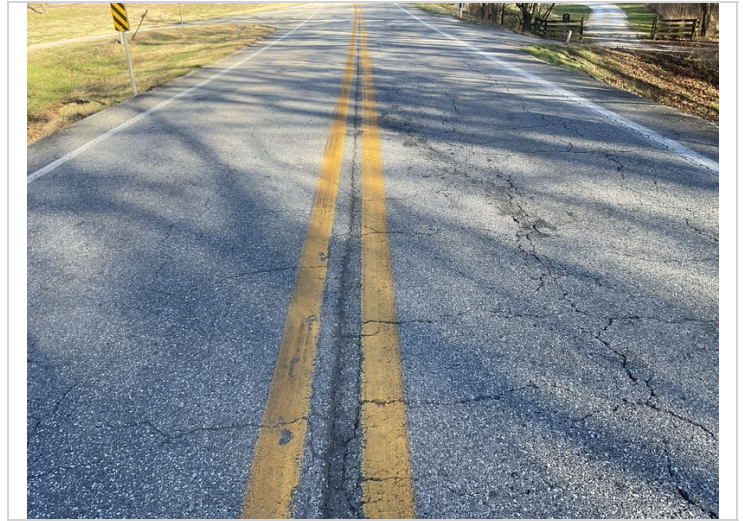
Typical driving surface.

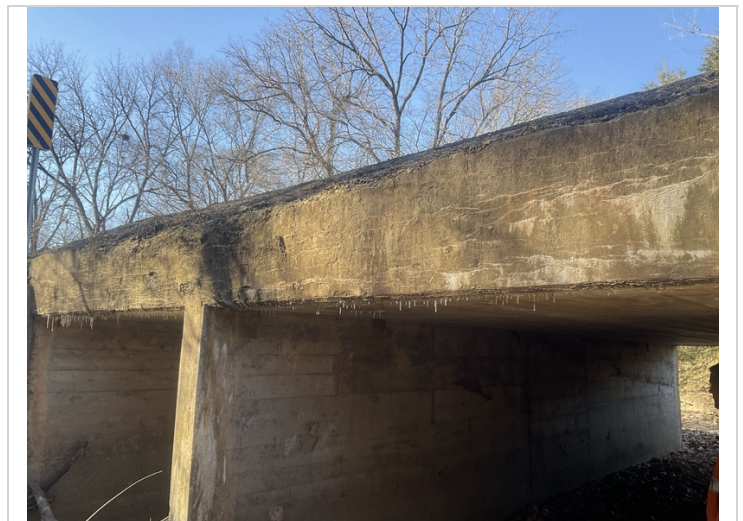
Right headwall concrete deterioration with efflorescence buildup.

There is map cracking with efflorescence and soft deteriorated concrete in both headwalls. There is map cracking with heavy efflorescence and leaching with light scale in the top slab at the inlet and outlet ends of both barrels. There is medium abrasion in the bottom slab and in the base of walls. There is map cracking with efflorescence in the center wall at the outlet end of box.

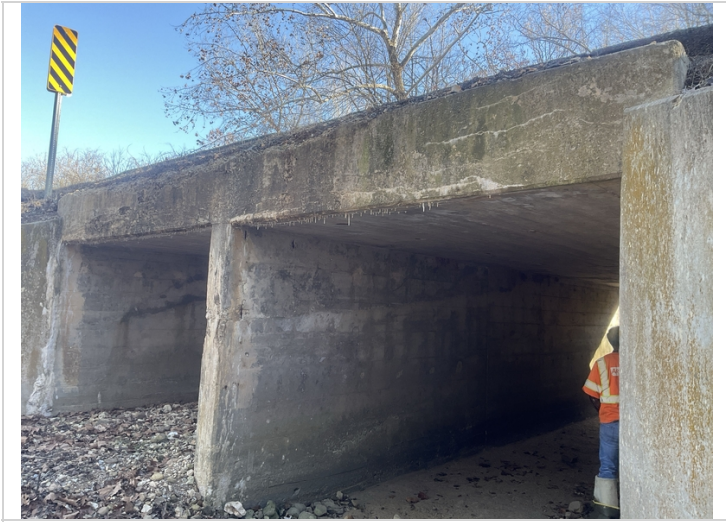
Left head wall concrete deterioration with efflorescence buildup.

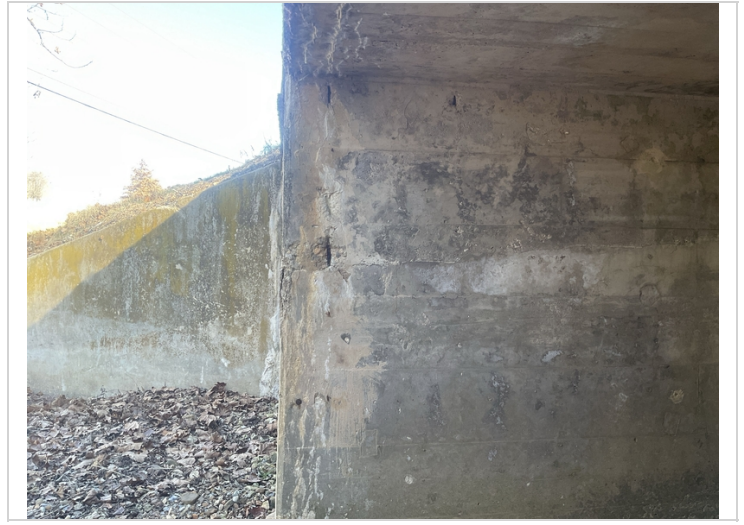
Wall # 2 Lt spalling with exposed reinforcing steel.

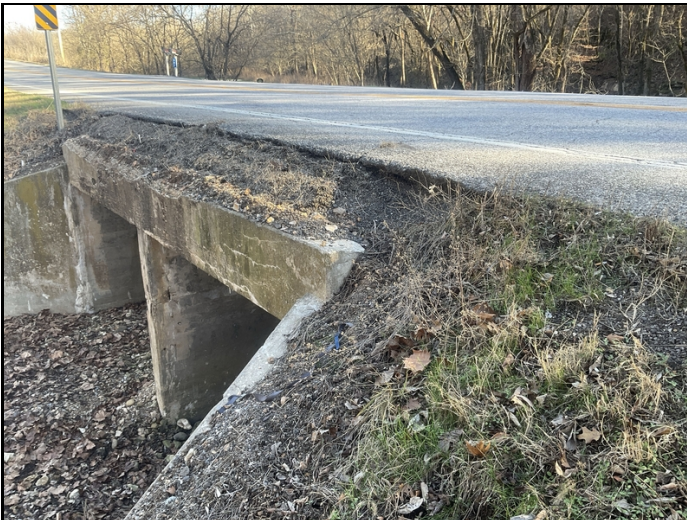
Approach Roadway-
The approach roadway has erosion along the north edge of the roadway.

The approach roadway has erosion along the north edge of the roadway.

Type of Work: Approach Leveling/Maintenance

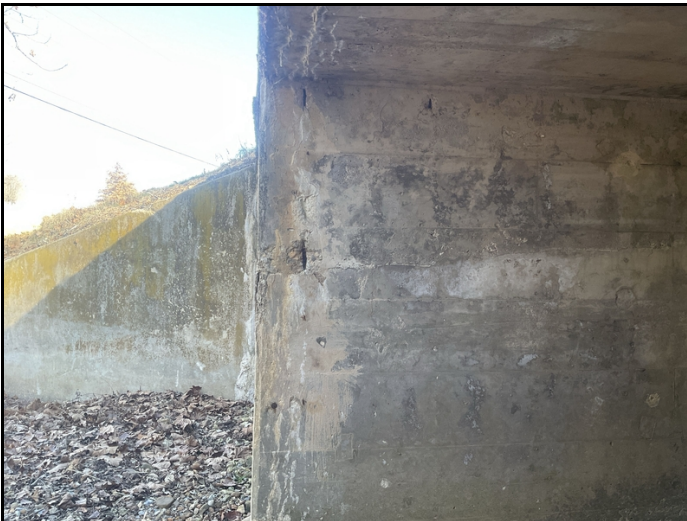
There are 3 softball size spalls with exposed reinforcing steel in the center wall visible on the left end of barrel # 1 and one 2" shallow spall with exposed reinforcing steel at base of barrel # 1 exterior wall located 10' from left end.

Wall # 2 Lt spalling with exposed reinforcing steel.

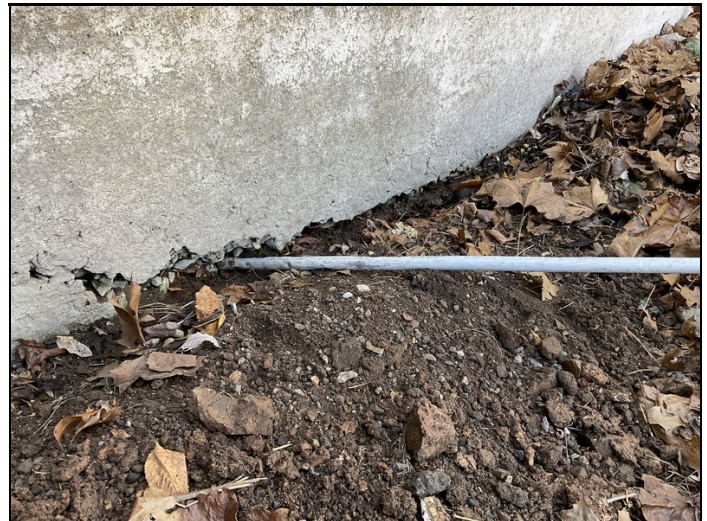
The base of the left wing wall at barrel # 1 has a 5' long area of concrete deterioration with up to 4" of concrete section loss.

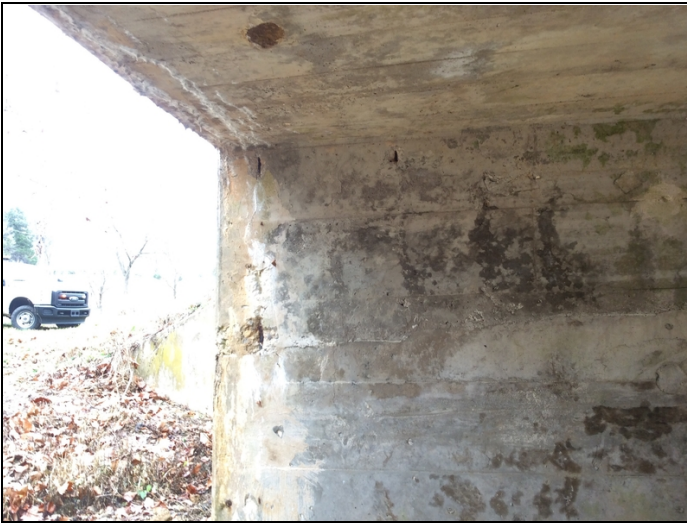
Spalling at the outlet end of the center wall that exposes reinforcing steel.

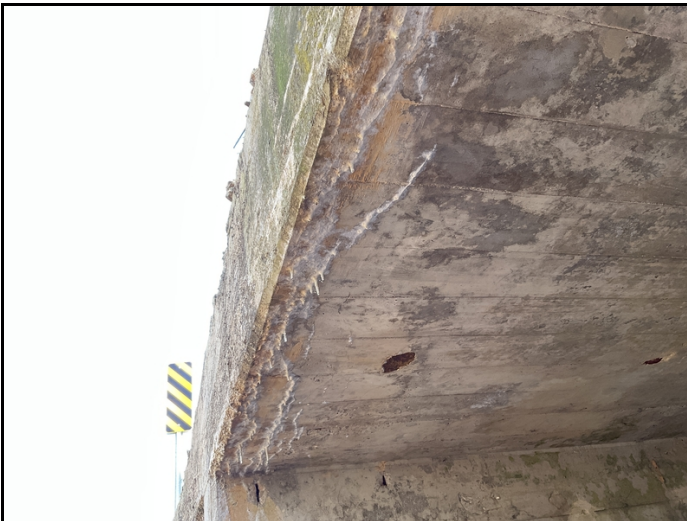
Barrel # 1 top slab, left side-Mapcracking with efflorescence.

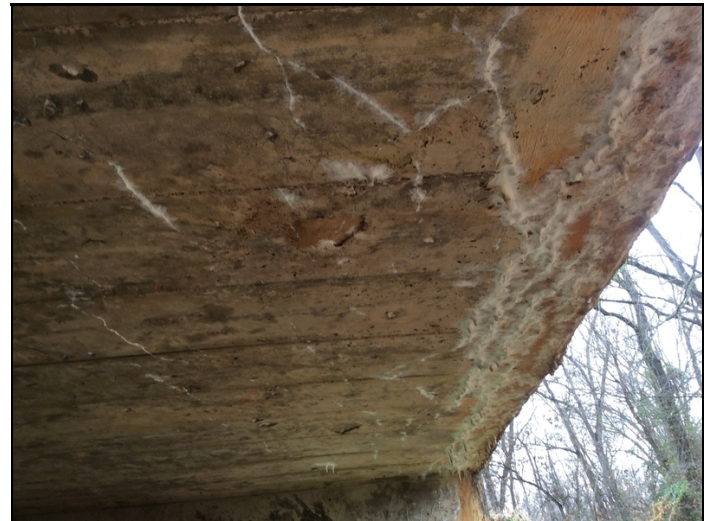
Barrel # 2 top slab cracking with efflorescence.

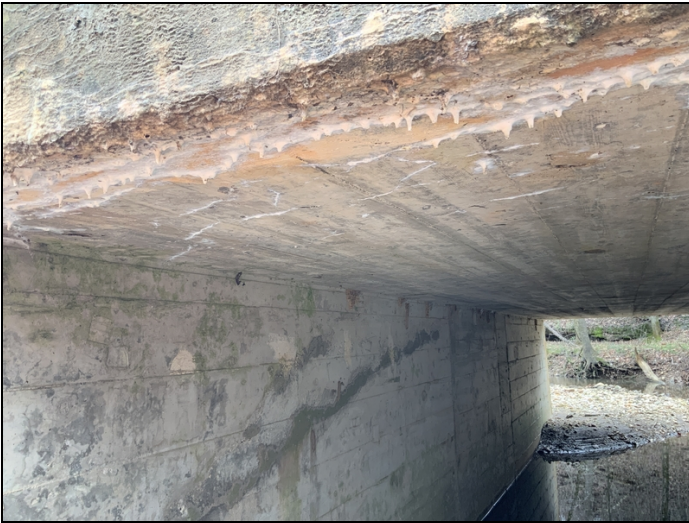
Barrel # 2 map cracking with efflorescence on the outlet side (typical for both barrels at the outlet and inlet sides)

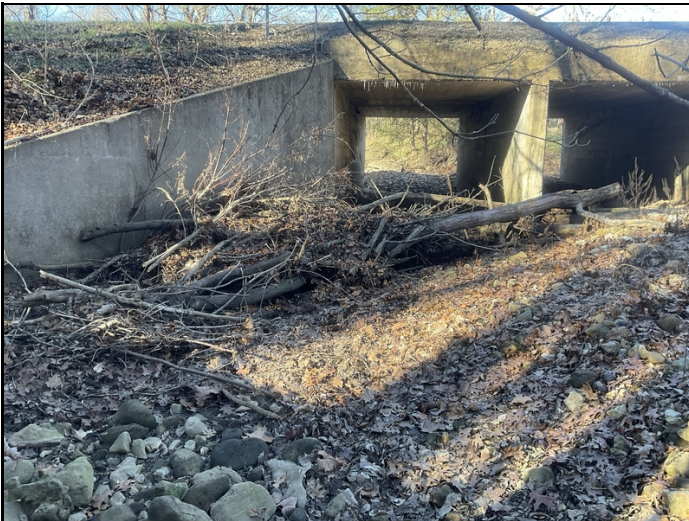
The outlet end of culvert has drift that is causing streambed material to accumulate and localized scour adjacent to the structure.

Type of Work: Channel Work/Drift Removal
