Asset #05507(Routine)

SH 31 Log 1.19 over BAYOU TWO PRAIRIE RELIEF

Location: 0.5 MI SO OF I-40

Team Lead: Bryan Saunders Inspection Date: 10/25/2023

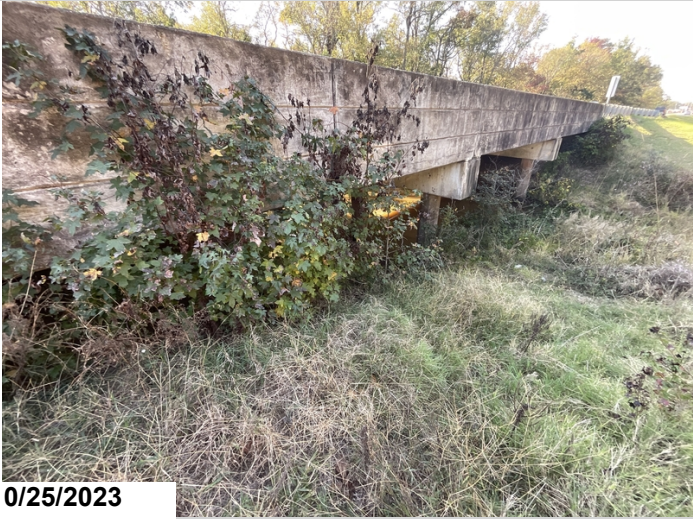
Trees and brush growing against bridge ends

**A-64 - Vegetation Removal Requested (Yes)**

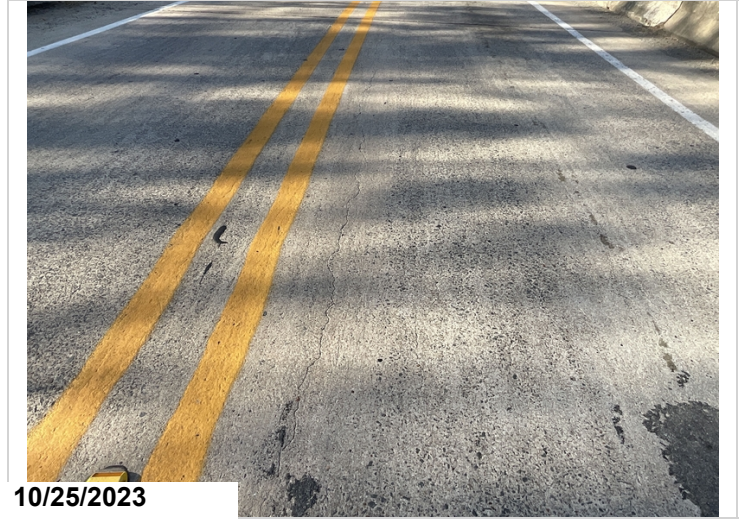
Spans 1,2,3 have a longitudinal crack near centerline and areas of map cracking in travel lanes.

Deck has longitudinal cracks in the center of bridge and map cracks in travel lane

Longitudinal cracks center of bridge

**A-54 - Sealable Deck Cracks (Yes)**

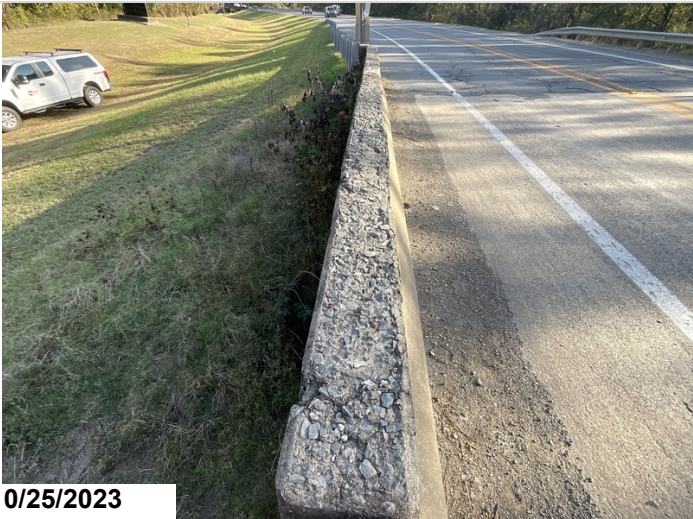
(331) The left rail of span 3 has scaling with several small Spalls and delams.

Scaling left bridge rail span 3

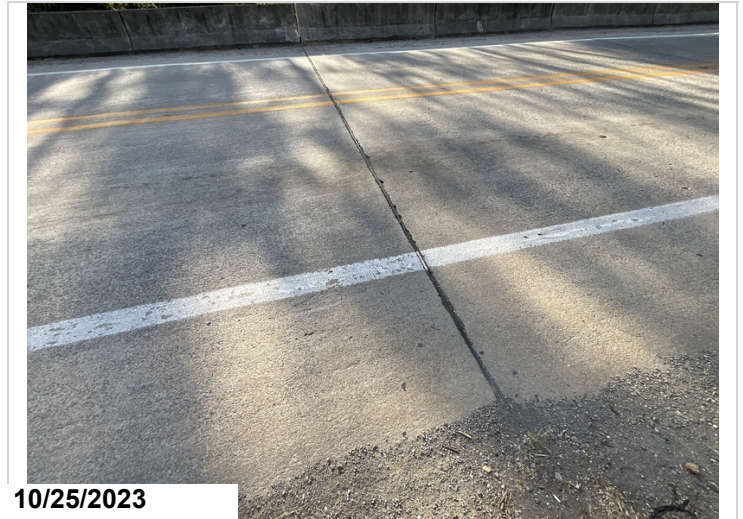
Joints have lost bond

(301) The seals at bents 2 and 3 have lost adhesion and have begun to accumulate debris.							
331	Reinforced Concrete Bridge Railing	LF	150	118	7	25	0
1080	Delamination/Spall/Patched Area	LF	25	0	0	25	0
1090	Exposed Rebar	LF	7	0	7	0	0

Joint at bent 3

Joints have lost bond

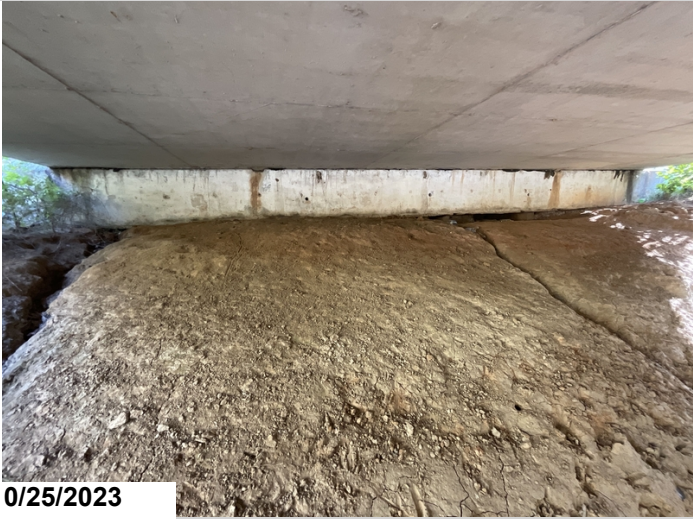
(215) Erosion exposing pile at bent 4							
227	Reinforced Concrete Pile	EA	12	2	10	0	0
1190	Abrasion/Wear (PSC/RC)	EA	10	0	10	0	0
(227) All pile have minor abrasion bents 2 and 3 Bent 4: erosion action has undermined the abutment exposing 2 pile.							
234	Reinforced Concrete Pier Cap	LF	70	67	3	0	0
1080	Delamination/Spall/Patched Area	LF	1	0	1	0	0
1090	Exposed Rebar	LF	2	0	2	0	0

Bent 4 abutment erosion exposing two pile

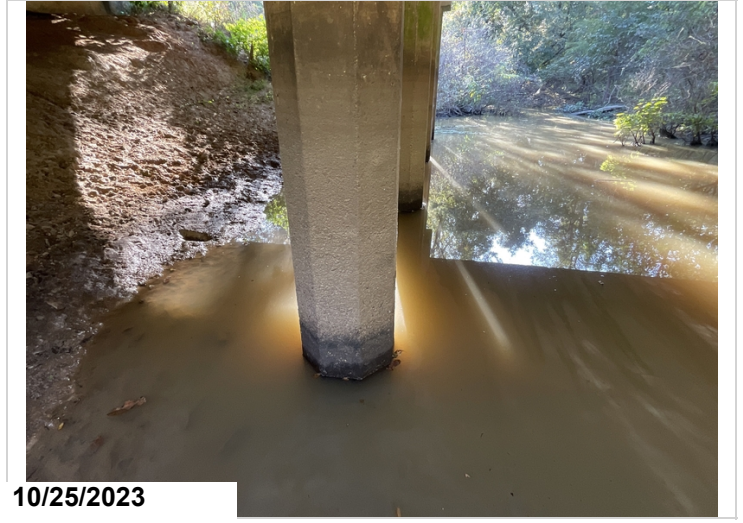
minor abrasion to pile

Abrasion to pile at bents 2 and 3

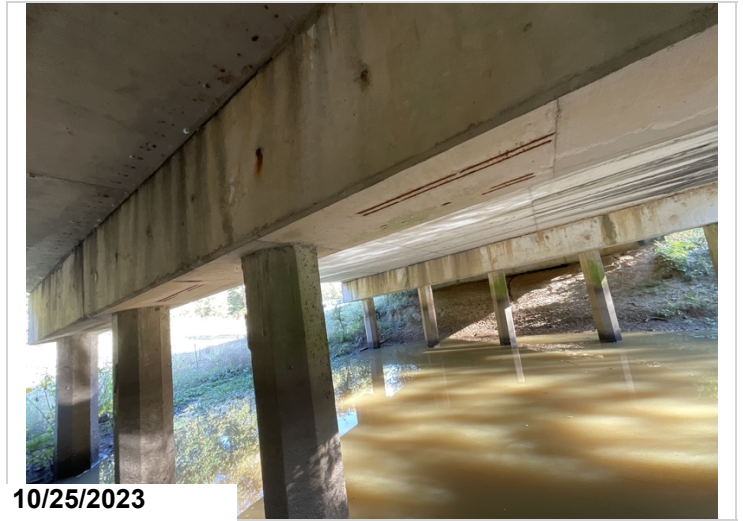
(234) Bent 2 on the bottom at pile 3 and 4, one small exposed rebar. Exposed wire to bottom of bent 2 Bent 3 left end of cap small spall.							
301	Pourable Joint Seal	LF	69	0	0	69	0
2320	Seal Adhesion	LF	34	0	0	34	0
2350	Debris Impaction	LF	35	0	0	35	0

Bent 2 exposed wire

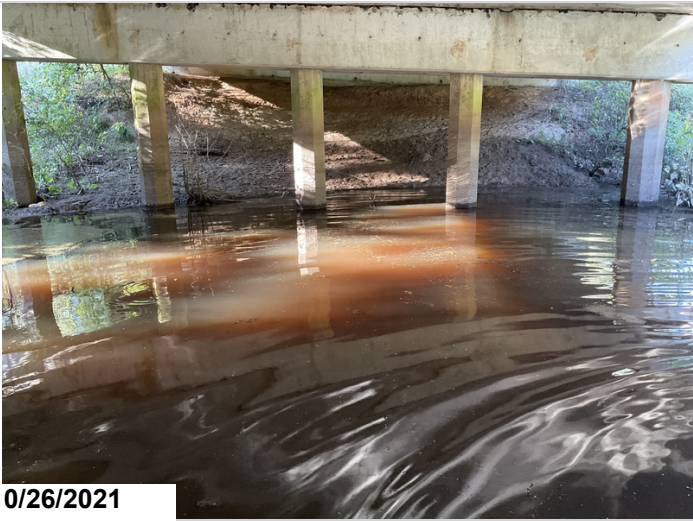
Bent 2 Abrasion on bottom of piles.

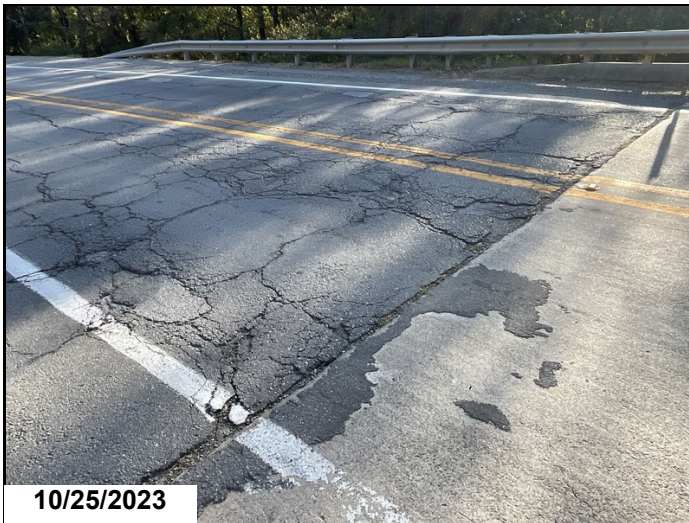
The approaching roadway pavement at both abutments is cracked and rough with pot holes.

Bent 4 cracks and potholes in roadway

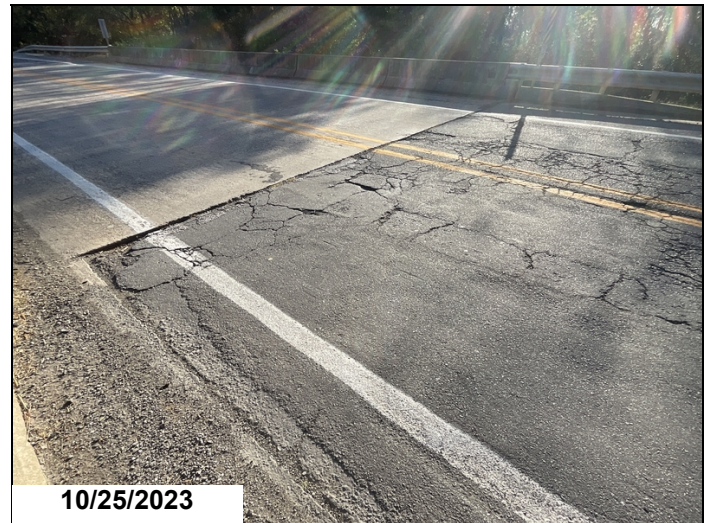
Bent 1 cracks and potholes in roadway

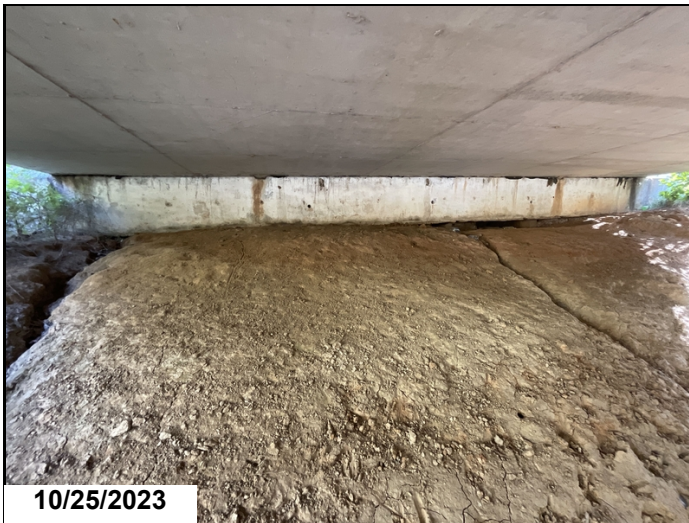
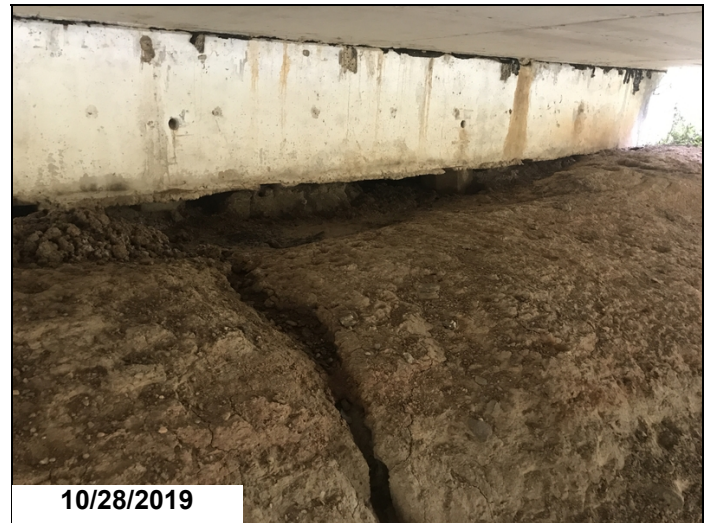
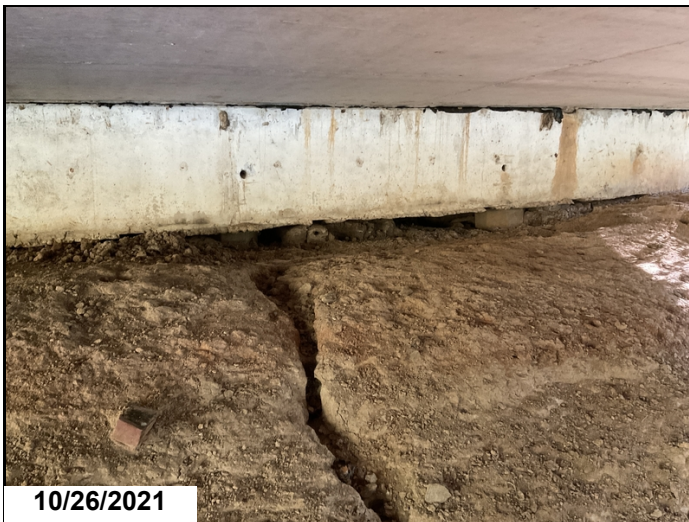
Erosion at Bent 4 has undermined the abutment and exposed two pile.

Bent 4 abutment erosion exposing two pile

Bent 4: erosion action has undermined the abutment exposing 2 pile

**Type of Work:** Repair (General)

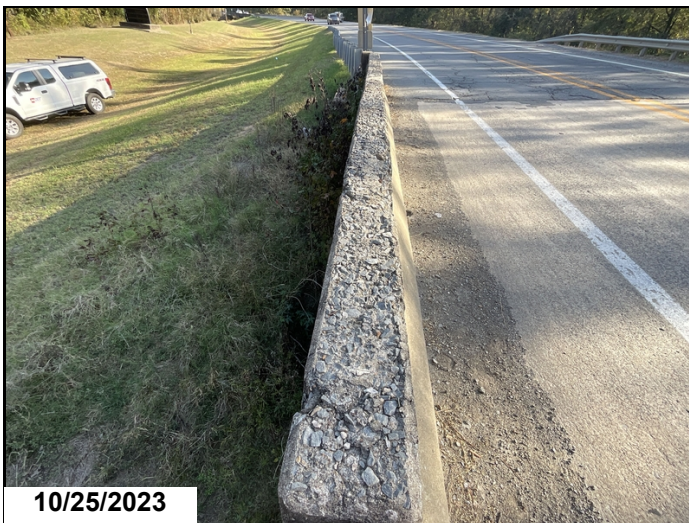
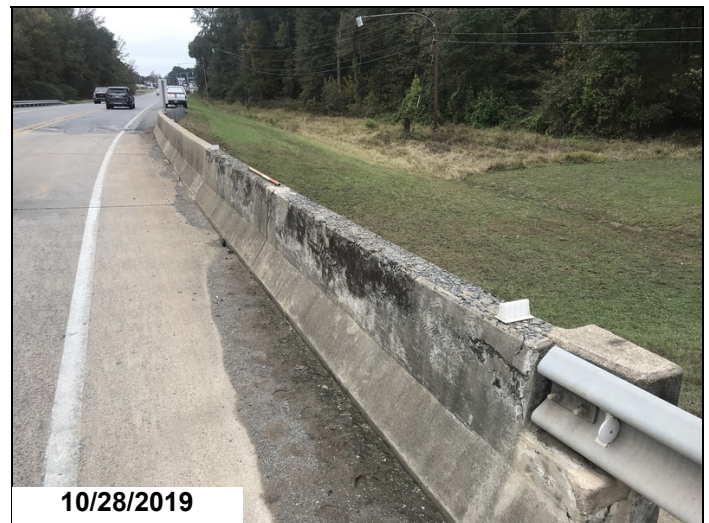
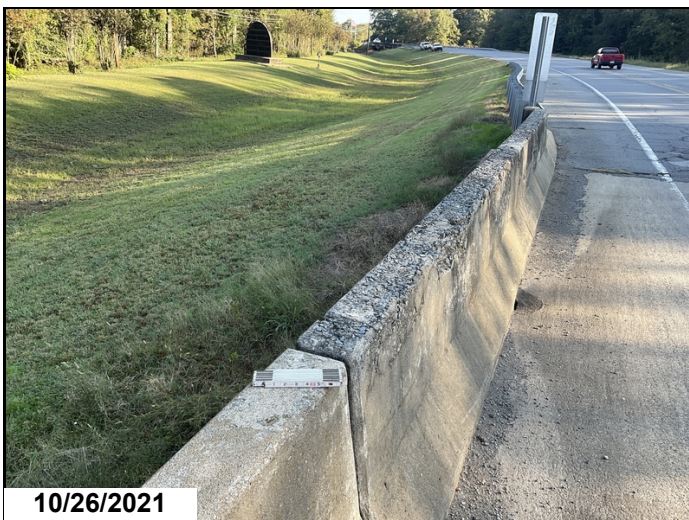
Span 3, Left concrete rail is deteriorating with aggregate losing bond.

Scaling left bridge rail span 3

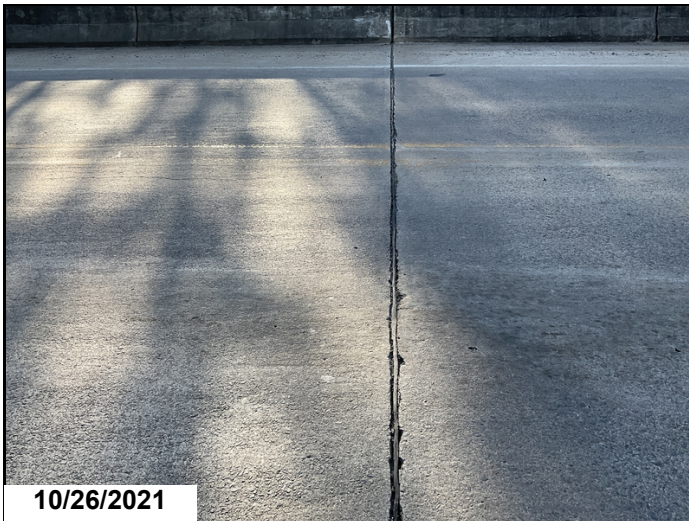
The poured joint material at bents 2 and 3 has lost adhesion and has begun to accumulate debris.

Bent 3 joint seal has lost adhesion and has debris impacted in joint

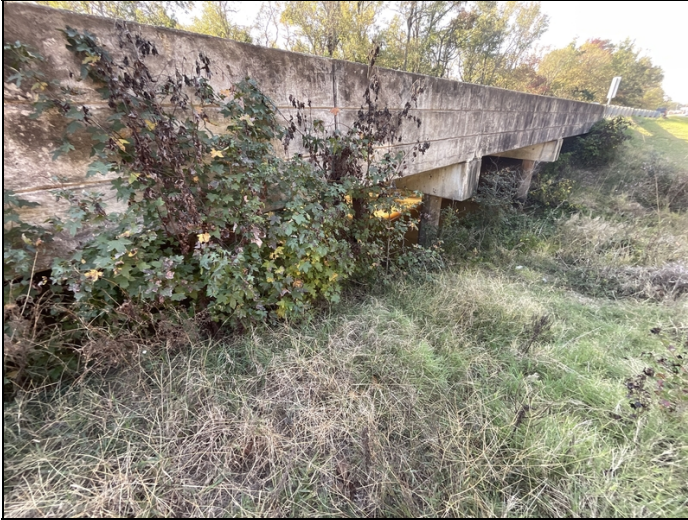
Trees and brush growing against bridge ends
