Asset #05508(Routine)

SH 31Log 1.33 over BAYOU TWO PRAIRIE

Location: 0.3 MI SO OF I-40

Team Lead: Bryan Saunders **Inspection Date:** 10/25/2023

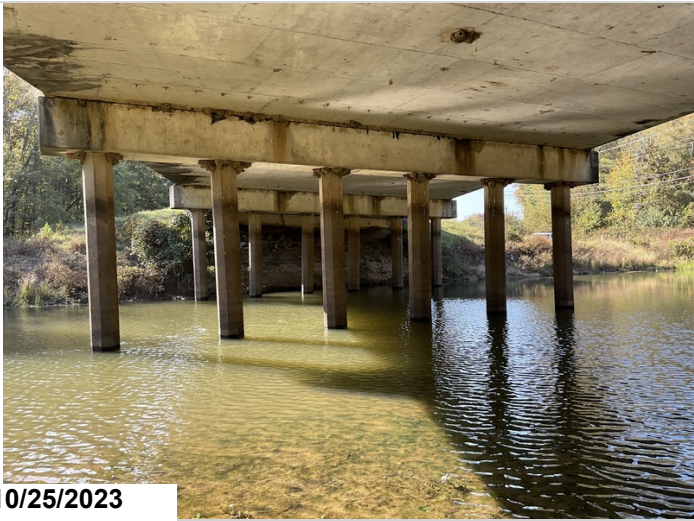
| ELEMENTS | DESCRIPTION | UNITS | TOTAL | CS1 | CS2 | CS3 | CS4 |
|--|---|---|---|---|---|---|---|
| 1190 | Abrasion/Wear (PSC/RC) | EA | 18 | 0 | 18 | 0 | 0 |

Bents 2,3 and 4 abrasion

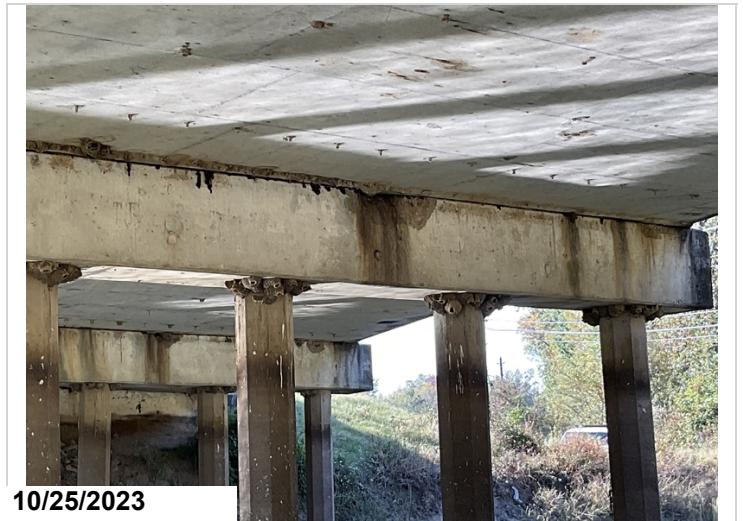
| ELEMENTS | DESCRIPTION | UNITS | TOTAL | CS1 | CS2 | CS3 | CS4 |
|--|---|---|---|---|---|---|---|
| (234) Bent 2 ahead face, spall above pile 1, spall with exposed rebar above pile 2. Bent 2 ahead side above pile 4 has a 1'x2'x7" deep spall with rebar exposed Bent 3 ahead face, spall with exposed rebar between pile 2&3 1'x2'x4" Bent 3 ahead above pile 6 has a 6"x6" spall Bent 4 has a spall with exposed rebar on the bottom near pile 3 and a small delam on the left end. | | | | | | | |

Bent 3 ahead face, spall with exposed rebar between pile
2&3 1'x2'x4"

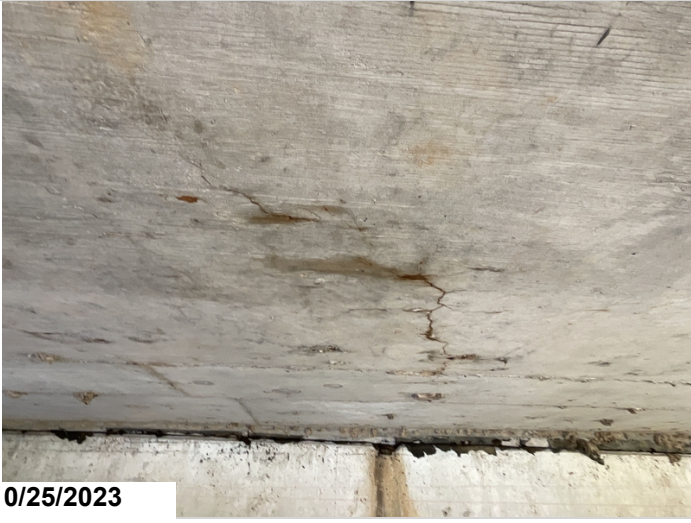
| ELEMENTS | DESCRIPTION | UNITS | TOTAL | CS1 | CS2 | CS3 | CS4 |
|--|---|---|---|---|---|---|---|
| (38) Longitudinal hairline cracks are visible on the soffit of all the spans near the sono voids. Span 4 soffit has small cracks with rust stains. Diagonal cracks are present in the deck surface near the joint and longitudinal and areas of map cracks are present in all spans. 0.030 inch avg. width. Both travel lanes have light abrasion | | | | | | | |

Cracks in the soffit with rust staining

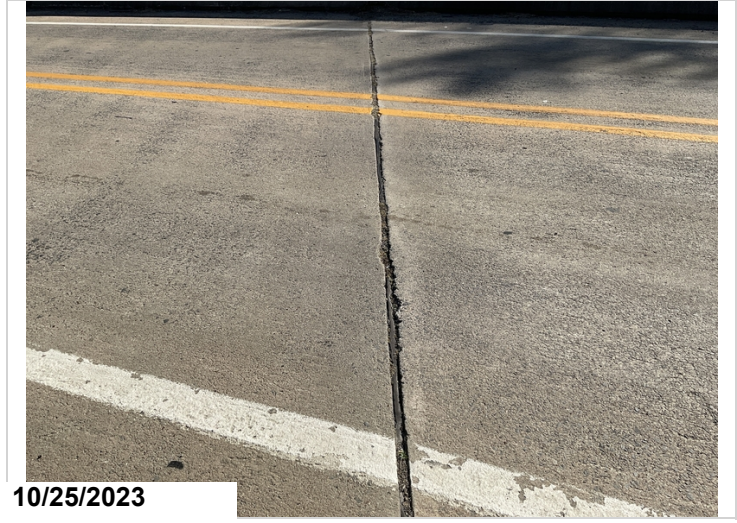
| ELEMENTS | DESCRIPTION | UNITS | TOTAL | CS1 | CS2 | CS3 | CS4 |
|--|---|---|---|---|---|---|---|
| (301) All of the joints have opened and have debris and small spalls along the joints. Bent 4 is the worst case this bridge. | | | | | | | |

Joint at bent 2

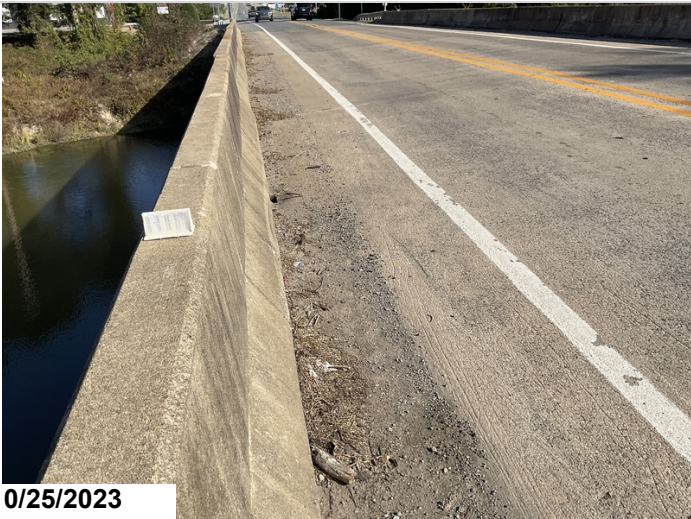
Deck washing needed

| Type of Maintenance | Is recommended? |
|---|---|
| A-55 - Deck Washing Needed | Yes |

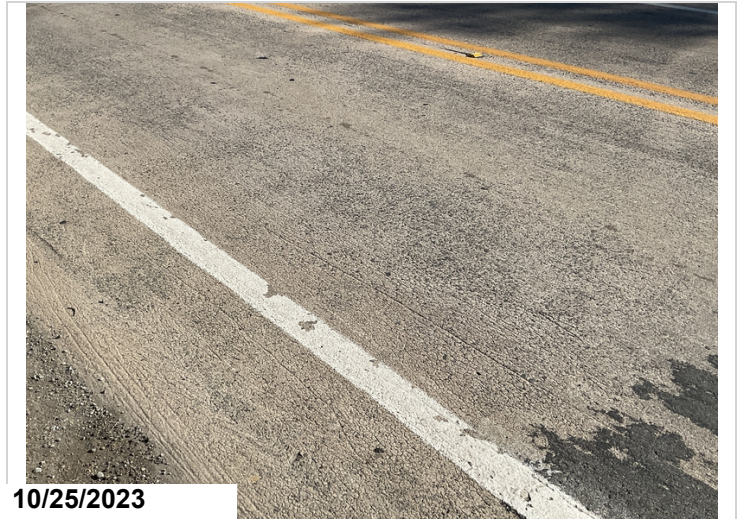
Sealable deck cracks

| Type of Maintenance | Is recommended? |
|---|---|
| A-54 - Sealable Deck Cracks | Yes |

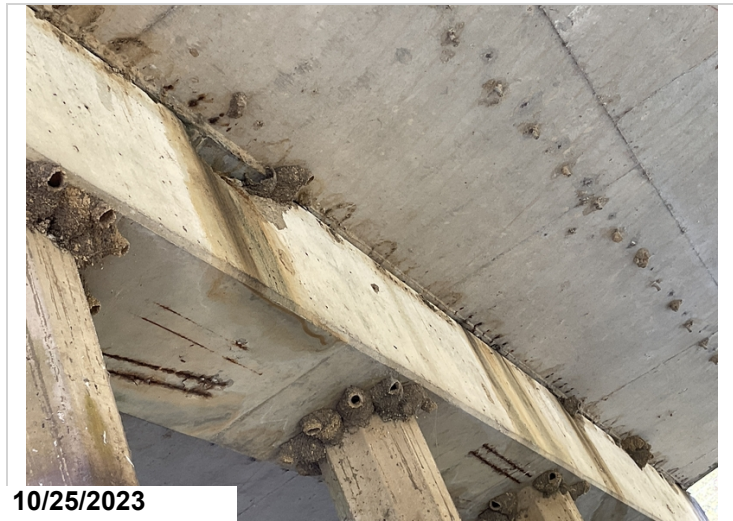
Bent 2 ahead side above pile 4 has a 1'x2'x7" deep spall with rebar exposed

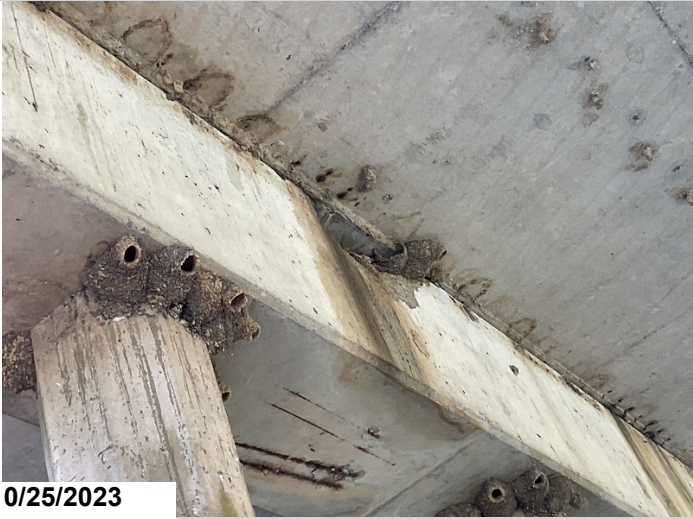
Bent 2 ahead side above pile 4 has a 1'x2'x7" deep spall with rebar exposed

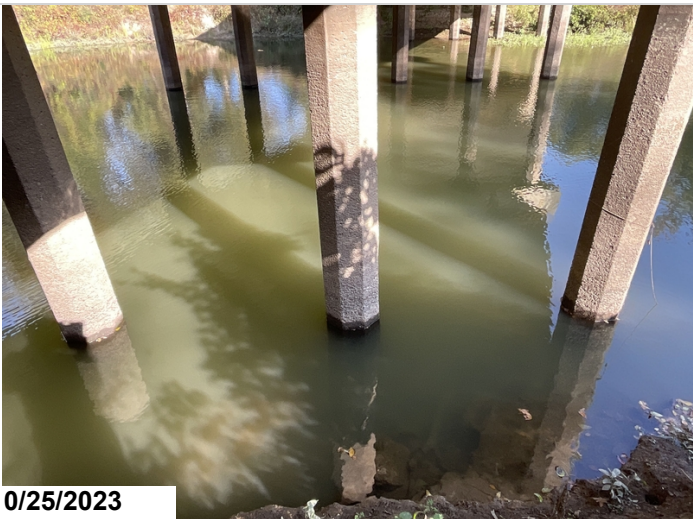
Abrasion to piles at bents 2,3 and 4

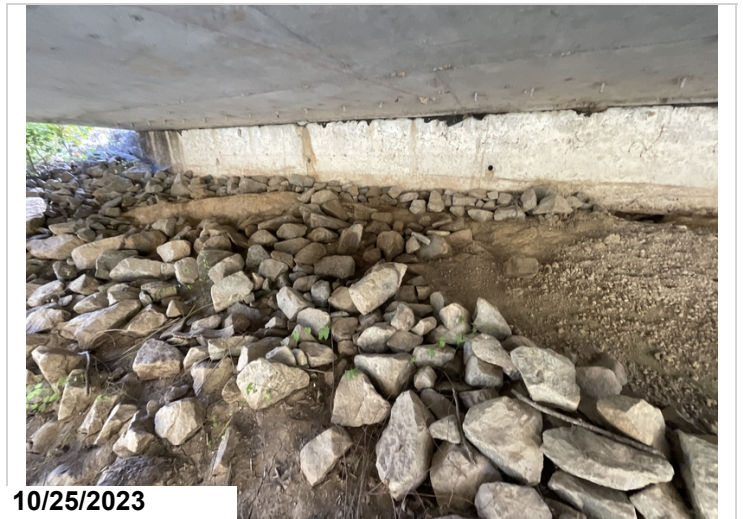
| ELEMENTS | DESCRIPTION | UNITS | TOTAL | CS1 | CS2 | CS3 | CS4 |
|--|---|---|---|---|---|---|---|
| (215) Bent 1: erosion action has undermined abutment exposing pile. State forces have placed top rap in this location. | | | | | | | |

Rip rap placed at bent 1

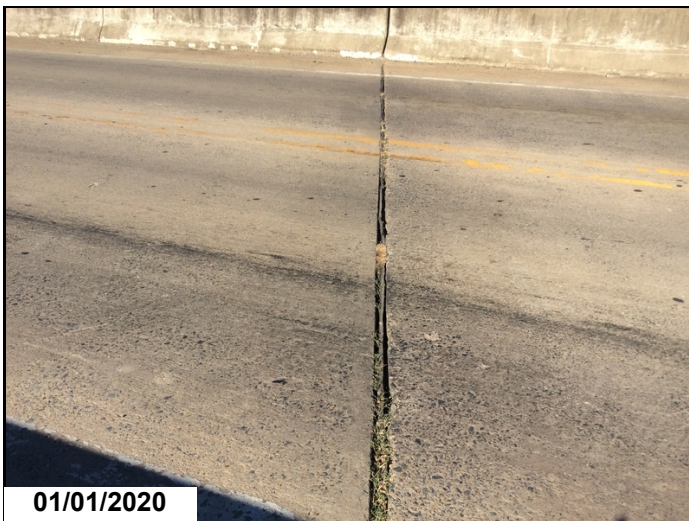
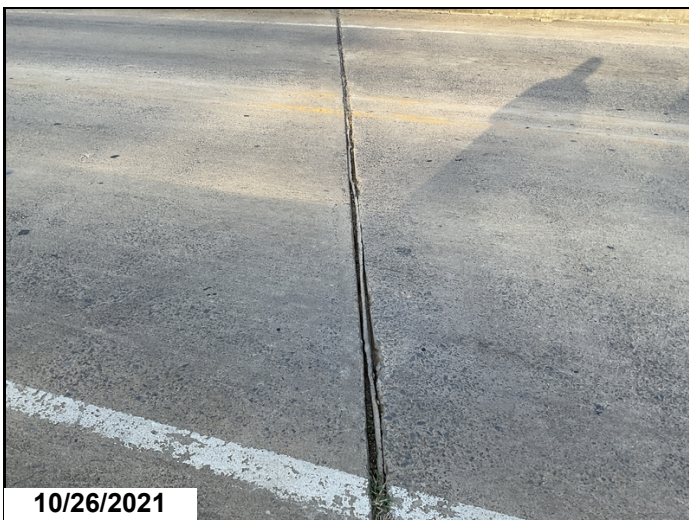
Due to the joint seals failing, incompressible material has impacted the joints causing the bridge to lengthen approximately 2 inches based on field measurements compared to the design plans.

Bent 4, looking left. The joint has opened and begun to fill with non-compressible material.

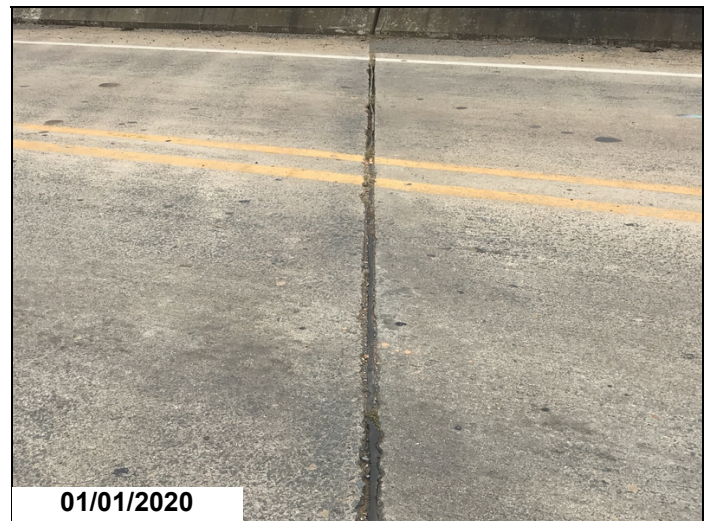
Bent 4: joint seal has lost bond and is full of non compressible material

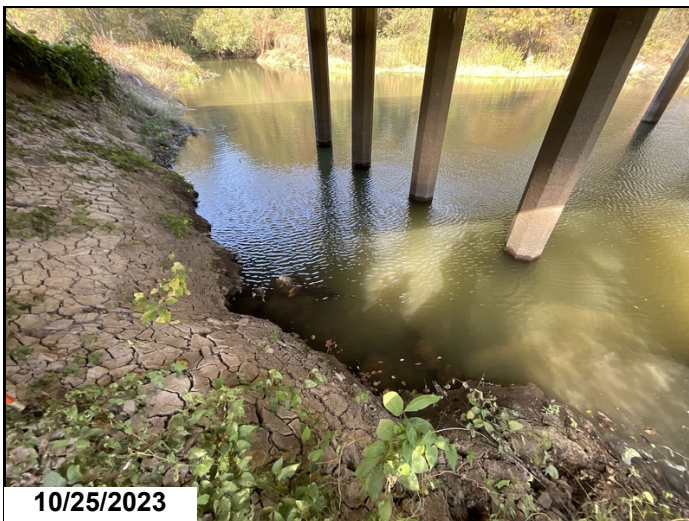
Scour hole at bent 2

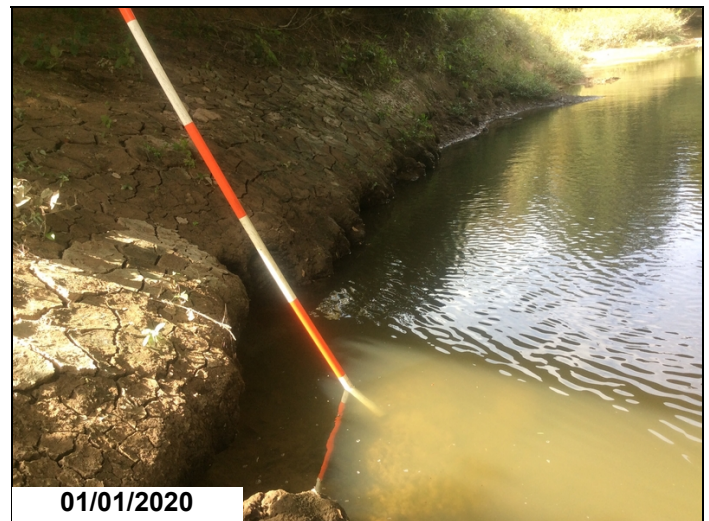
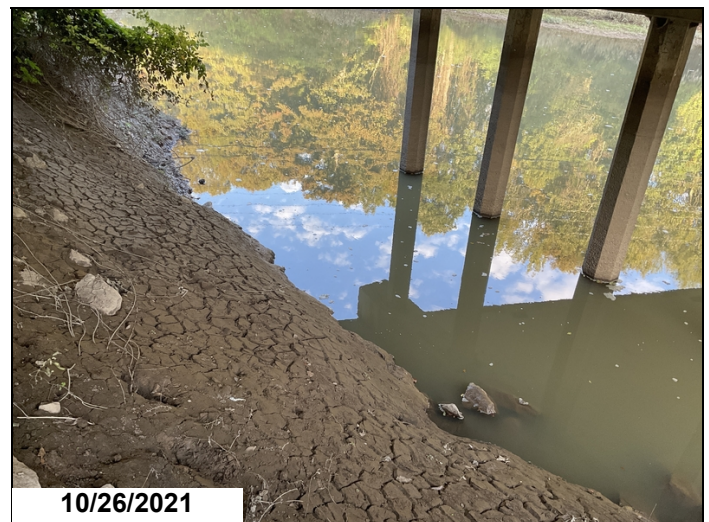
The embankment under span 1 has a scour hole beginning to develop, causing the embankment to slide. Common span 4.

The embankment under span 1 has a scour hole beginning to develop, causing the embankment to slide.

Assigned Lonoke Co 06431 11-2-15

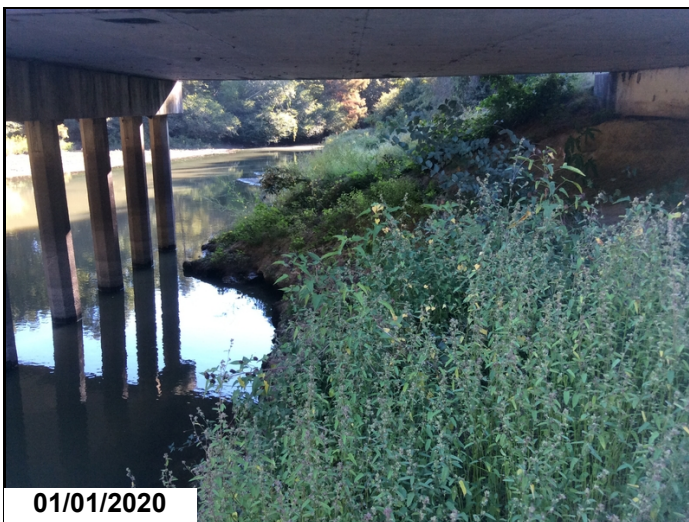
Under Span 1, there is a scour hole beginning to develop, causing the embankment to slide downward.

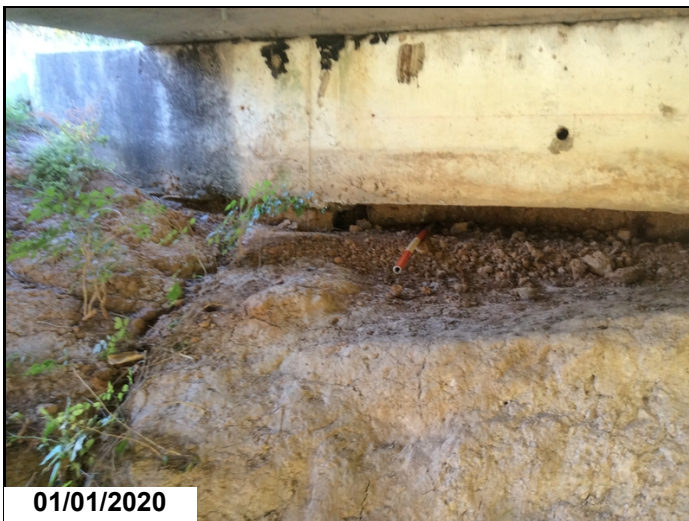
Erosion at bent 1 has begun to undermine the abutment.

Bent 1, looking back at the right side. Erosion has begun to undermine the abutment.

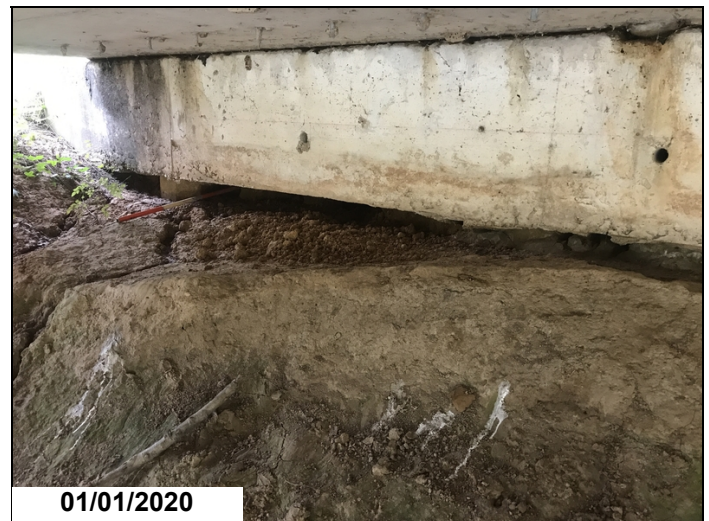
Bent 1: erosion action has undermined abutment exposing pile

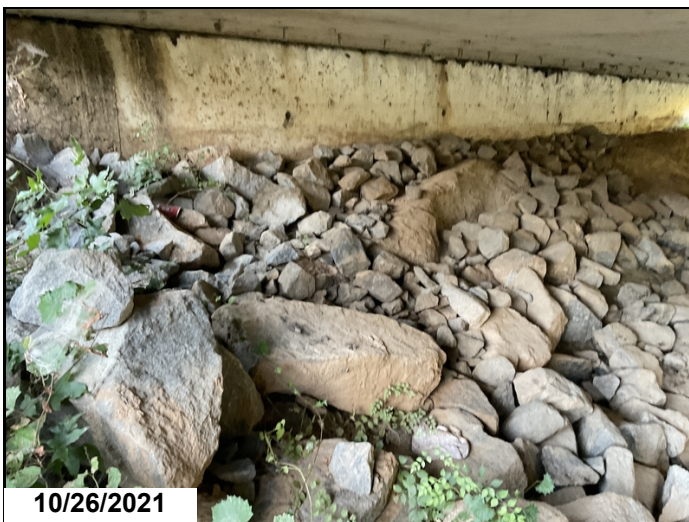
State forces have placed rip rap at bent 1.

Assigned Lonoke Co 06431 11-2-15
State forces have placed rip rap.

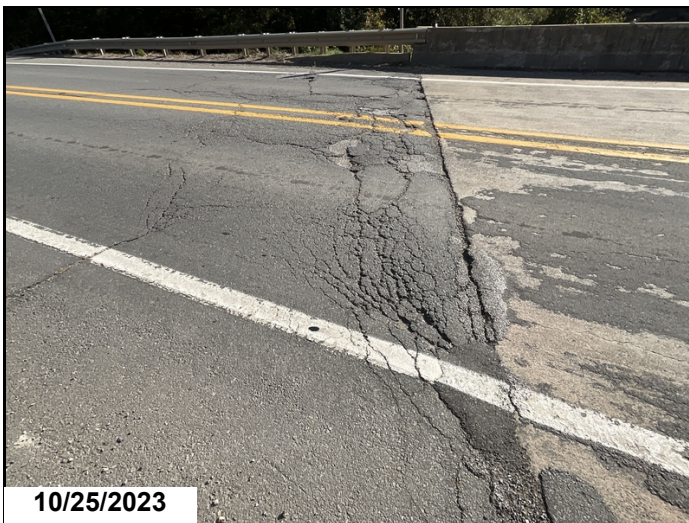
Potholes at bent 6

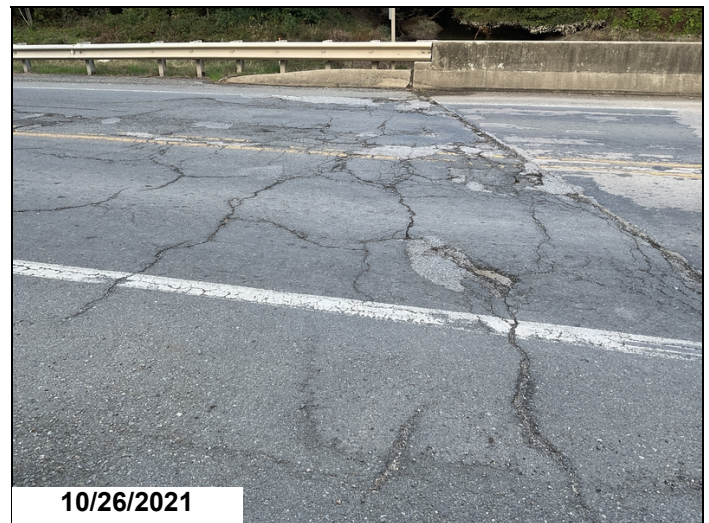
Approach roadway on south end of bridge has settled and has pot holes.
Common on north end.

Approach roadway on south end of bridge has settled and has pot holes.

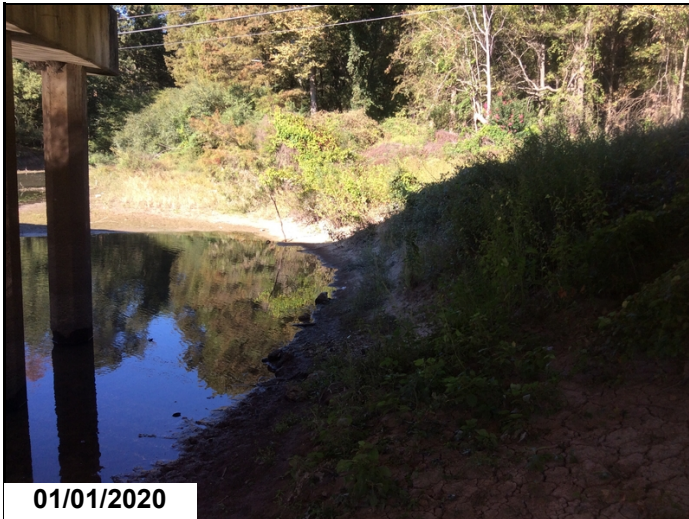
The stream bank under span 4 is being scoured.

Near and under span 4 the stream bank is beginning to scour.

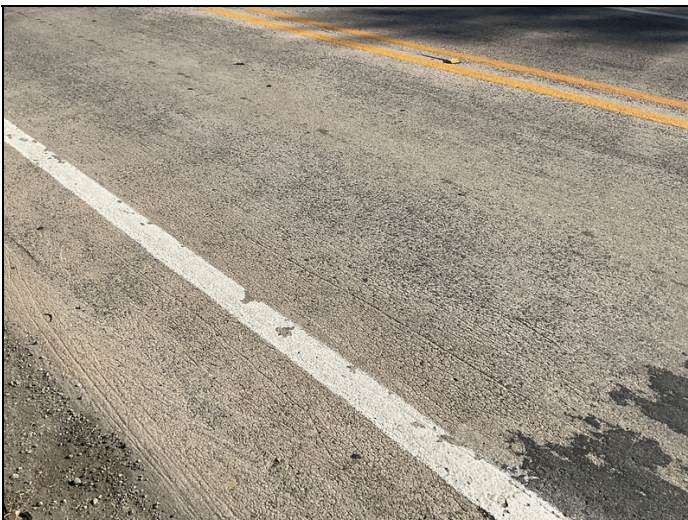
Sealable deck cracks

A-54 - Sealable Deck Cracks (Yes)

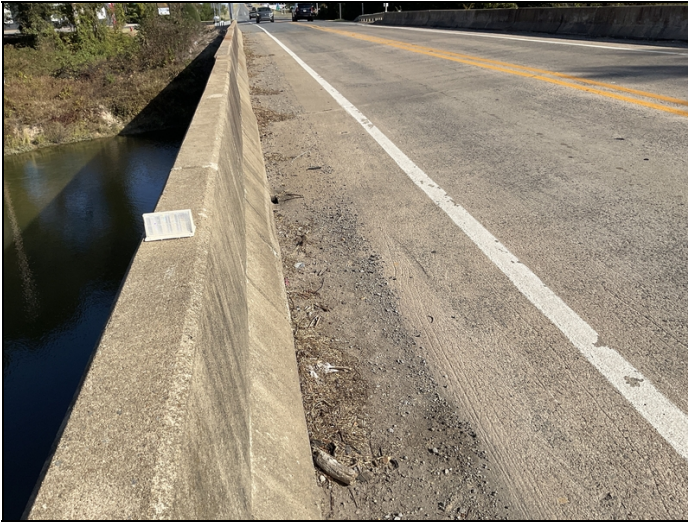
Deck washing needed

A-55 - Deck Washing Needed (Yes)
