Asset #06131(Routine)

SH 31 Log 7.67 over WATTENSAW BAYOU

Location: 6.9 MI N JCT I-40

Team Lead: Bryan Saunders Inspection Date: 11/14/2023

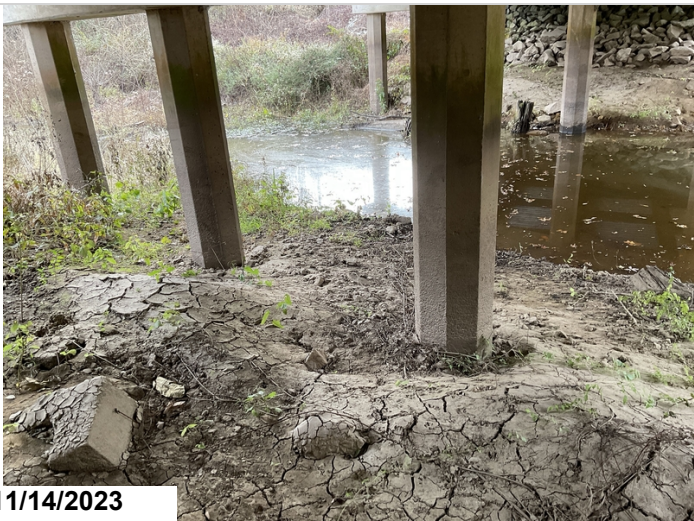
(215) Scattered cracks in both abutment back walls.							
227	Reinforced Concrete Pile	EA	10	0	10	0	0
1190	Abrasion/Wear (PSC/RC)	EA	10	0	10	0	0
(227) All pile have abrasion							
234	Reinforced Concrete Pier Cap	LF	70	70	0	0	0
302	Compression Joint Seal	LF	70	70	0	0	0
311	Movable Bearing	EA	10	5	5	0	0
1000	Corrosion	EA	5	0	5	0	0

Abrasion to pile

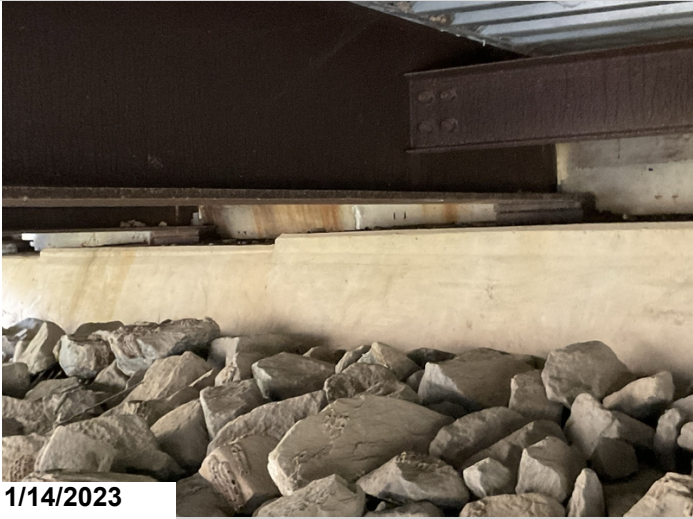
All bearings have laminated rust.

Typical bearings

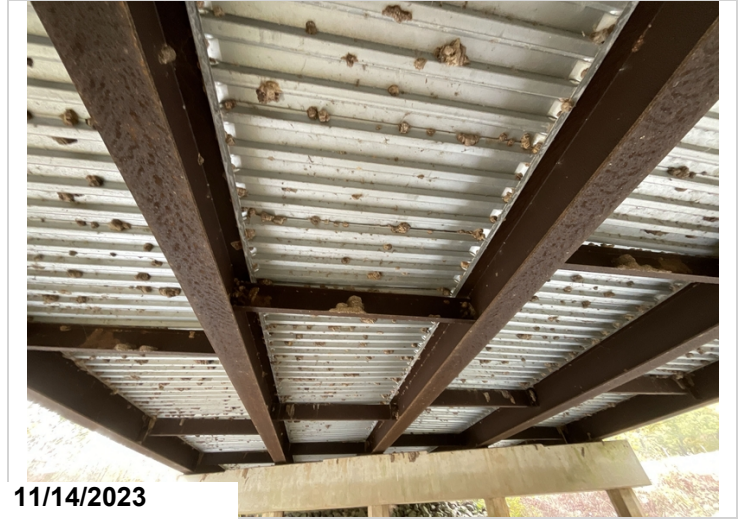
ELEMENTS	DESCRIPTION	UNITS	TOTAL	CS1	CS2	CS3	CS4
12	Reinforced Concrete Deck	SF	3213	3088	125	0	0
1130	Cracking (RC and Other)	SF	125	0	125	0	0
(12) Small areas of map cracks and transverse cracks in the soffit overhangs.							
107	Steel Open Girder/Beam	LF	450	450	0	0	0
515	Steel Protective Coating	SF	2552	0	2552	0	0
3430	Oxide Film Degradation Color/Texture Adherence(Steel Protective Coatings)	LF	2552	0	2552	0	0
(515-107) All beams have a granular texture							
215	Reinforced Concrete Abutment	LF	110	104	6	0	0
1130	Cracking (RC and Other)	LF	6	0	6	0	0

Soffit view

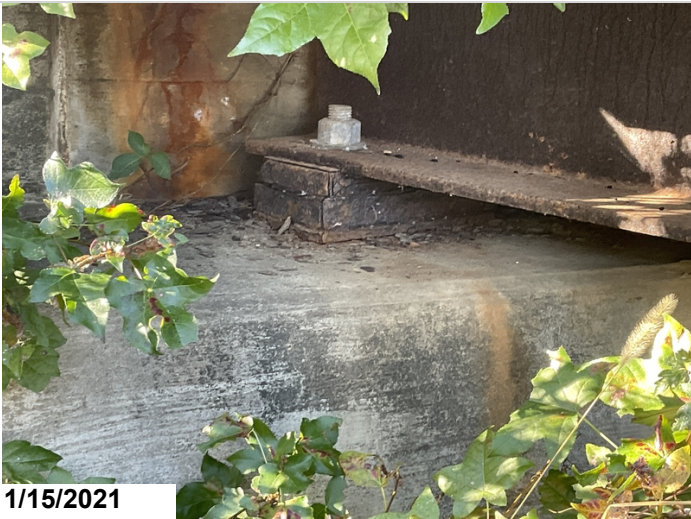
(311) Bent 1 bearings 1,4&5 have laminated corrosion Bent 4 bearings 1&5 have laminated corrosion							
313	Fixed Bearing	EA	10	10	0	0	0
331	Reinforced Concrete Bridge Railing	LF	185	177	8	0	0
1130	Cracking (RC and Other)	LF	8	0	8	0	0

Bent 1 laminated rust on bearing 5

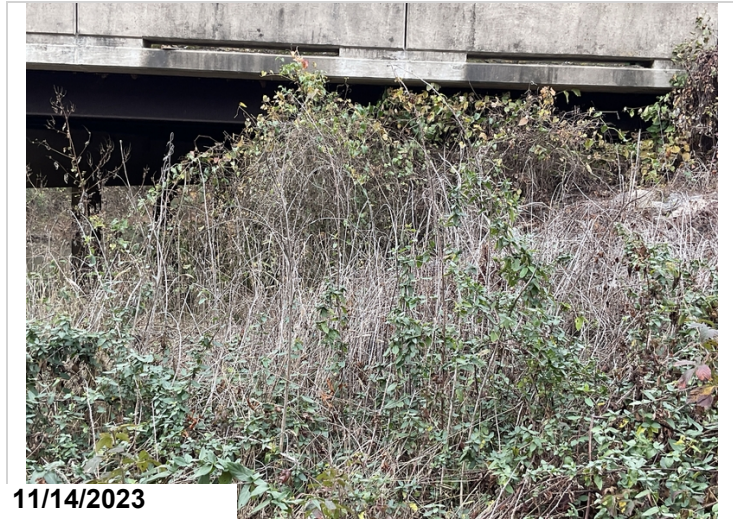
Vines and brush under bridge

**A-64 - Vegetation Removal Requested (Yes)**

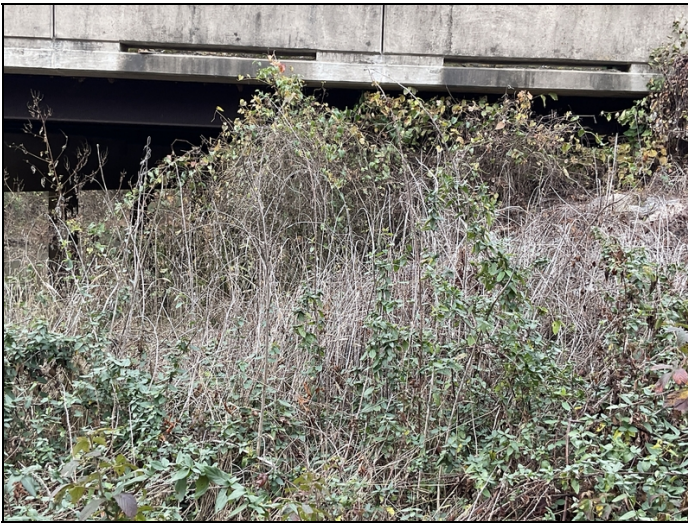
Vines and brush under bridge
