Route:31 Section:03 Log:11.768

District 06, 85 - Lonoke County

**Asset #06132**(Routine, Underwater type 2)  
**SH 31-3 Log 11.77 over PIGEON ROOST CREEK**  
**Location: 10 MI N JCT I-40**  
**Team Lead: Keith Harris Inspection Date: 11/30/2021**

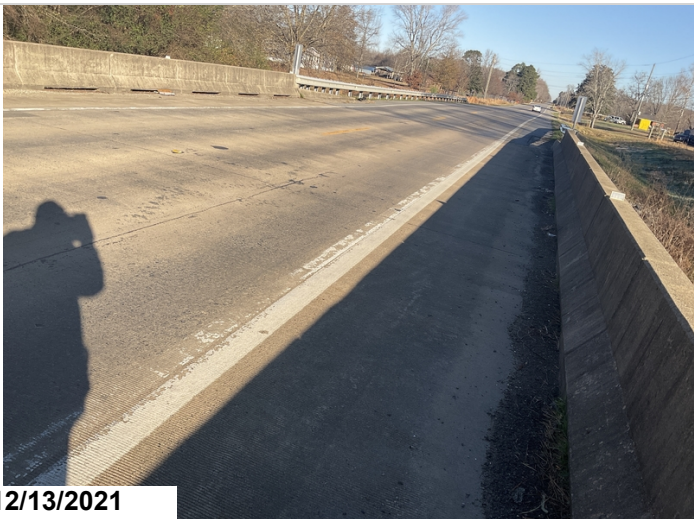
ELEMENTS	DESCRIPTION	UNITS	TOTAL	CS1	CS2	CS3	CS4
12	Reinforced Concrete Deck	SF	2685	2560	125	0	0
1130	Cracking (RC and Other)	SF	125	0	125	0	0
(12) Random transverse cracks in all spans.							
107	Steel Open Girder/Beam	LF	375	375	0	0	0
515	Steel Protective Coating	SF	2126	0	2126	0	0
3430	Oxide Film Degradation Color/Texture Adherence(Steel Protective Coatings)	LF	2126	0	2126	0	0
(515-107) All beams have a granular texture							
215	Reinforced Concrete Abutment	LF	82	79	3	0	0
1130	Cracking (RC and Other)	LF	3	0	3	0	0
227	Reinforced Concrete Pile	EA	10	4	6	0	0
1190	Abrasion/Wear (PSC/RC)	EA	6	0	6	0	0

Deck overview

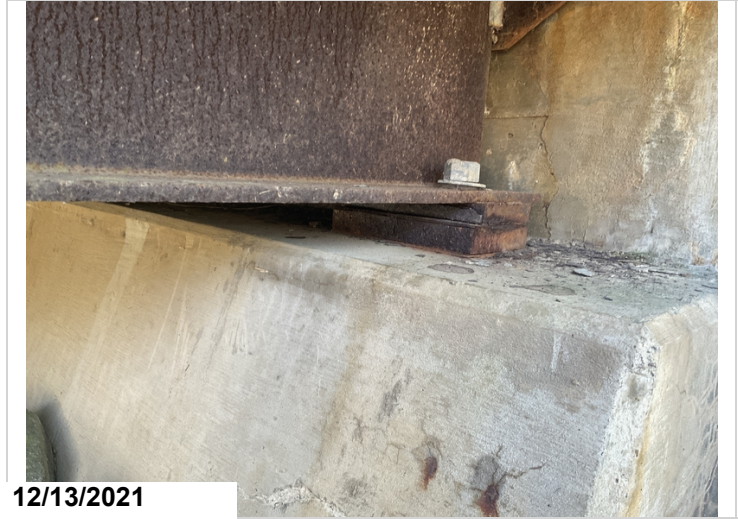
(311) Bearings 1&5 at bent 1&4 have laminated rust							
313	Fixed Bearing	EA	10	10	0	0	0
331	Reinforced Concrete Bridge Railing	LF	154	137	17	0	0
1080	Delamination/Spall/Patched Area	LF	1	0	1	0	0
1130	Cracking (RC and Other)	LF	16	0	16	0	0

Bent 1 bearing 1 laminated rust

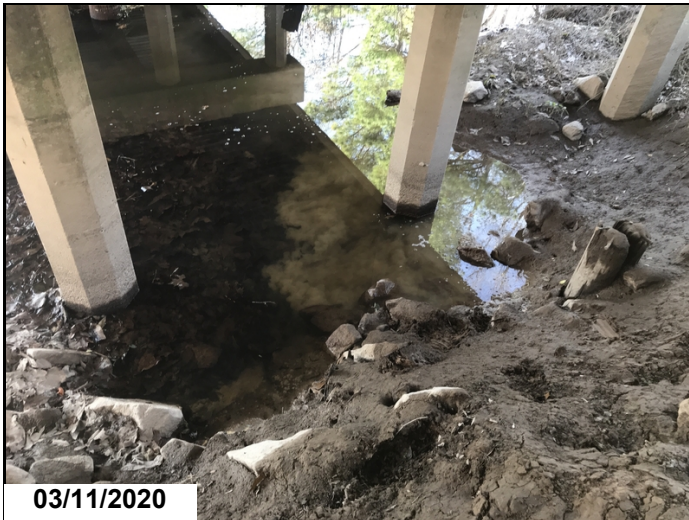
At bent 3 scour has eroded the bank at columns 2 and 3.

Minor aggradation / degradation noted in the stream. Rip-rap remains in place.  
Assigned Lonoke 06431 5/15/18

Bent 3, piles 2 & 3: local scour at this location
