Asset #06133(Routine, Underwater type 2)

SH 31 Log 15.43 over BRUSH CREEK

Location: 1.25 MI N JCT SH 38

Team Lead: Keith Harris Inspection Date: 11/30/2021

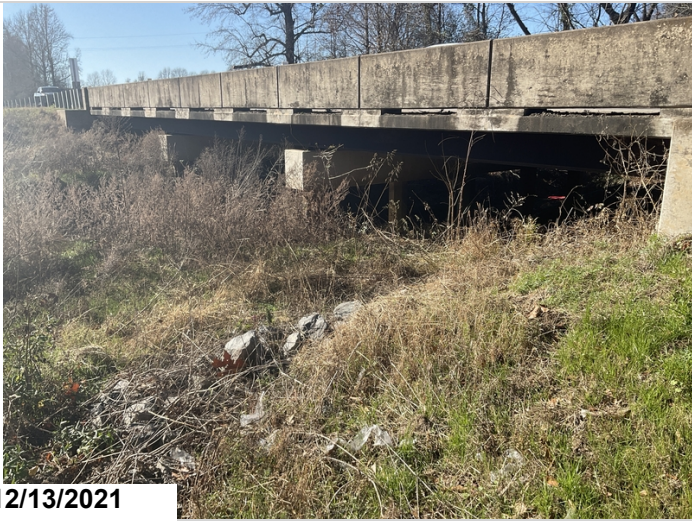
Elevation

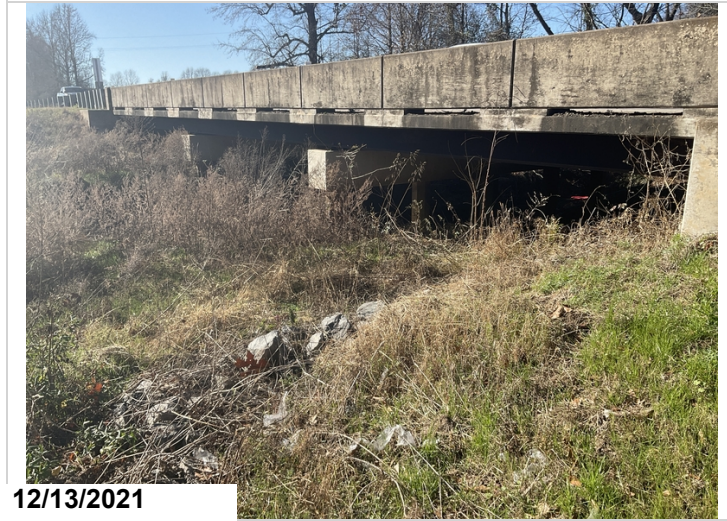
Elevation

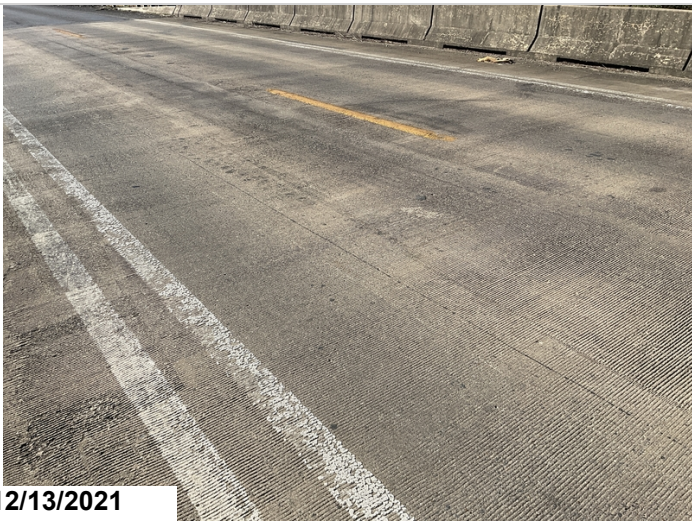
Deck overview

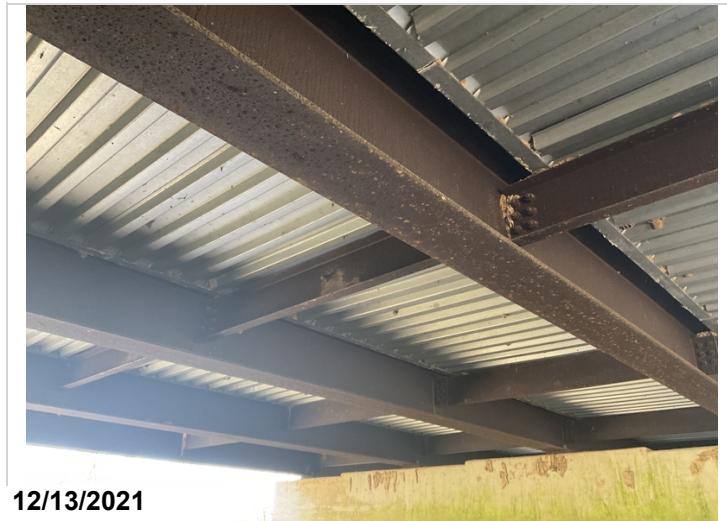
Soffit view

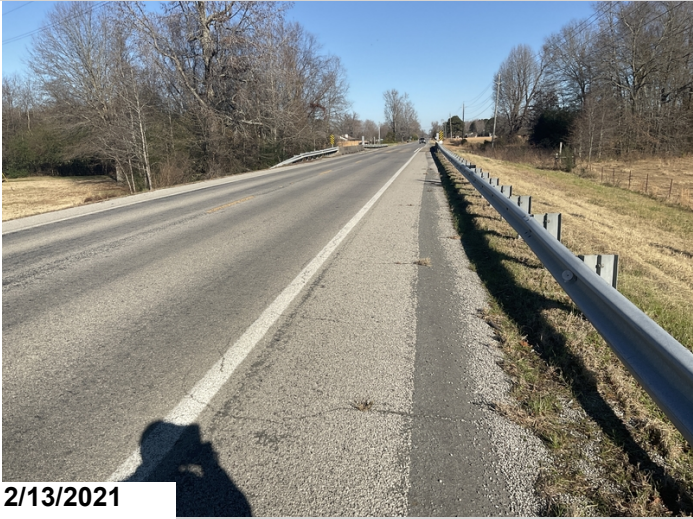
Approach
