## Bridge 01203 Inspection Report

SH 10-7 Log 4.71 over BRINGLE CREEK

Team Lead: Chris Doggett Inspection Date: 12/08/2025

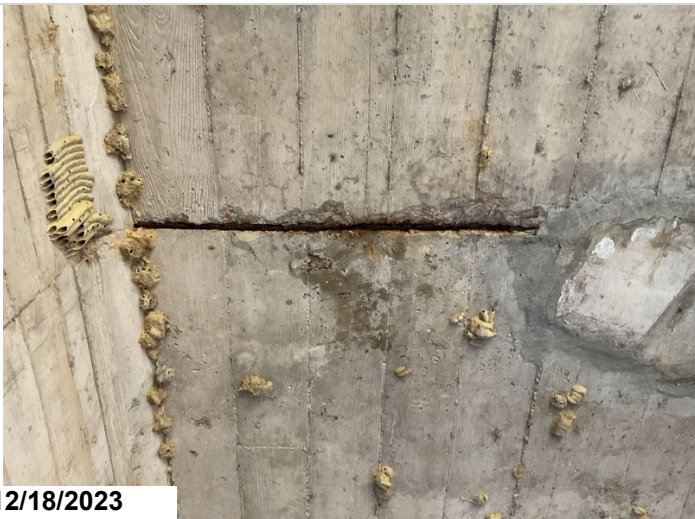
Overall the deck is in satisfactory condition. The soffit has scattered cracks delaminations patched areas and small spalls.  
Span 3 spall and delam between girders 3 & 4.  
Span 4 between girders 3 & 4 spall with exposed rebar in the soffit. 3' x 1" x 1/2" deep.

Span 4 between girders 3 & 4 spall with exposed rebar in the soffit. 3' x 1" x 1/2" deep.

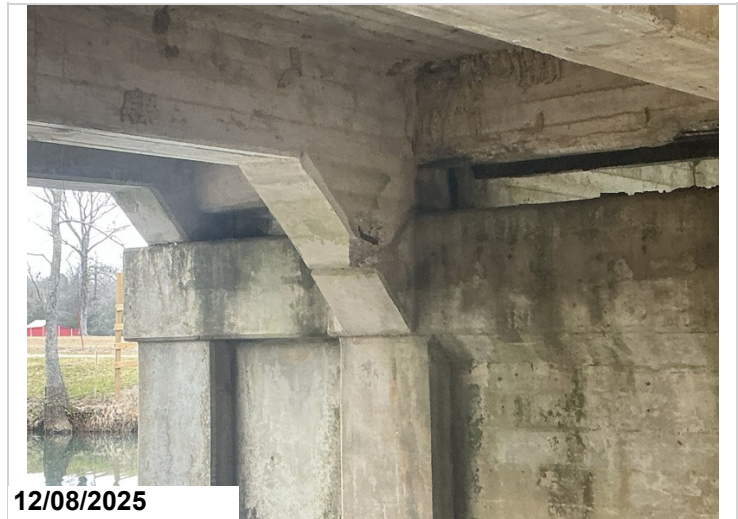
Overall the superstructure is in satisfactory condition. Span 1 bent 2 girder 2 right side spall with exposed rebar at girder haunch.  
Span 2 girder 2 at bent 3 left side spall with exposed rebar and girders 3 and 4 have delaminations.

Span 1, girder 2, at bent 2: small spall with exposed rebar. CS3-1'

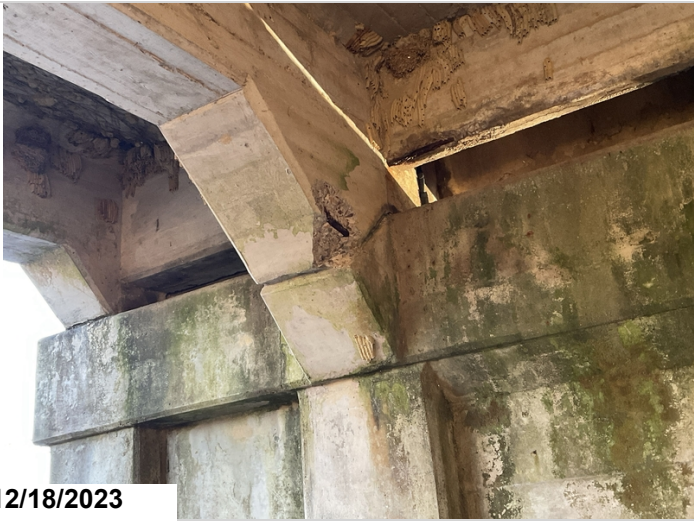
12/18/2023

Span 1 bent 2 girder 2 right side spall with exposed rebar at girder haunch. 8" x 8" x 1" deep.

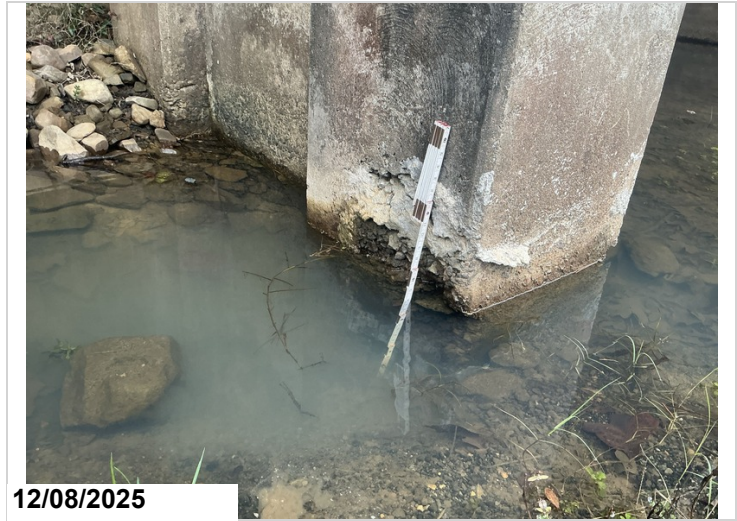
12/08/2025

| ELEMENTS | DESCRIPTION | UNITS | TOTAL | CS1 | CS2 | CS3 | CS4 |
|--|---|---|---|---|---|---|---|
| (205) bent 4 column 1 has heavy abrasion at the water line | | | | | | | |

Bent 4, column 1: bottom of column with a spall. CS3-1

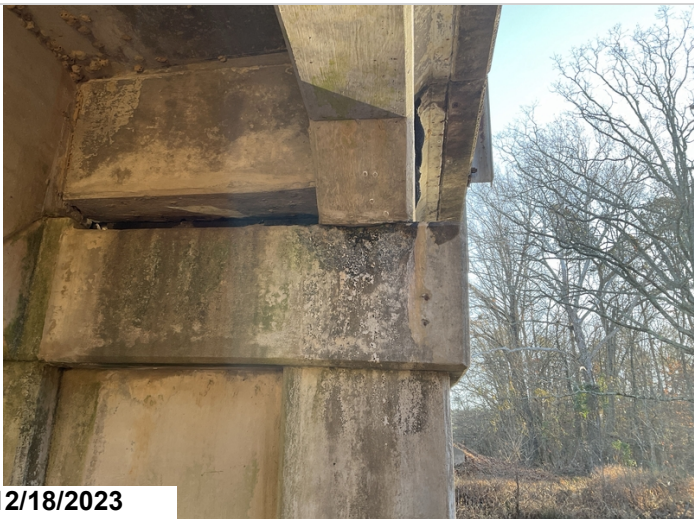
12/18/2023

| ELEMENTS | DESCRIPTION | UNITS | TOTAL | CS1 | CS2 | CS3 | CS4 |
|---|---|---|---|---|---|---|---|
| (234) Bent 2 pier wall back small spalls with exposed rebar & delamination under girder 5. 1' x 8"x 2" deep. | | | | | | | |

Bent 2 pier wall back small spalls with exposed rebar & delamination under girder 5. 1' x 8"x 2" deep.

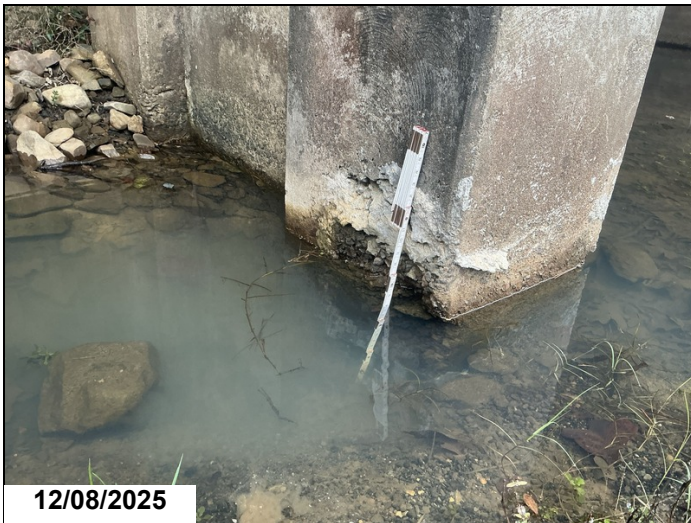
12/08/2025

Bent 4, column 1: bottom of column with a spall. CS3-1  
2025

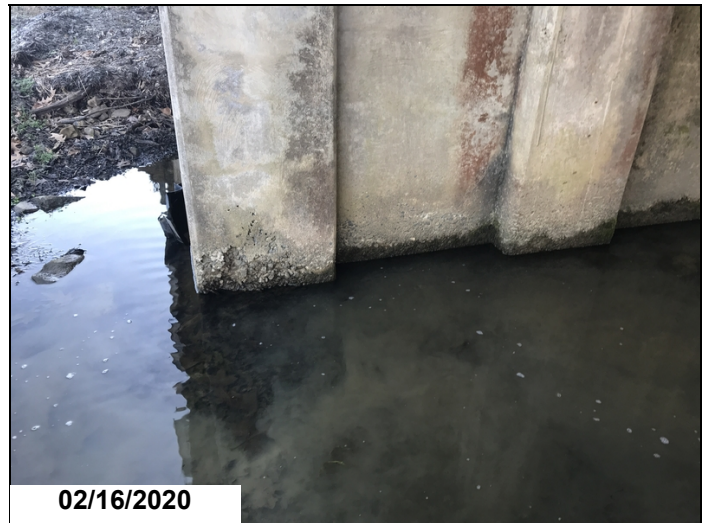
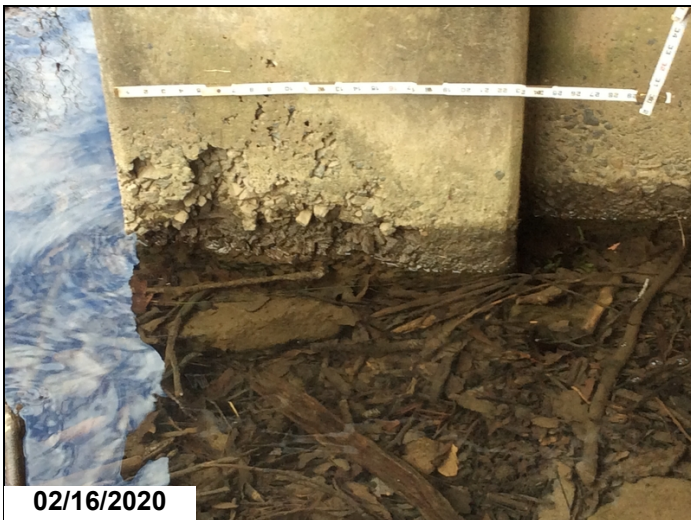
Bent 4 pier wall back server abrasion. Common at bent 3.

**Type of Work:** Repair (General)

**Status:** Monitor

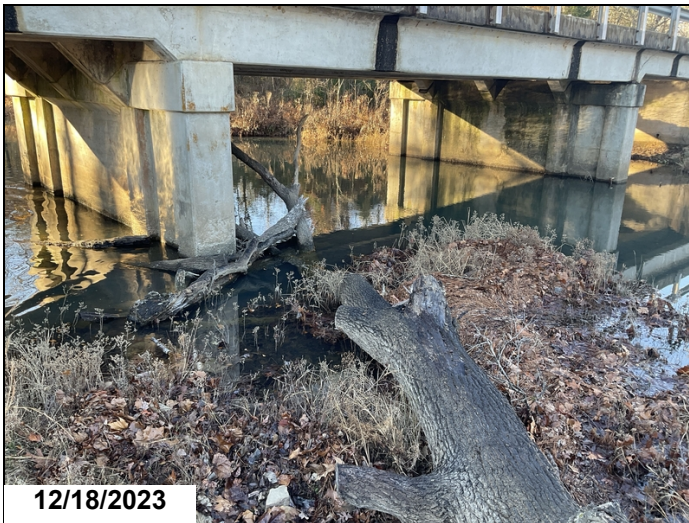
Logs and debris at bent 3 restricting water flow.

**Type of Work:** Channel Work/Drift Removal

**Status:** Monitor
