Bridge 01204 Inspection Report

Asset #01204(Record Change)

SH 10-7 Log 3.66 over DEER LAKE CREEK

Team Lead: Riley House Inspection Date: 02/18/2026

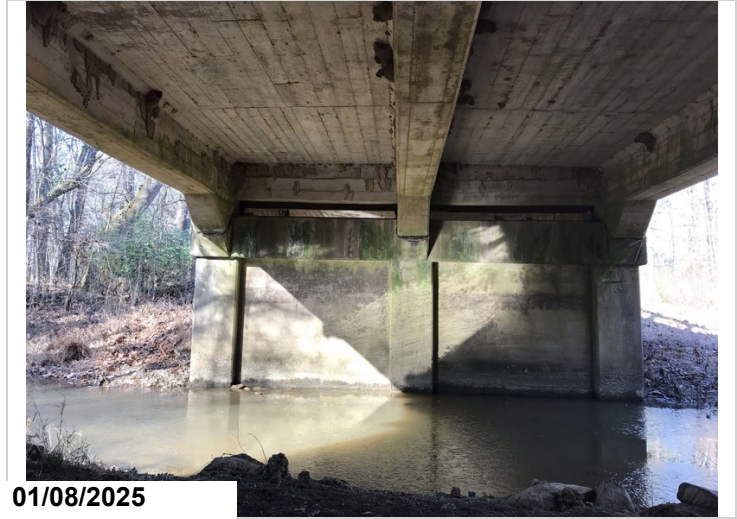
Overall the deck is in satisfactory condition. The deck has an asphalt wearing surface. The undersurface has small spalls with exposed rebar and scattered small cracks with light efflorescence.

Under surface view

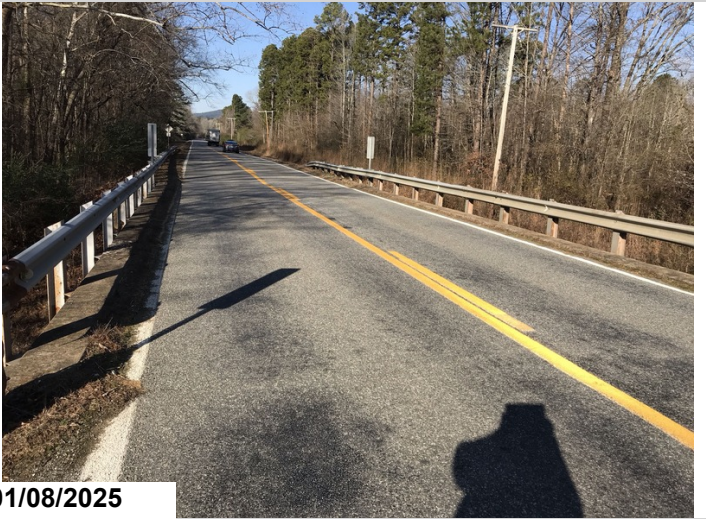
Deck view

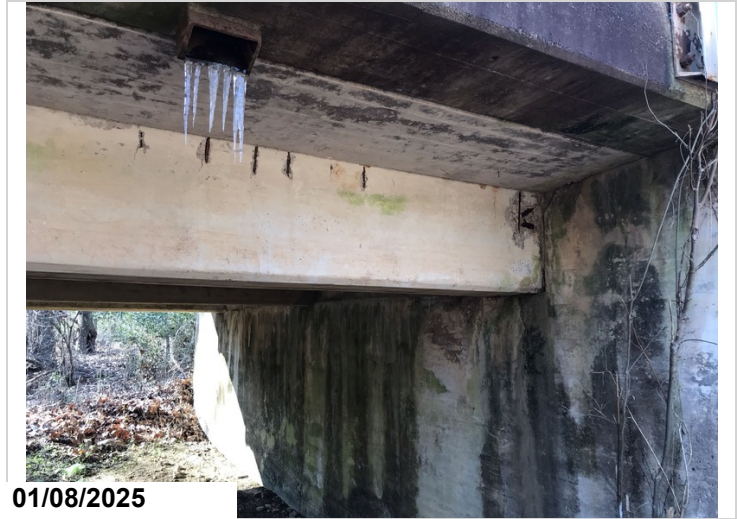
| ELEMENTS | DESCRIPTION | UNITS | TOTAL | CS1 | CS2 | CS3 | CS4 |
|---|---|---|---|---|---|---|---|
| (110) Span 1 girder 1 left side at bent 1 spalls with exposed rebar. Span 2 girders 1 & 3 have small spalls with exposed rebar and small delaminations. Scattered small vertical cracks. | | | | | | | |

Span 1 girder 1 left side spalls with exposed rebar. CS3-7'

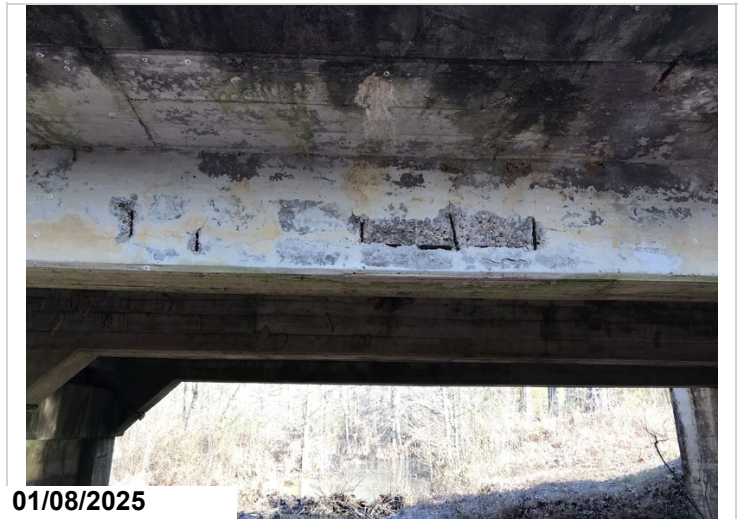
Span 2 girder 3 right side spalls with exposed rebar. CS3-4'

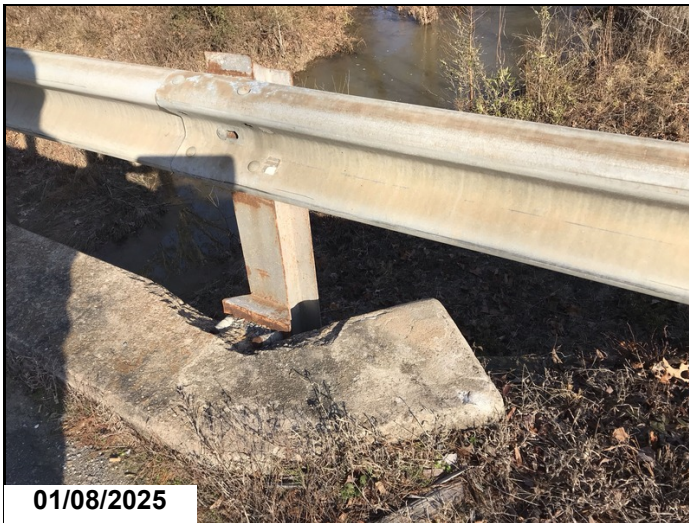
Span 2 bridge rail post left side at bent 3 spalled exposing anchor bolts. See photo.

Bent 3 left side guardrail post damage.

Type of Work: Repair (General)

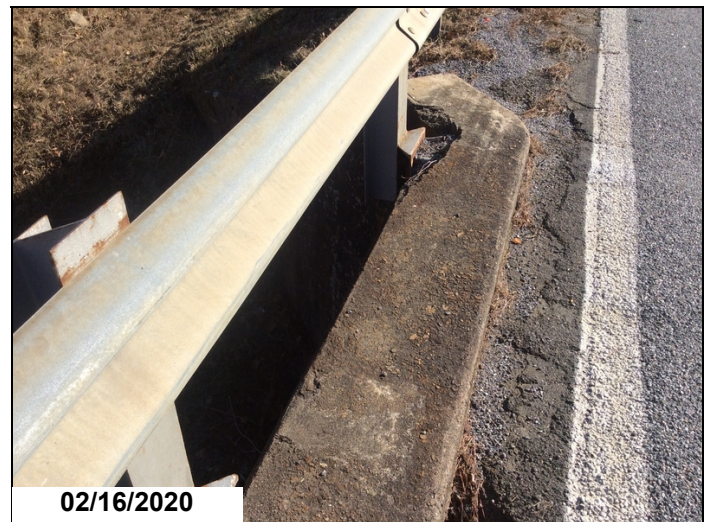
Loose bolts from impact damage
