Bridge 01205 Inspection Report

Asset #01205(Record Change)

SH 10-7 Log 2.97 over HOLLIDAY CREEK

Team Lead: Riley House Inspection Date: 02/18/2026

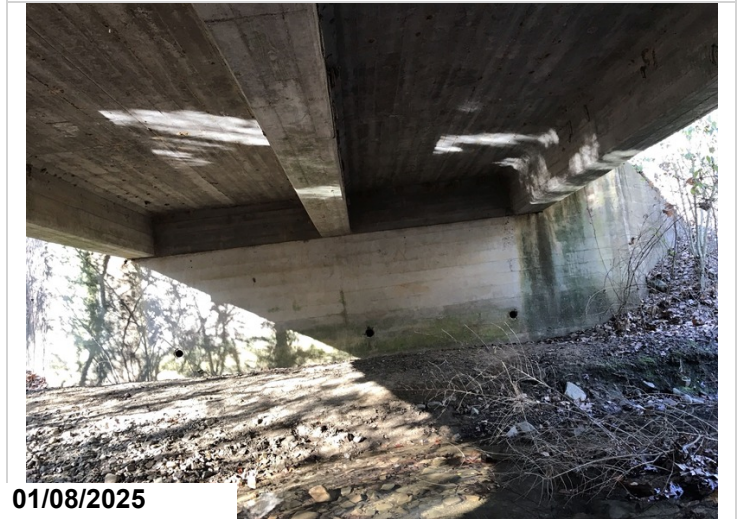
Overall the deck is in satisfactory condition. The deck has an asphalt wearing surface. The undersurface has small spalls with exposed rebar and scattered small cracks with light efflorescence.

Undersurface view

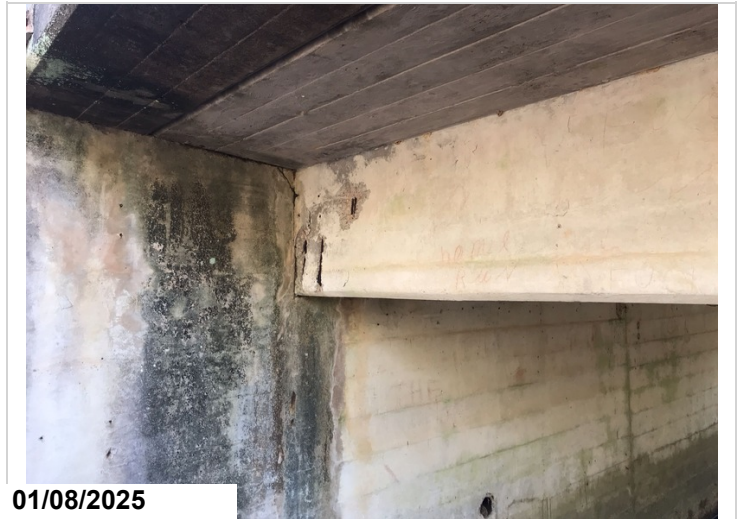
(110) Span 1, girder 1, bent 2: delamination on the end of beam. Span 1, girder 3 at bent 2: spall with rebar left side. Span 2, girder 1, bent 3: left side and bottom has spall with exposed rebar.							
205	Reinforced Concrete Column	EA	3	0	3	0	0
1190	Abrasion/Wear (PSC/RC)	EA	3	0	3	0	0

Girder 1, left side at bent 3: spall with exposed rebar. CS3-2'

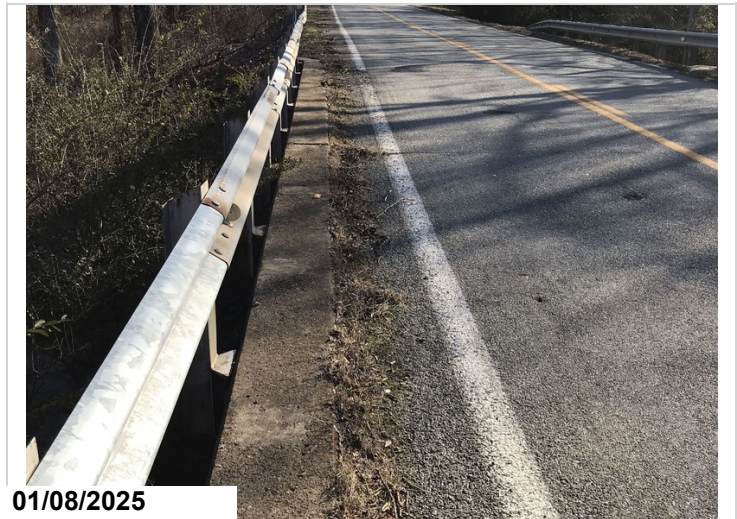
Dirt and debris accumulated in the gutter line

A-55 - Deck Washing Needed (Yes)

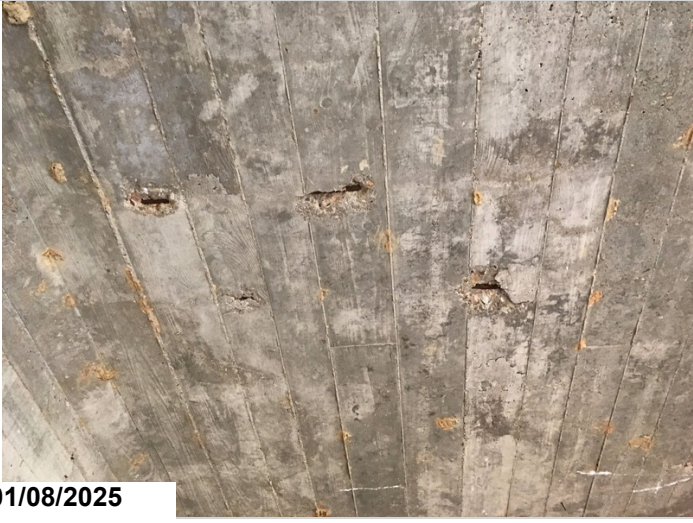
01/08/2025

(16) Span 1 undersurface between girders 2 & 3 small spalls with exposed rebar and scattered small cracks with light efflorescence. Span 2 soffit has scattered small spalls with rebar and cracks. (510-16) Some cracking in the wearing surface.							
110	Reinforced Concrete Open Girder/Beam	LF	180	174	0	6	0
1080	Delamination/Spall/Patched Area	LF	2	0	0	2	0
1090	Exposed Rebar	LF	4	0	0	4	0

Span 1 undersurface between girders 2 & 3 several small spalls with exposed rebar. CS3-3'

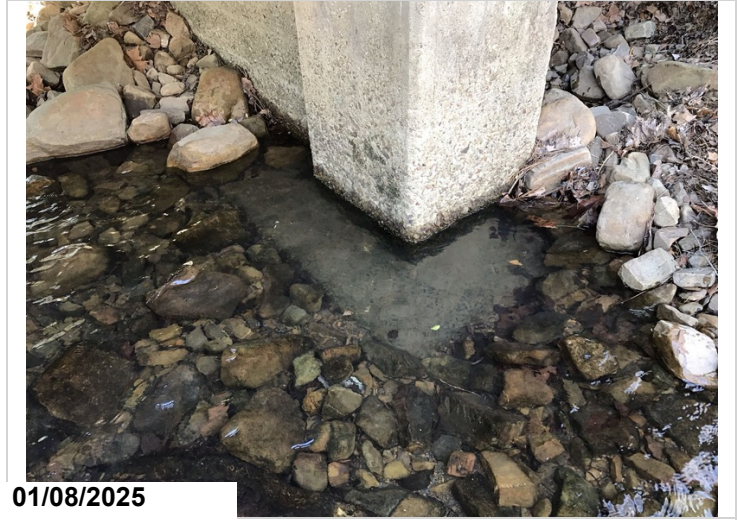
01/08/2025

Bent 2 ahead side footing exposed.

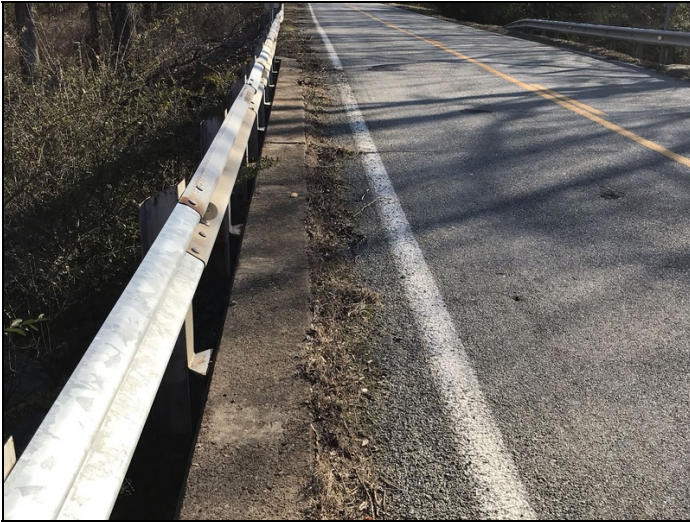
Dirt and debris accumulated in the gutter line
