Bridge 01206 Inspection Report

Asset #01206(Record Change)
SH 10-7 Log 1.67 over ROTHY CREEK
Location: 1.67 MI E OF PERRY CO LIN
Team Lead: Riley House Inspection Date: 02/18/2026

National Bridge Inventory Data Sheet

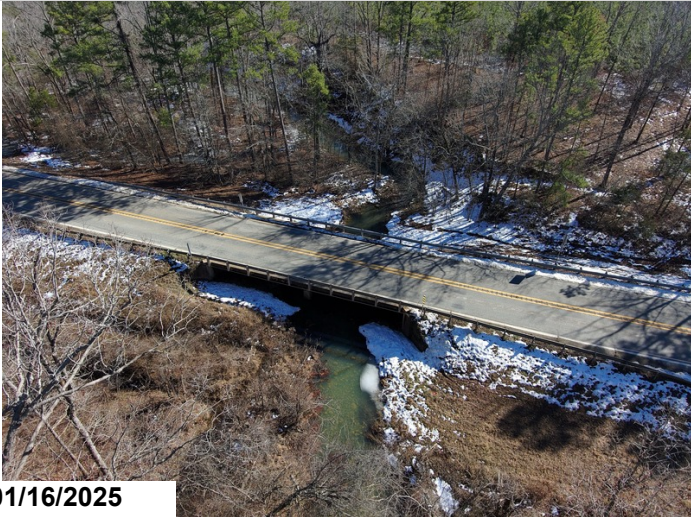
01/16/2025

Elevation

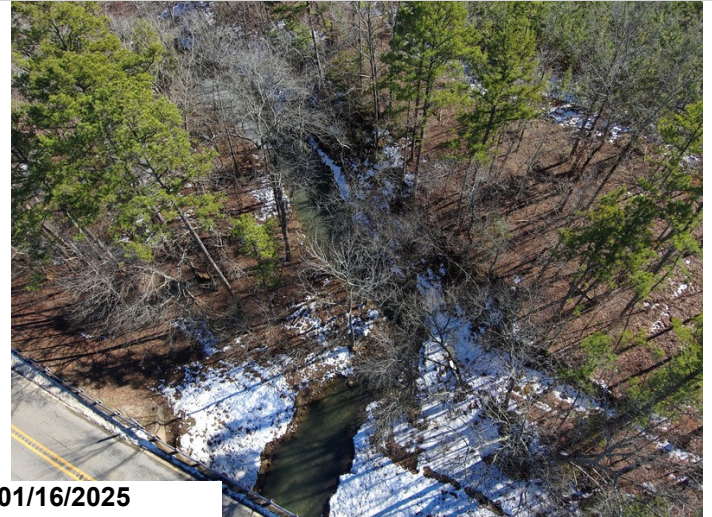
01/16/2025

Channel looking down stream

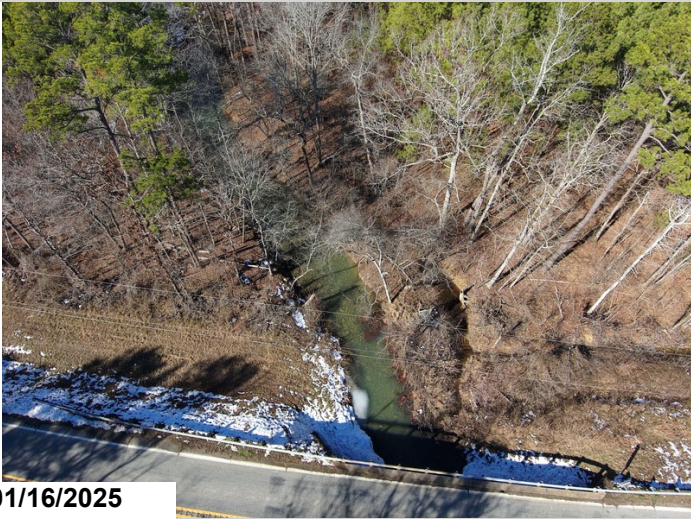
01/16/2025

Channel looking upstream

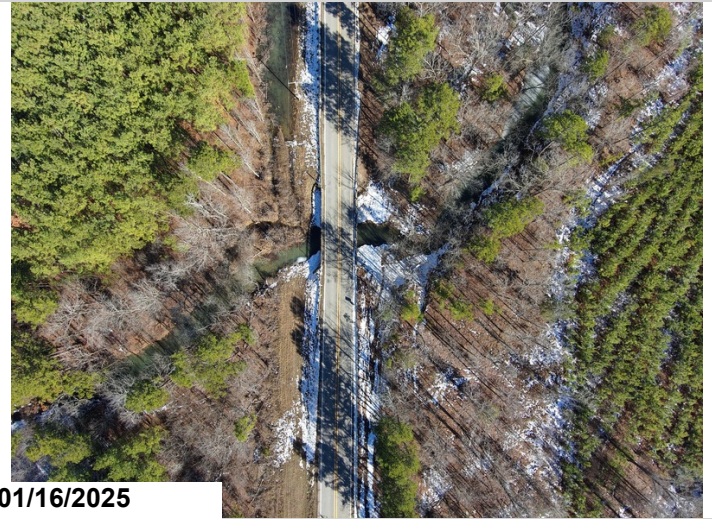
01/16/2025

Channel overview

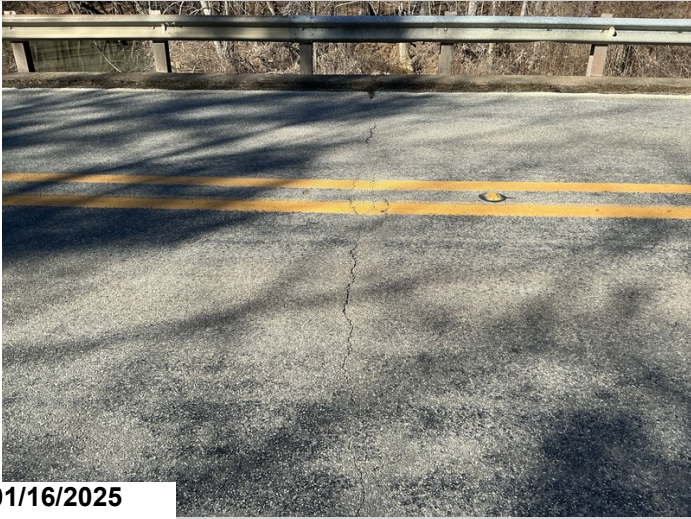
| ELEMENTS | DESCRIPTION | UNITS | TOTAL | CS1 | CS2 | CS3 | CS4 |
|---|---|---|---|---|---|---|---|
| 3220 | Crack (Wearing Surface) | SF | 36 | 0 | 36 | 0 | 0 |
| (510-16) Cracks in the wearing surface at the joints. (CS3-24') | | | | | | | |

Bent 4: cracking at the joint in the asphalt wearing surface.
CS3-24'

| Type of Maintenance | Is Recommended? |
|---|---|
| A-59 - Joint Repair Needed | Yes |

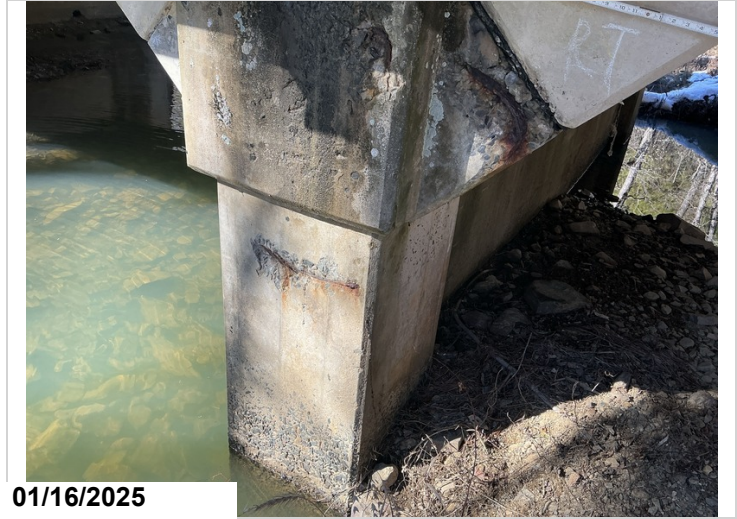
| ELEMENTS | DESCRIPTION | UNITS | TOTAL | CS1 | CS2 | CS3 | CS4 |
|---|---|---|---|---|---|---|---|
| (205) Spall with exposed rebar to the outside of the right column. CS3-1' | | | | | | | |

Spall with exposed rebar to the outside of the right column.
CS3-1'

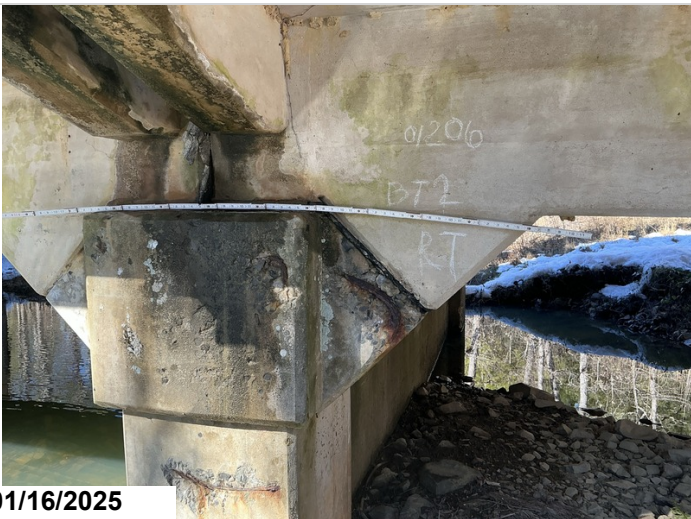
| ELEMENTS | DESCRIPTION | UNITS | TOTAL | CS1 | CS2 | CS3 | CS4 |
|---|---|---|---|---|---|---|---|
| (234) Bent 2: spall with exposed rebar at the end of the cap. CS31' | | | | | | | |

Bent 2: spall with exposed rebar at the end of the cap. CS31'

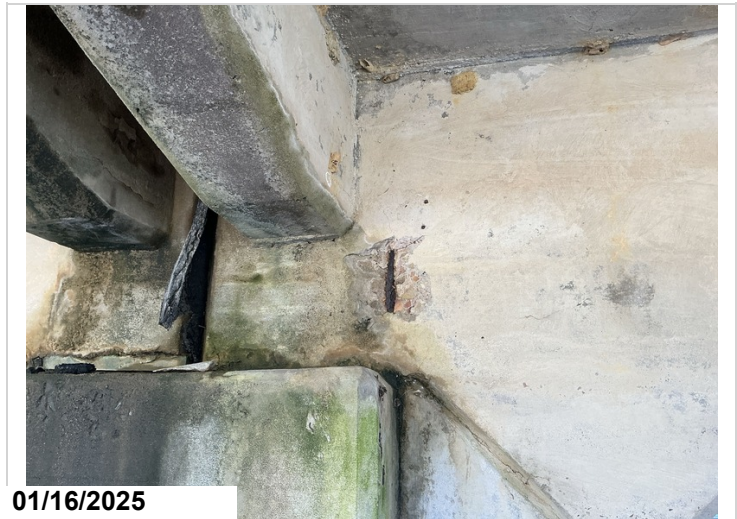
| ELEMENTS | DESCRIPTION | UNITS | TOTAL | CS1 | CS2 | CS3 | CS4 |
|---|---|---|---|---|---|---|---|
| Span 1 bent 2 girder 1 left side spall with exposed rebar. | | | | | | | |

Bent 2, span 1, girder 1: small spall with exposed rebar to the girder. CS3-1'

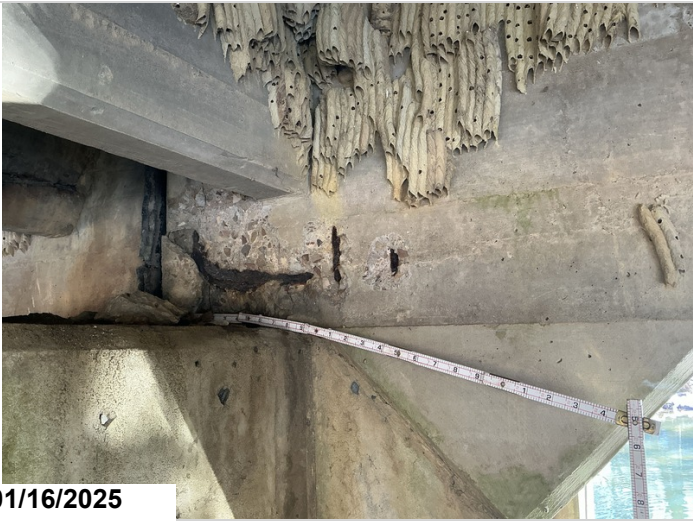
| ELEMENTS | DESCRIPTION | UNITS | TOTAL | CS1 | CS2 | CS3 | CS4 |
|---|---|---|---|---|---|---|---|
| (110) Scattered spalls with exposed rebar on the girder legs (CS3-3') and scattered small vertical cracks in concrete girders. (CS2-25') | | | | | | | |

Bent 2, span 1, girder 1: multiple spalls with exposed rebar to the girder. CS3-2'

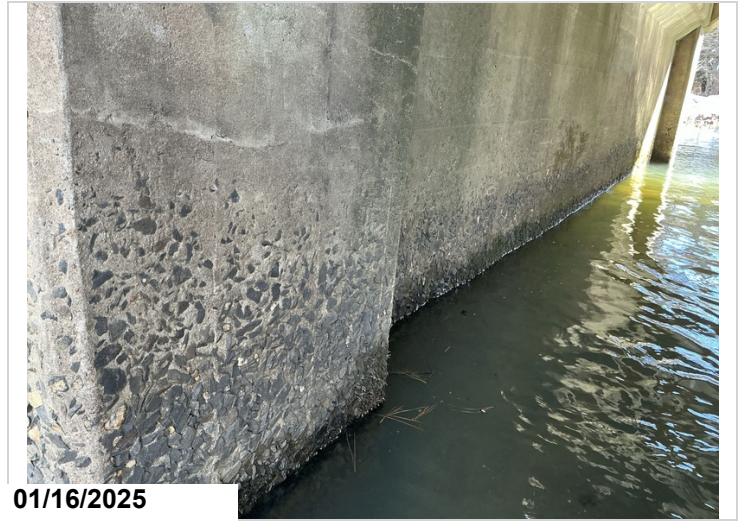
| ELEMENTS | DESCRIPTION | UNITS | TOTAL | CS1 | CS2 | CS3 | CS4 |
|---|---|---|---|---|---|---|---|
| (210) Bent 2: moderate abrasion to the lower section of the pier. CS2-18' | | | | | | | |

Bent 2: moderate abrasion to the lower section of the pier. CS2-18'

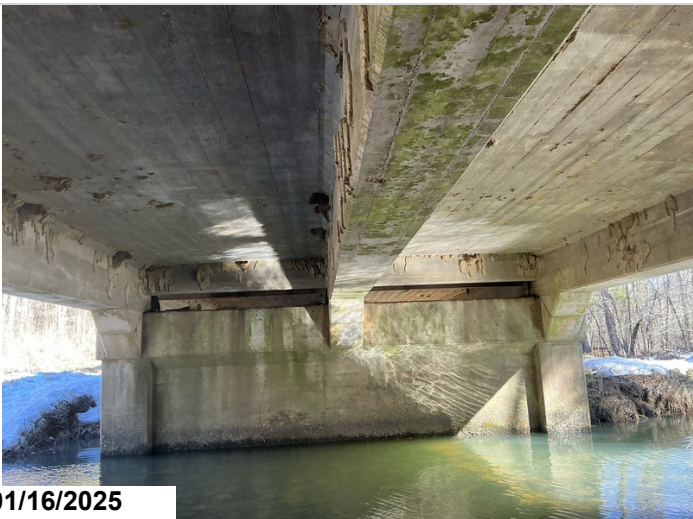
Under surface view

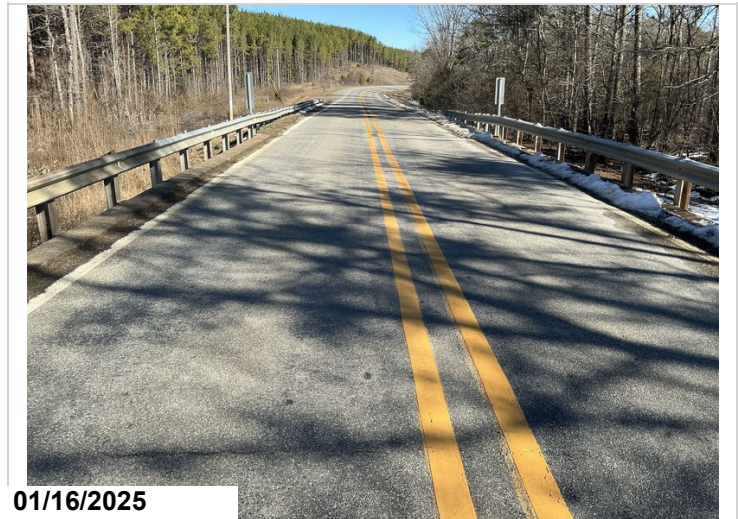
Deck view

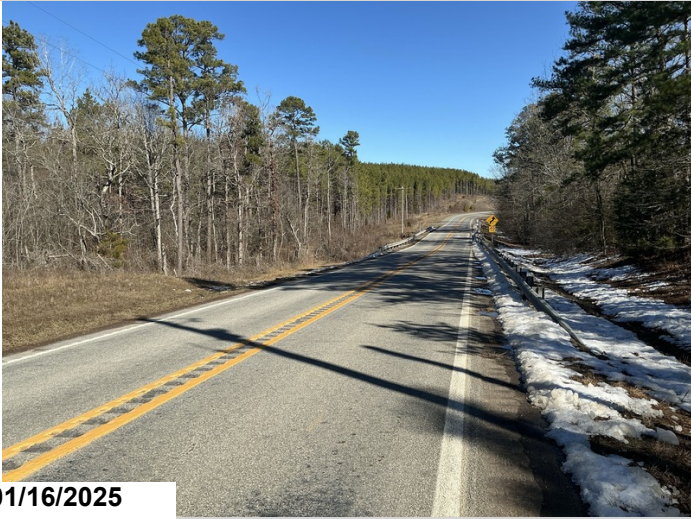
01/16/2025

Inventory looking east
