## Bridge 02362 Inspection Report

SH 10 Log 14.11 over NOWLIN CREEK

Location: 3.63 MI W SH 300

Team Lead: Bryan Saunders Inspection Date: 09/15/2025

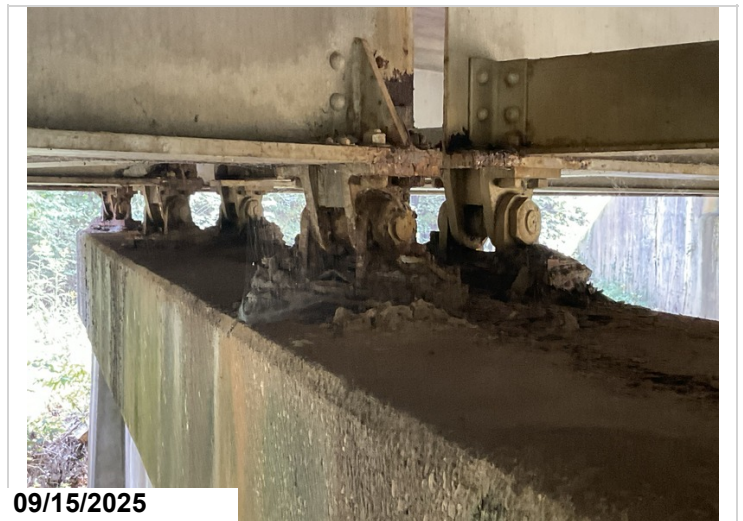
All beam ends and bearing have active corrosion

Girder ends and bearings are in need of major cleaning and repairs

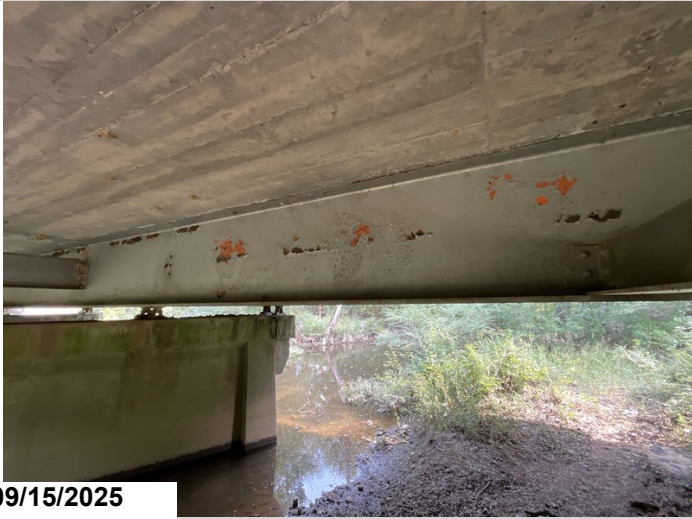
All beams have scattered areas of corrosion

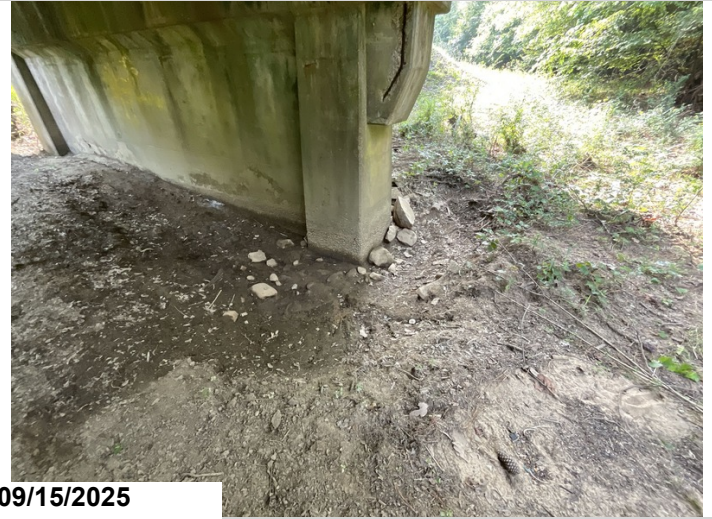
Bent 2 upstream end, 4' deep scour hole exposing footing. Footing is not undermined at this time.  
Bent 3 column 2, local scour has exposed top of footing  
Bent 4 right side has a 3' deep by 10' around horseshoe scour

Bent 4 right side has a 3' deep by 10' around horseshoe scour

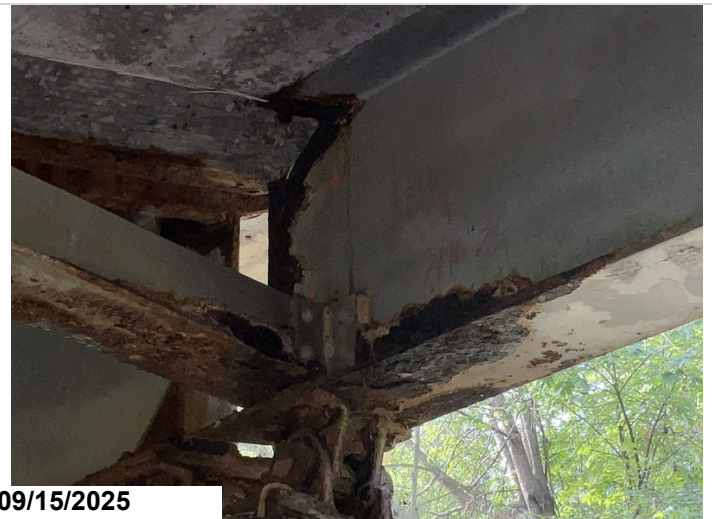
Overall the superstructure is in fair condition  
Beam ends have active corrosion with section loss in haunch, web and flanges.  
Span 3, at bent 4 beam 4, 16" in front of bearing only 1/4" remain on left side of bottom flange. Up to 3/16" section loss in lower web. Worst case this bridge.

Bent4 girder 4 has up to 1/4" section loss to lower flange

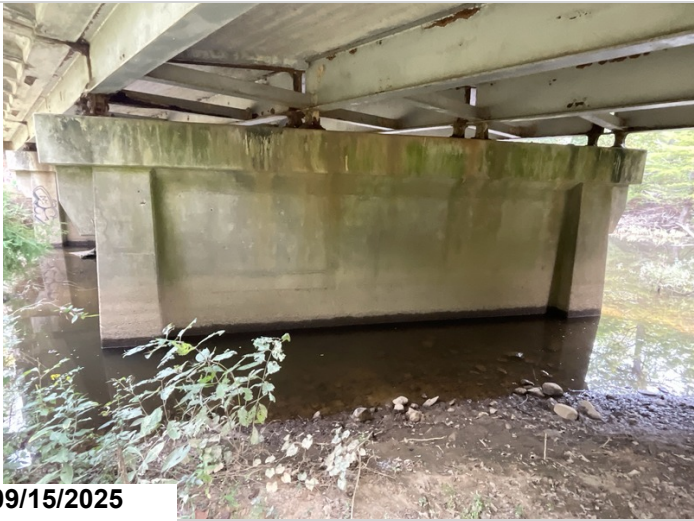
Columns have abrasion to lower exposed portions

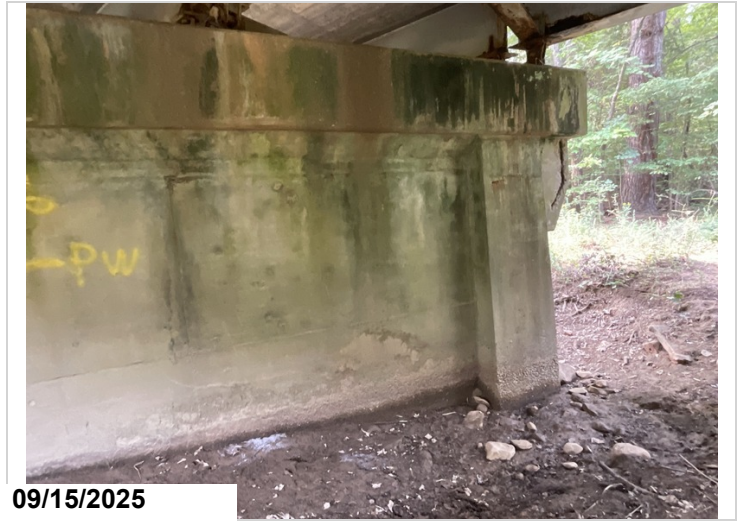
Bent 4 backside right has 1lf exposed rebar cs3 and abrasion to lower exposed portion

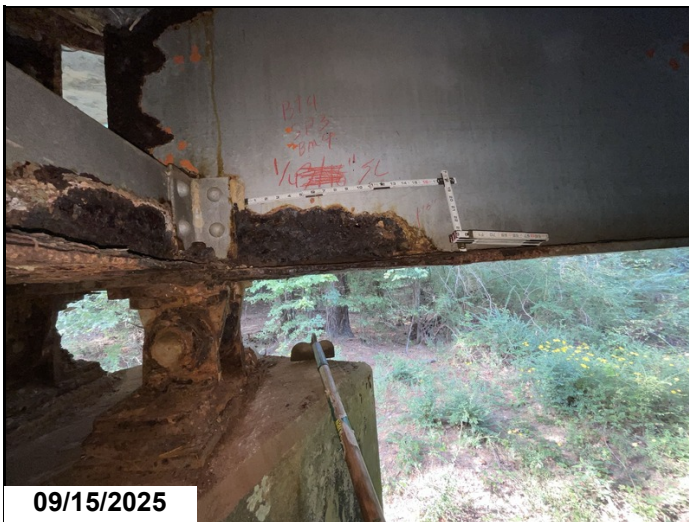
Span 3, at bent 4 beam 4, 1/4" remain on left side of bottom flange. Up to 3/16" section loss in lower web. Worst case this bridge.

09/15/2025  
Bent 4 span 3 girder 4 1/4" section loss to lower web and bottom flange

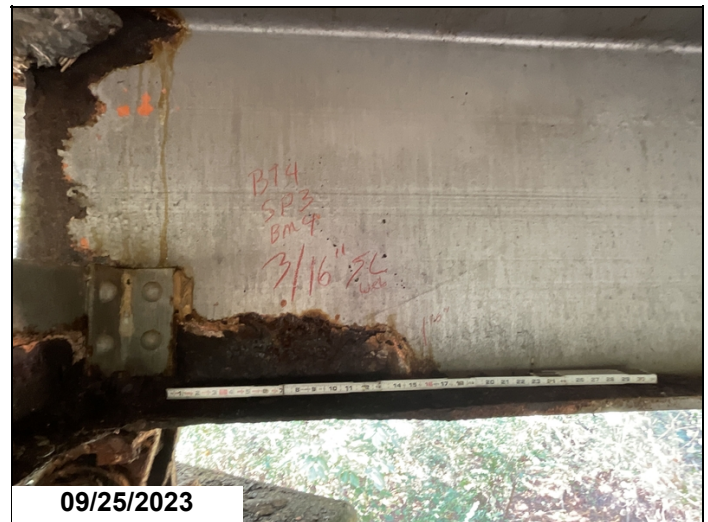
09/25/2023  
span 3, at bent 4 beam 4, 1/4" remain on left side of bottom flange. Up to 3/16" section loss in lower web. Worst case this bridge.

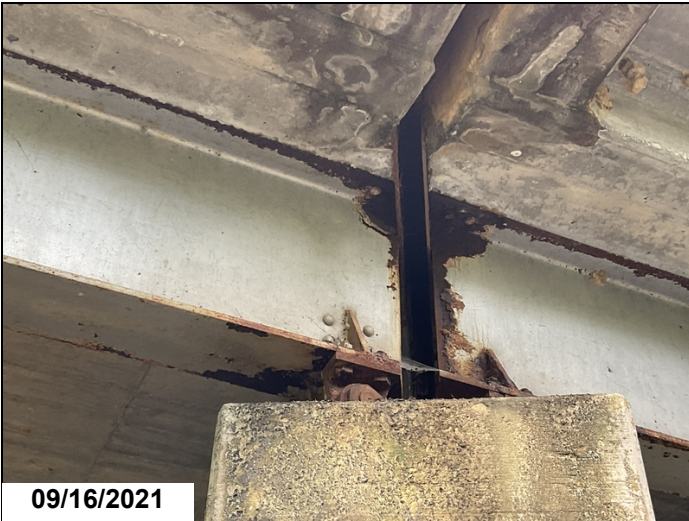
Bent 3: active corrosion on the beam end with moderate pitting.

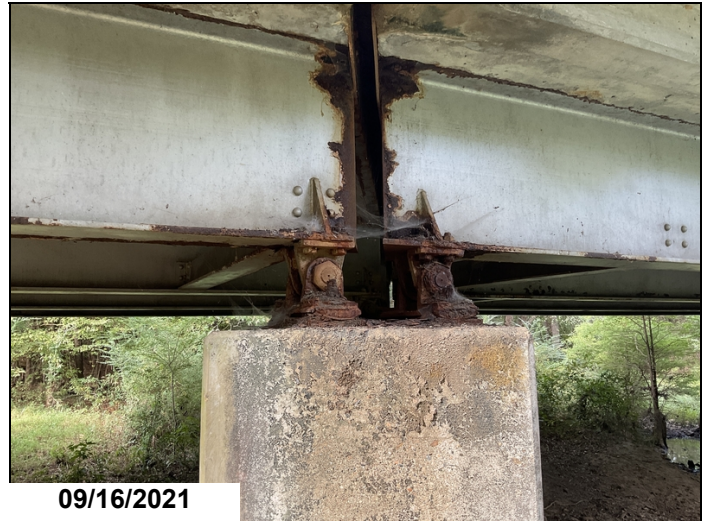
Bent 4, spans 3&4, girder 1: both bearings and beam ends with laminating rust with section loss.

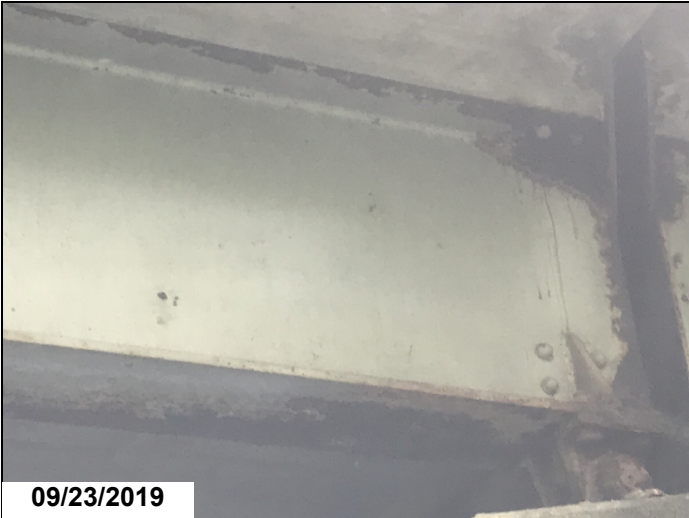
Span 2 beam 4 at bent 3 active corrosion on the beam end with moderate pitting.

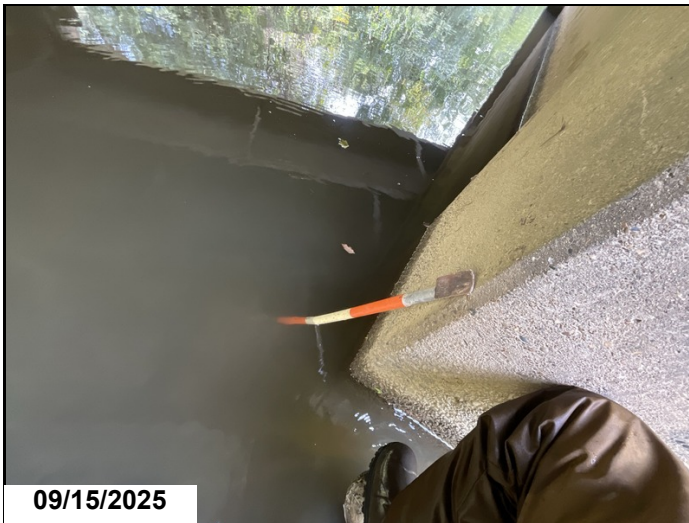
Bent 2 upstream end, 4' deep scour hole exposing footing. Footing is not undermined at this time.

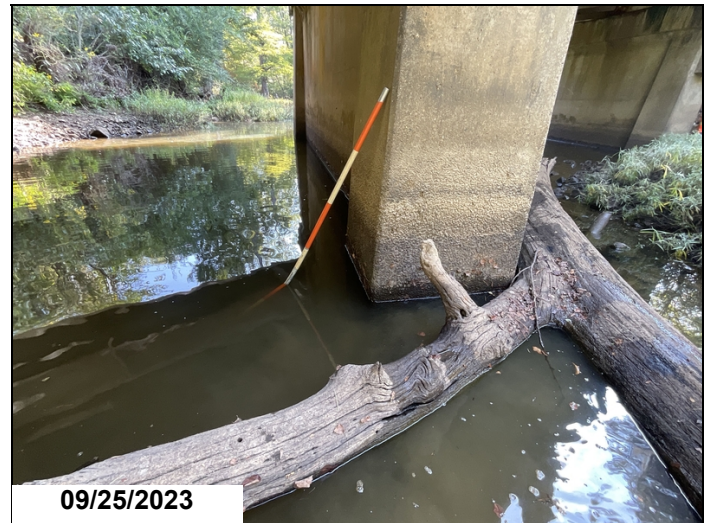
Bent 2 upstream end, 4' deep scour hole exposing footing. Footing is not undermined at this time.

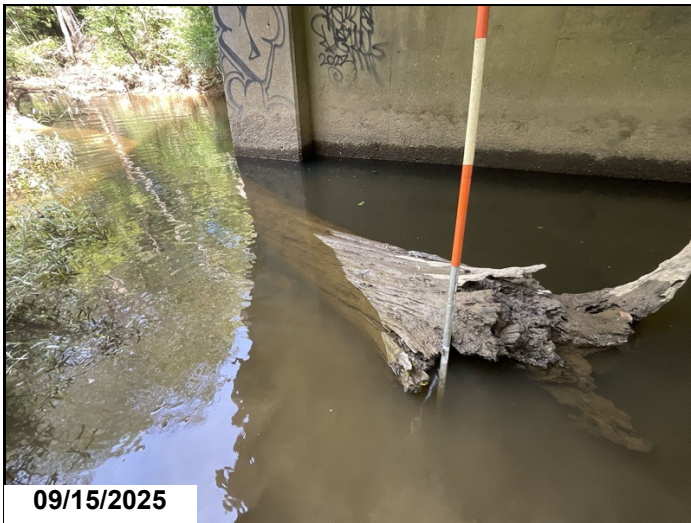
09/15/2025

Bent 2 upstream end has log against column restricting water flow.

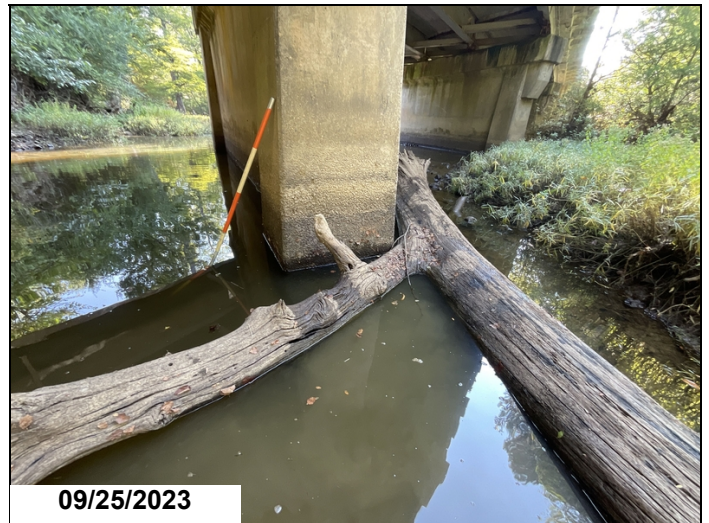
09/25/2023

Bent 2 upstream end has log against column restricting water flow.

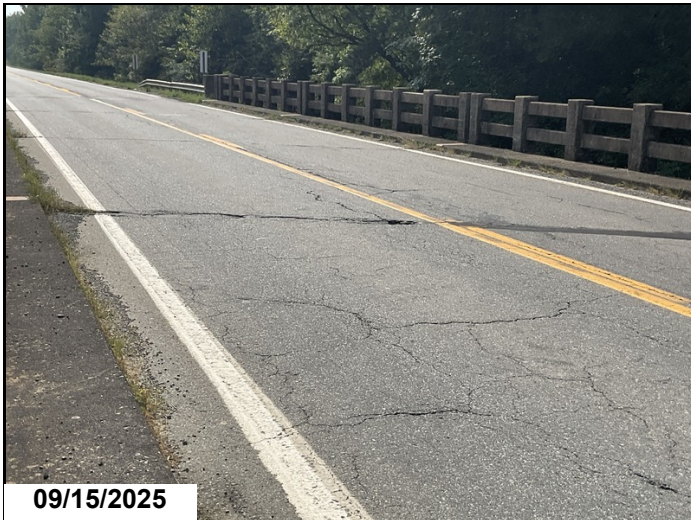
Bent 2 and 4: asphalt overlay with a pot hole at the joint in the westbound lane.  
Potholes have been patched and have reappeared

Bent 2 potholes have reappeared

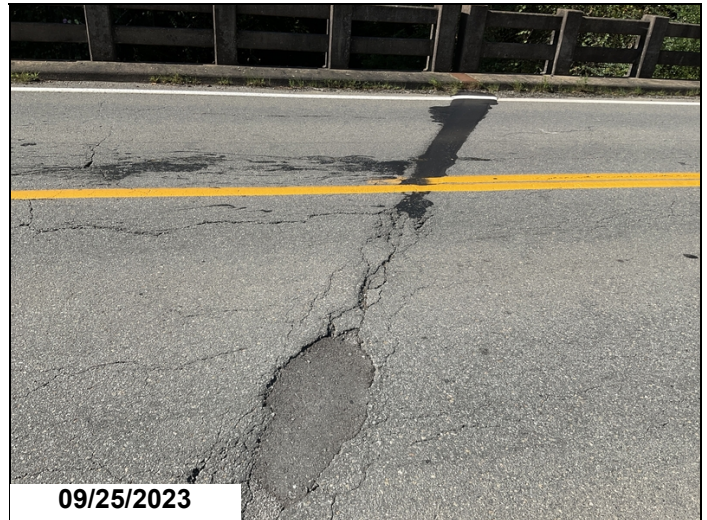
Bent 2 potholes have been patched

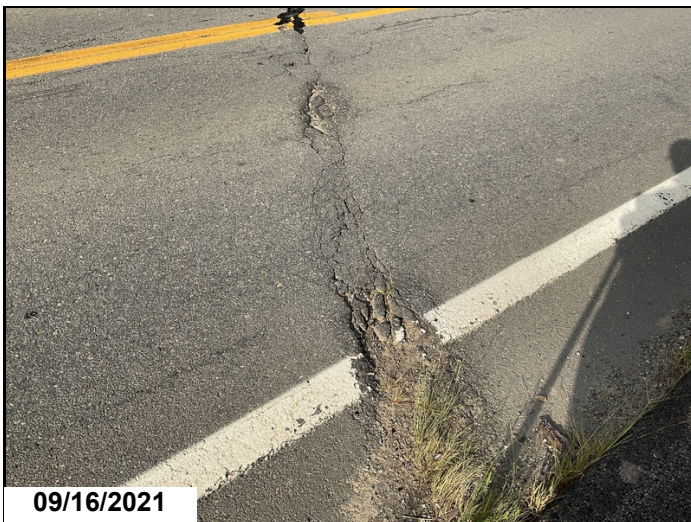
Bent 4: asphalt overlay with a pot hole at the joint in the westbound lane.

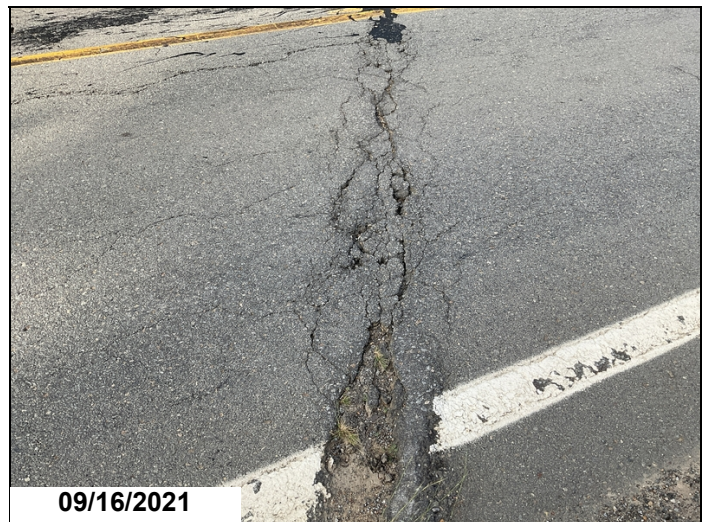
Bent 2: asphalt overlay with a pot hole at the joint in the westbound lane.

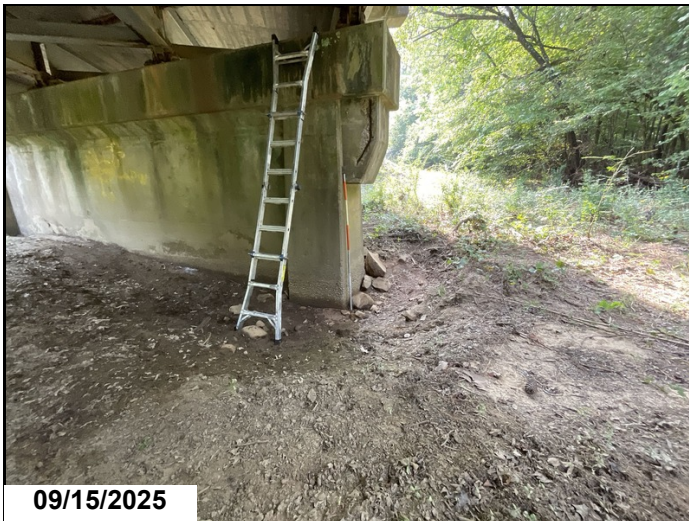
Bent 4, right side: local scour action removing material away from pier. Similar condition to bent 3.

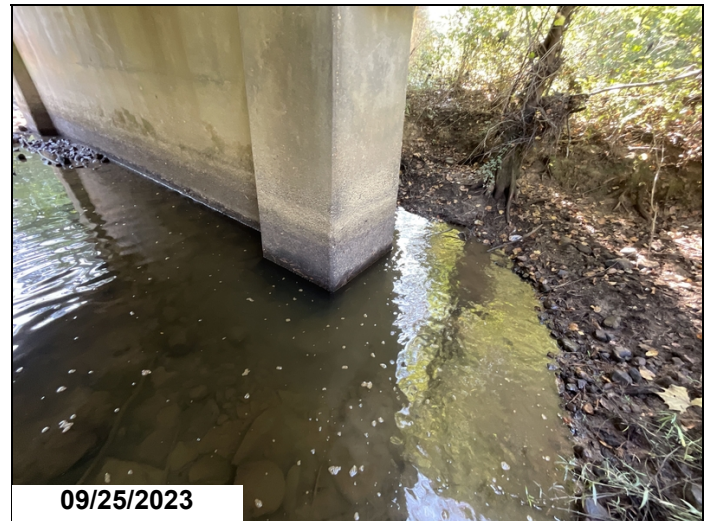
Bent 3 upstream end, local scour has exposed top of footing

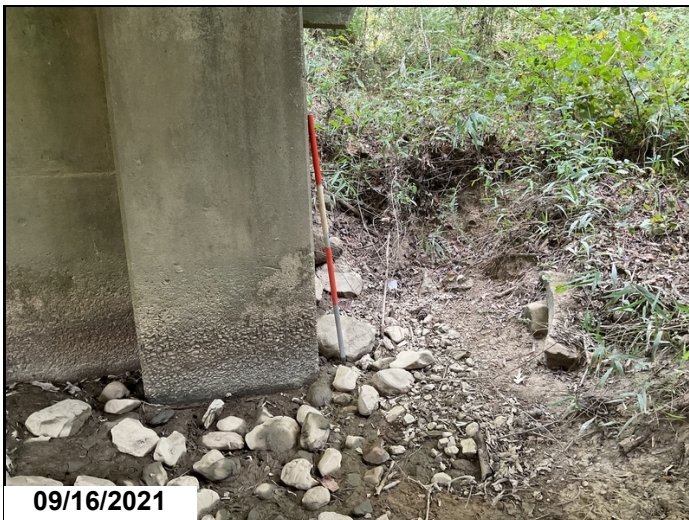
Bent 4, right side: local scour action removing material away from pier. Similar condition to bent 3.

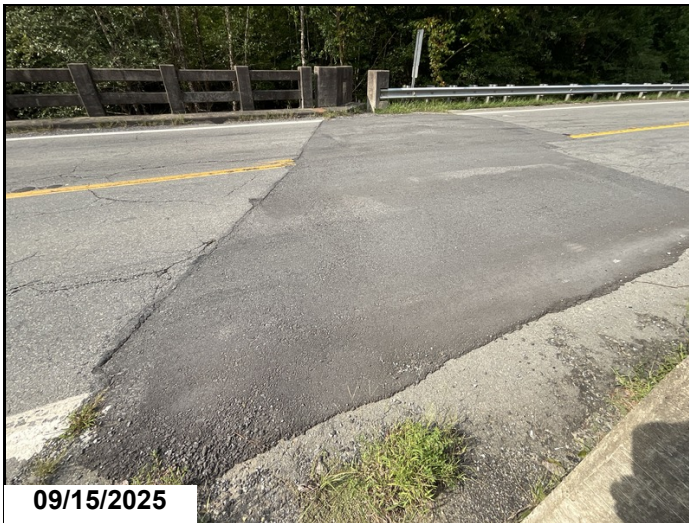
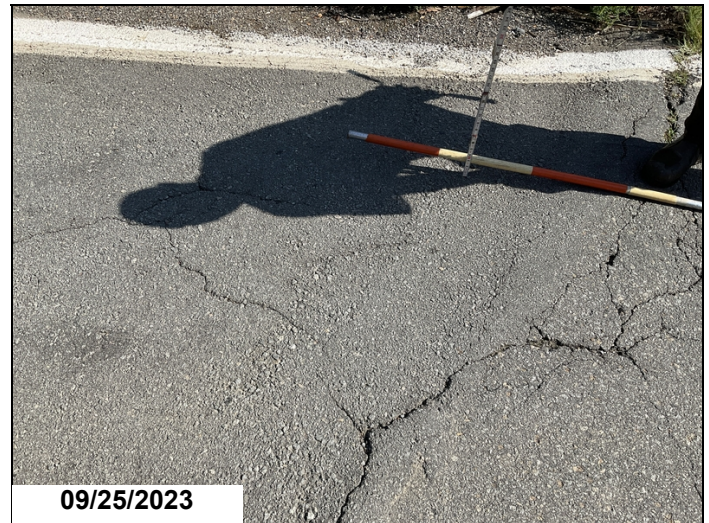
Approach roadway at west end of bridge has settled up to 2"

West approach roadway has settled up to 2"

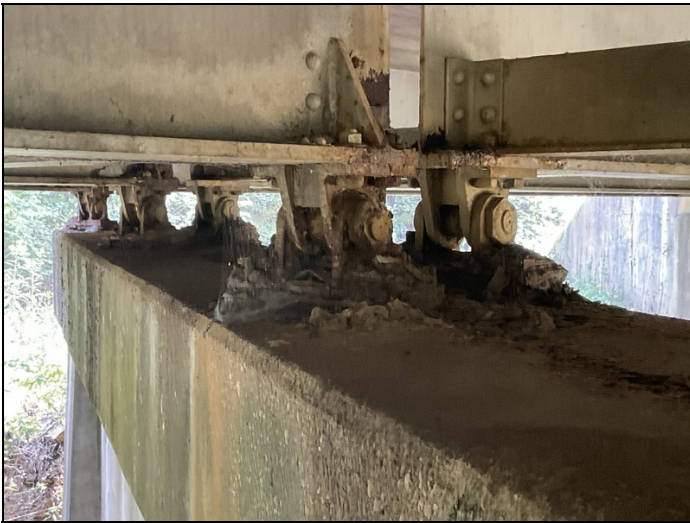
All beam ends and bearing have active corrosion

Girder ends and bearings are in need of major cleaning and repairs

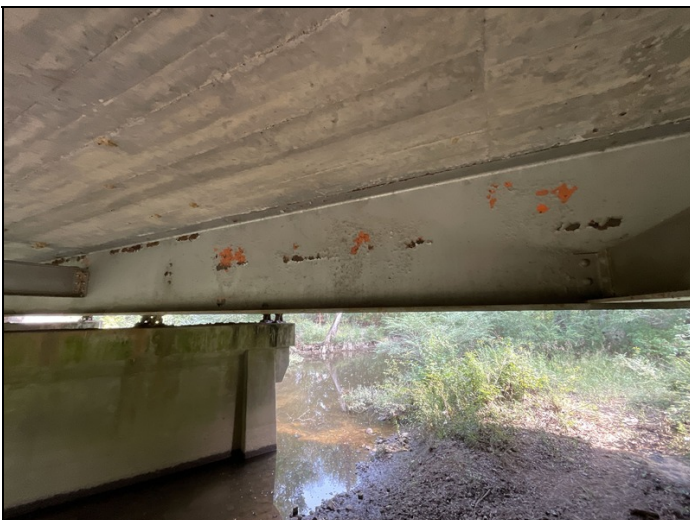
All beams have scattered areas of corrosion
