## Bridge 06592 Inspection Report

Route:10 Section:06 Log:0.54

Asset #06592(Routine)  
SH 10 over Big Branch  
Location: 0.5 MI E JCT SH 9

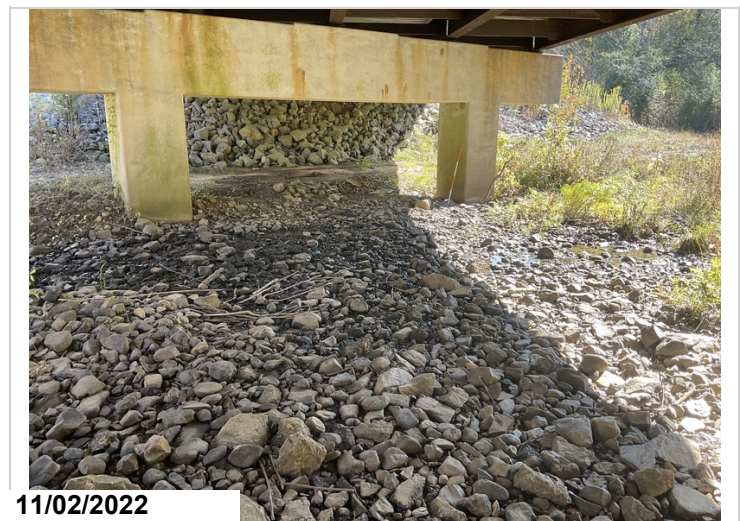
CHANNEL: GRAVEL & ROCK - NO SCOUR.

No scour.

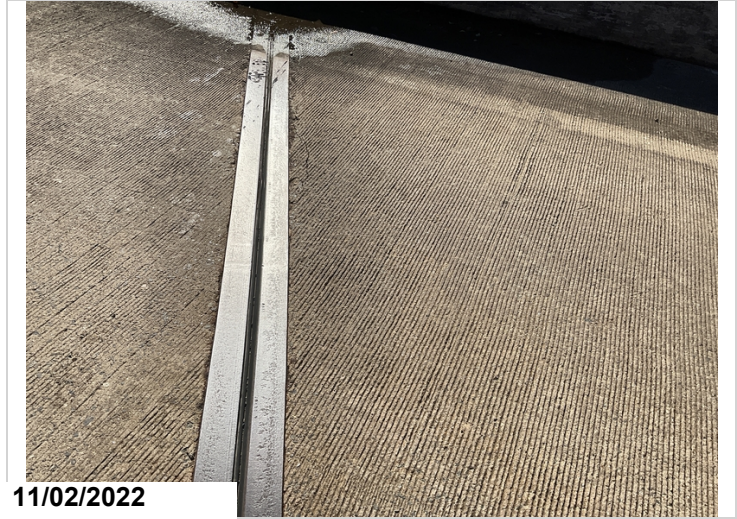
- Deck has a few transverse cracks along the joints.
- Wheel paths have minor abrasion.
- Soffit has cracks with efflorescence in the overhangs.

Deck has a few transverse cracks along the joints.

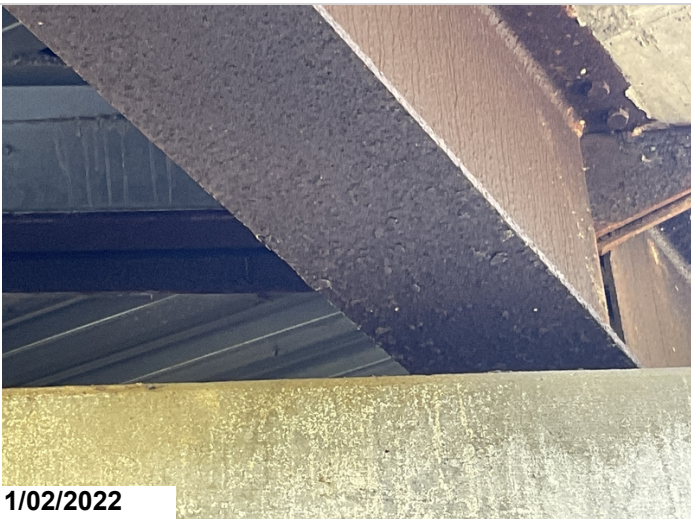
- Girders 1 and 5 have minor corrosion with flaking rust on the bottom flange at bents 2 and 3.

Girders 1 and 5 have minor corrosion on the bottom flange at bents 2 and 3.

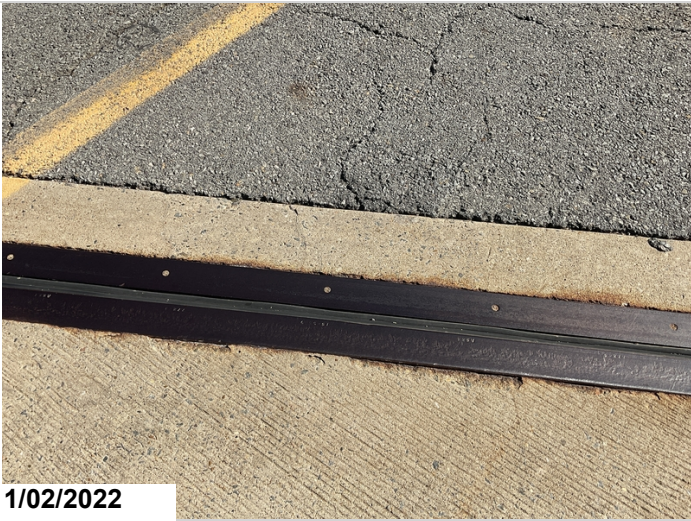
- Both abutments have a few cracks in the top of the back wall.
- Abutment 1 has a few vertical cracks with efflorescence.

Abutment 4 has a few cracks in the top of back wall.

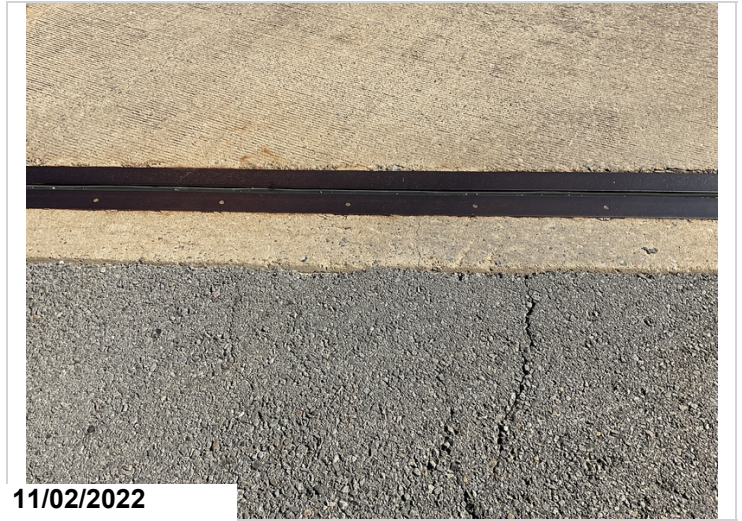
Abutment 1 has a few cracks in the top of the back wall.

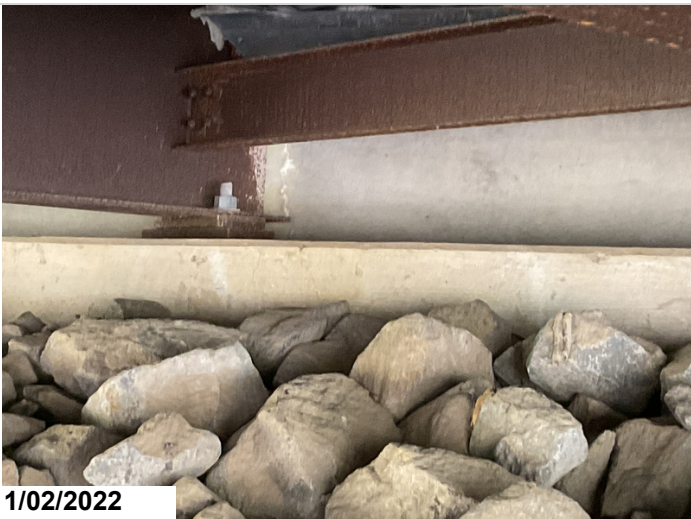
Abutment 1 has a few vertical cracks with efflorescence.

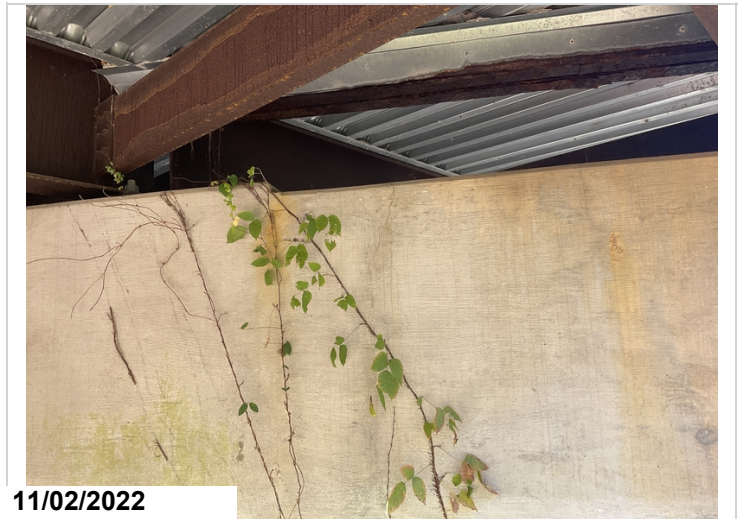
(234) KRM & MLM 11/2/2022 - Bent 2 back side of cap has a vertical crack above column 2.							
302	Compression Joint Seal	LF	160	160	0	0	0
(302) KRM & MLM 11/2/2022 - No notable defects at this inspection.							
311	Movable Bearing	EA	15	9	4	2	0
1000	Corrosion	EA	6	0	4	2	0

Bent 2 back side of cap has a vertical crack above column 2.

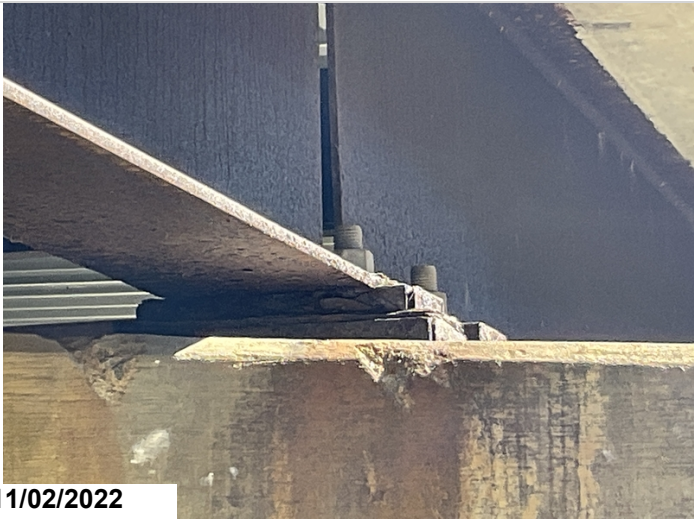
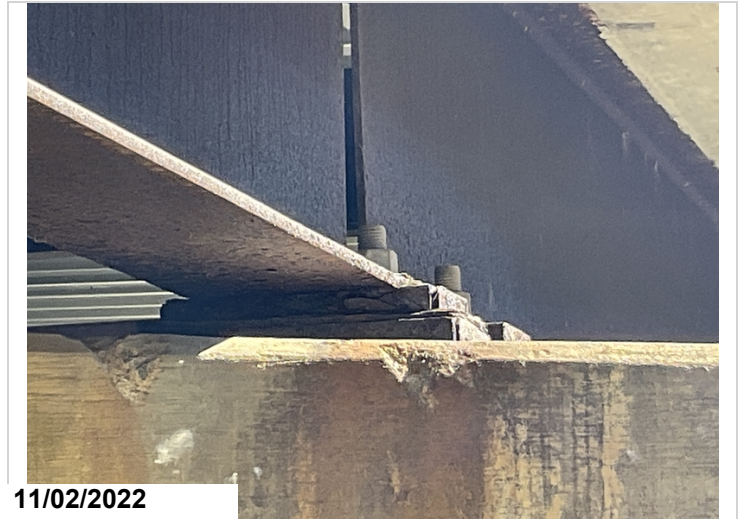
(311) KRM & MLM 11/2/2022 - Bearings 1 and 5 have minor corrosion with flaking rust at bents 2 and 3.							
313	Fixed Bearing	EA	15	9	4	2	0

Bearings 1 and 5 have minor corrosion with flaking rust at bents 2 and 3.

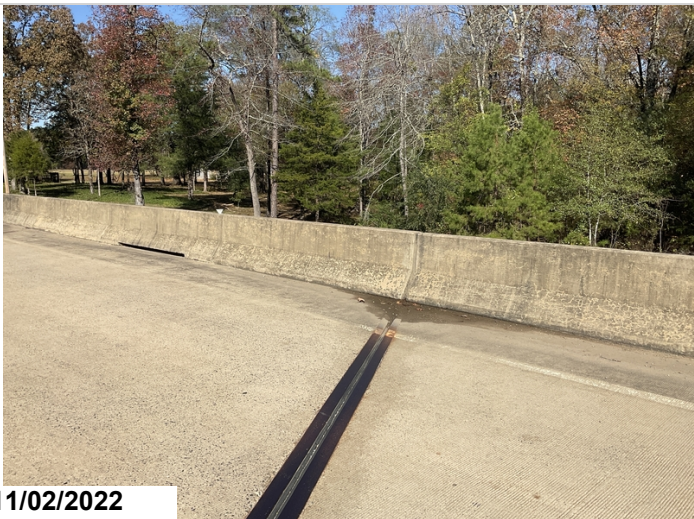
Concrete bridge rail has minor cracks that have been sealed.

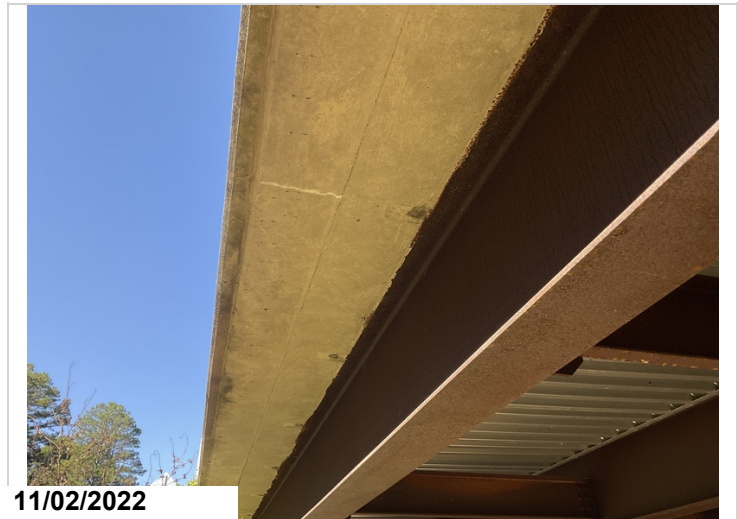
Soffit has cracks with efflorescence in the overhangs.

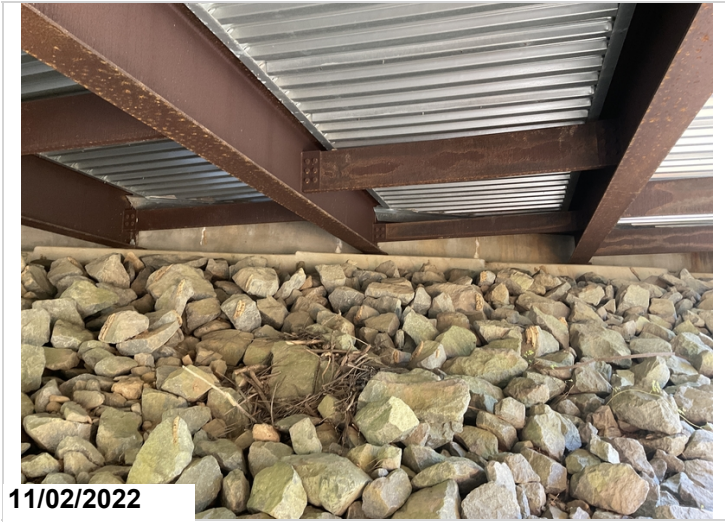
Abutment 1 has a few vertical cracks with efflorescence.

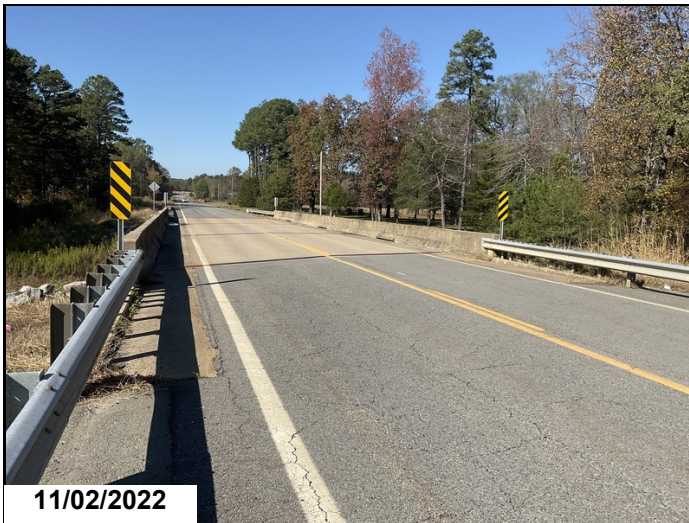
Mile marker signs are missing at both ends of the bridge.

Mile marker signs are missing at both ends of bridge.
