Bridge M0323 Inspection Report

Asset #M0323(Underwater)

SH 10-7 Log 6.44 over LAKE MAUMELLE

UNDERWATER BRIDGE INSPECTION REPORT

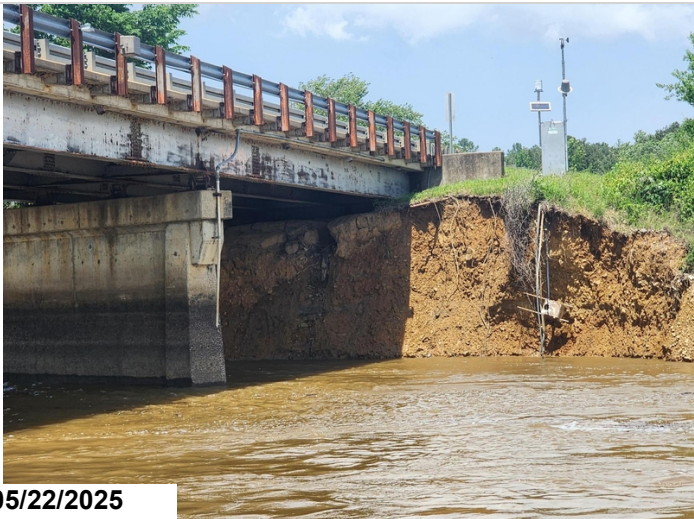
Bent 4 embankment sloughing and channel protection damage

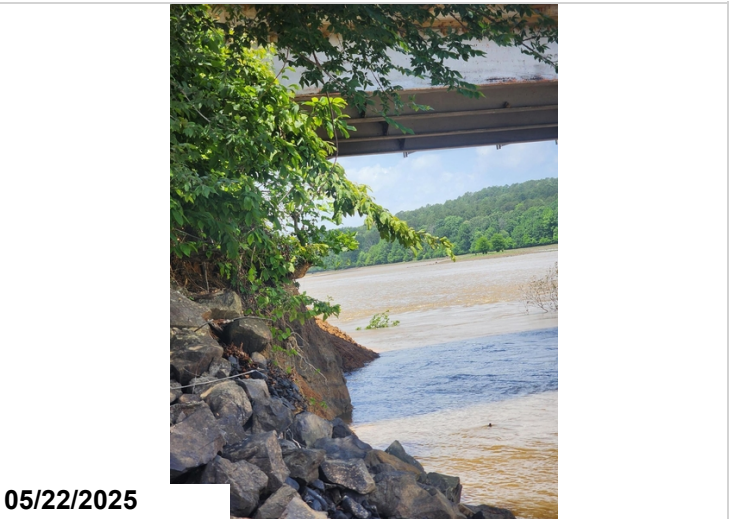
Bent 1 embankment sloughing and channel protection damage

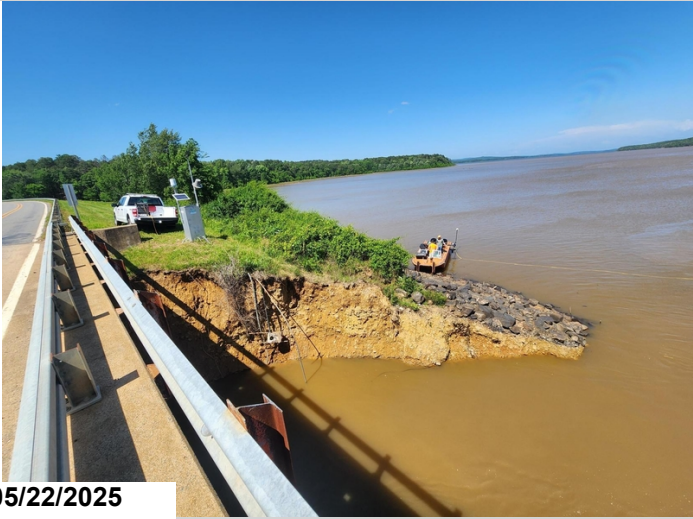
Bent 4 embankment sloughing and channel protection damage

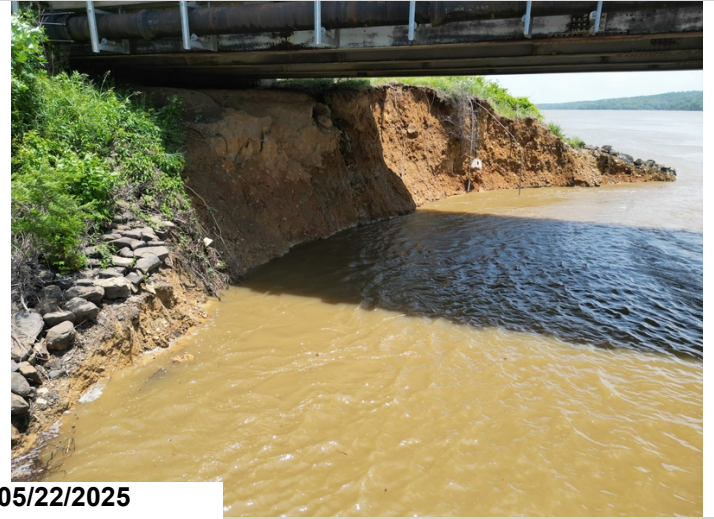
Bent 4 embankment sloughing and channel protection damage

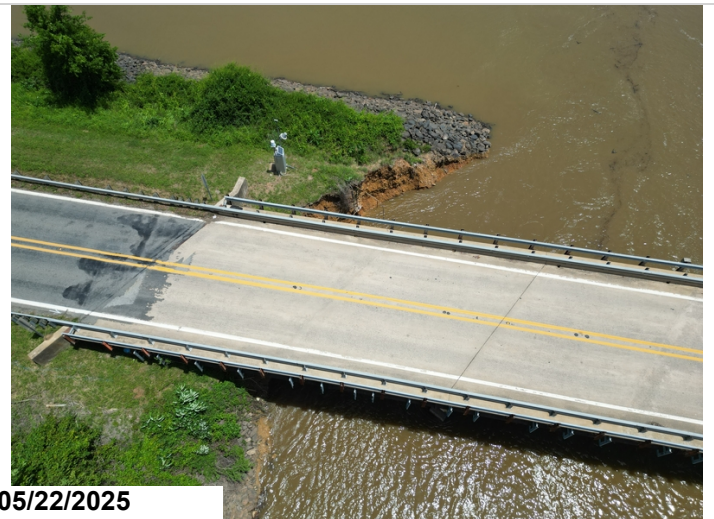
Bent 4 embankment sloughing and channel protection damage

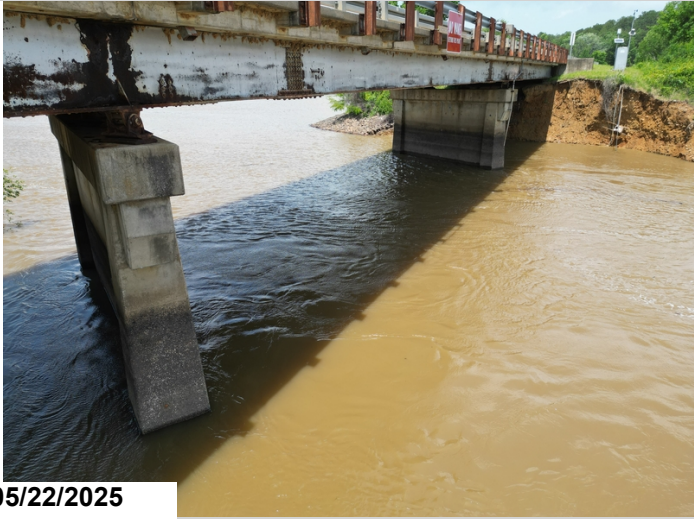
Bent 4 embankment sloughing and channel protection damage

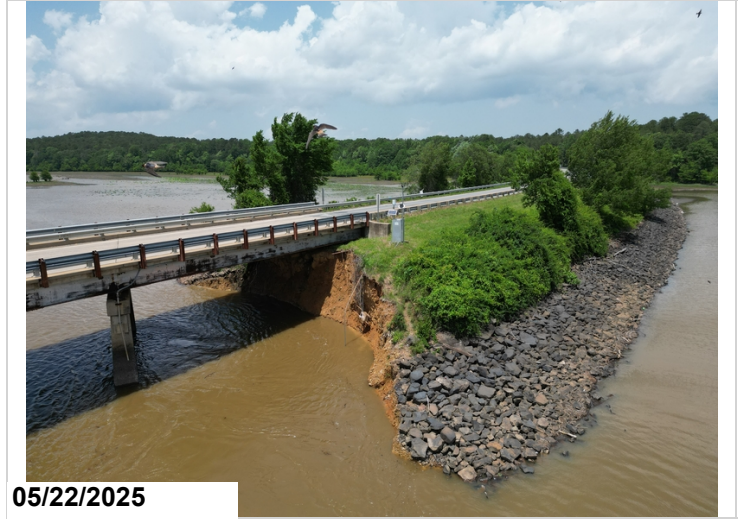
Bent 4 embankment sloughing and channel protection damage

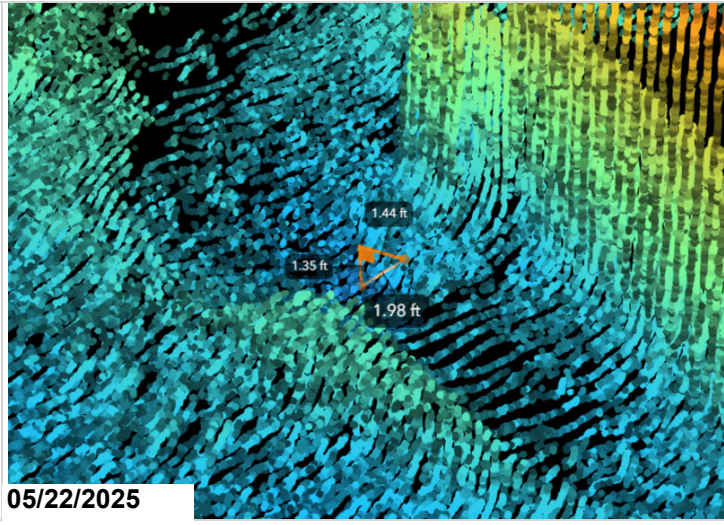
Bent 3, Column 1, Back Face: 1.35 ft of vertical exposure

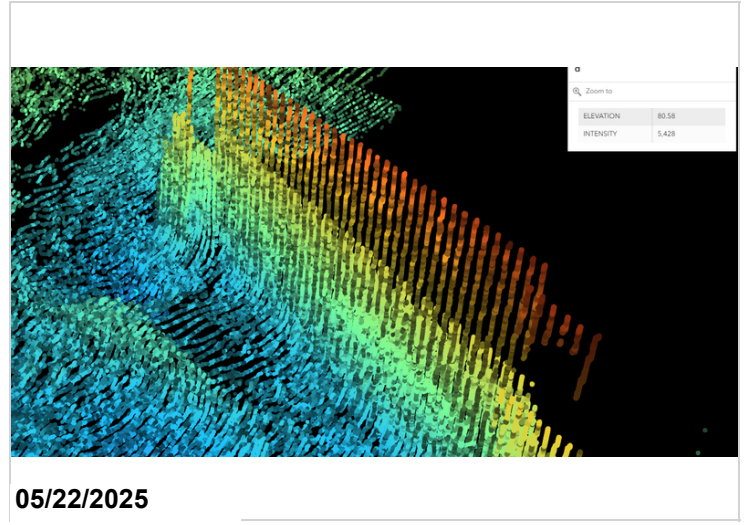
Bent 3, Column 1, Back Face: Elevation of ground line is 80.58 m = 264.4 ft, No undermining

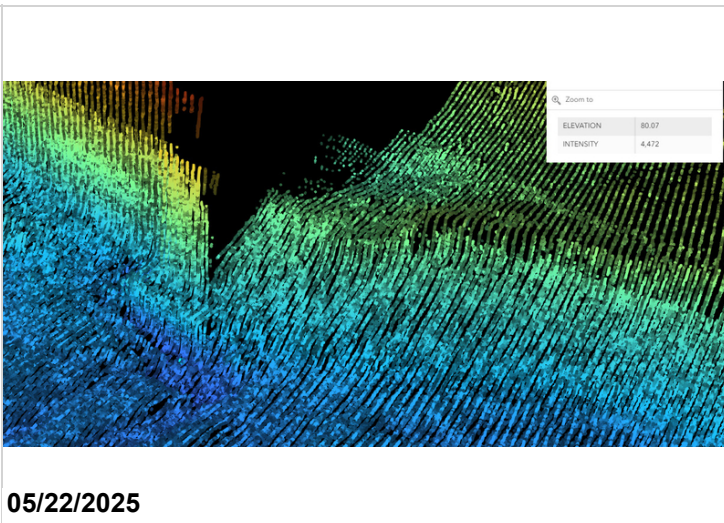
Bent 3, Column 2, Back Face: Elevation of ground line is 80.07 m = 262.7 ft

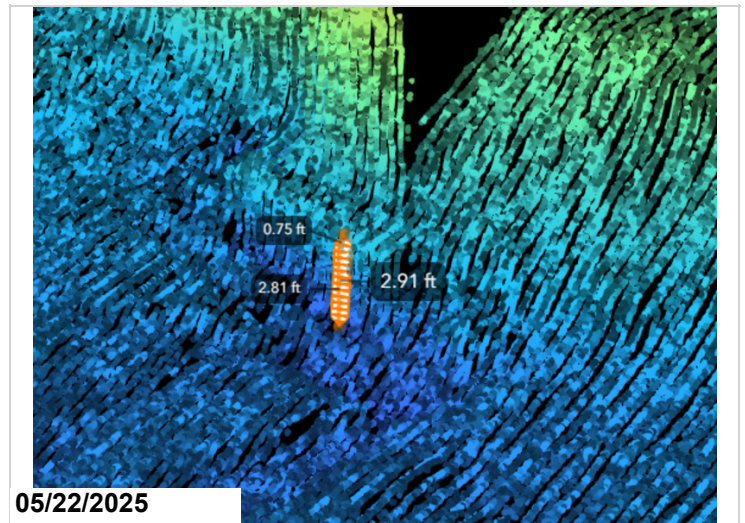
Bent 3, Column 2, Back Face: 2.8 ft of vertical exposure

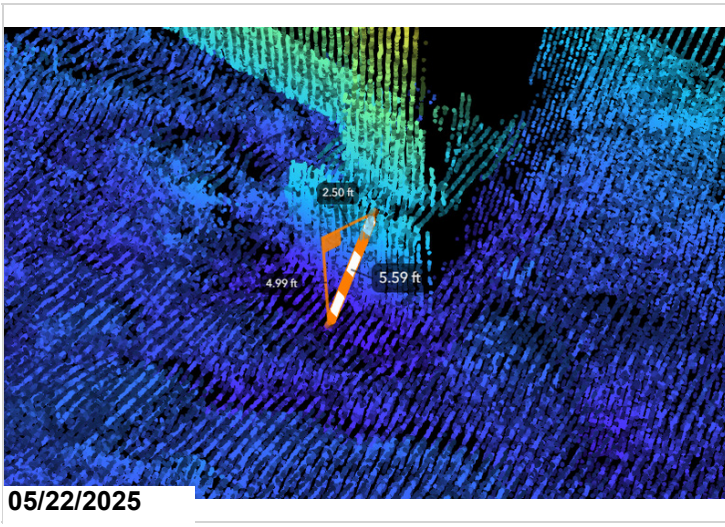
Bent 2, Column 1, Ahead Face: 5 ft of vertical exposure

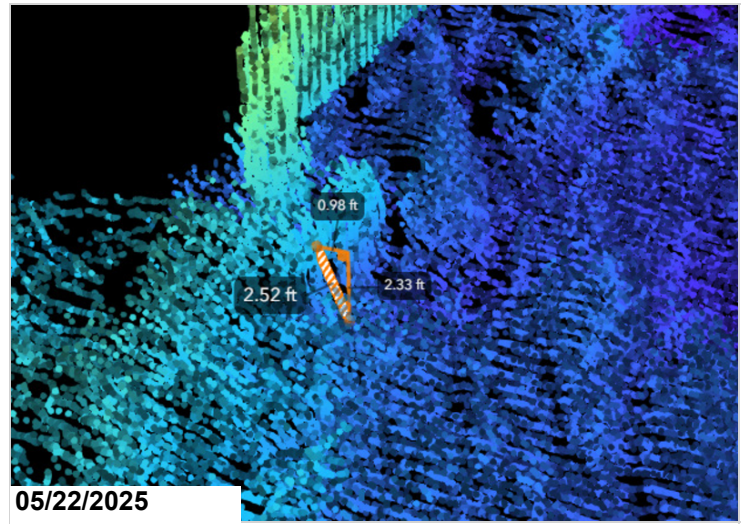
Bent 2, Column 2, Ahead Face: 2.33 ft of vertical exposure

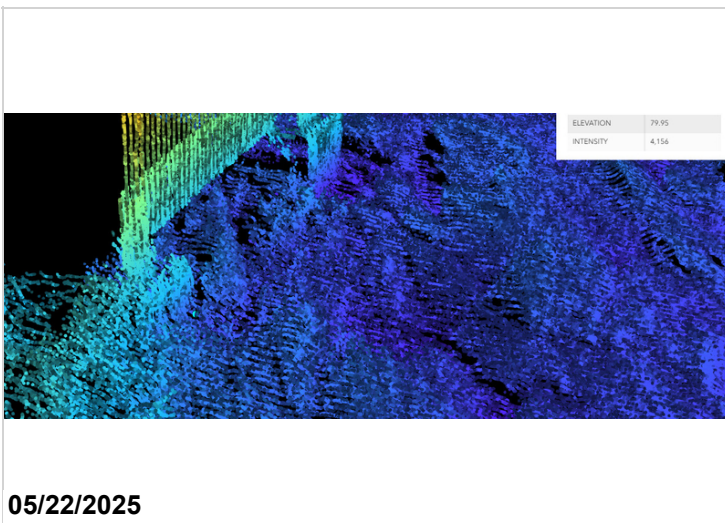
Bent 2, Column 2, Ahead Face: Elevation of ground line is 79.95 m = 260.6 ft, No undermining

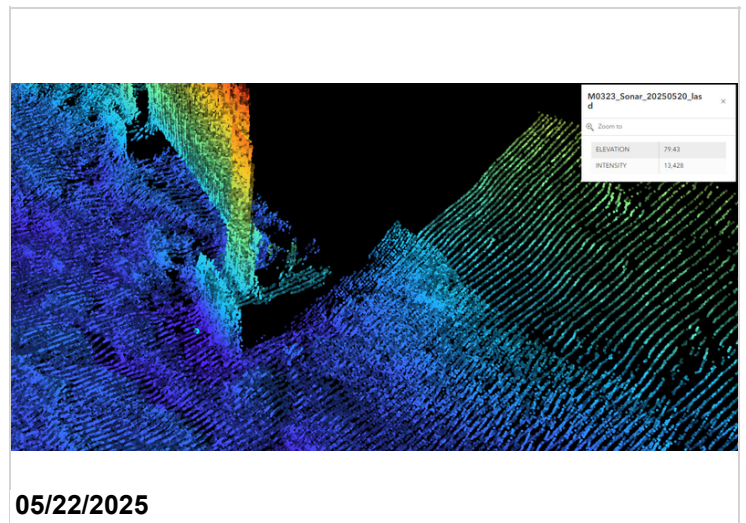
Bent 2, Column 1, Ahead Face: Elevation of ground line is 79.43 m = 262.4 ft, No undermining

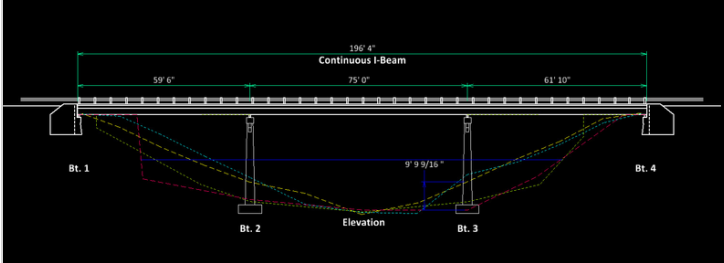
05/21/25 - VLE, CCP, NVH
According to plans, Bents 1 - 4 are supported by spread footings.
All footings on Bents 2 and 3 have moderate exposure with no undermining.
As built plans are not available for this structure.
During the 2022 Underwater Inspection, the footings were completely covered and riprap was intact. During this inspection, the ground line at intermediate bents has reduced 10' and riprap has displaced from all bents.
Scour rating lowered at this inspection.

10' of scour since 2022

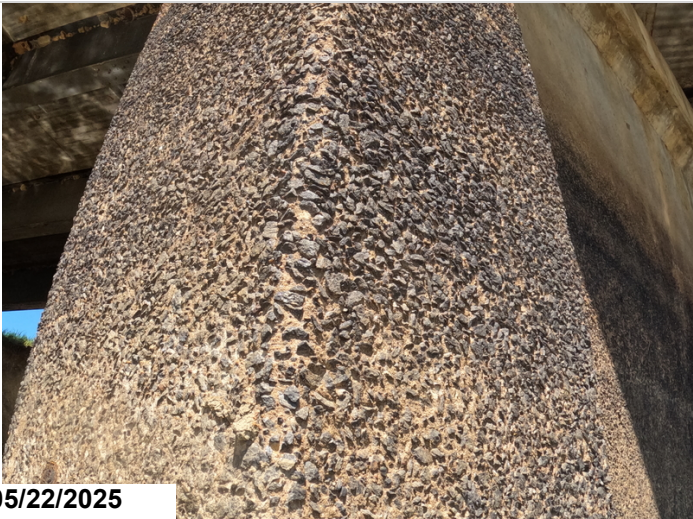
ELEMENTS	DESCRIPTION	UNITS	TOTAL	CS1	CS2	CS3	CS4
205	Reinforced Concrete Column	EA	4	0	0	0	4
1190	Abrasion/Wear (PSC/RC)	EA	4	0	0	0	4
(205) 2025 Underwater Inspection VLE, CCP, NVH Bent 2, Columns 1 & 2: Heavy abrasion with aggregate voids. (CS4, 2 EA) Bent 3, Columns 1 & 2: Heavy abrasion with aggregate voids. (CS4, 2 EA)							
(1190-205) 2025 Underwater Inspection VLE, CCP, NVH Bent 2, Columns 1 & 2: Heavy abrasion with aggregate voids. (CS4, 2 EA) Bent 3, Columns 1 & 2: Heavy abrasion with aggregate voids. (CS4, 2 EA)							
220	Reinforced Concrete Pile Cap/Footing	LF	24	0	24	0	0
6000	Scour	LF	24	0	24	0	0

Typical CS3 abrasion covering all columns and the pier walls.

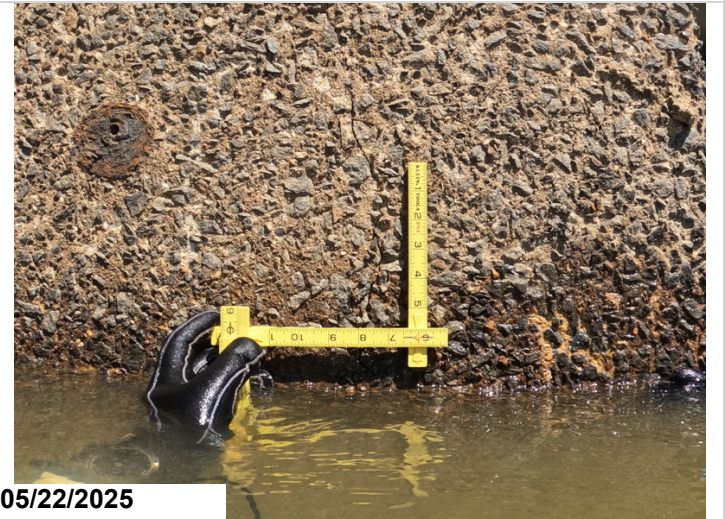
Minor cracking in columns.

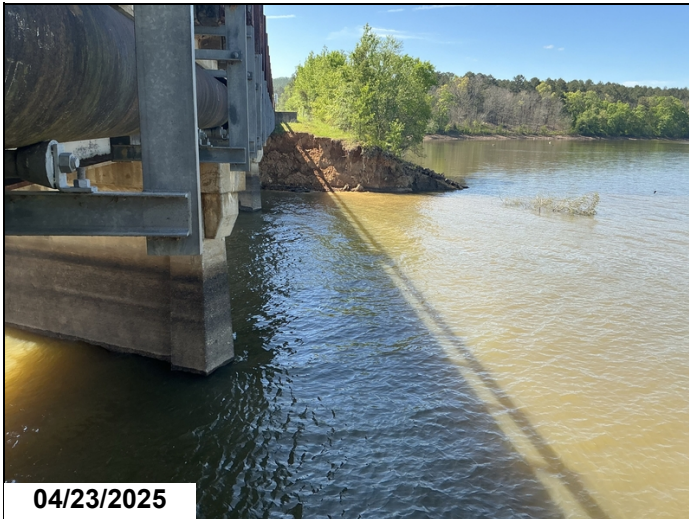
At both abutments the embankments have slumped off due to flooding. The lake has been low all winter and spring to work on the dam and due to the water rising fast the embankment has slumped off. In normal pool I don't believe this would have happened.

Southwest side of bridge embankment has slumped off.

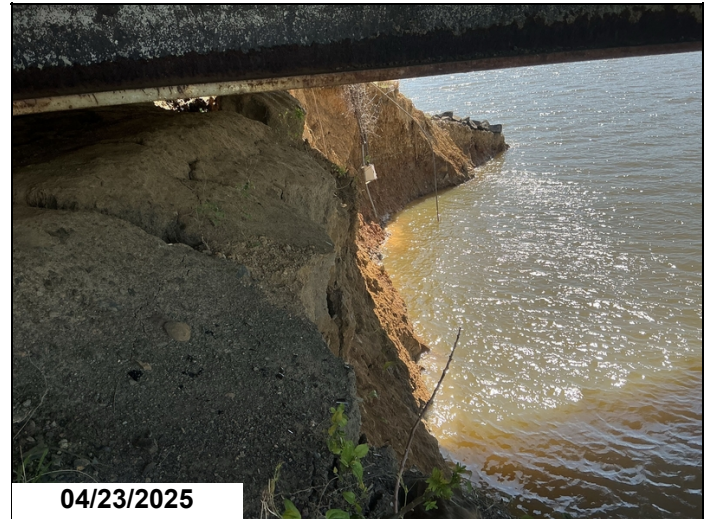
North end of bridge embankment

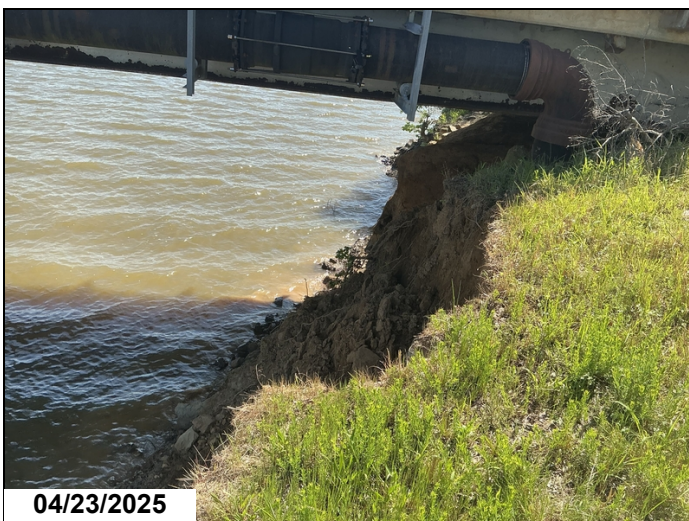
North end of bridge embankment

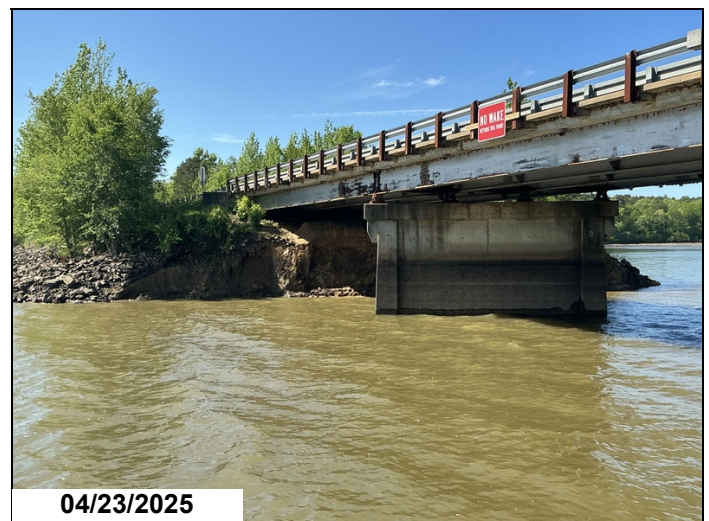
South east side of bridge embankment

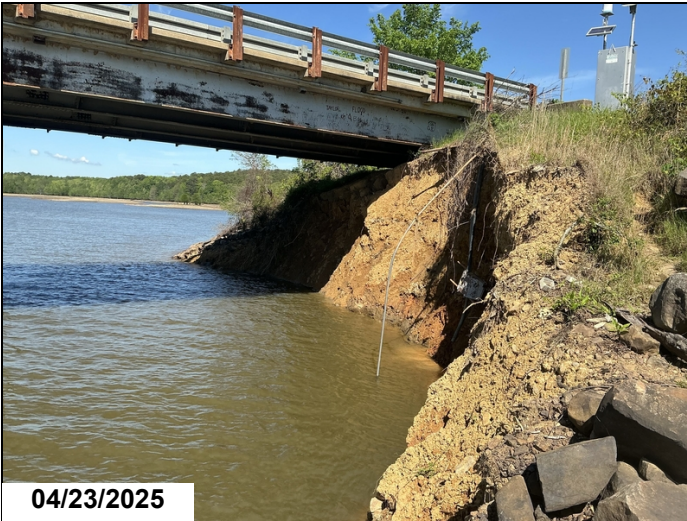
North end of bridge embankment has slumped off.
