## Bridge M0326 Inspection Report

Route:10 Section:07 Log:10.808

(4) Place Code	0
(6) Features Intersected	WORTHEN CREEK
(7) Facility Carried	SH 10 Log 10.81
(9) Location	6.93 MI W SH 300
(11) Mile Point	10.808 mi
(12) Base Highway Network	Yes

Team Lead: Chris Doggett, Inspection Date: 10/07/2025

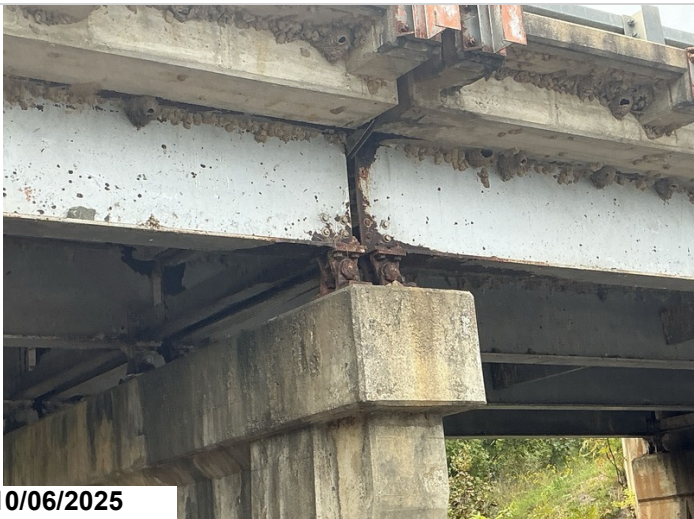
Bent 2 span 2 beam 1 has moderate pitting to the lower web and flange above bearing.

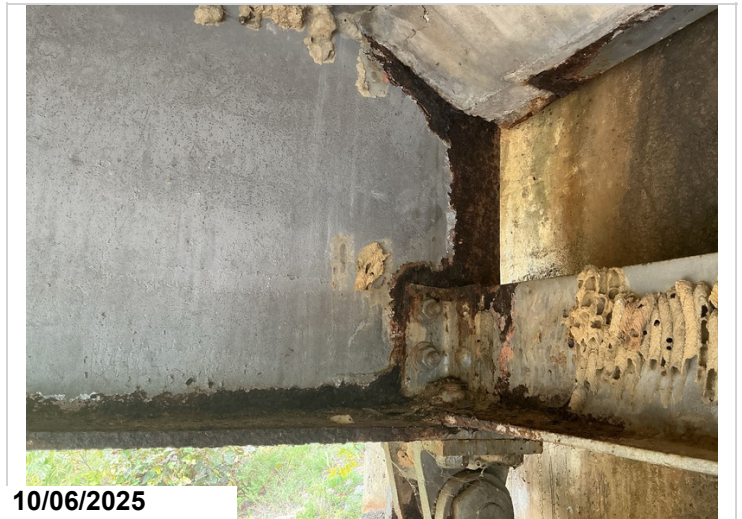
Bent 1, girder 4: section loss to the the beam end near the haunch and the lower flange. CS3-2'

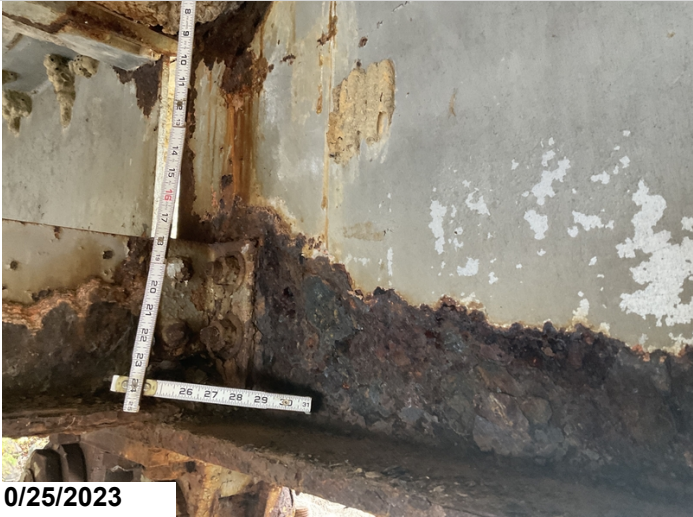
Bent 2 span 1 beam 4 at bearing area has moderate pitting to web and lower flange. Upper web at haunch area has 5/16" pitting in the upper web. Lower web above bearing has a 1/4" pitting. Lower flange has 1/16" pitting.

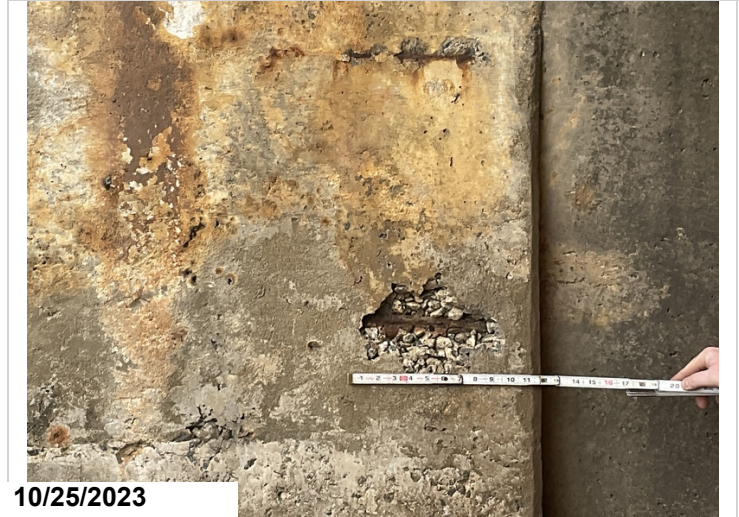
Bent 3 column 1 two small spalls with exposed rebar. 6"x 8"x 1" deep.

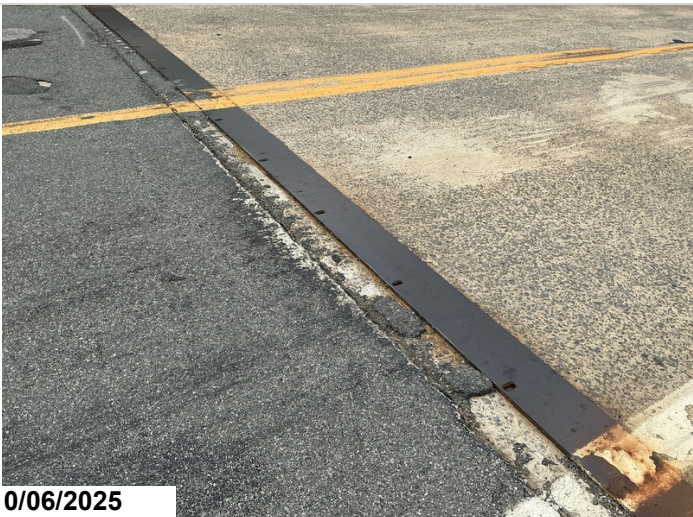
Bent 3: top of headwall with spall. CS 2-9'

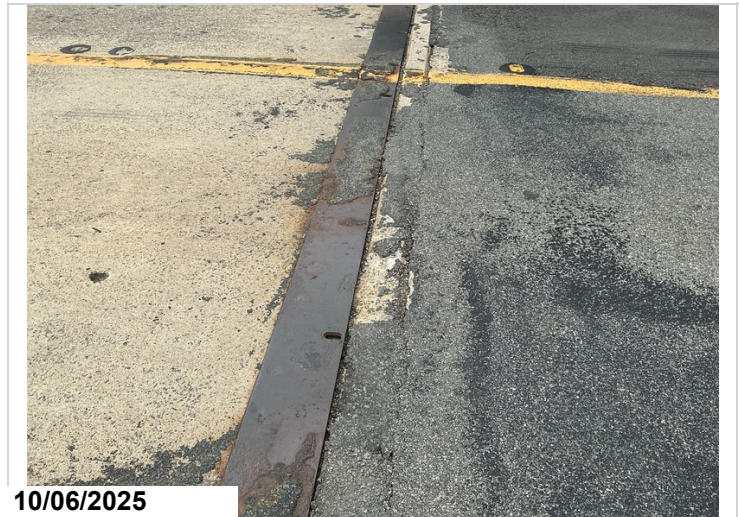
Bent 1: headwall with a small spall

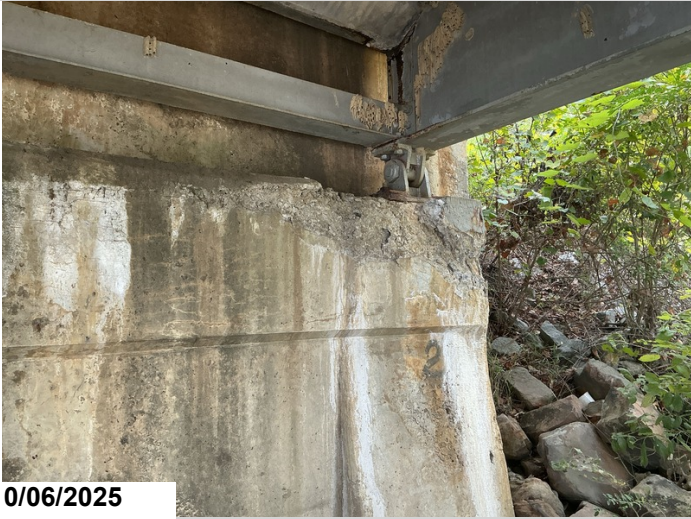
Bent 3 spall under bearing 4 due to concrete deterioration.

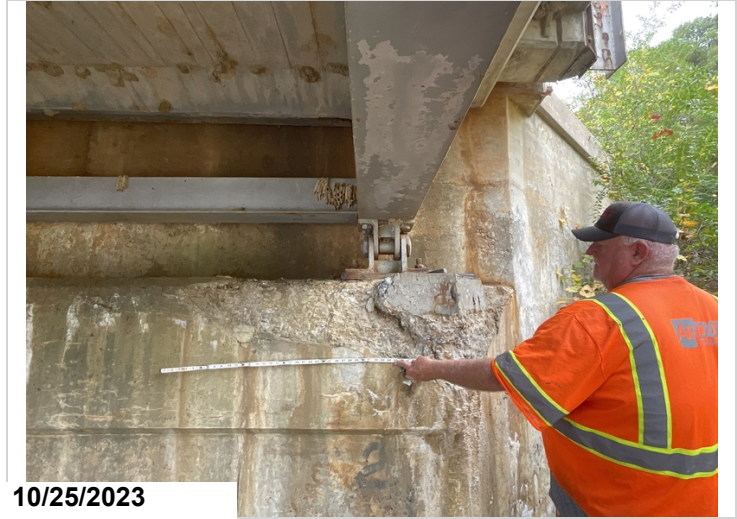
Bent 3 cap under bearing 4 has a spall due to concrete deterioration. State forces have patched in the past but the patch is beginning to fail. No bearing loss at this time.

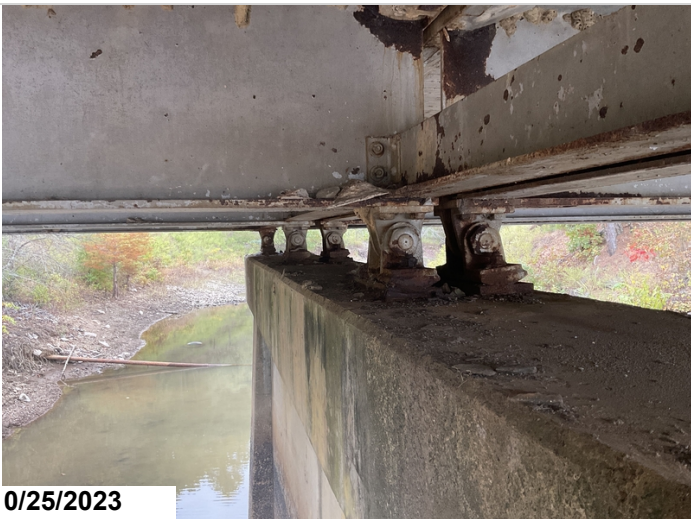
Bent 2 moveable bearing have laminating rust at masonry plates and bottom of bearings.

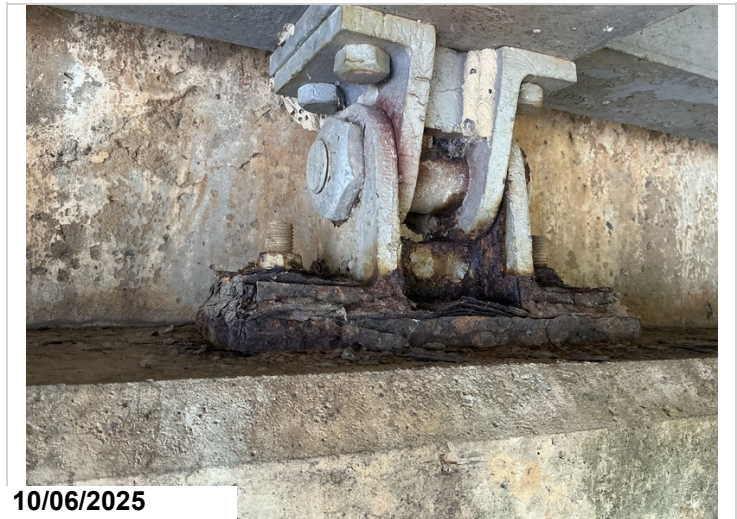
Bent 3, girder 3: heavy laminating rust at bearing and masonry plate common all bearings this bent.

**A-57 - Girder End and Bearing Painting Needed (Yes)**

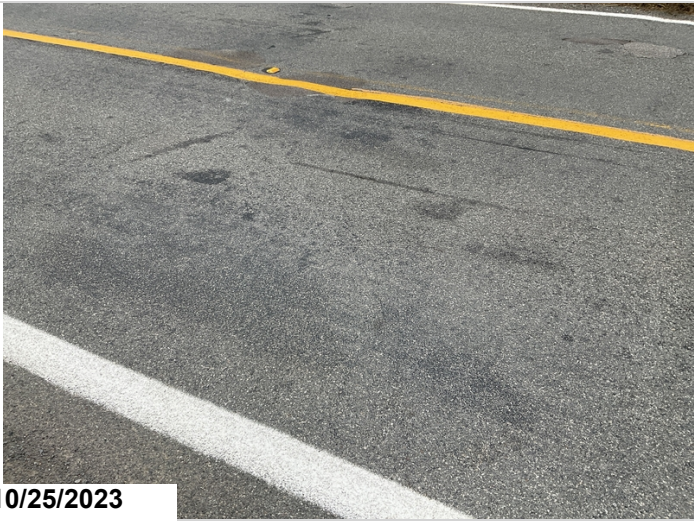
Asphalt wearing surface.

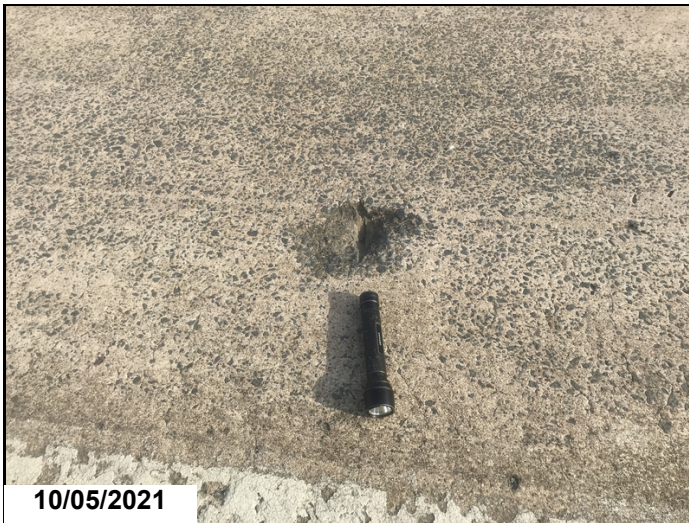
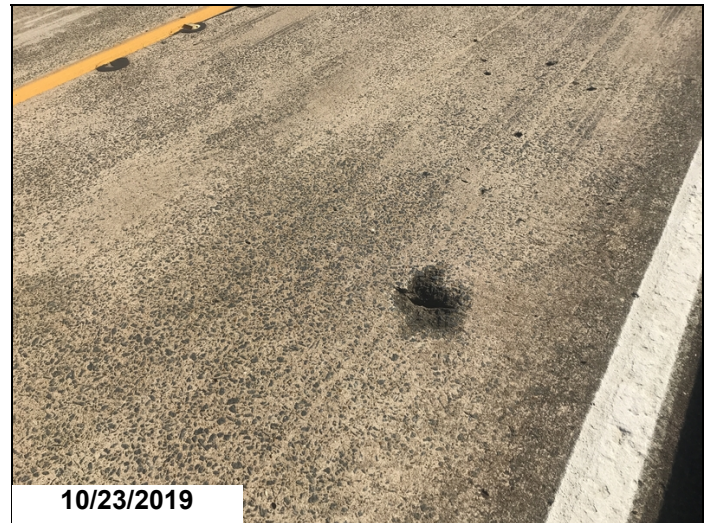
Span 2 pothole in deck.

Span 2 spall

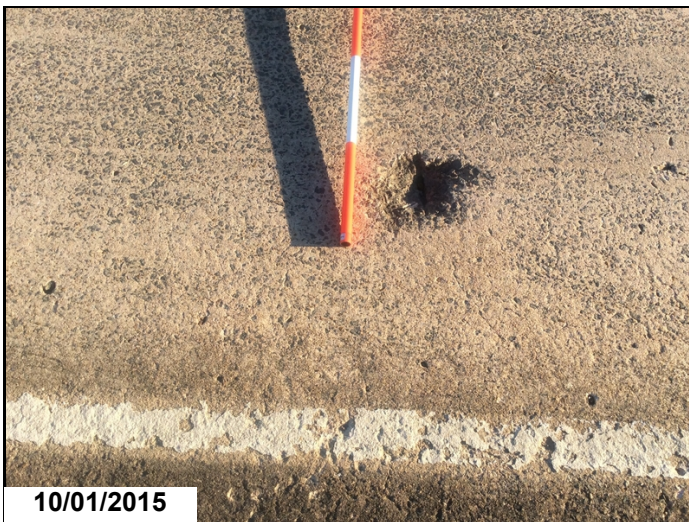
Overall the deck is in good condition. Deck has minor spalls, abrasion and map cracking.  
Both spans have areas map cracking and minor abrasion.  
Small spall in the deck of span 1 and 2. See photo.  
Span 1 minor spall. 4"x4"x1" deep.  
Span 2 moderate spall in concrete deck. 8"x8"x2" deep.  
Soffit shows no signs of distress.

Span 2 spall in the deck.

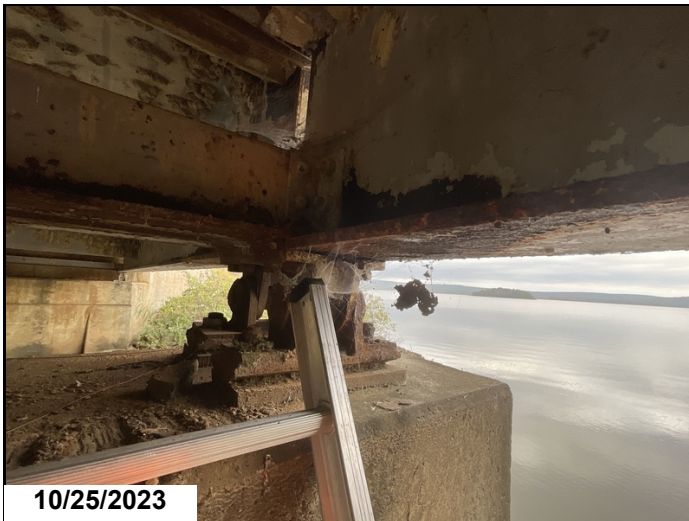
All beams at bents 1,2,3 have minor to moderate corrosion to webs and lower flanges.

Bent 2 span 2 beam 1 has moderate pitting to the lower web and flange above bearing.

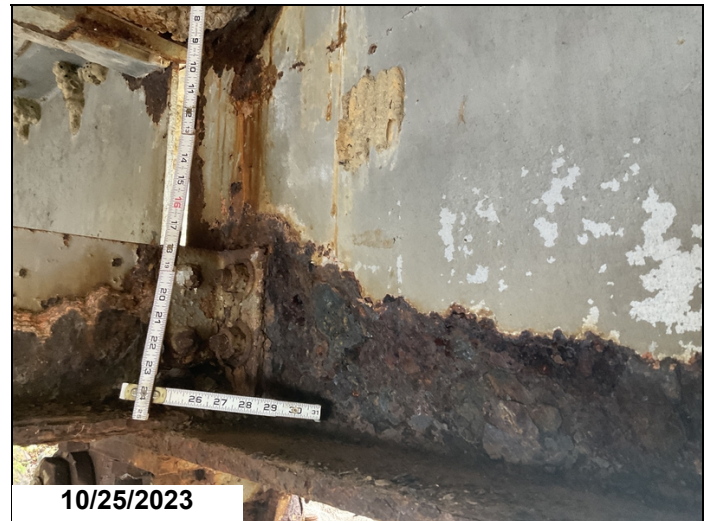
Bent 2 span 1 beam 4 at bearing area has moderate pitting to web and lower flange. Upper web at haunch area has 5/16" pitting in the upper web. Lower web above bearing has a 1/4" pitting. Lower flange has 1/16" pitting.

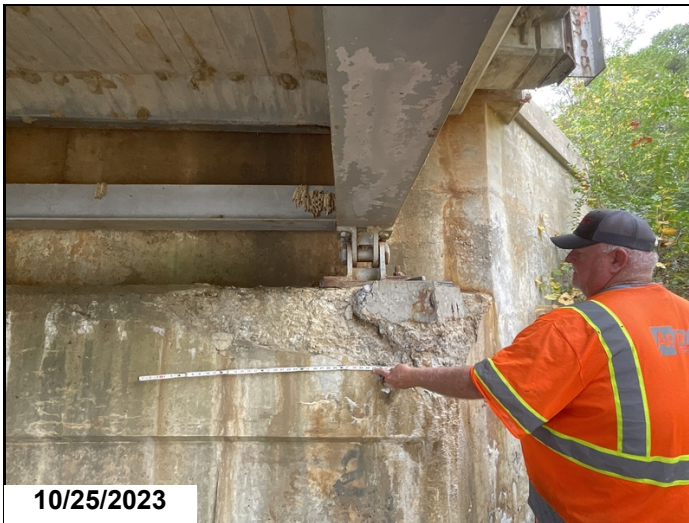
Bent 3 spall under bearing 4 due to concrete deterioration.

Bent 3 cap under bearing 4 has a spall due to concrete deterioration. State forces have patched in the past but the patch is beginning to fail. No bearing loss at this time.
