Bridge 00680 Inspection Report

SH 66 Searcy over COVE CREEK

Location: 0.003 miles EAST OF JCT OF US 65 LESLIE

Team Lead: Benjamin Smith Inspection Date: 09/10/2024

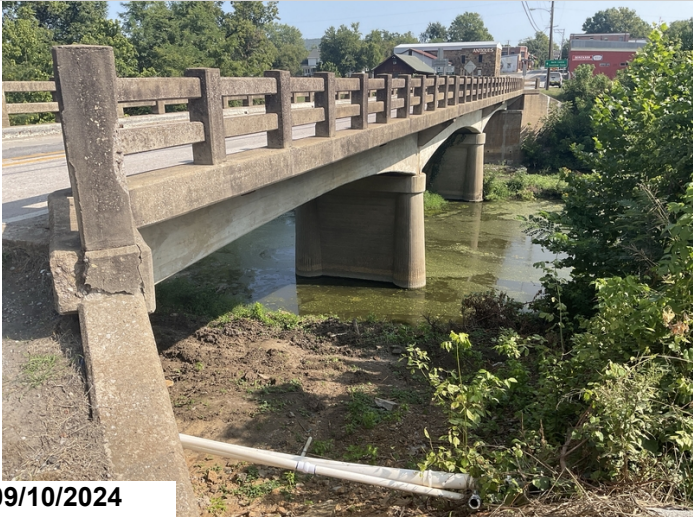
Elevation view.

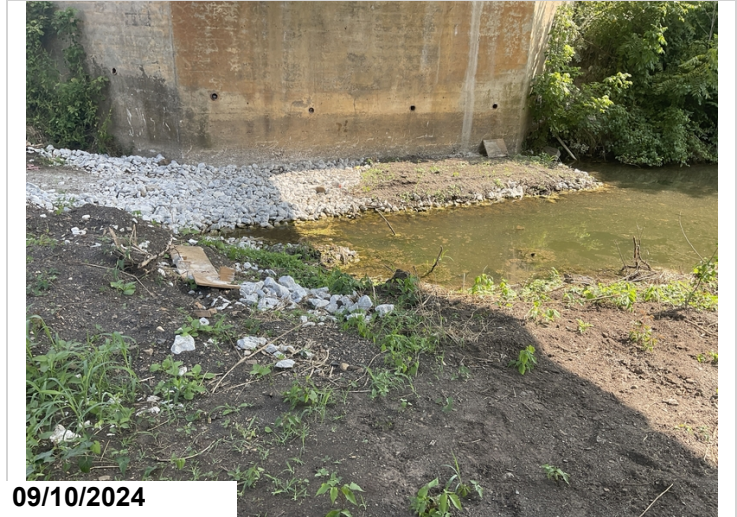
Rip rap has been placed at abutment #2 as a work platform.

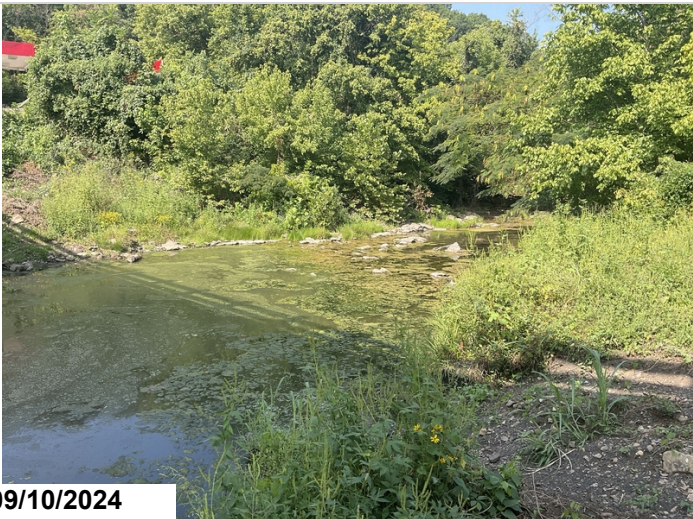
The downstream channel is well vegetated.

Downstream channel view.

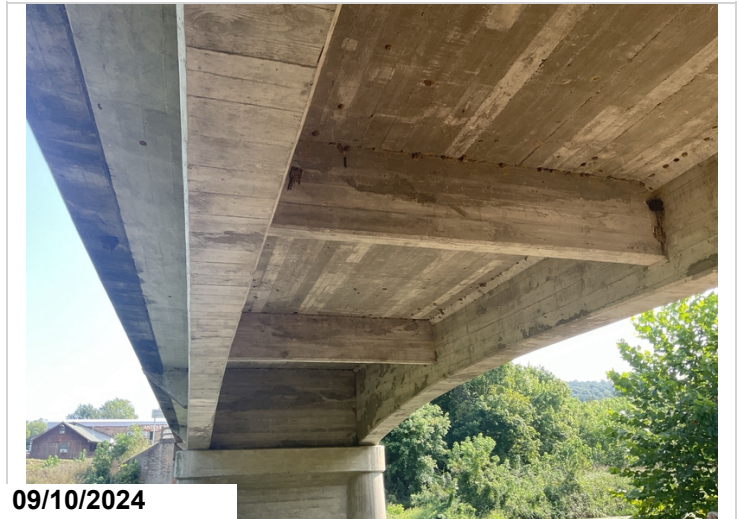
The driving surface has been roto milled in the past. The deck has asphalt repaired areas.
The undersurface has areas of shallow exposed rebar in the overhangs.

Undersurface view.

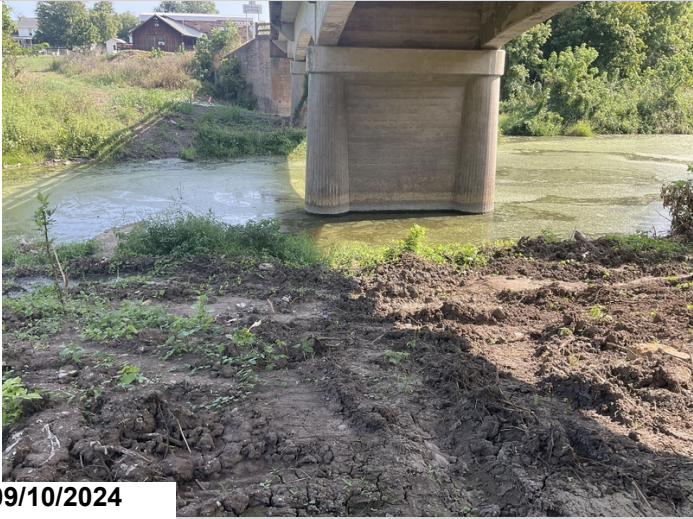
The channel beneath the structure flows mainly in spans #1,2. The footings exposed at pier #1 with no undermining.

Channel beneath the structure.

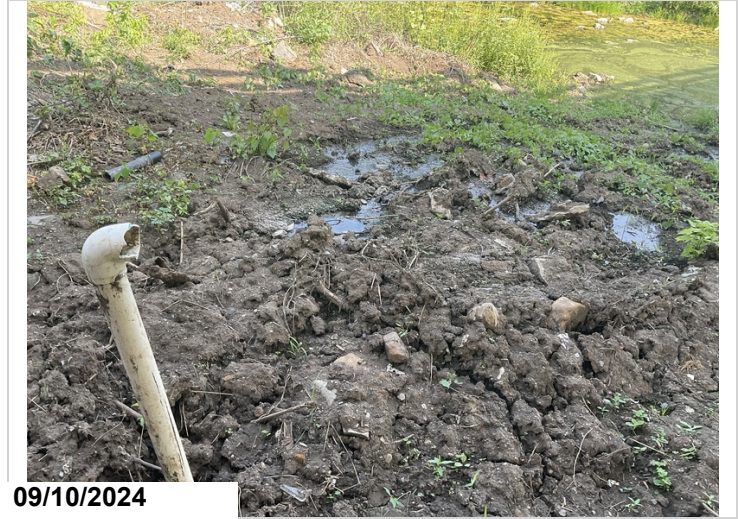
Possible sewage leak at abutment #1.

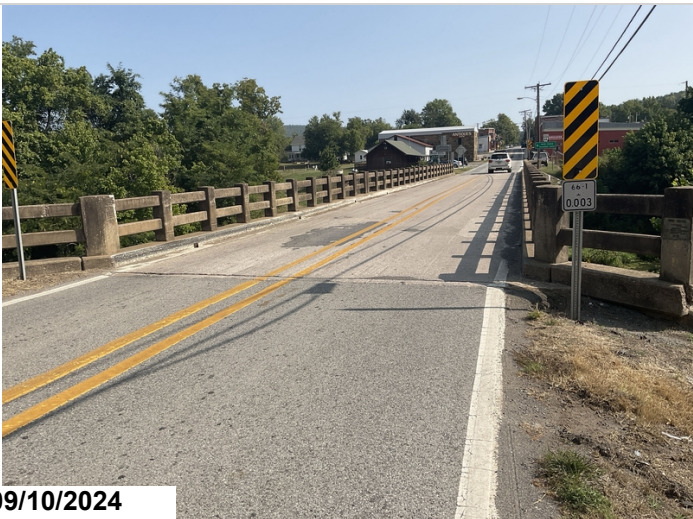
Approach view in direction of log mile.

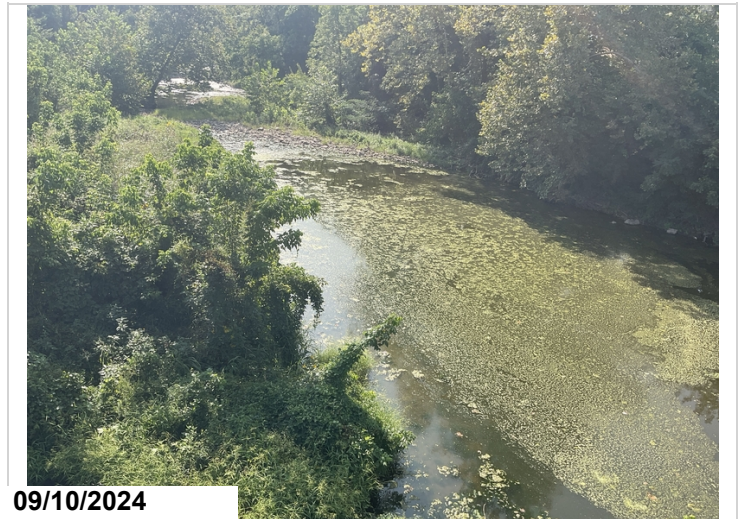
The upstream channel is well vegetated.

Upstream channel view.

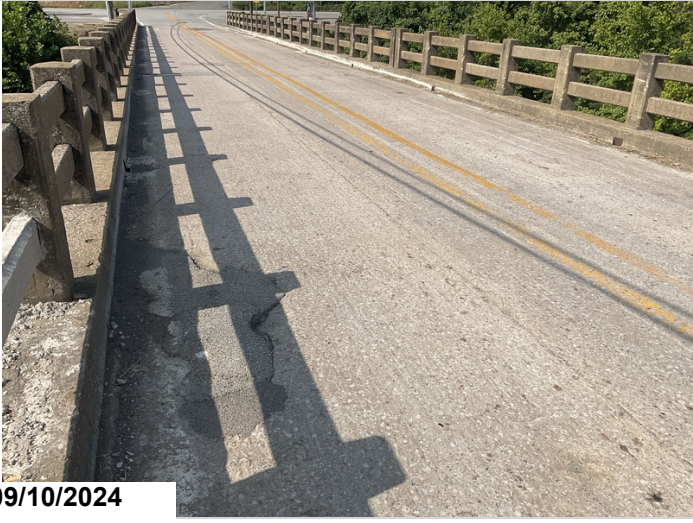
Driving surface view.

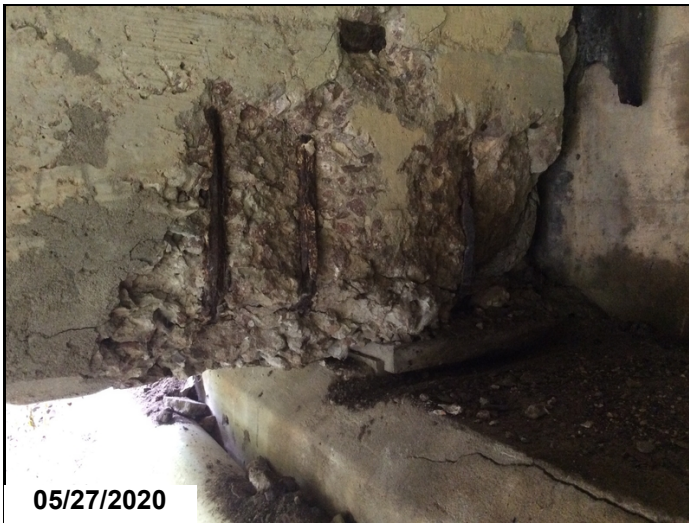
Tee beam #2 has spalling with rebar exposed over abutment #1 on the interior side.

Inside view of girder #2 over abutment #1

It was noted during the routine inspection that this area has been repaired. BDS 2024

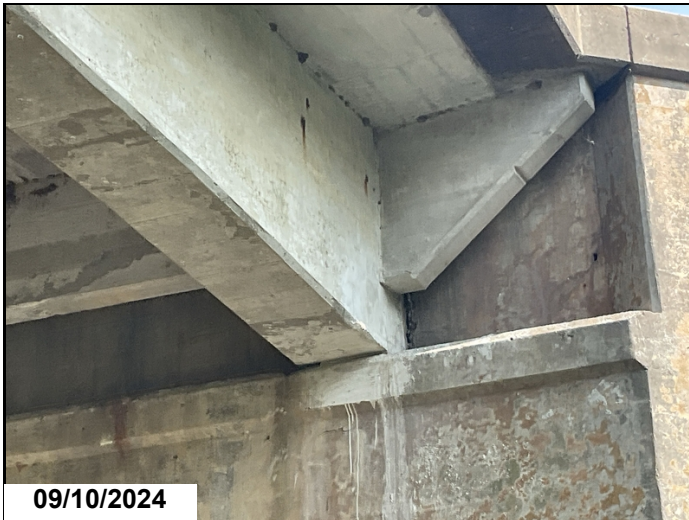
Tee beam #2 at abutments #1 and #2 has cracking at the bridge seat. The tee beam is nearly in contact with the top of the abutment wall at abutment #1.

Repairs at tee beam #2 over abutment #2.

It was noted during the routine inspection that the tee beams have been repaired.

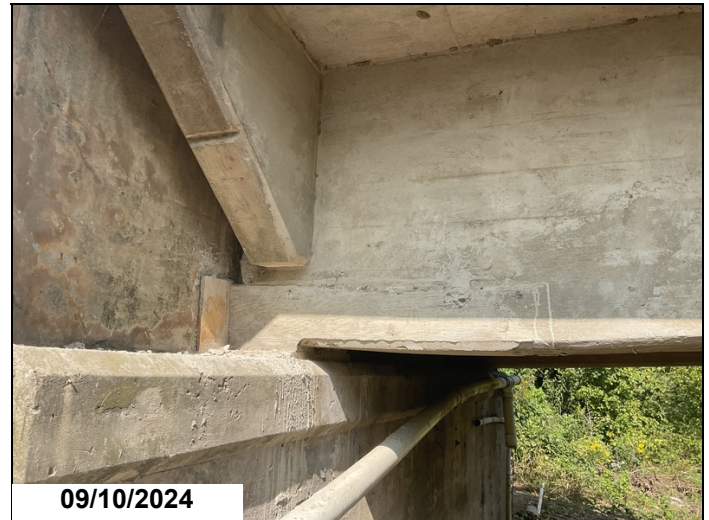
Tee beam #2 over abutment #1 has been repaired.

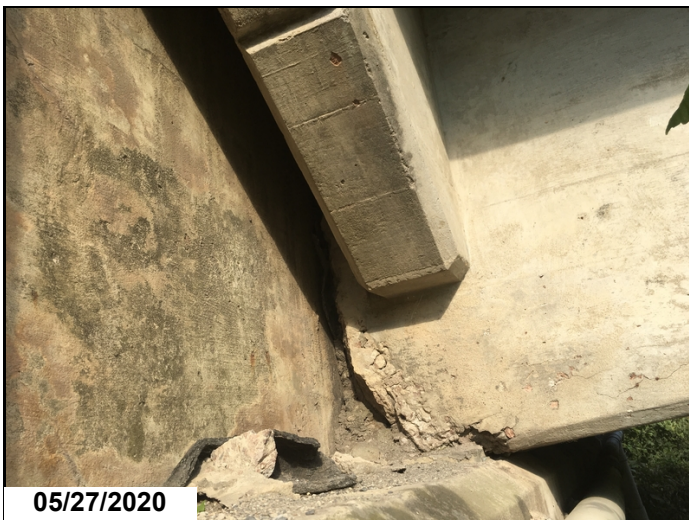
View of the exterior bearing area of beam #2 over abutment #1. Showing deterioration and crushing. The bottom edge of the tee is nearly in contact with the top face of the abutment

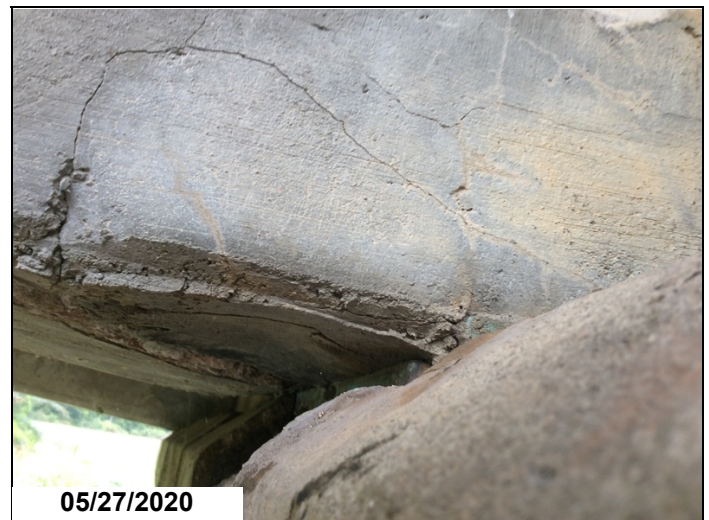
Small amount of Crushing at girder#2 at abutment #2.

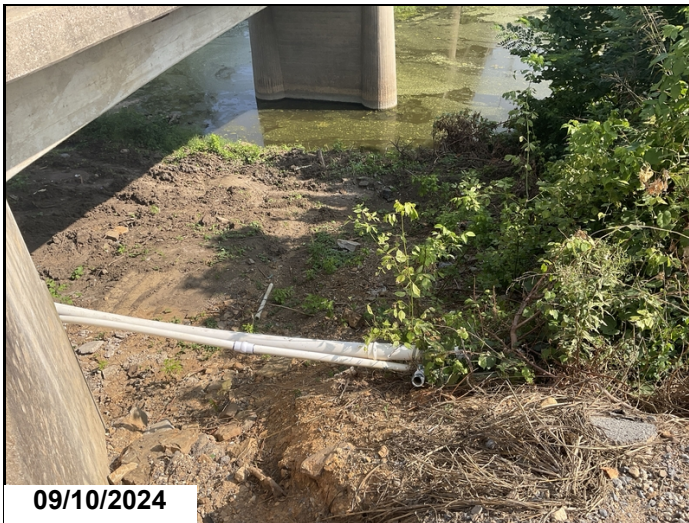
Vegetation / Trees under structure in spans #1 and #3.

Vegetation has been cleared.

It was noted during the routine inspection that the vegetation has been removed.

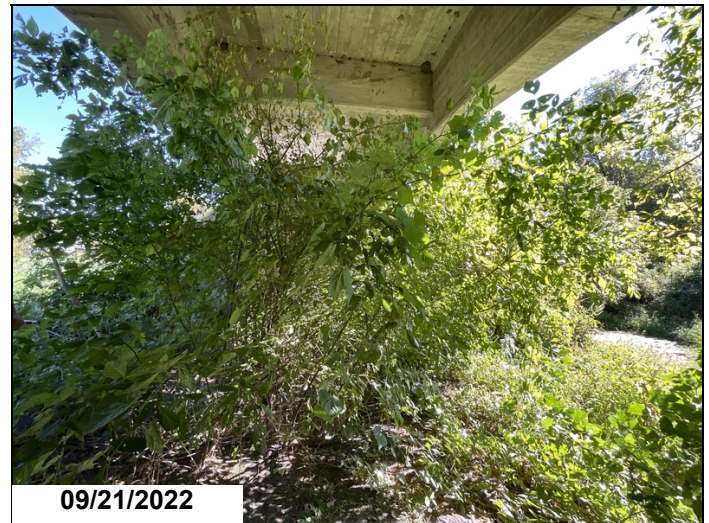
Vegetation under structure.
