Bridge 00892 Inspection Report

Asset #00892(Routine, Underwater type 2)

SH 66/Stone County over S. SYLAMORE

Team Lead: Floyd Haley Inspection Date: 10/07/2024

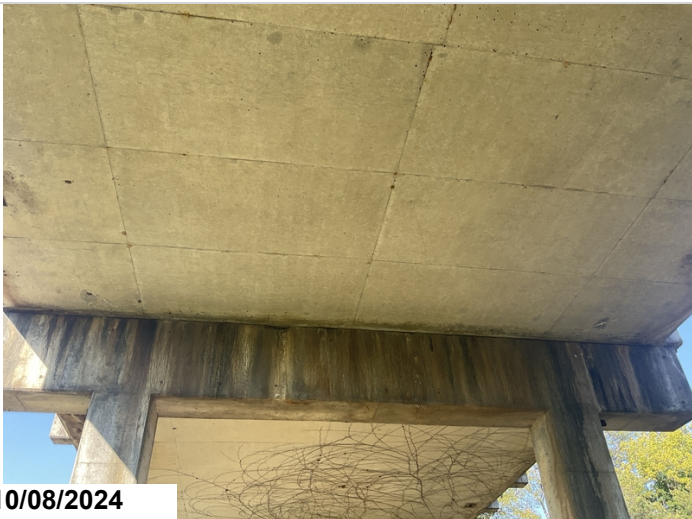
Typical undersurface.

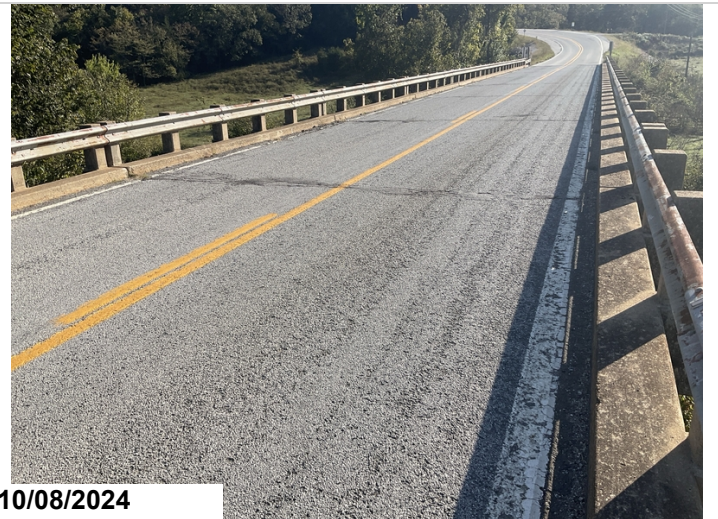
Typical deck

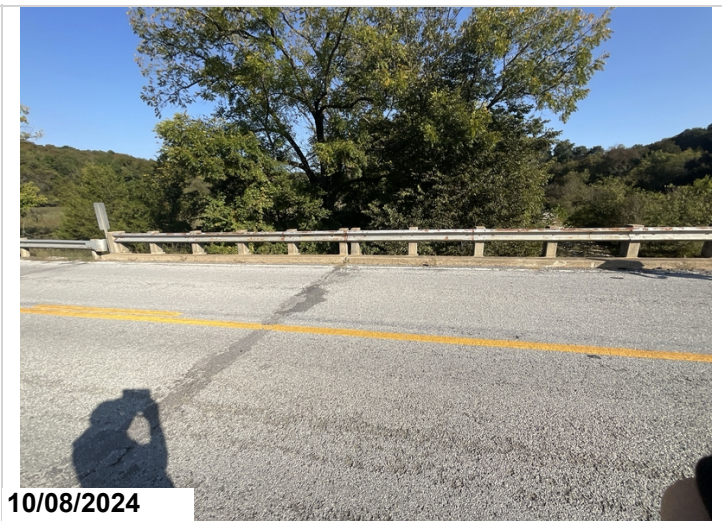
Typical rail is in satisfactory condition with surface corrosion.

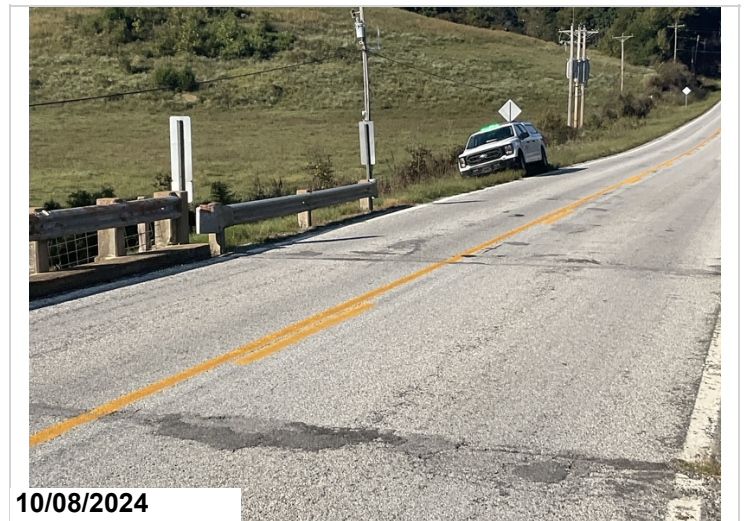
The transitions are in good condition with minor surface corrosion.

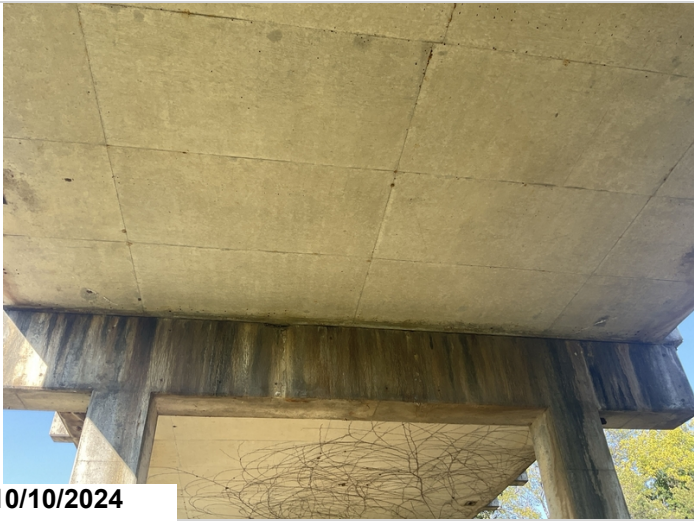
Span 6, ahead of bent 5: typical efflorescence in the undersurface.

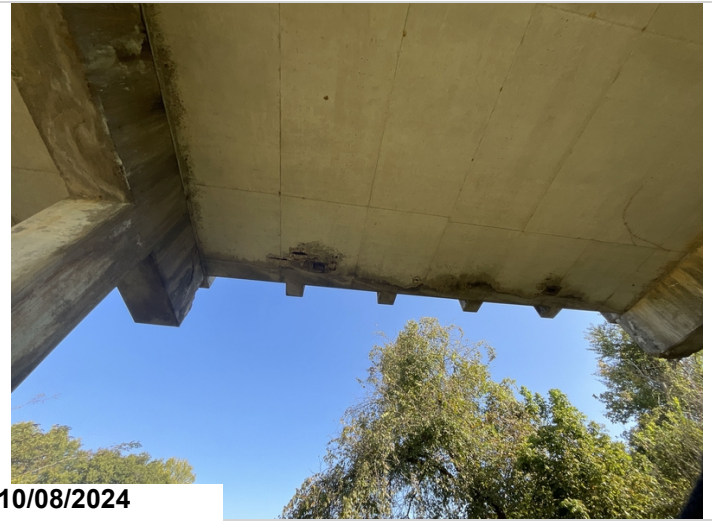
Span 7, left, first drain: has spalling with exposed rebar typical of drain locations throughout. 3SF CS3

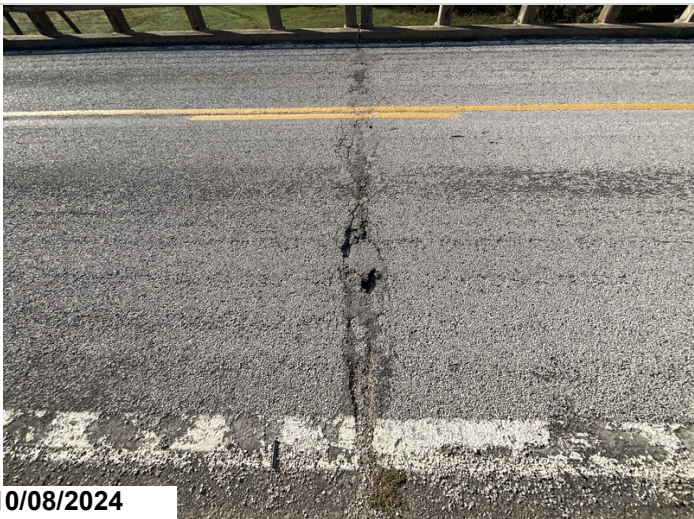
Bent 5, left: has a spall in the wearing surface typical of joint locations. CS3

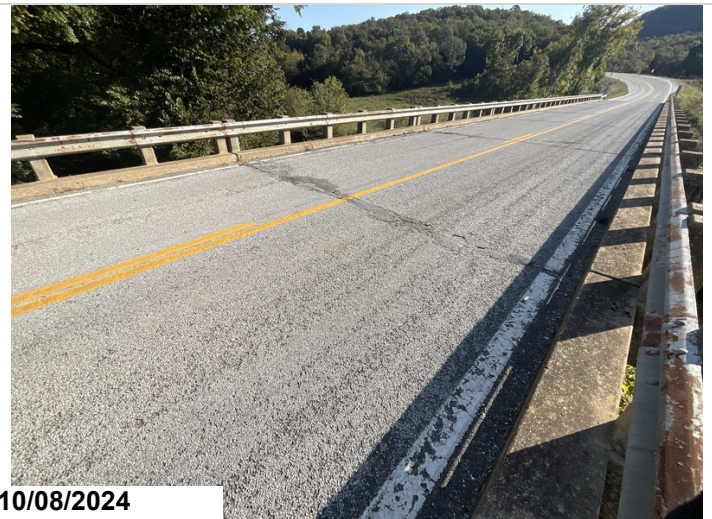
Typical wearing surface has cracks and patches over joints.

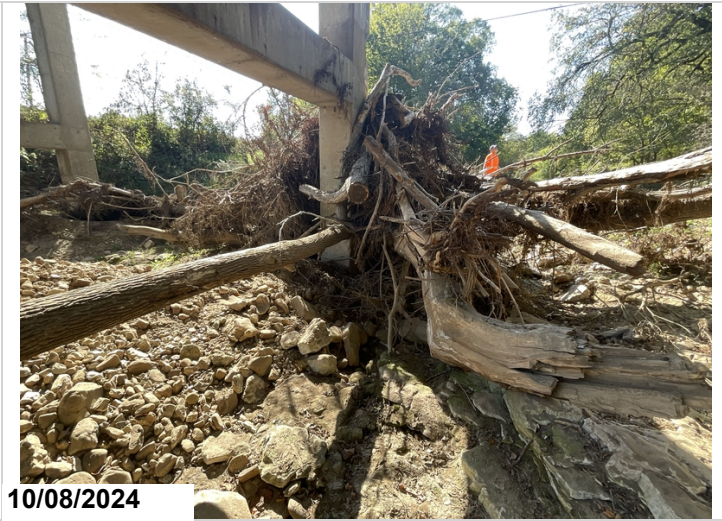
Scour is present at bents 2 and 3 because of heavy drift buildup. The channel bed has lost 4' of material at these bents. No undermining or exposed footings were found.

Bent 2, column 2: has a large pile of accumulated debris that is creating a scour hole.

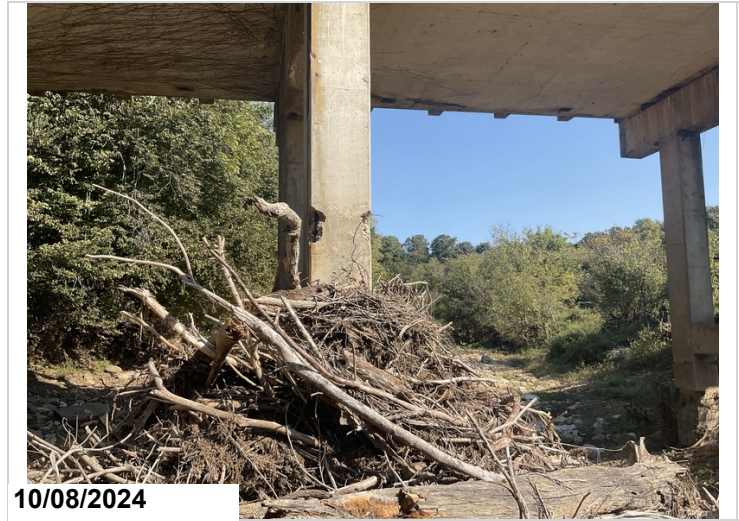
Bent 2, column 2: has 2 deep spalls with exposed rebar. 1EA CS3

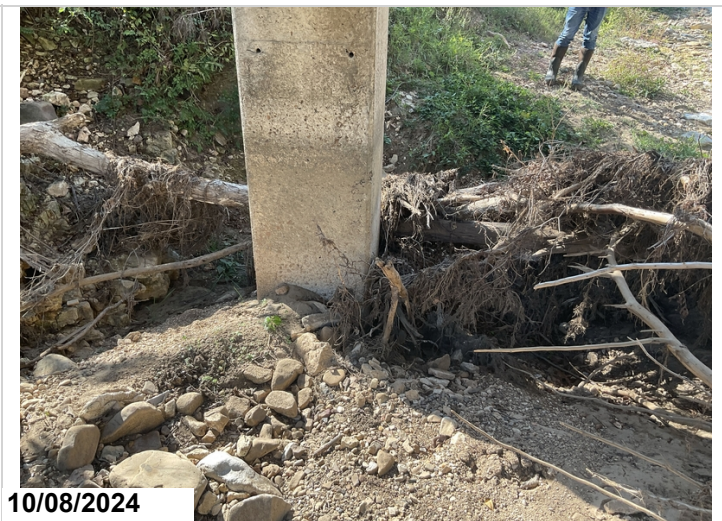
Bent 3, column 2: has drift accumulation and minor scour. 1EA CS2

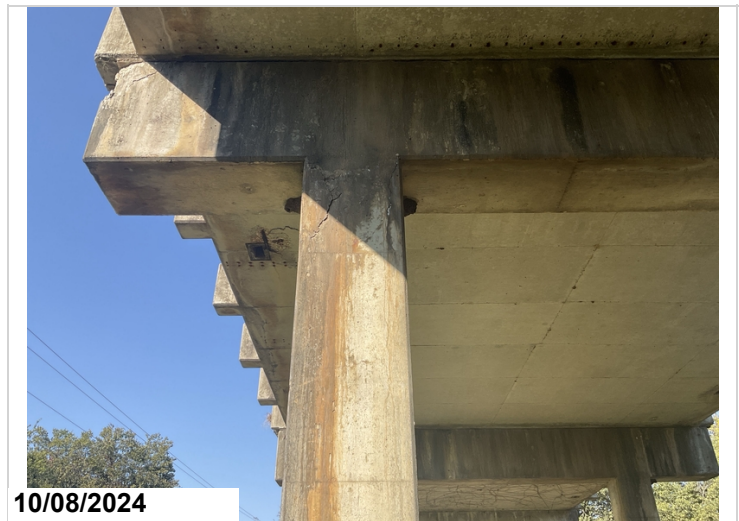
Bent 6, ahead, column 2: has large delams and vertical cracks. Column 1 is similar 2EA CS3

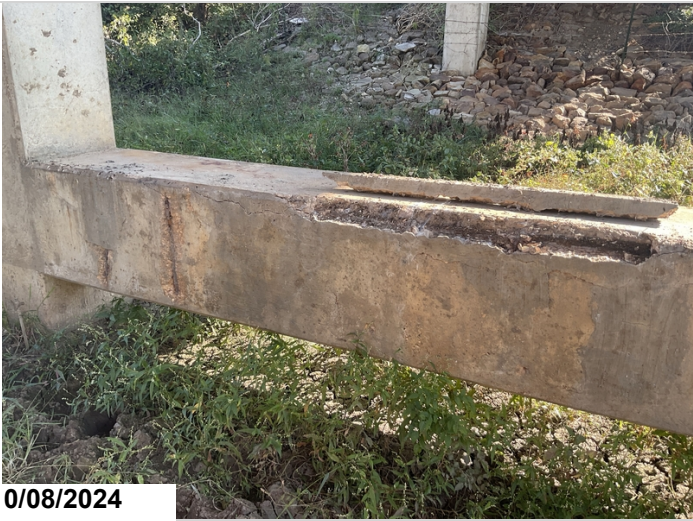
Bent 6, back, pier wall: has exposed rebar typical of this element.

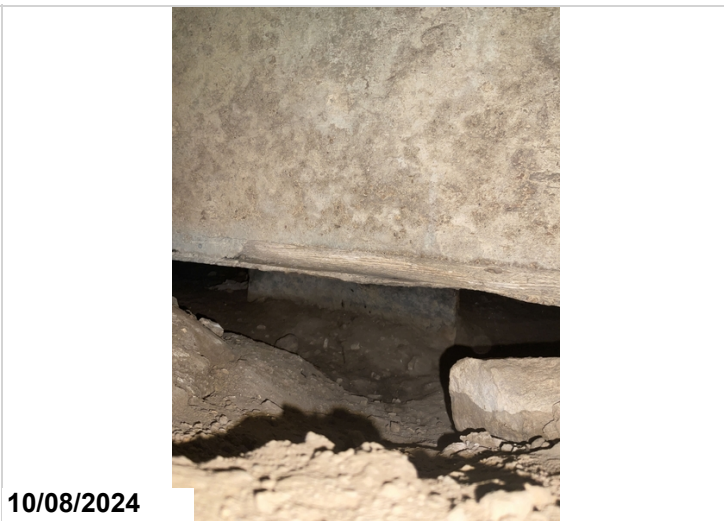
(215) Abutment 1: has scour on the right end and at the centerline. Both areas are undermined 2' back under with 1 pile exposed at the center location. 10LF CS3							
225	Steel Pile	EA	1	1	0	0	0

Abutment 1, center: has scour with undermining and an exposed pile. 2LF CS2

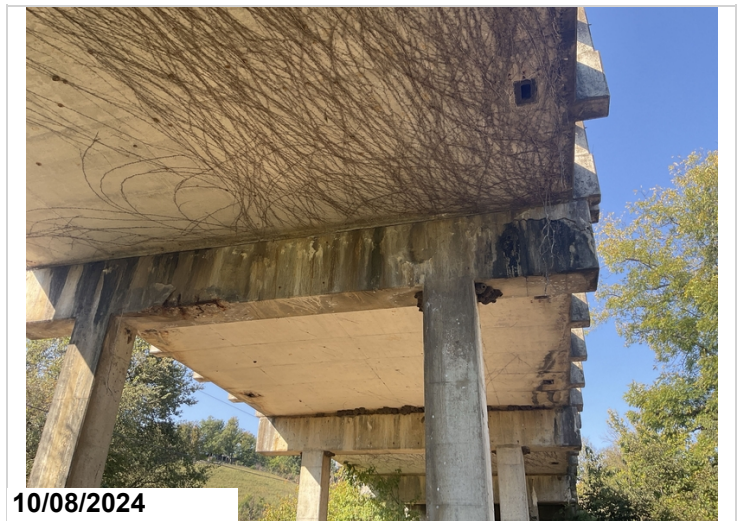
Bent 3: has a large spall with exposed rebar. 5LF CS3

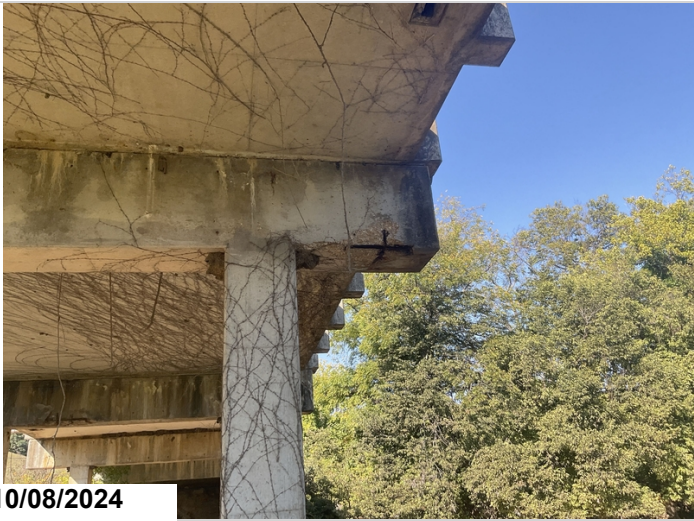
Bent 4, left: has exposed rebar. 3LF CS3

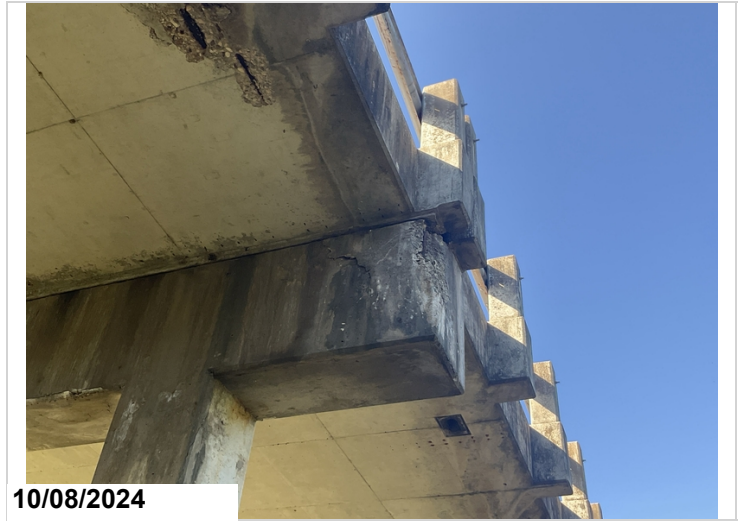
Bent 6, left: has a spall with exposed rebar. 1LF CS3

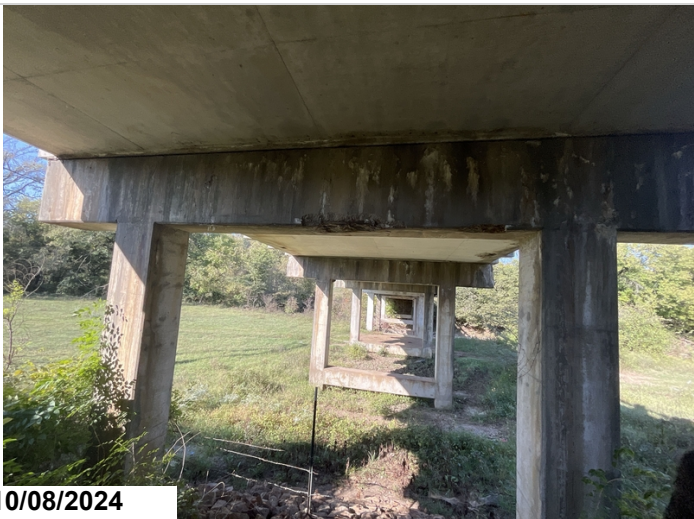
Bent 7: has a spall with exposed rebar on the underside.
6LF CS3

Bent 7: has efflorescence throughout. 12LF CS3

Bent 7: has isolated delaminations. 3LF CS2

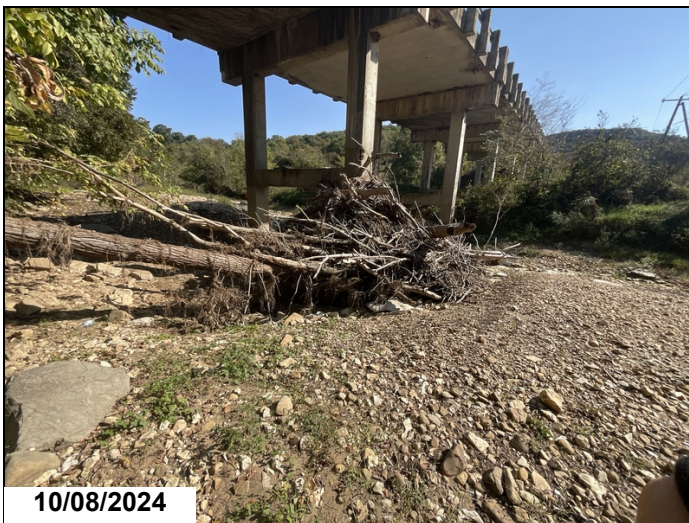
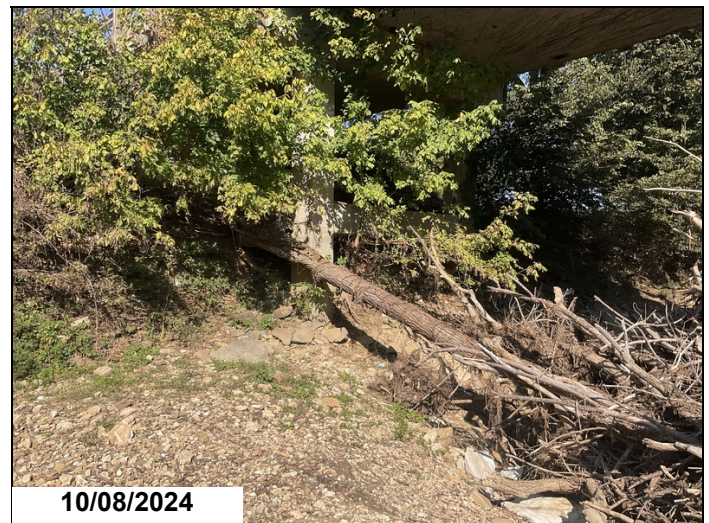
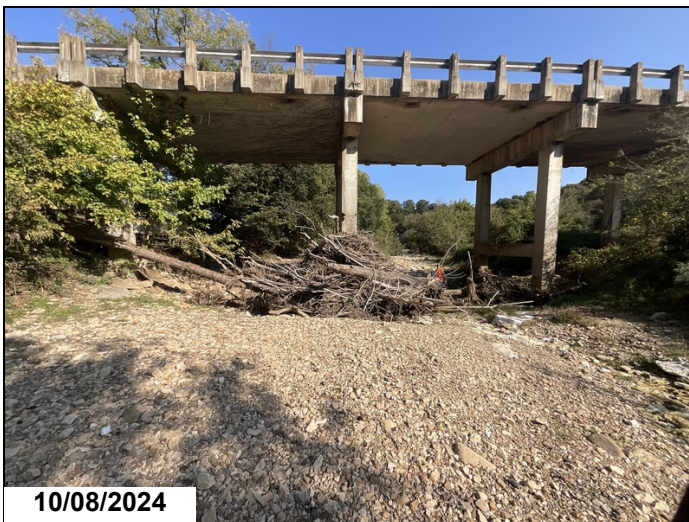
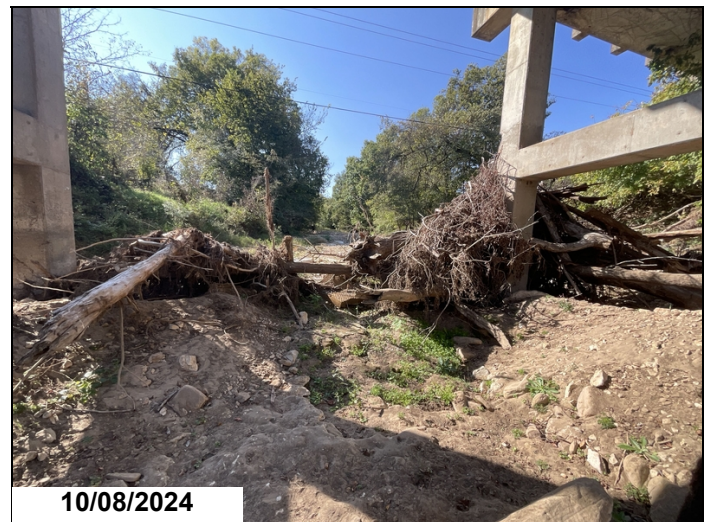
Bents 1-3 have excessive debris buildup causing scour. Full-size trees and logs are wedged against the substructure at these bents.

Bent 2: typical debris.

Bent 1: typical debris.

Bents 1 2 and 3 have excessive debris causing scour

Type of Work: Channel Work/Drift Removal

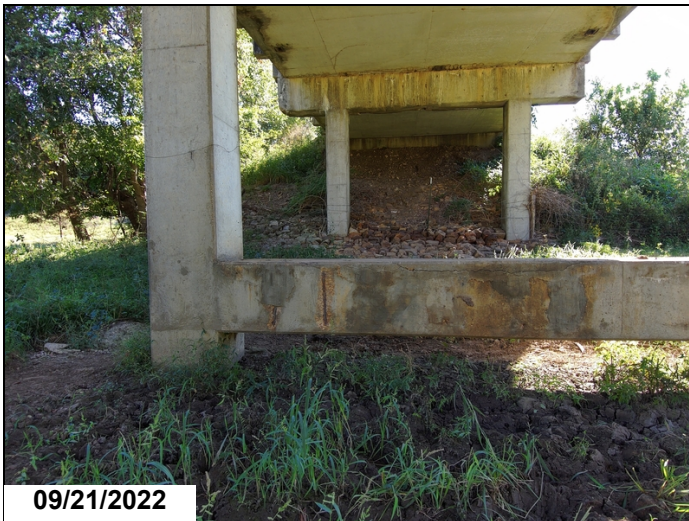
Bent 6 Concrete Diaphragm has spall with 18" of exposed rebar.

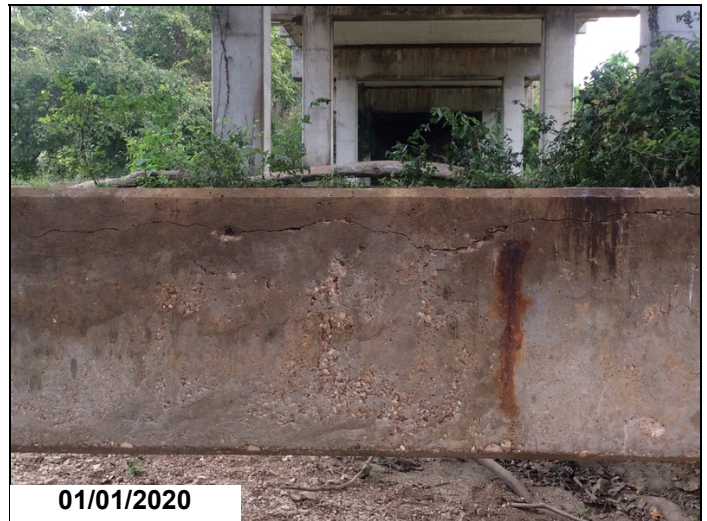
Horizontal cracking to concrete diaphragm @ Bent 3.

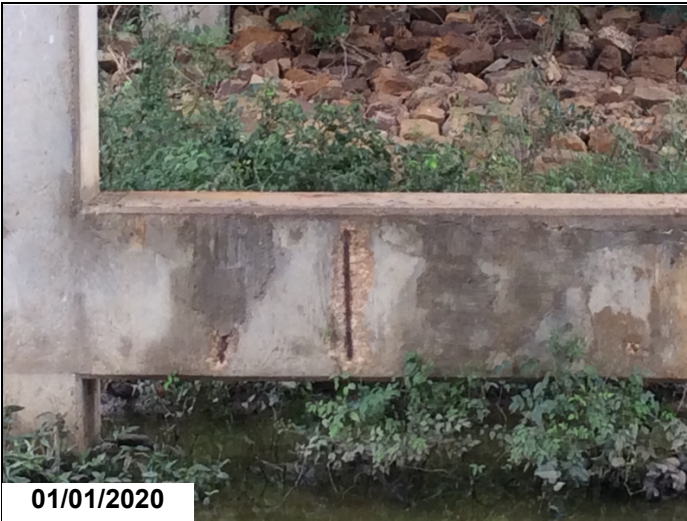
Spall with 18" rebar exposed to concrete diaphragm @ Bent 6.

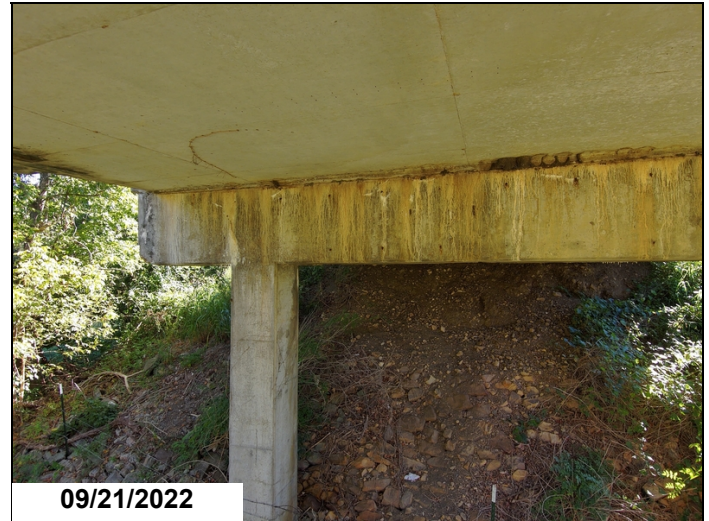
Efflorescent map cracking, spalls with rebar exposed & delaminating to caps@ all bents.
Typical efflor to all caps.

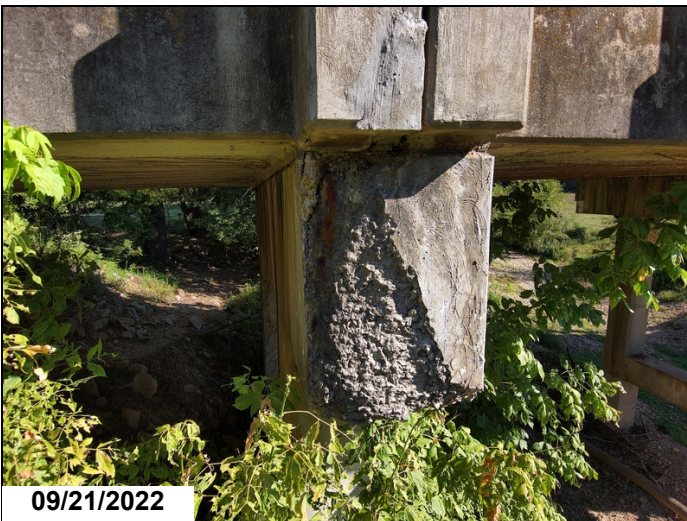
Efflorescent map cracking, spalls with rebar exposed & delaminating to caps@ all bents.
Bent 1, Rt side.

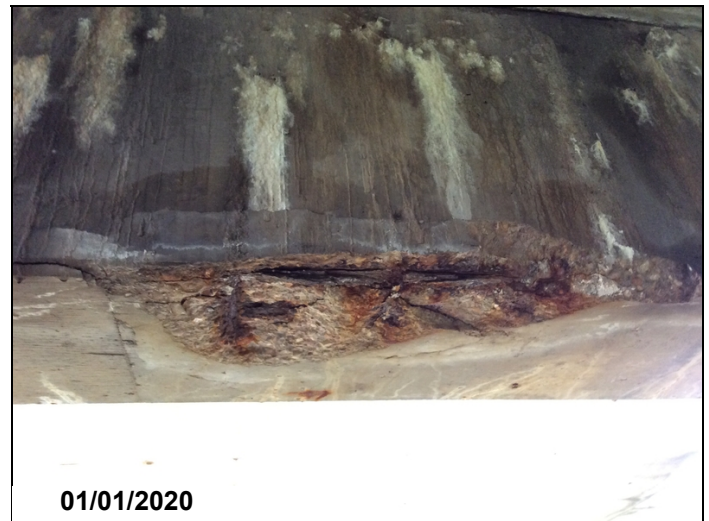
Spalls with rebar exposed & efflorescent cracking to Cap @ Bent 7.

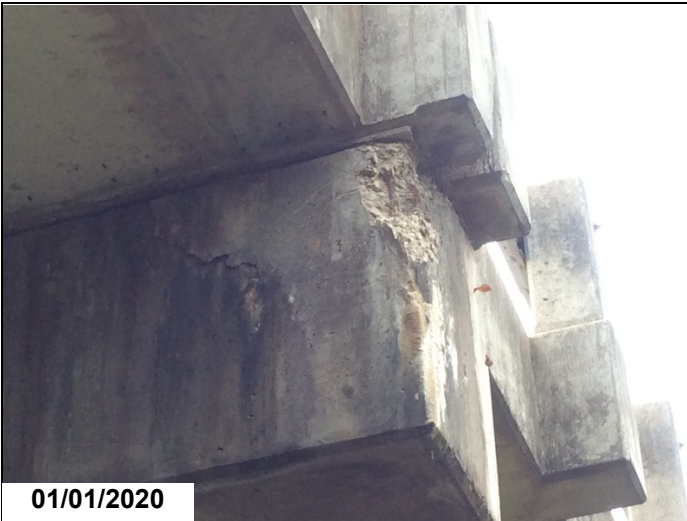
Spalls with rebar exposed @ delaminated area to Left
end of Cap @ Bent 6.

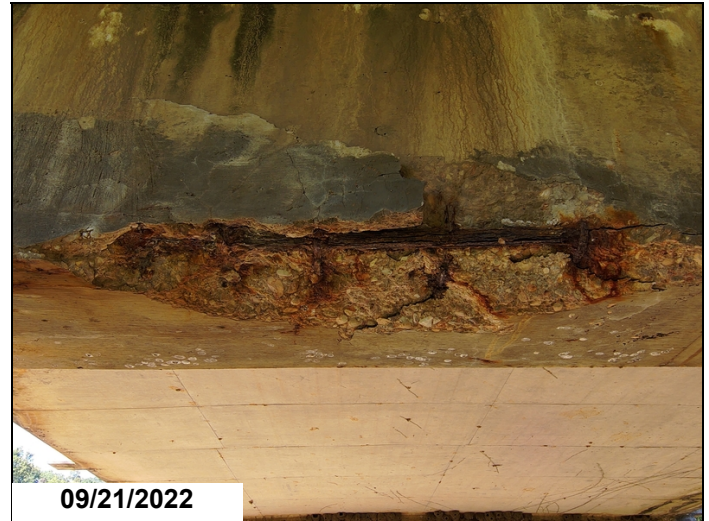
Bents 1, 3, 4 & 7
Large spalls with rebar exposed to caps
Bent 2, ahead side.

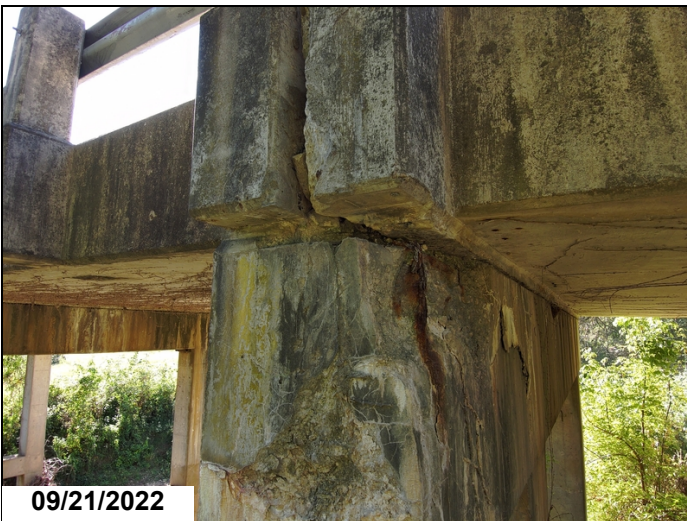
Bents 1, 3, 4 & 7
Large spalls with rebar exposed to caps
Bent 1, Lt side.

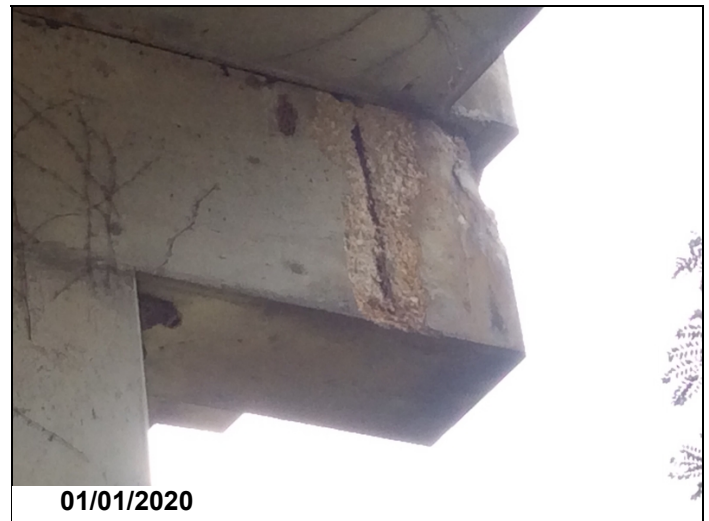
Spalls with rebar exposed to Right end of Cap @ Bent 4.

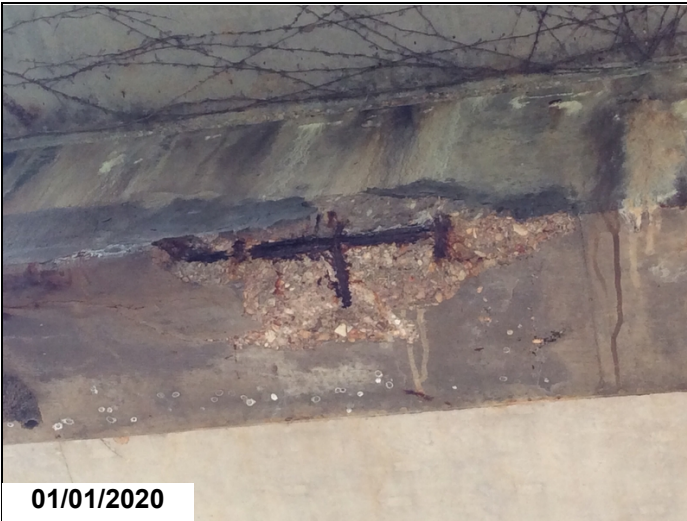
Spalls with rebar exposed to bottom of Cap @ Bent 3.
