Bridge 02573 Inspection Report

SH 66/Stone County over TIMBO CREEK

Location: 0.4 MI W SH 263

Team Lead: Floyd Haley Inspection Date: 11/20/2024

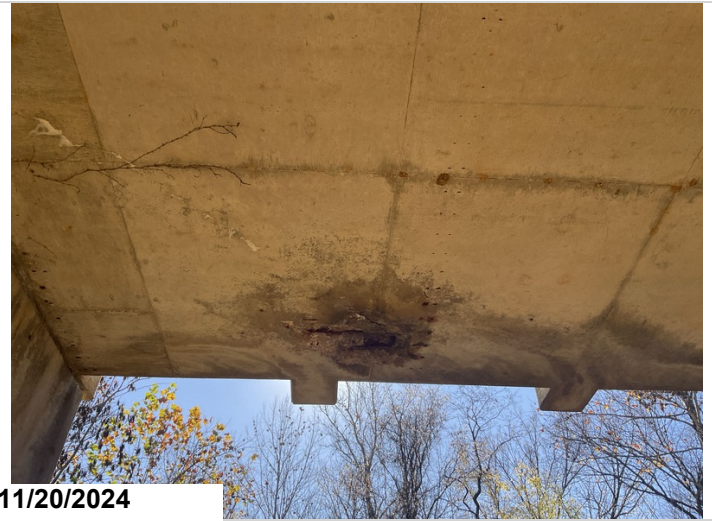
Span 4 :Left and Right drains: Spalls with corroded reinforcing steel exposed. 6' CS3

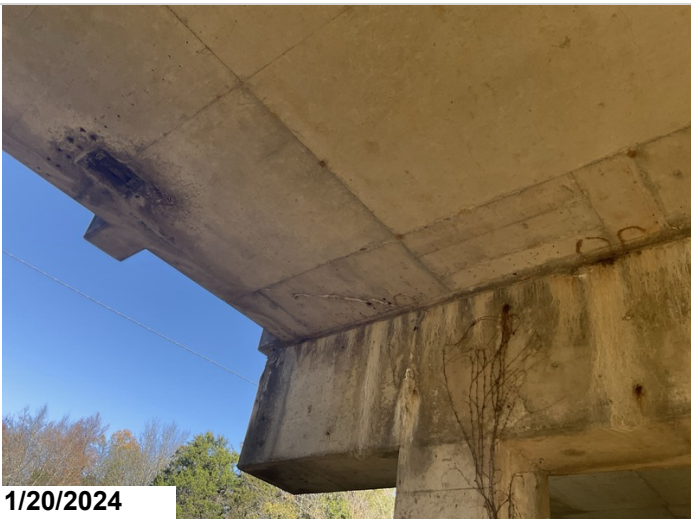
Span 4: Efflorescent cracking. 5' CS3 4' CS2

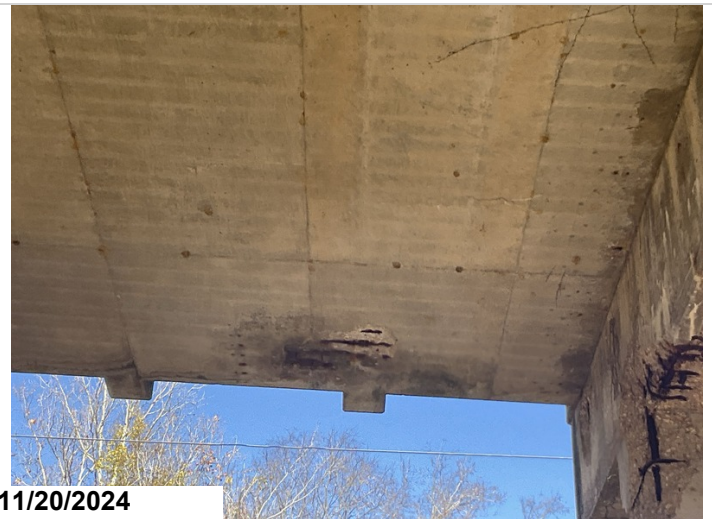
Span 3: Left drain: Spalls with corroded reinforcing steel exposed. 4' CS3

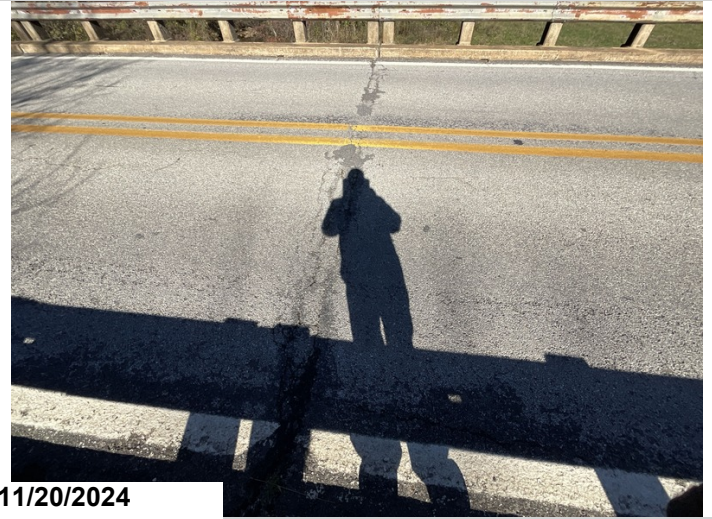
The wearing surface has cracks at all joints. 144SF CS3

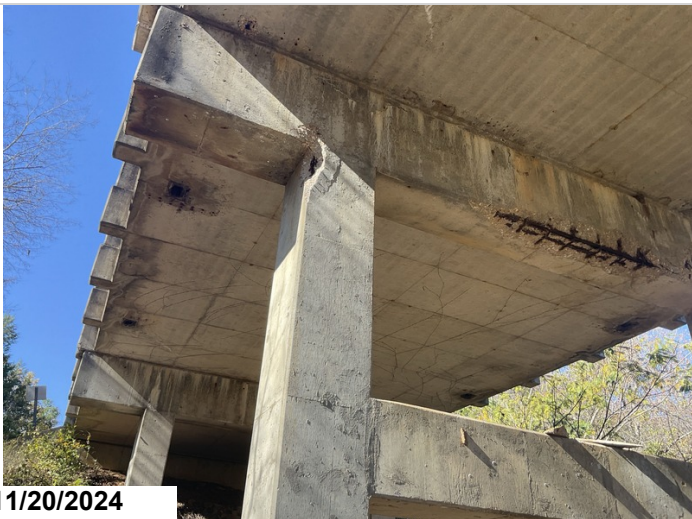
Bent 2, column 1: has exposed rebar. 1EA CS3

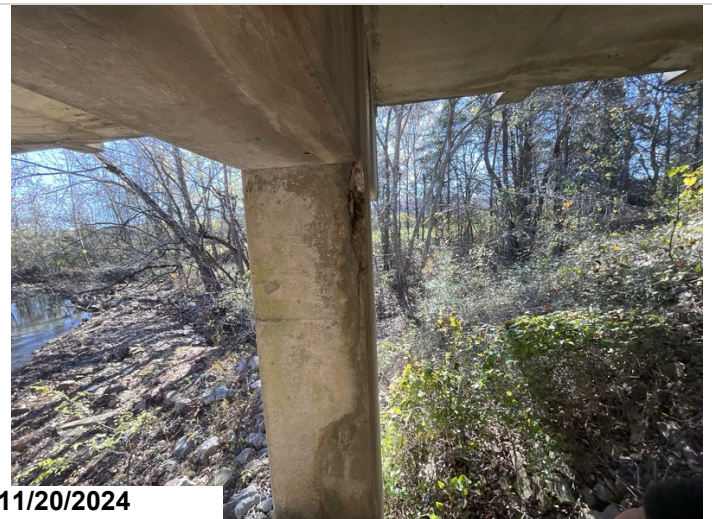
Bent 1, column 2: exposed rebar. 1EA CS3

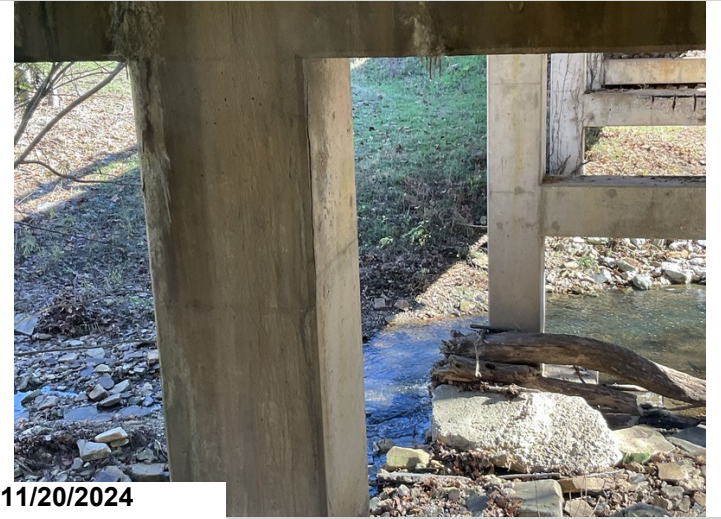
Bent 1, left: cracking

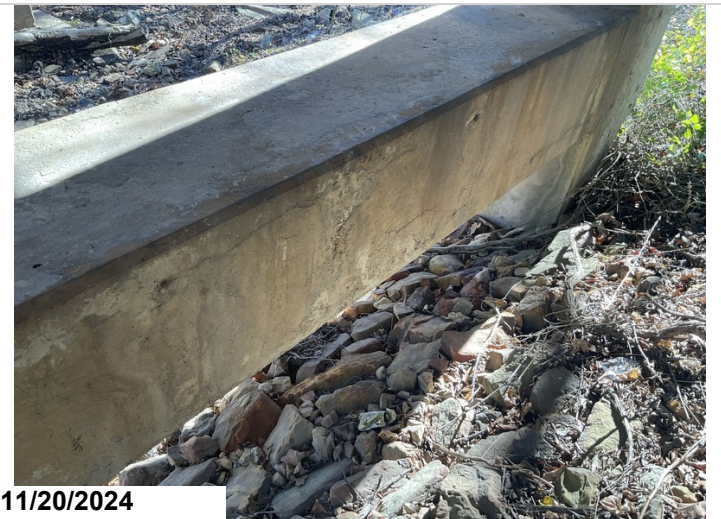
Bent 1, back: horizontal cracking. 6LF CS3

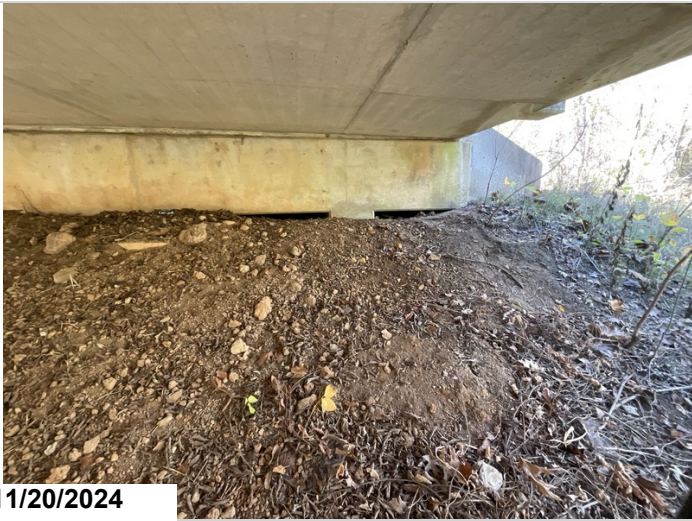
Substructure is in Poor condition with scour at Abutment 1, scour to footings at Bents 2 and 3, and heavy deterioration to columns, caps and pier walls at all bents. AS a result, a rating of 4.

Abutment 1, left: has scour under the cap with a column exposed. 1' down, 2.5' back under. 25LF CS2

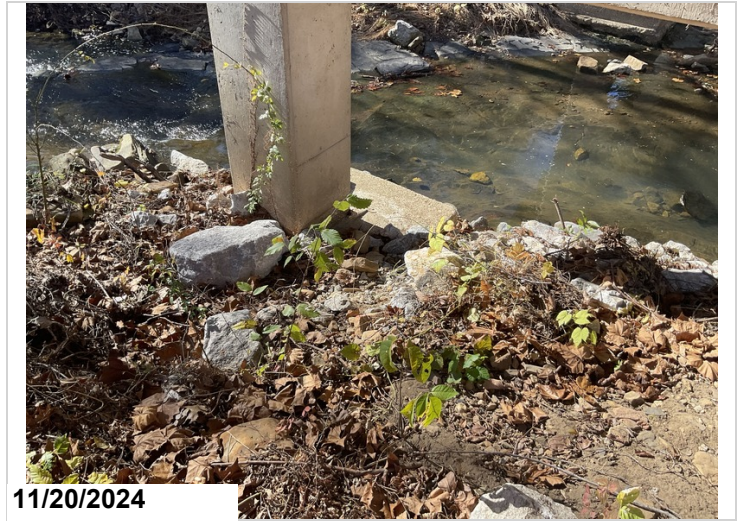
Footings exposed at Bents 2 and 3. Footings are on solid rock

Bent 3, right: has an exposed footing.

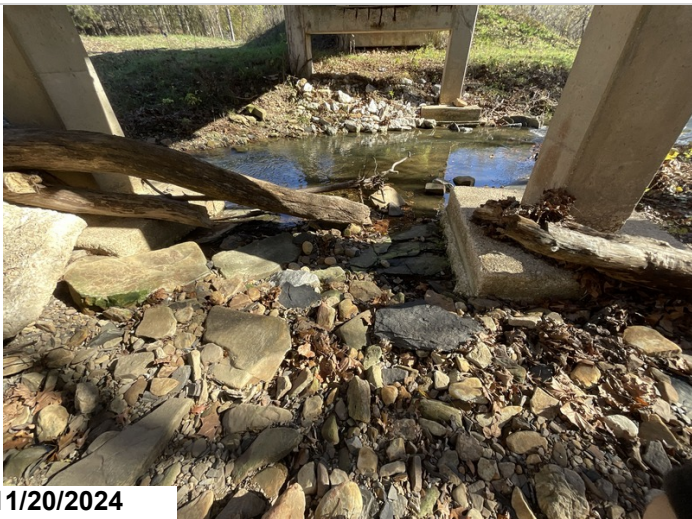
Bent 2, both footings exposed.

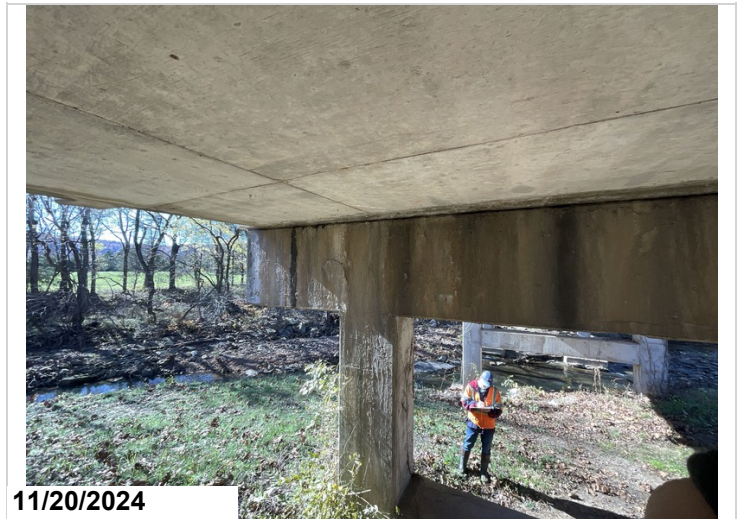
Bent 4: Back and Ahead sides: Vertical and horizontal efflorescent cracking. 6' CS3

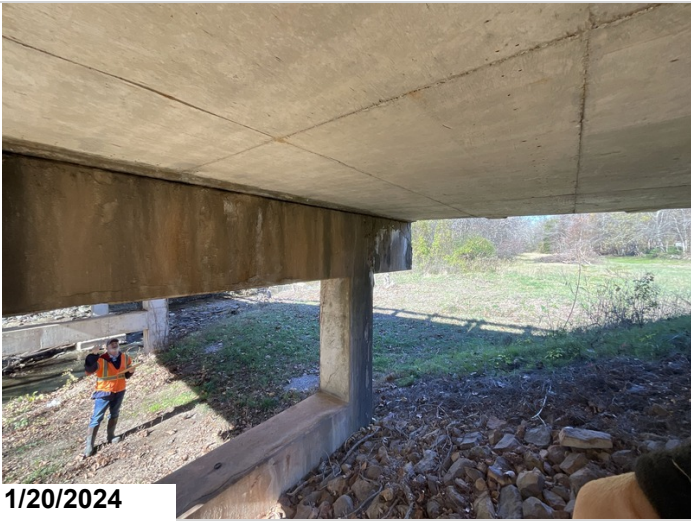
Bent 4: Ahead Left: Spall. 1' CS3

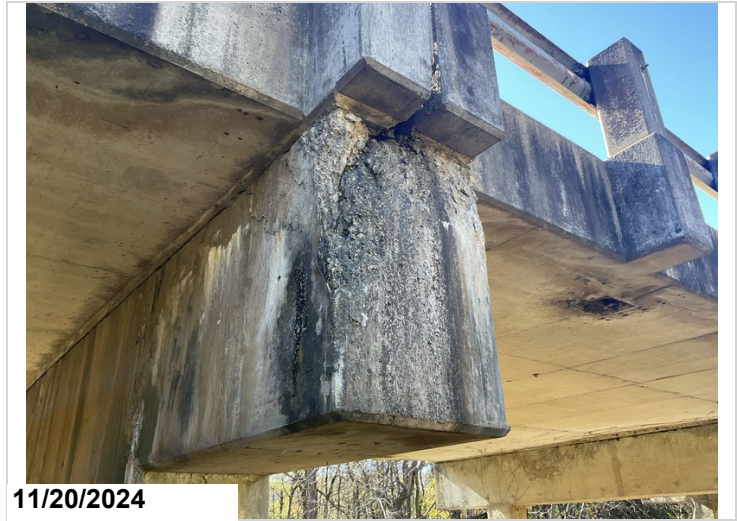
Bent 4: Bottom: Spall with corroded reinforcing steel exposed. 1' CS3

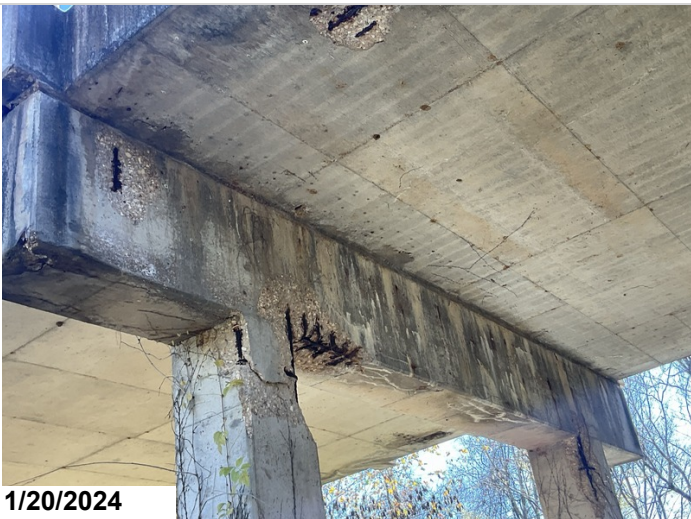
Bent 3: Backside/bottom: Efflorescent map cracking. 10' CS3

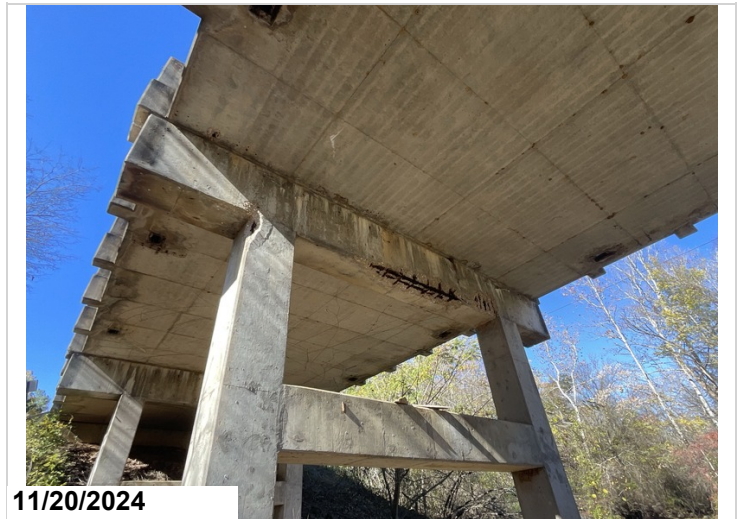
Bent 2: Ahead: Spalls with corroded reinforcing steel exposed, some with 100% section loss. 10' CS3

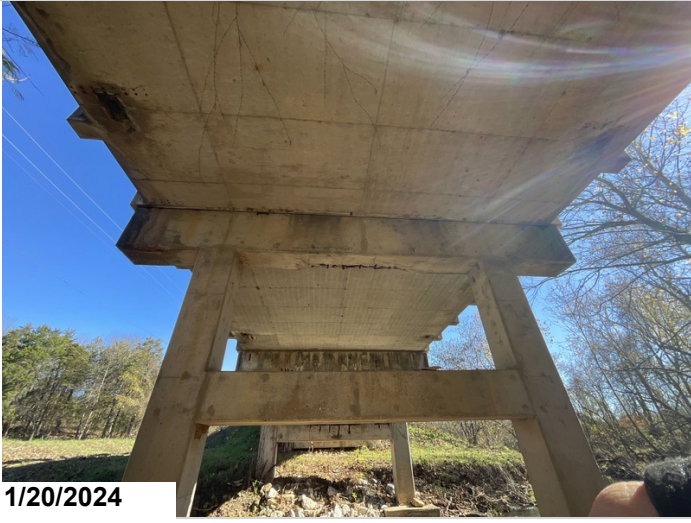
Bent 2: Ahead: Horizontal efflorescent cracking. 3' CS3

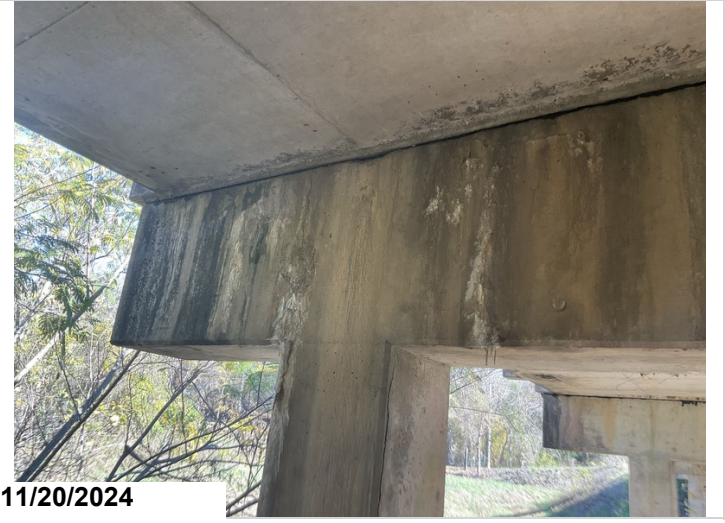
Bent 1: Back and ahead sides: Efflorescent cracking. 13' CS3

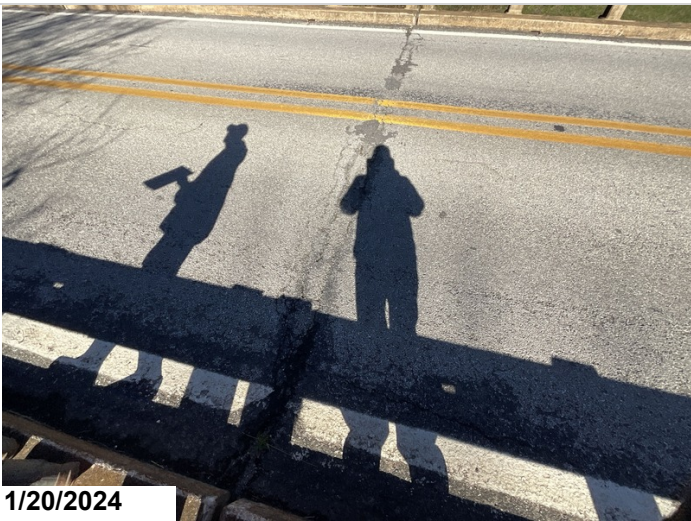
The joints have been impacted by the wearing surface.

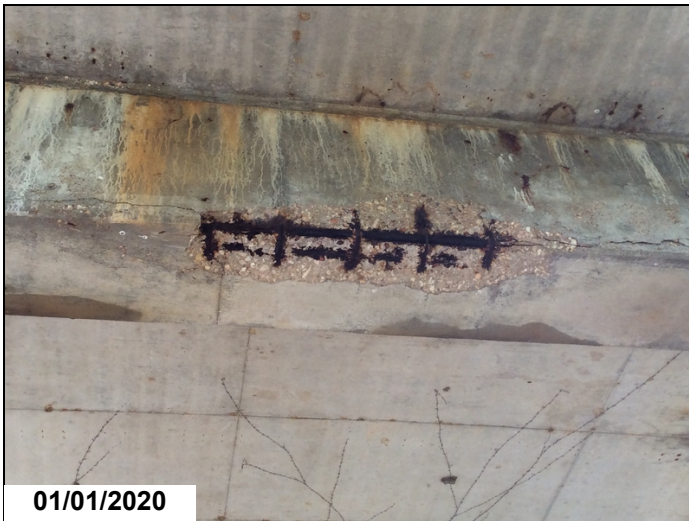
Bents 2 & 4 - Large spalls with rebar exposed. Rebar has 100% section loss.

Spalls with rebar exposed to bottom of cap @ Bent 2.

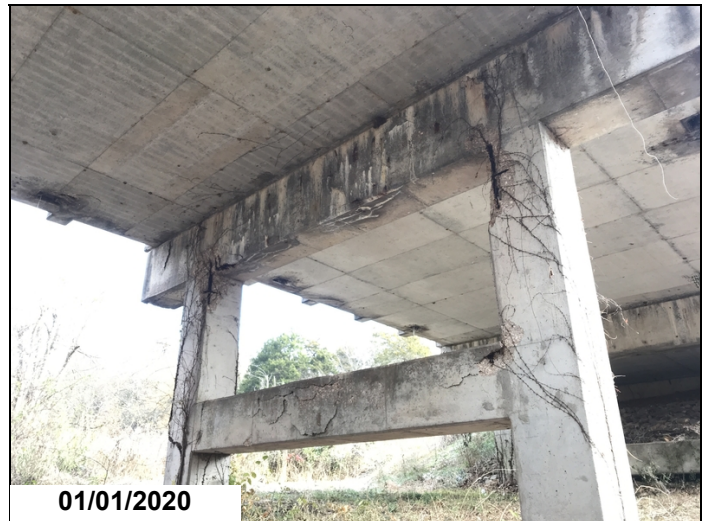
Bent 3 - Large spall w/ 3' of rebar exposed and efflorescent map cracking w/ rust stains to cap & Lt. & Rt. columns and diaphragm.

Bent 3 back side Cap, Columns & Diaphragm have large spalls with rebar exposed, Large areas of delaminations, & efflorescent cracks with rust stains.

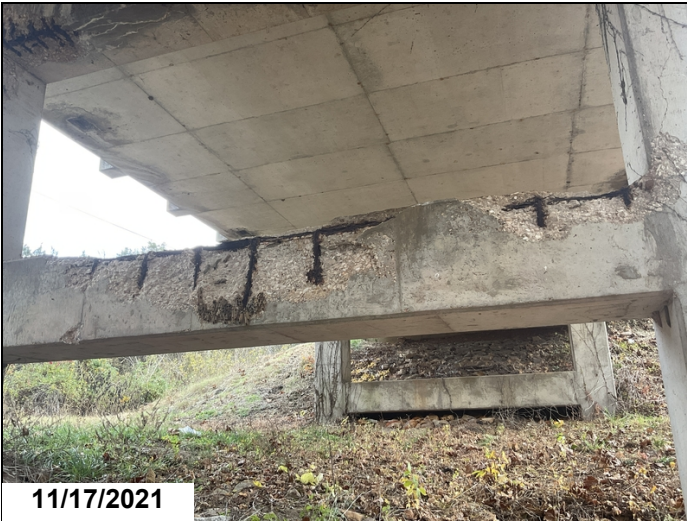
Bent 3 - Large spall w/ 3' of rebar exposed and efflorescent map cracking w/ rust stains to cap & Lt. & Rt. columns and diaphragm.

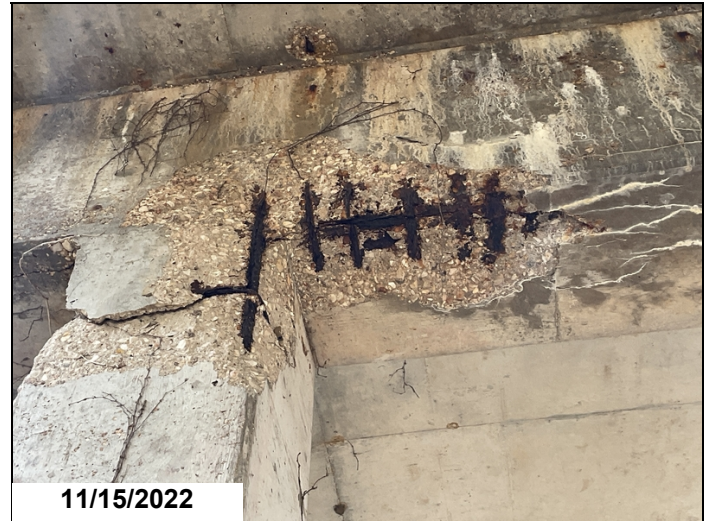
Bent 3 - Large spall w/ 3' of rebar exposed and efflorescent map cracking w/ rust stains to cap & Lt. & Rt. columns and diaphragm.

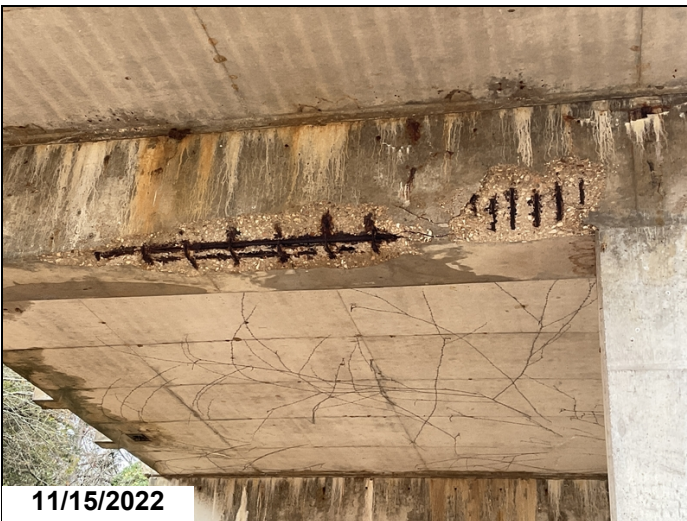
Bents 2 & 4 - Large spalls with rebar exposed. Rebar has 100% section loss.

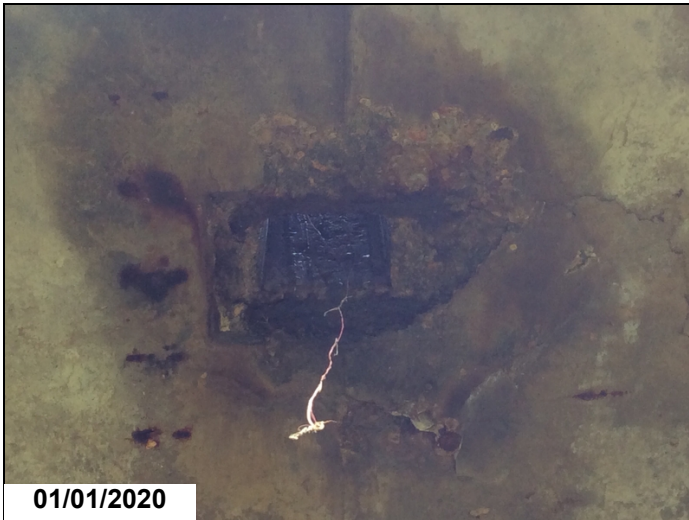
Spalls with rebar exposed to soffit @ Right drain opening
@ Span 4.

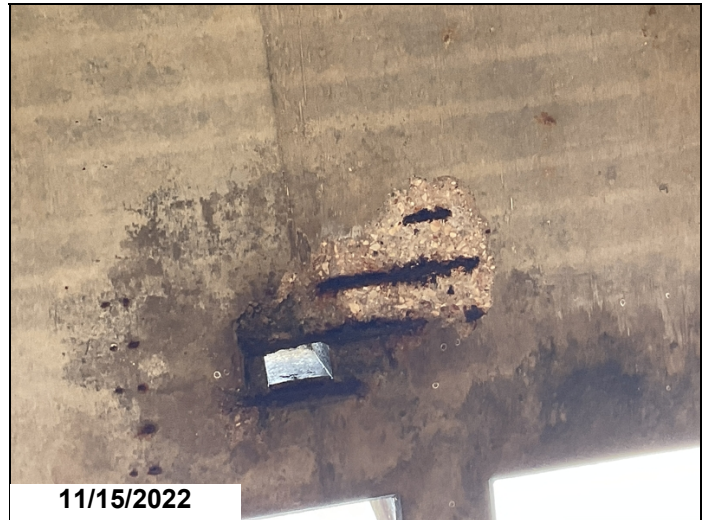
Soffit @ Spans 3 & 4
Spalls w/ rebar exposed around Left & Right drain
openings.
Span 3.

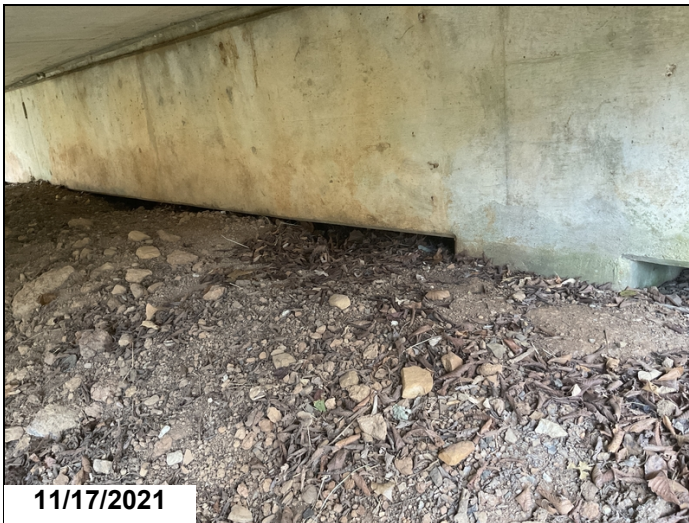
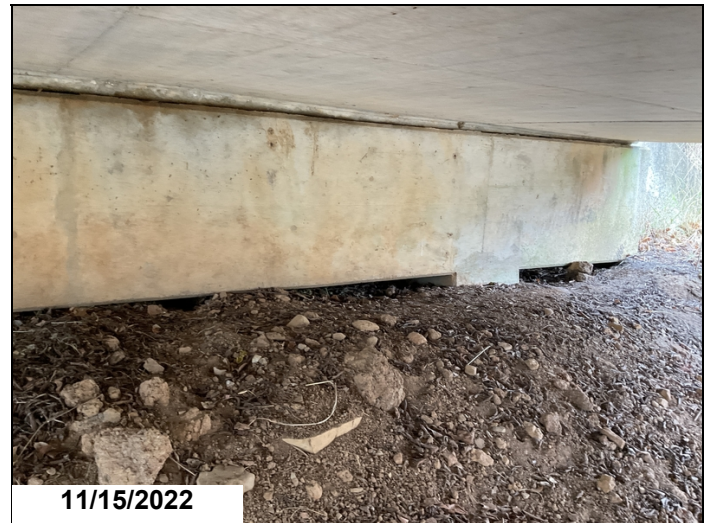
Abutment 1: Scour 1' down and 2.5' back under exposing 1 column.
