WRONG-WAY CRASH STUDY

INTERSTATES AND FREEWAYS | CALENDAR YEAR 2019

Published August 2021

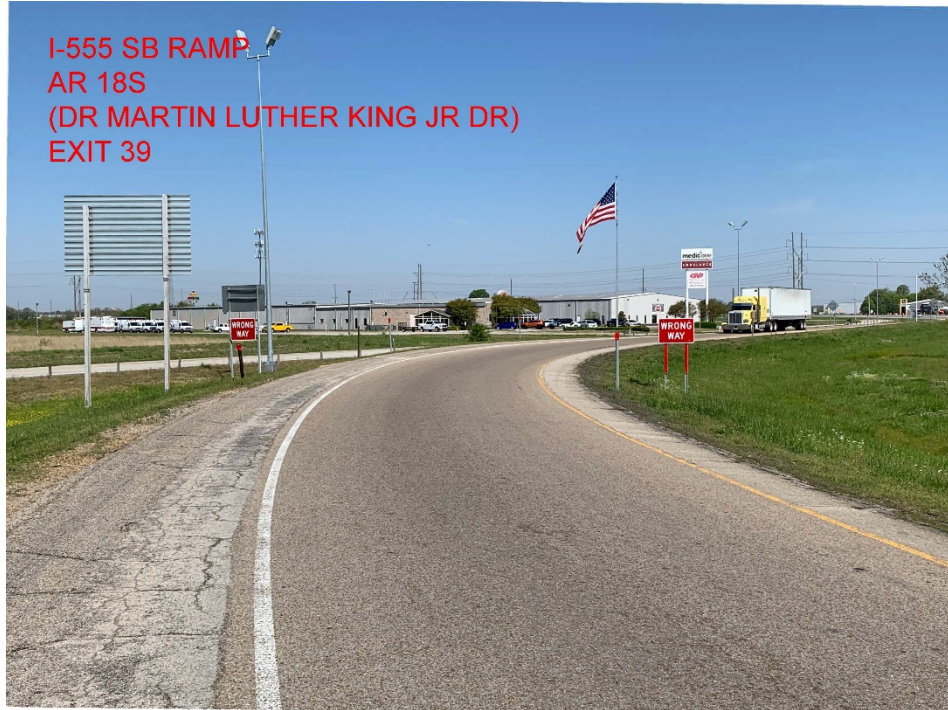
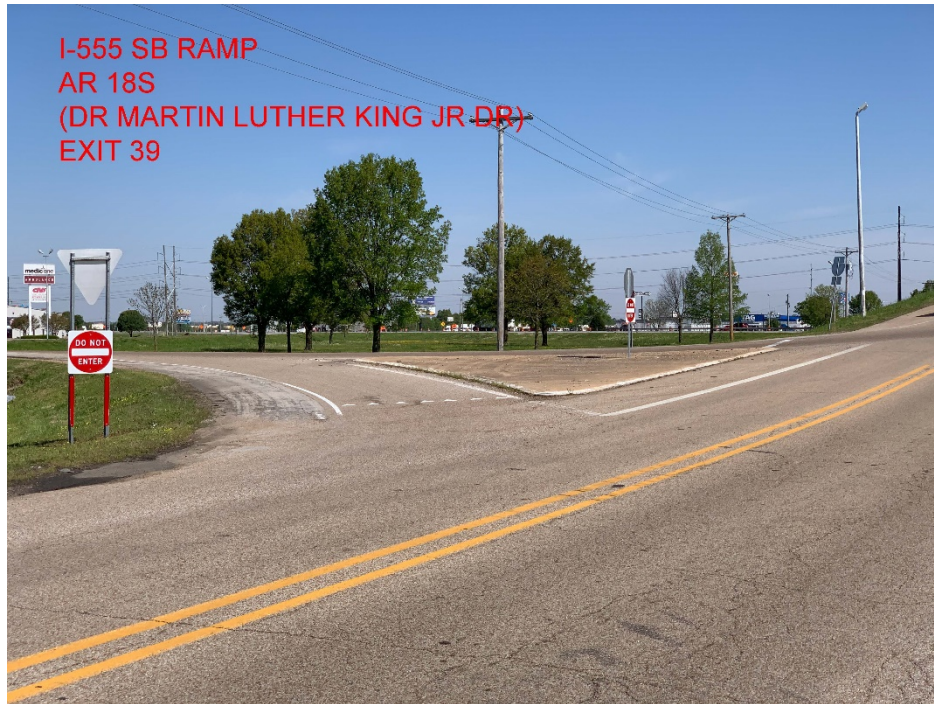
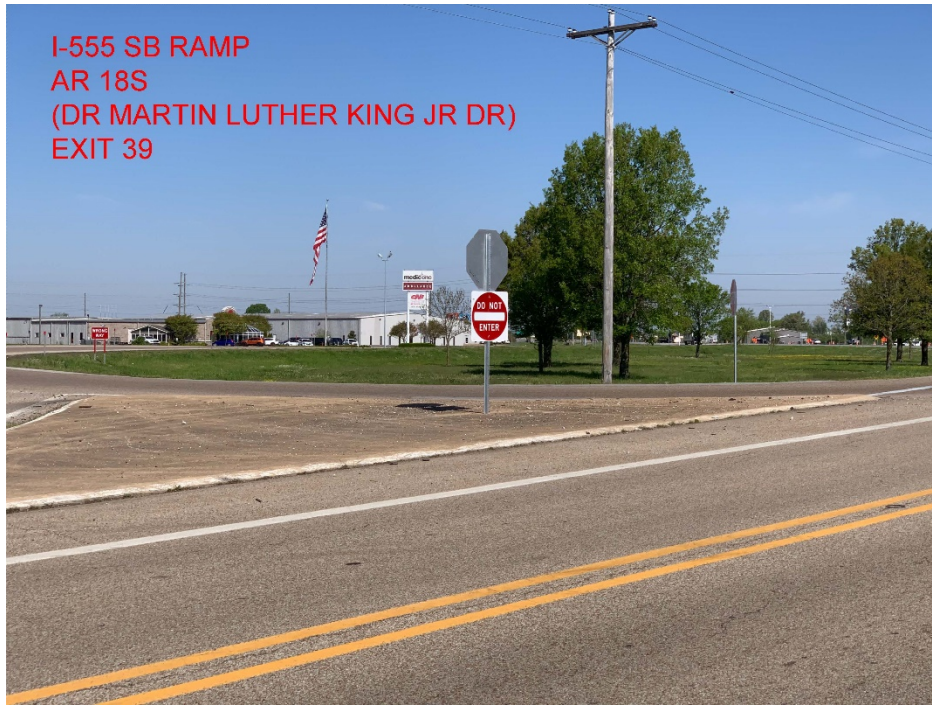
The southbound entrance ramp for the interchange at Exit 39 was reviewed. Signs were in place and in conformance with MUTCD requirements. However, the 30"x30" Do Not Enter and 36"x12" One Way signs were missing and installed to be consistent with current ARDOT requirements on May 10, 2021.

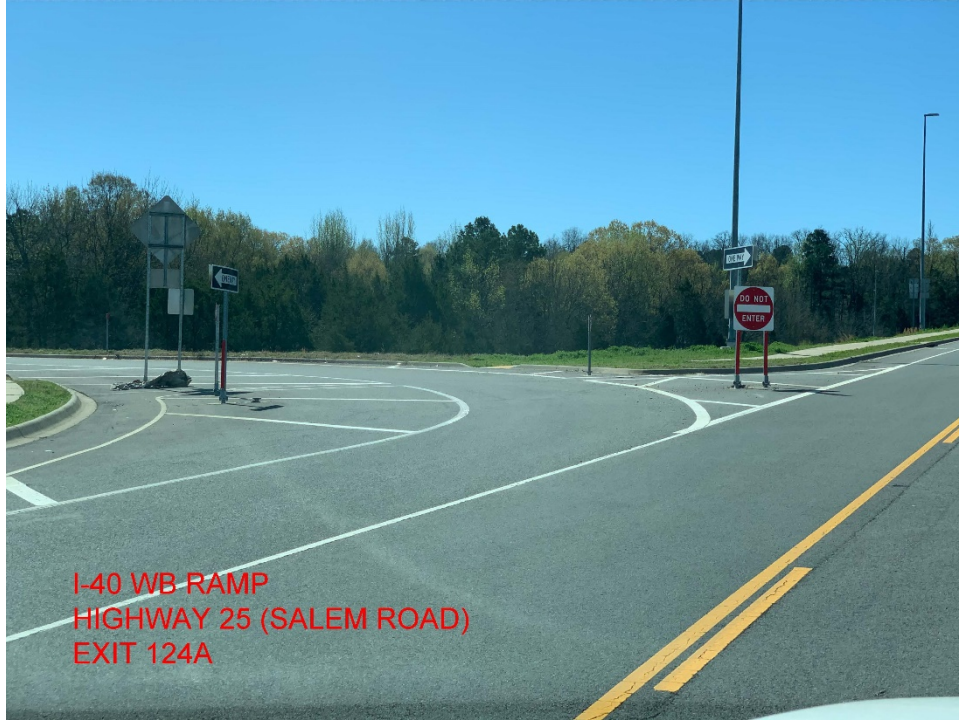
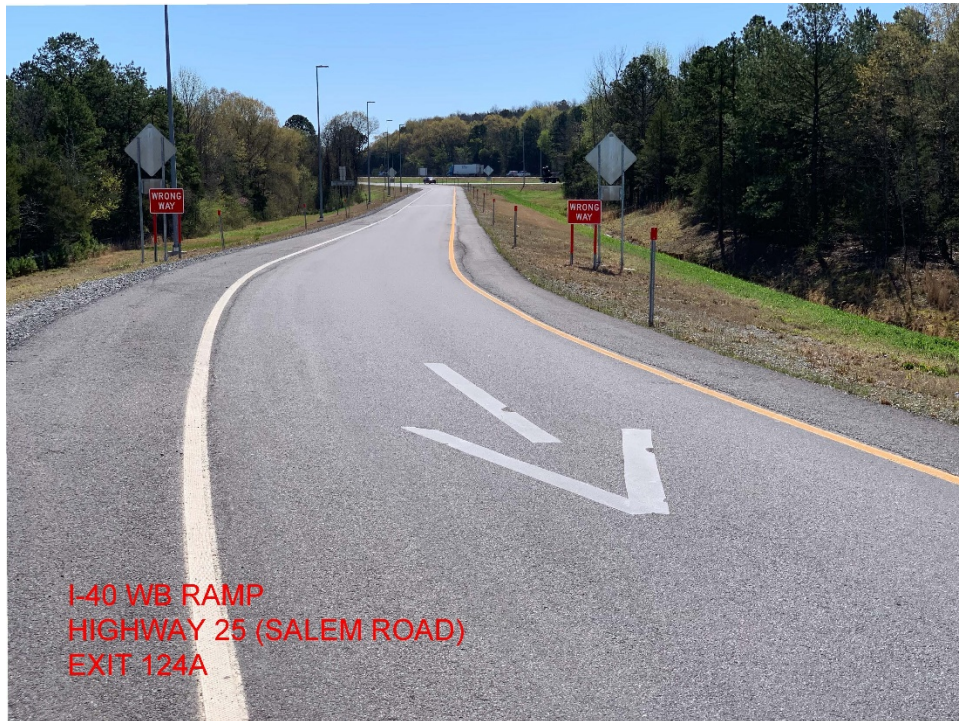
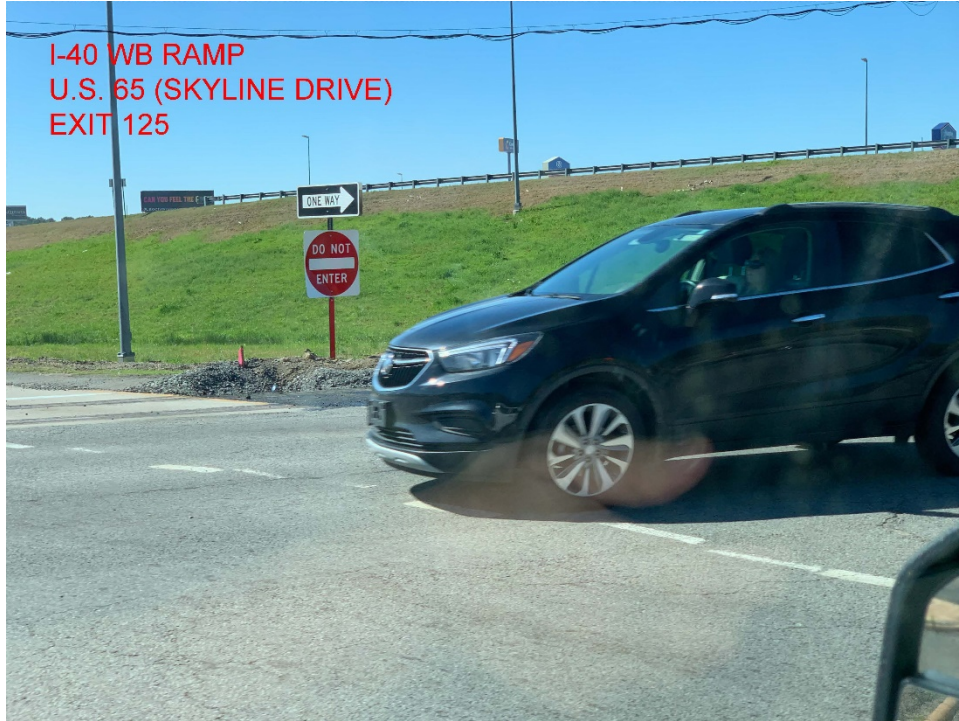
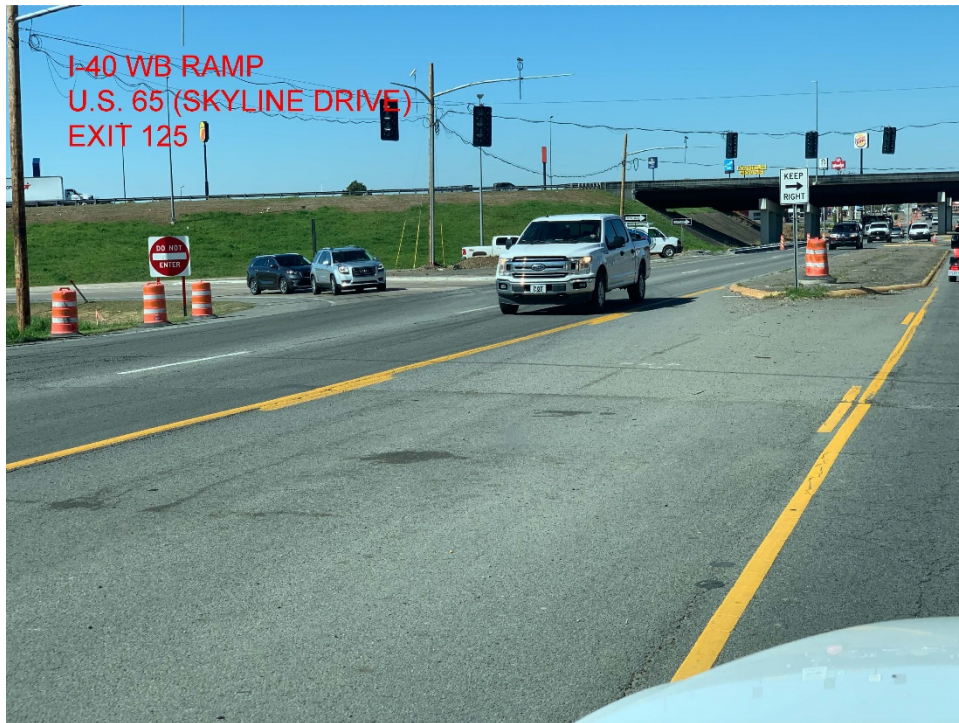
The interchange at Exit 124A was reviewed. Signs were in place and in conformance with MUTCD requirements. However, the 36"x36" Do Not Enter sign was missing and will be installed to be consistent with current ARDOT requirements. These modifications will be implemented by statewide forces as soon as their schedule permits. Pavement markings should be moved up to be consistent with ARDOT requirements. This modification will be implemented by district forces as soon as their schedule permits.

The interchange at Exit 125 was reviewed. Pavement markings and signs were in place and in conformance with MUTCD and ARDOT requirements.

The interchange at Exit 127 was reviewed. Signs were in place and in conformance with MUTCD requirements. However, the 36"x36" Do Not Enter and 54"x18" One Way signs were missing and installed to be consistent with current ARDOT requirements on May 11, 2021.

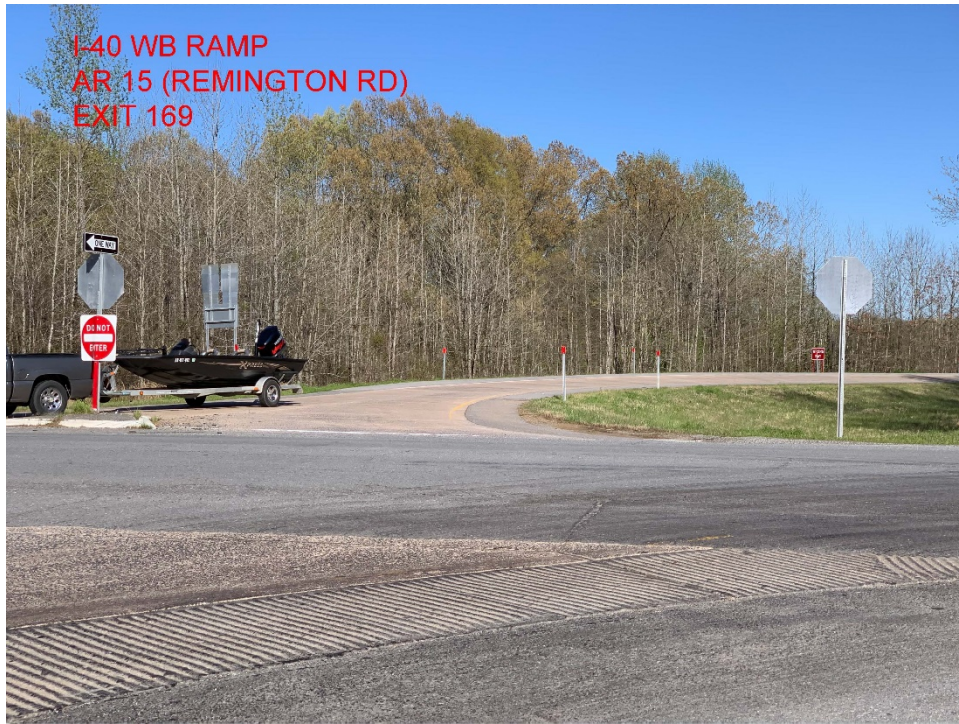
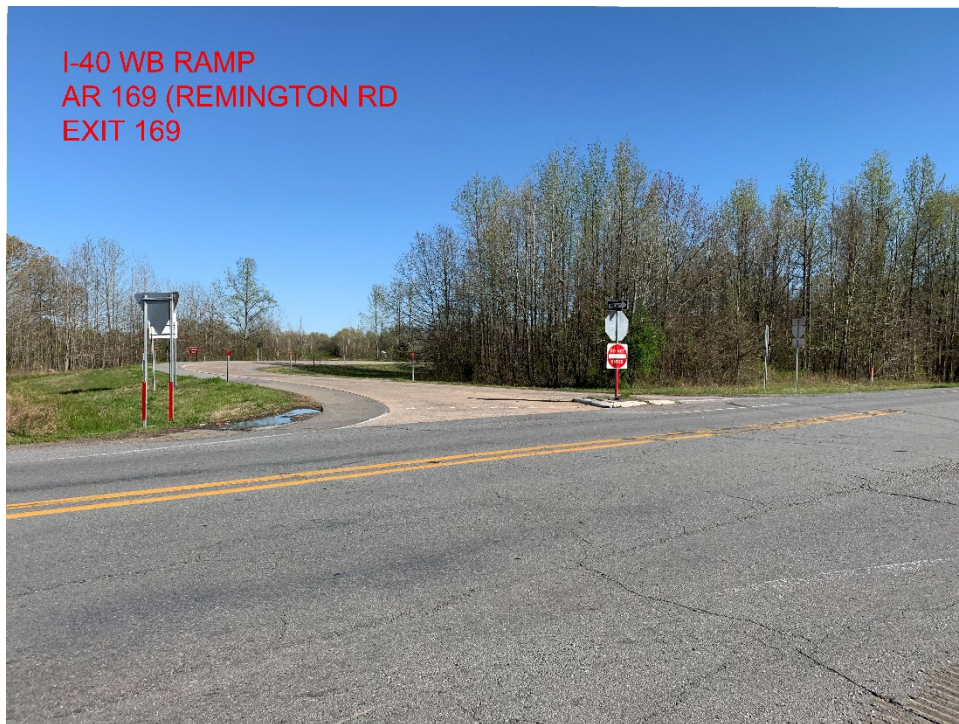
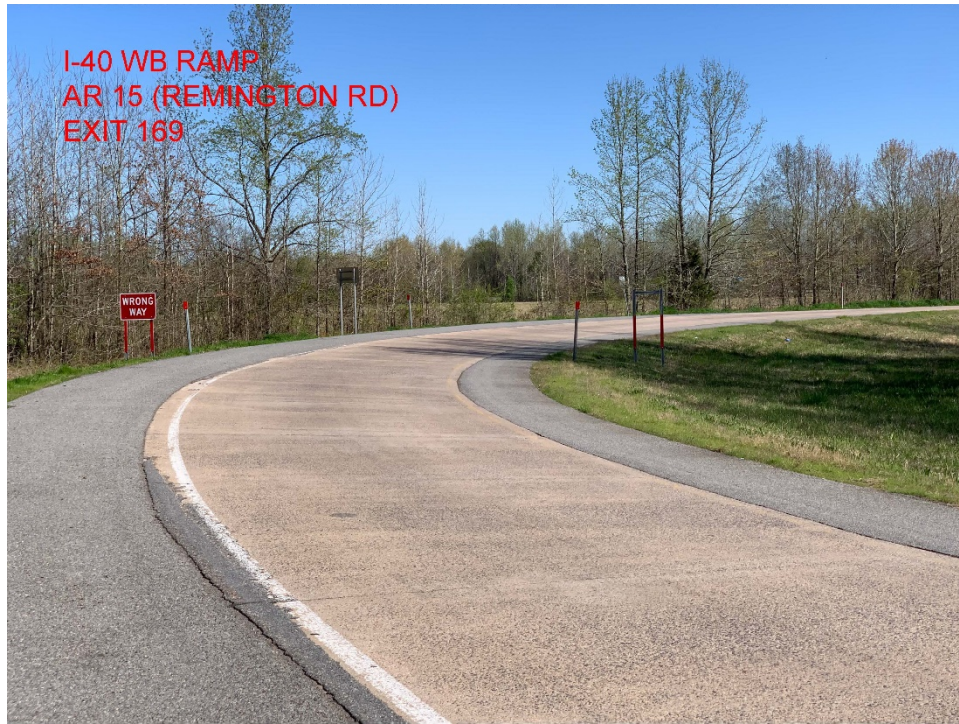
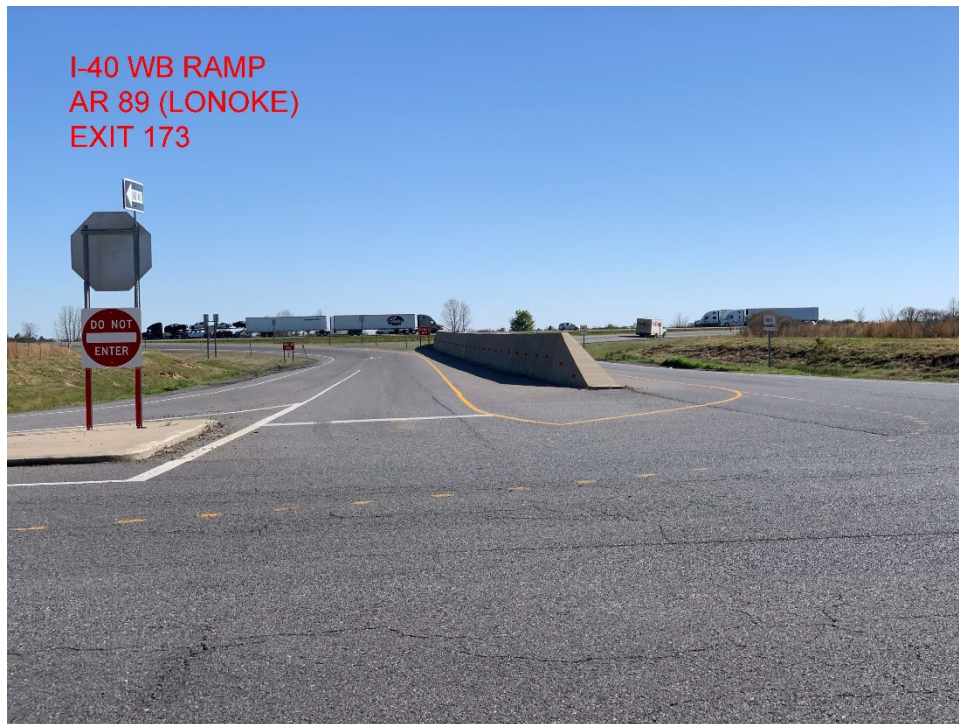
The interchange at Exit 169 was reviewed. Pavement markings and signs were in place and in conformance with MUTCD requirements. However, the 42"x 30" Wrong Way, 30"x30" Do Not Enter and 36"x12" One Way signs were missing and installed to be consistent with current ARDOT requirements on May 10, 2021.

The interchange at Exit 173 was reviewed. Pavement markings and signs were in place and in conformance with MUTCD requirements. However, the 24"x 30" Keep Right sign was missing and will be installed to be consistent with current ARDOT requirements. These modifications will be implemented by statewide forces as soon as their schedule permits.

The interchange at Exit 175 was reviewed. Pavement markings and signs were in place and in conformance with MUTCD and ARDOT requirements.

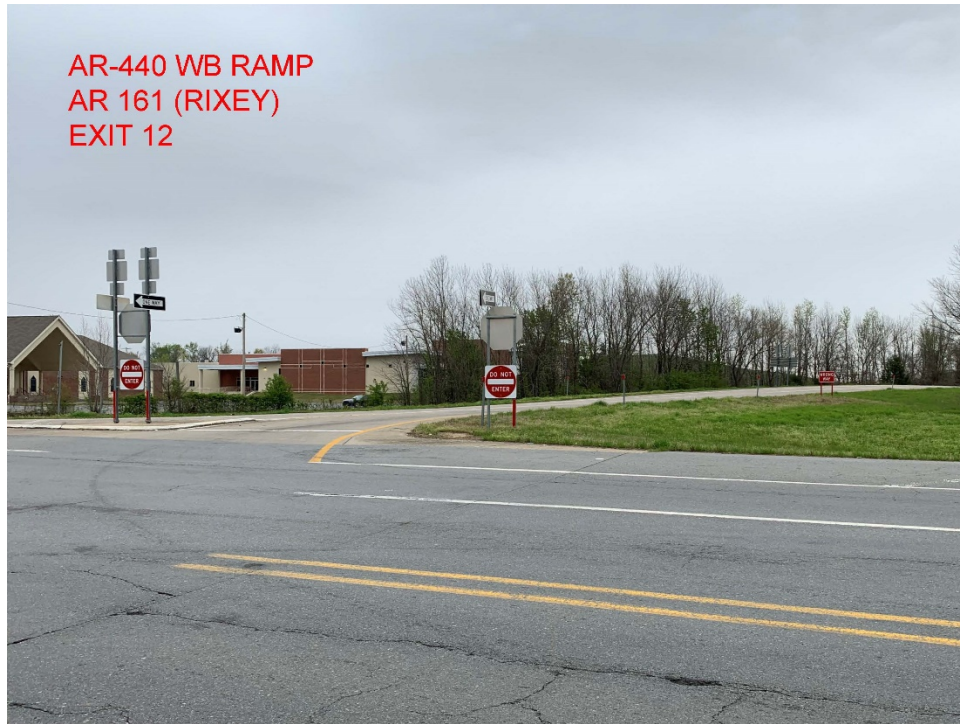
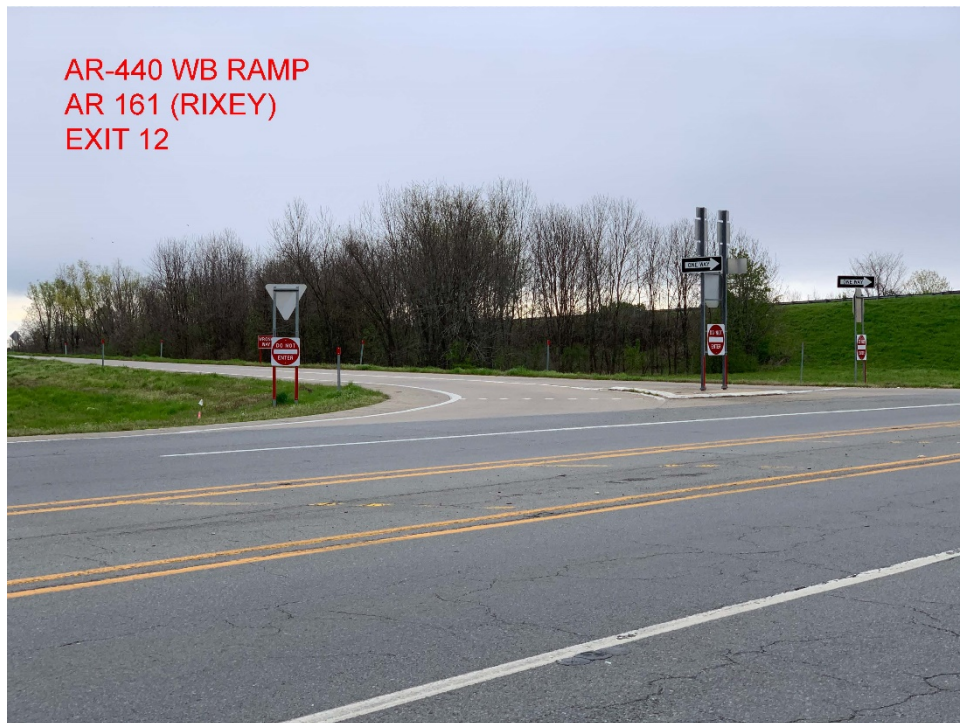
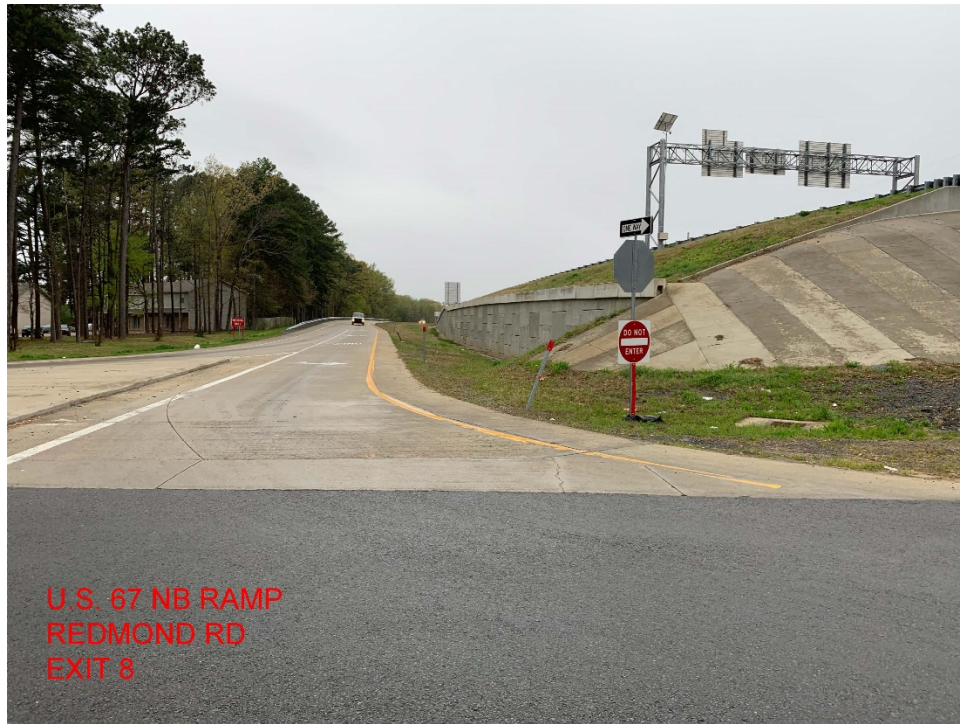
The interchange at Exit 12 was reviewed. Signs were in place and in conformance with MUTCD requirements. However, the 42"x30" Wrong Way sign was missing and installed to be consistent with current ARDOT requirements on May 17, 2021.

The interchange at Exit 8 was reviewed. Signs were in place and in conformance with MUTCD requirements. However, the 42"x 30" Wrong Way sign was missing and installed to be consistent with current ARDOT requirements on May 17, 2021. Pavement markings should be installed to meet current ARDOT requirements. These modifications will be implemented by district and statewide forces as soon as their schedule permits.

The interchange at Exit 9 was reviewed. All signs required to bring this ramp in conformance with MUTCD and ARDOT requirements were completed on May 18, 2021.
