WRONG-WAY CRASH STUDY

INTERSTATES AND FREEWAYS | CALENDAR YEAR 2018

June 2020

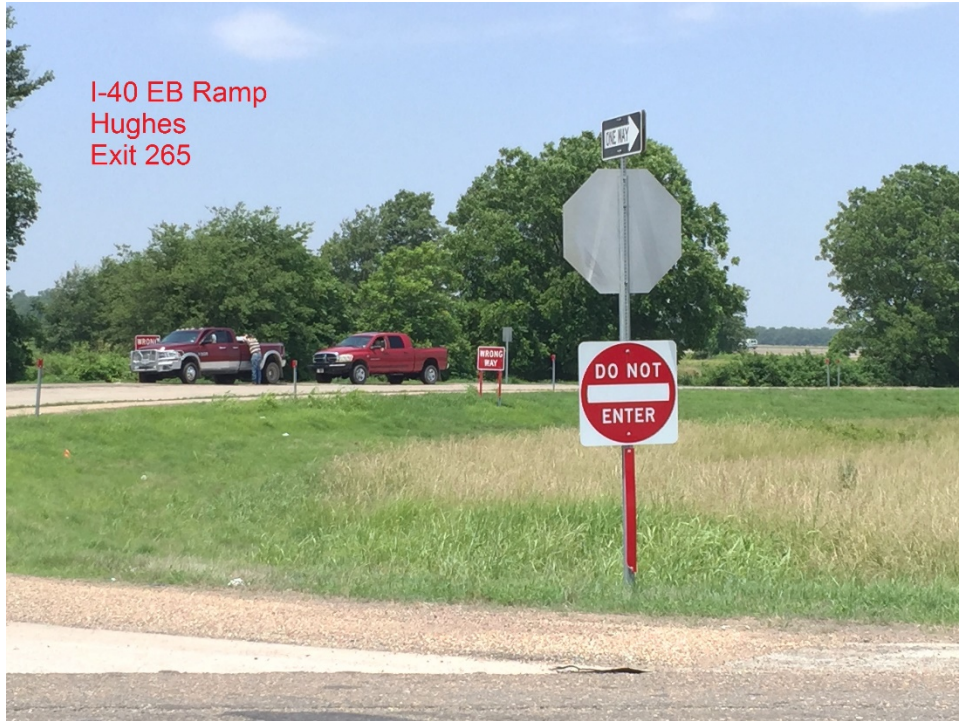
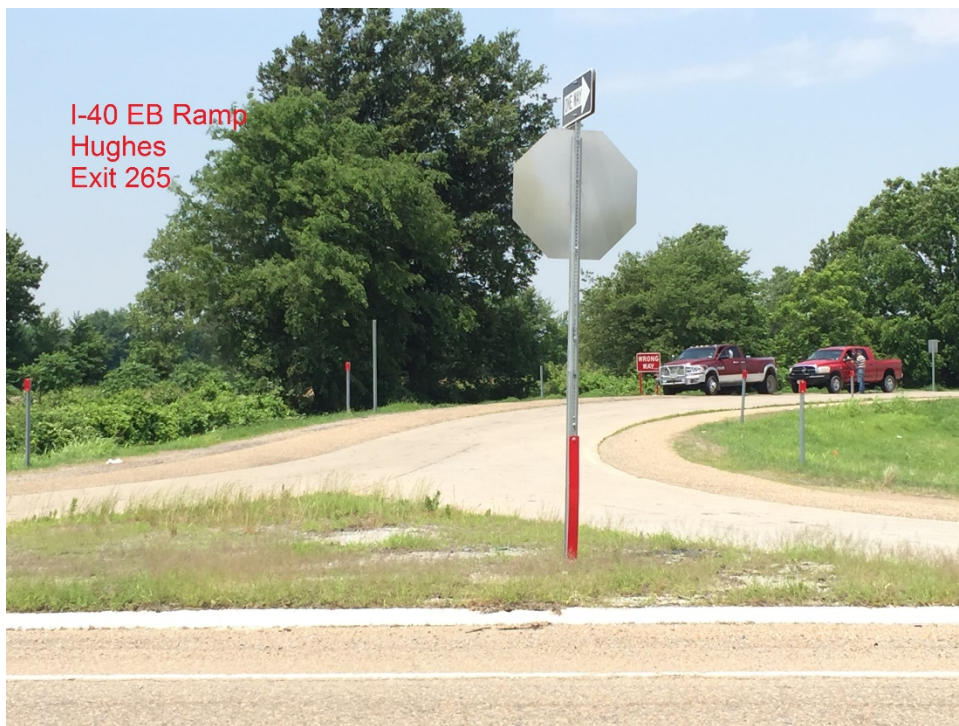
The interchange at Exit 265 was reviewed. Pavement markings and signs were in place and in conformance with MUTCD standards. However, two 30"x30 "DO NOT ENTER" signs are missing and will be installed to be consistent with current ARDOT standards. These modifications will be implemented by statewide forces as soon as their schedule permits.

The interchange at Exit 271 was reviewed. Pavement markings and signs were in place and in conformance with MUTCD and ARDOT standards.

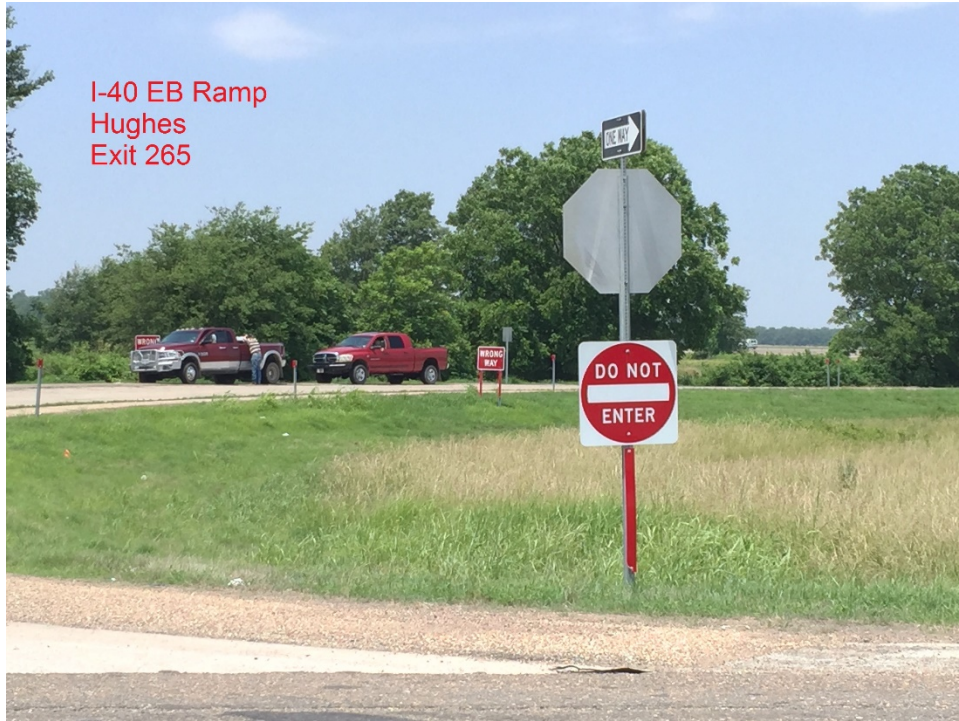
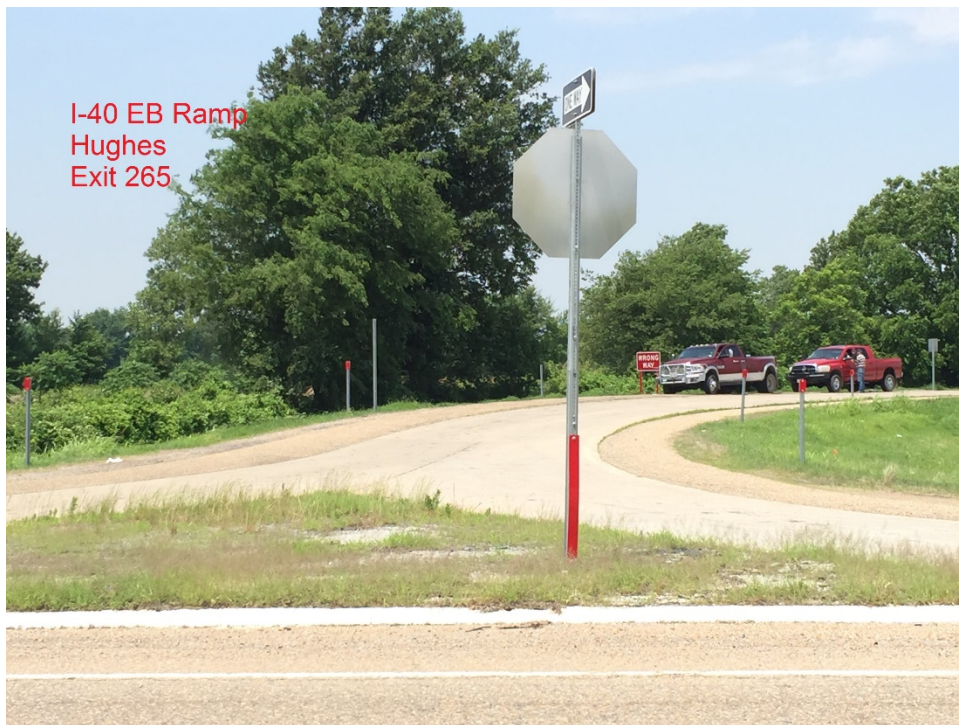
The interchange at Exit 265 was reviewed. Pavement markings and signs were in place and in conformance with MUTCD. However, two 30"x30 "DO NOT ENTER" signs are missing and will be installed to be consistent with current ARDOT standards. These modifications will be implemented by statewide forces as soon as their schedule permits.

The interchange at Exit 271 was reviewed. Pavement markings and signs were in place and in conformance with MUTCD and ARDOT standards.

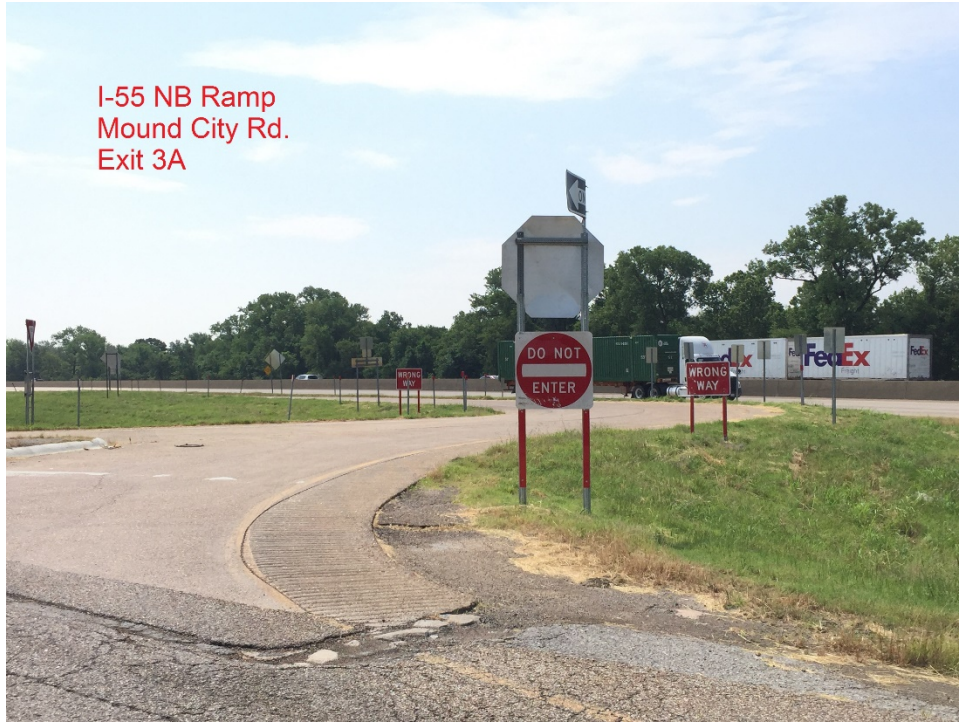
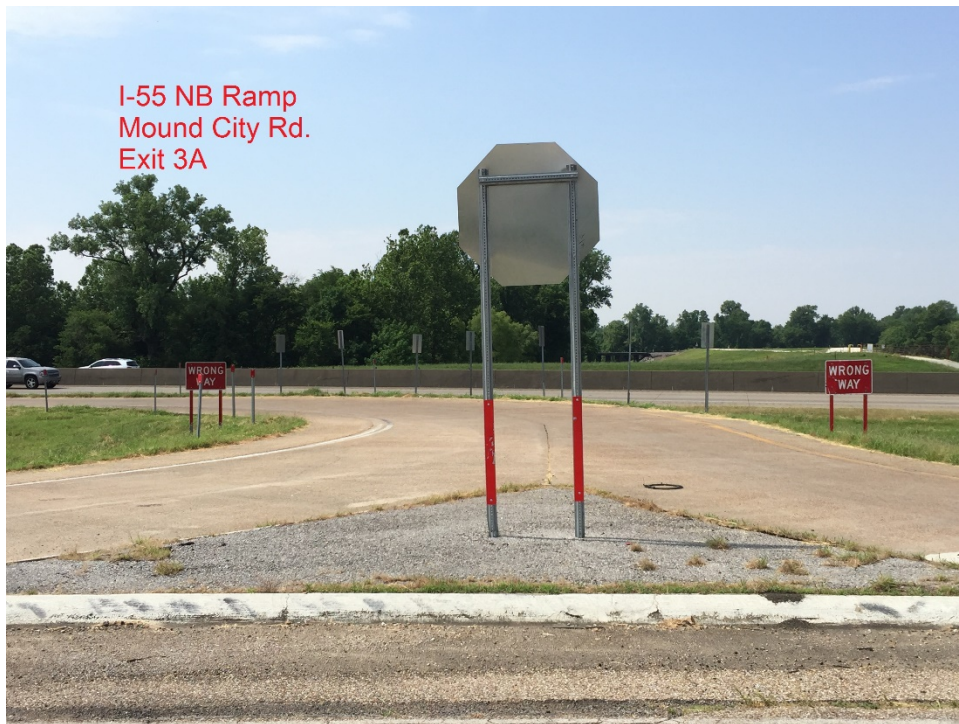
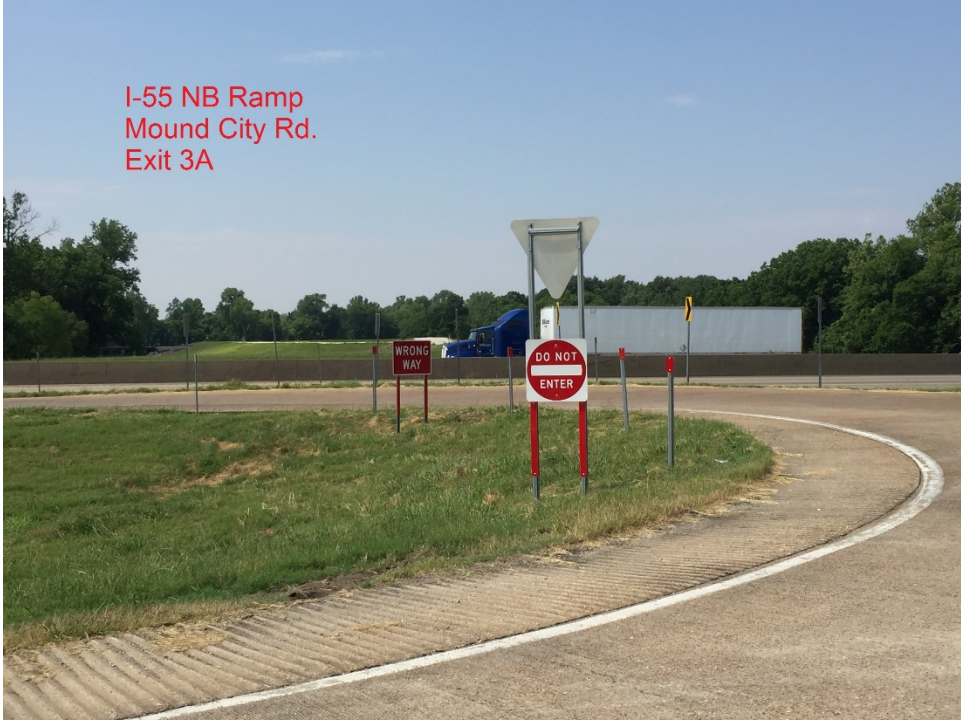
The interchange at Exit 3A was reviewed. Pavement markings and signs were in place and in conformance with MUTCD standards. However, the 36"x36" "DO NOT ENTER" sign along with two 18"x54" "ONE WAY" signs were missing and will be installed to be consistent with current ARDOT standards. These modifications will be implemented by statewide forces as soon as their schedule permits.

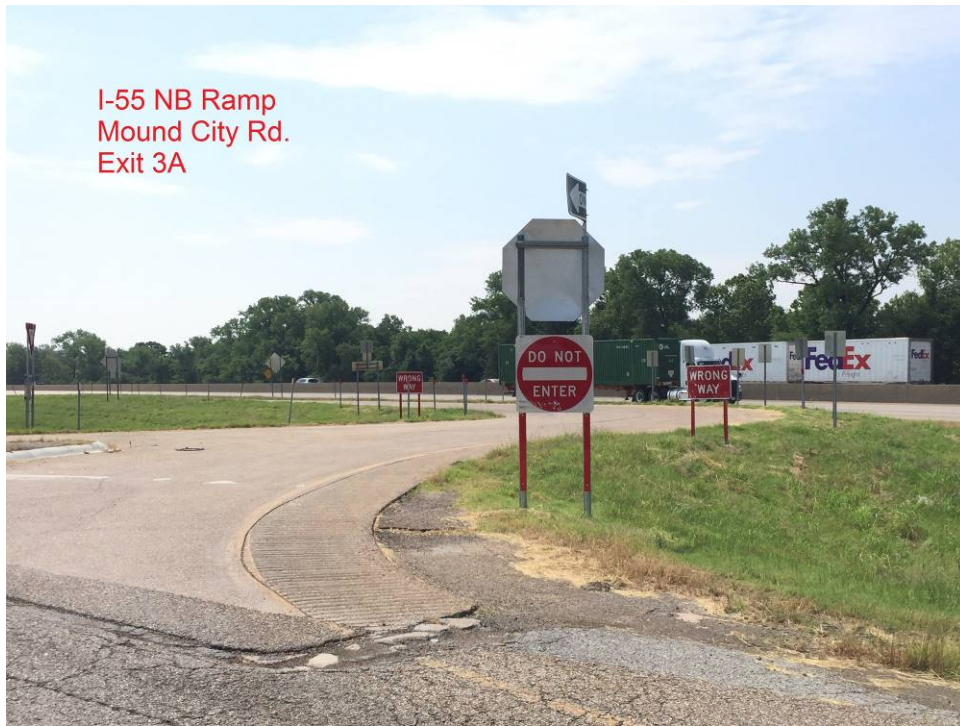
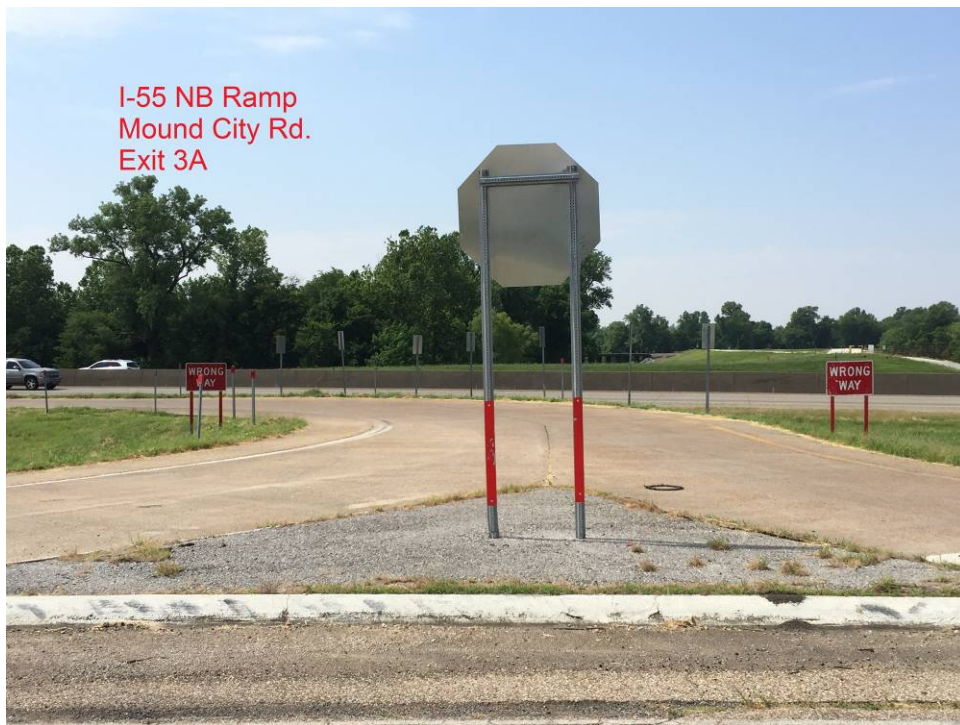
The interchange at Exit 3A was reviewed. Pavement markings and signs were in place and in conformance with MUTCD standards. However, the 36"x36" "DO NOT ENTER" sign along with two 18"x54" "ONE WAY" signs are missing and will be installed to be consistent with current ARDOT standards. These modifications will be implemented by statewide forces as soon as their schedule permits.

The interchange at Exit 3B was reviewed. Pavement markings and signs were in place and in conformance with MUTCD standards. However, six 18"x54" "ONE WAY" signs are missing and will be installed to be consistent with current ARDOT standards. These modifications will be implemented by statewide forces as soon as their schedule permits.

The interchange at Exit 4 was reviewed. Pavement markings and signs were in place and in conformance with MUTCD and ARDOT standards.

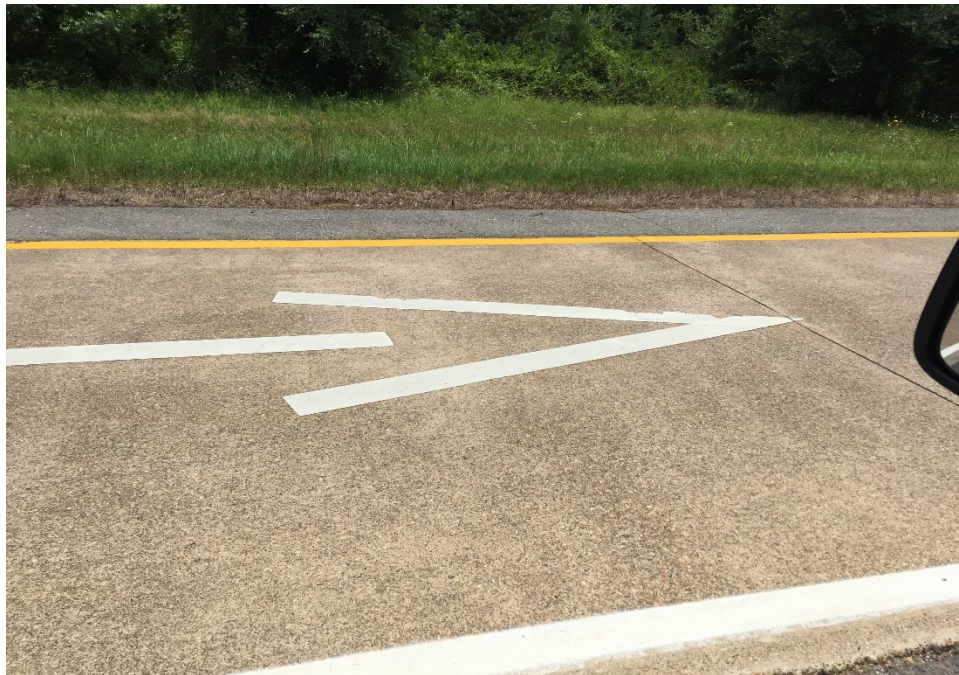
The interchange at Exit 98B was reviewed. Pavement markings and signs were in place and in conformance with MUTCD standards. However, the pavement marking arrow and 42"x30" "WRONG WAY" sign was missing and will be installed to be consistent with current ARDOT standards. These modifications will be implemented by statewide forces as soon as their schedule permits.

The interchange at Social Hill Rest Area was reviewed. Pavement markings and signs were in place and in

conformance with MUTCD and ARDOT standards.

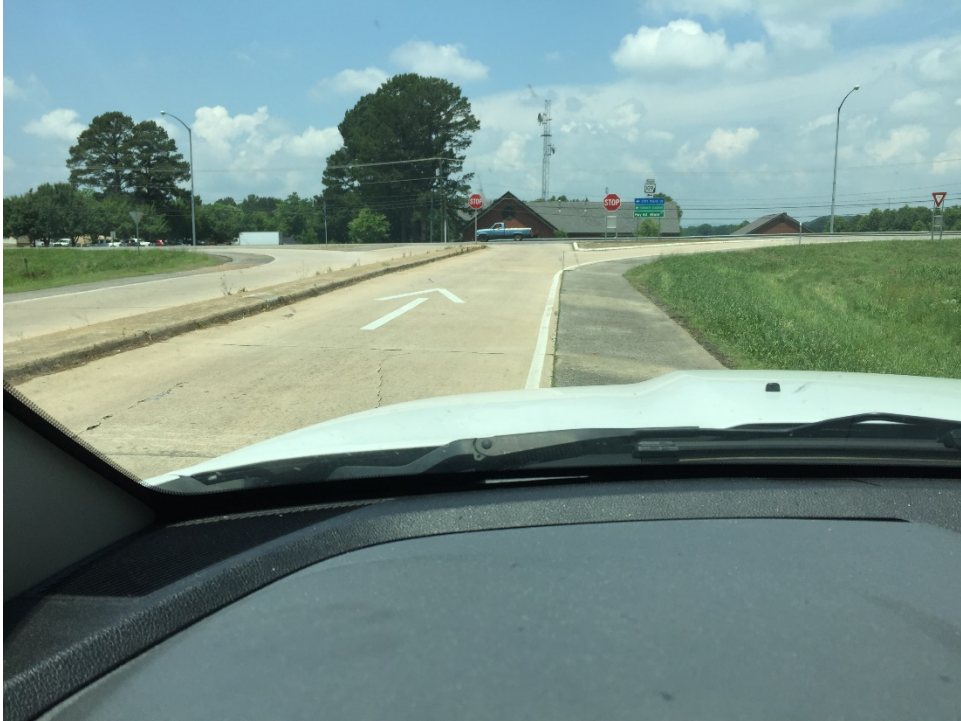
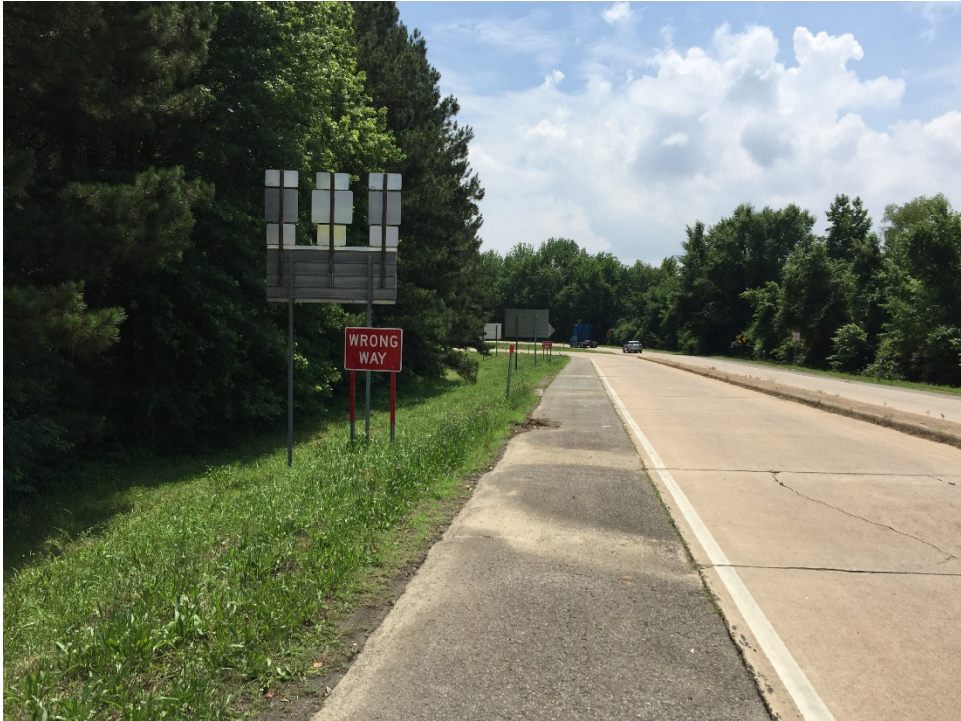
The interchange at Exit 57 was reviewed. Pavement markings and signs were in place and in conformance with MUTCD standards. However, the 36"x12" "ONE WAY" signs and 30"x30" "DO NOT ENTER" sign are missing and will be installed to be consistent with current ARDOT standards. These modifications will be implemented by statewide forces as soon as their schedule permits.

The interchange at Exit 58 was reviewed. Pavement markings and signs were in place and in conformance with MUTCD and ARDOT standards.

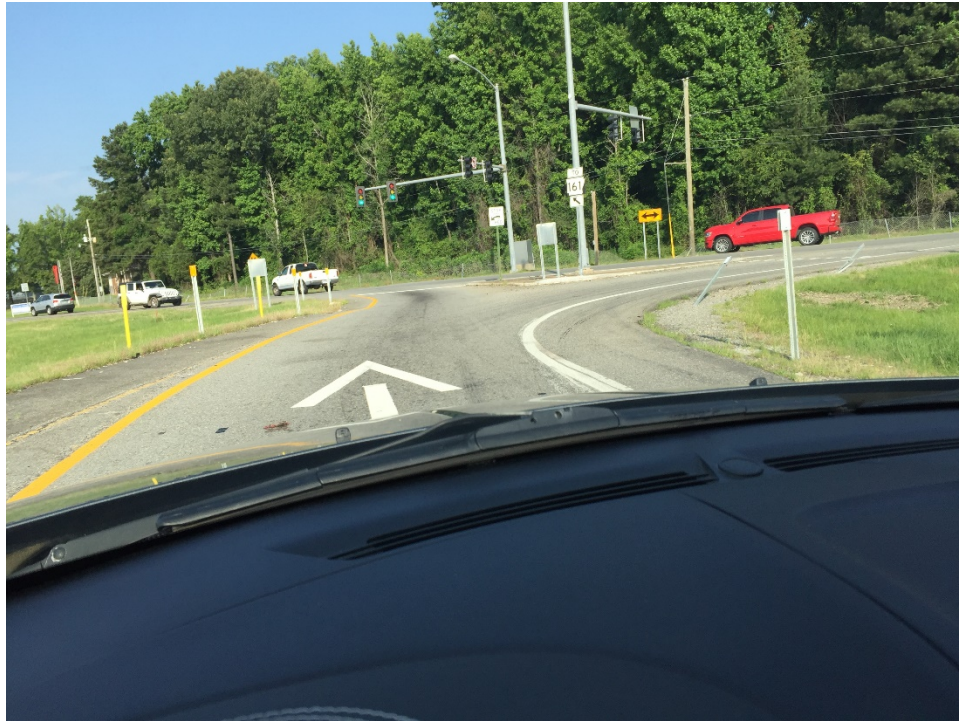
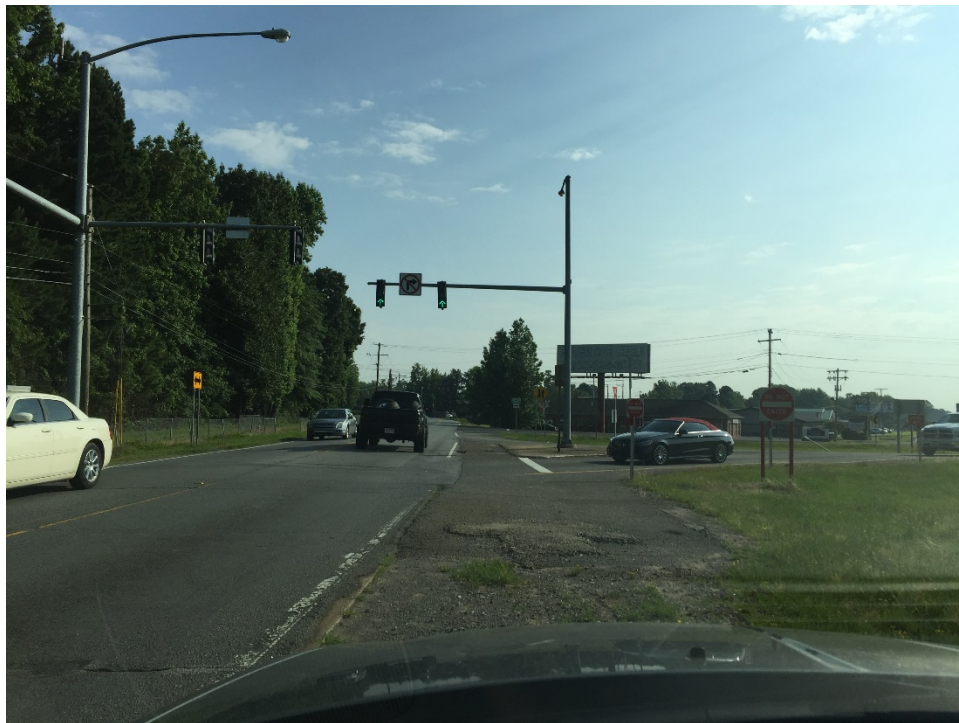
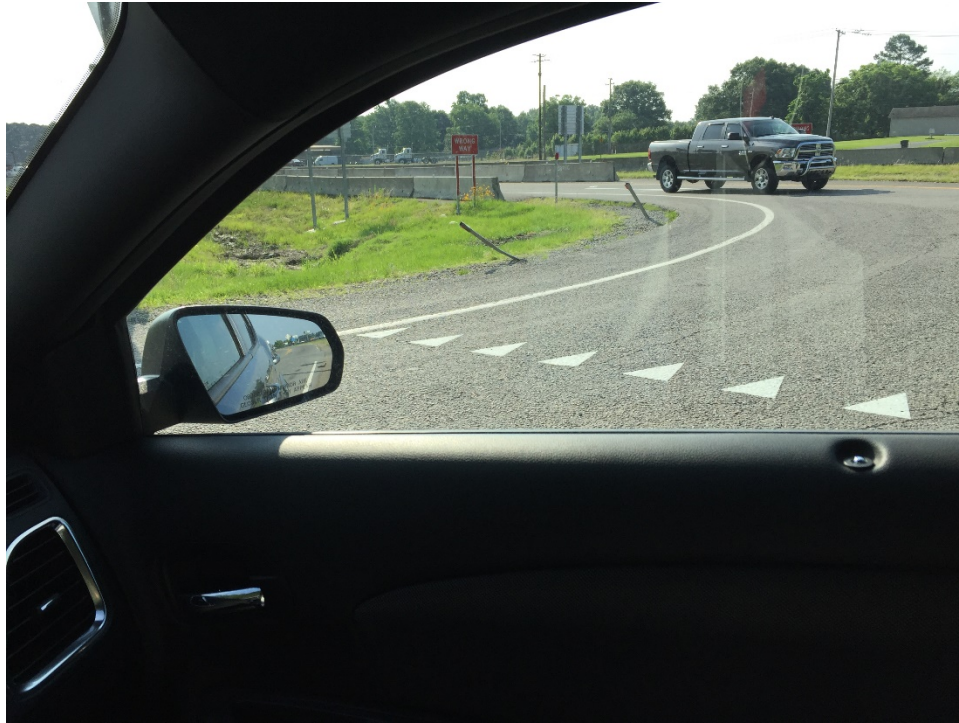
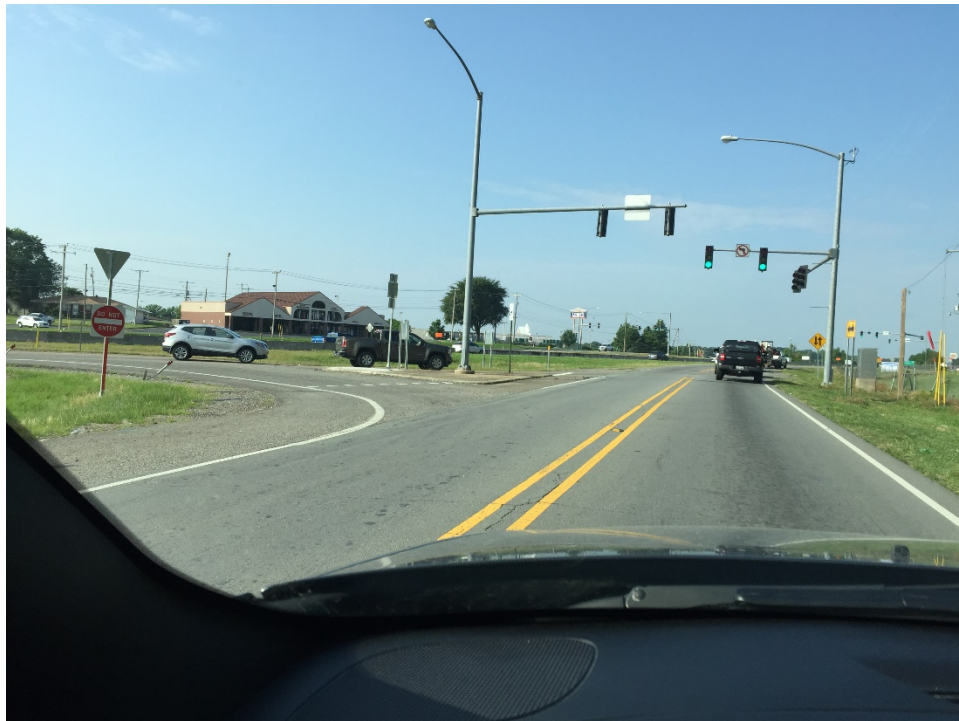
The interchange at Exit 11 was reviewed. Pavement markings and signs were in place and in conformance with MUTCD standards. However, the 36"x12" "ONE WAY" signs are missing and will be installed to be consistent with current ARDOT standards. These modifications will be implemented by statewide forces as soon as their schedule permits.

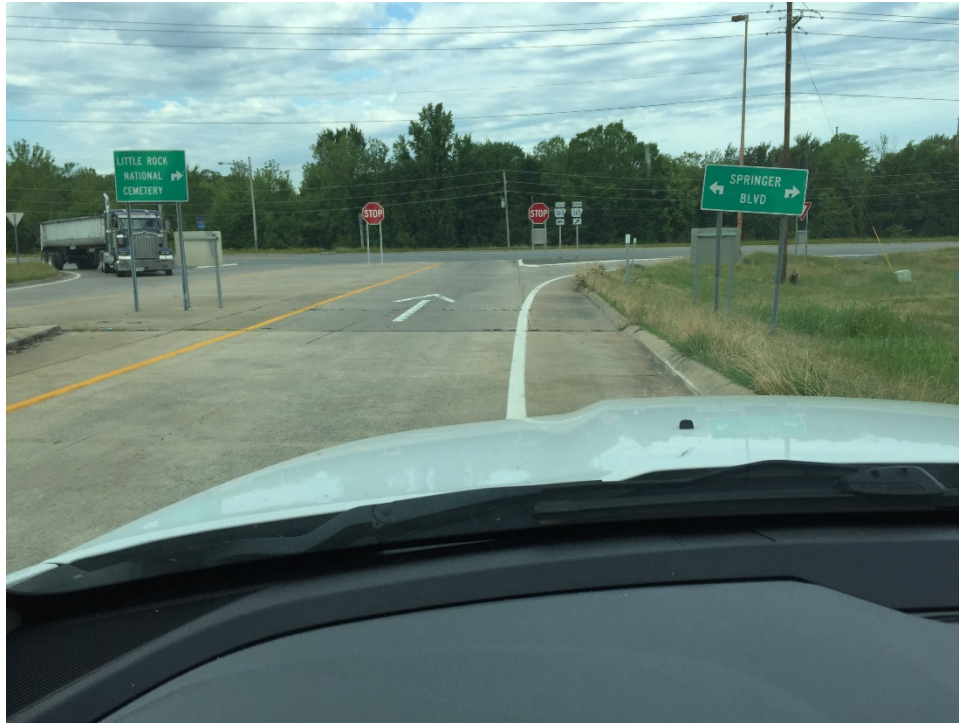
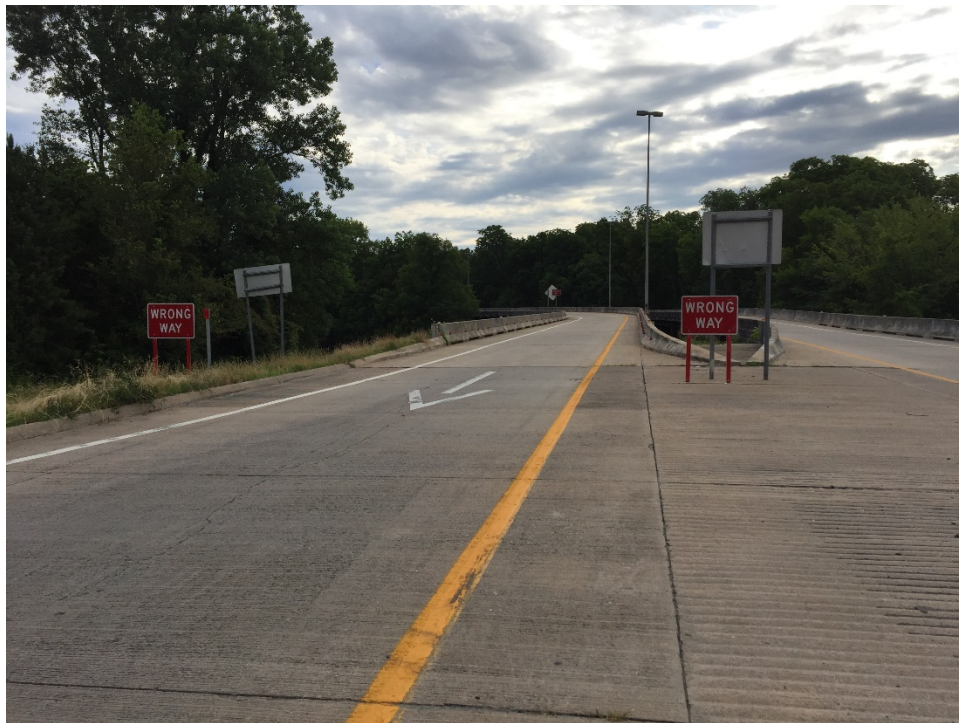
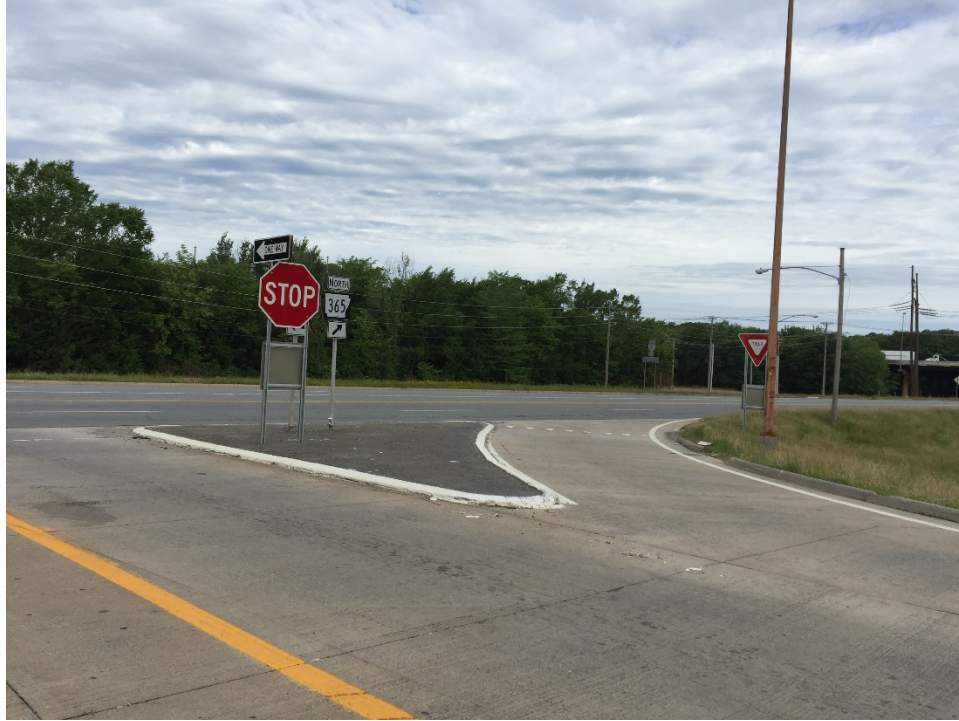
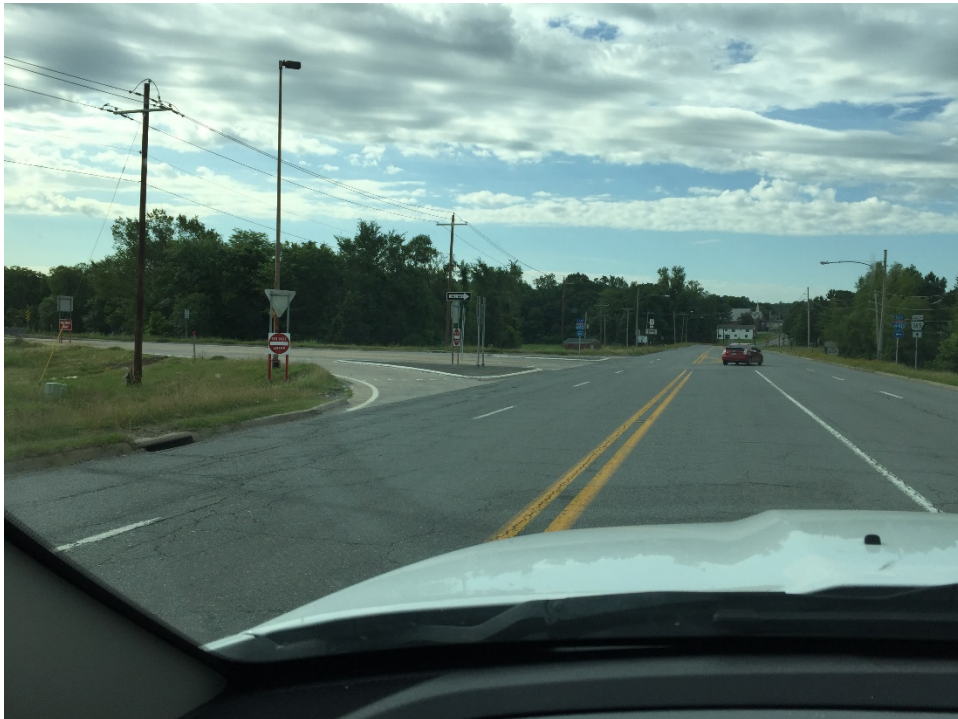
The interchange at Exit 139A was reviewed. Pavement markings and signs were in place and in conformance with MUTCD standards. However, to be consistent with current ARDOT standards and sizes, the 36"x12" "ONE WAY" signs at the ramp will be replaced with 54"x18" signs. The 30"x30" "DO NOT ENTER" signs will be replaced with 36"x36" signs and the 36"x24" "WRONG WAY" sign will be replaced with a 42"x30" sign. These modifications will be implemented by statewide forces as soon as their schedule permits.

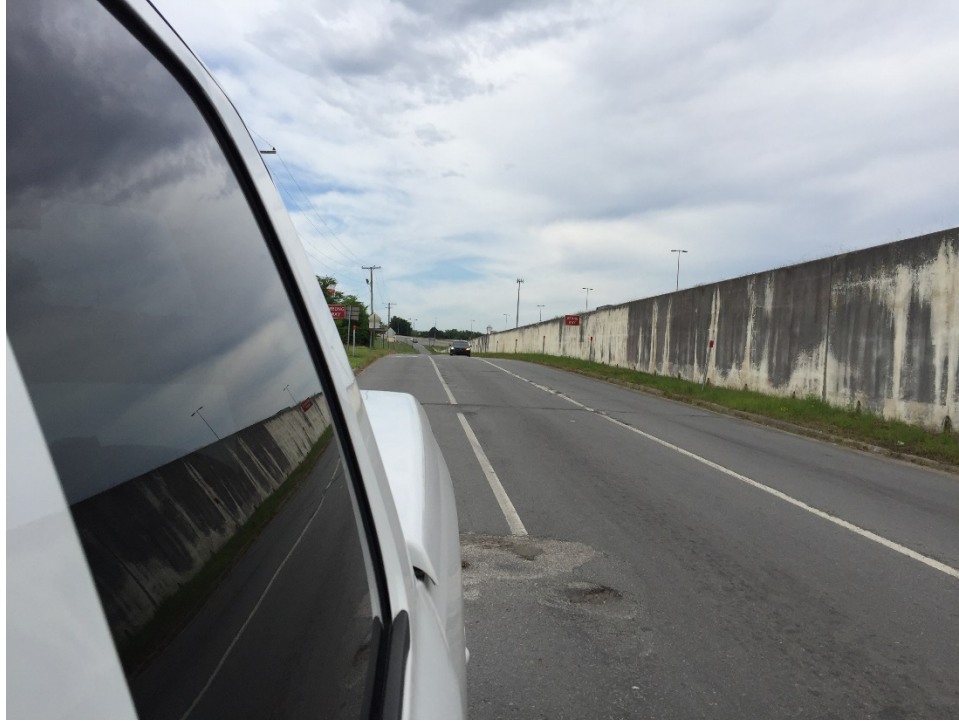
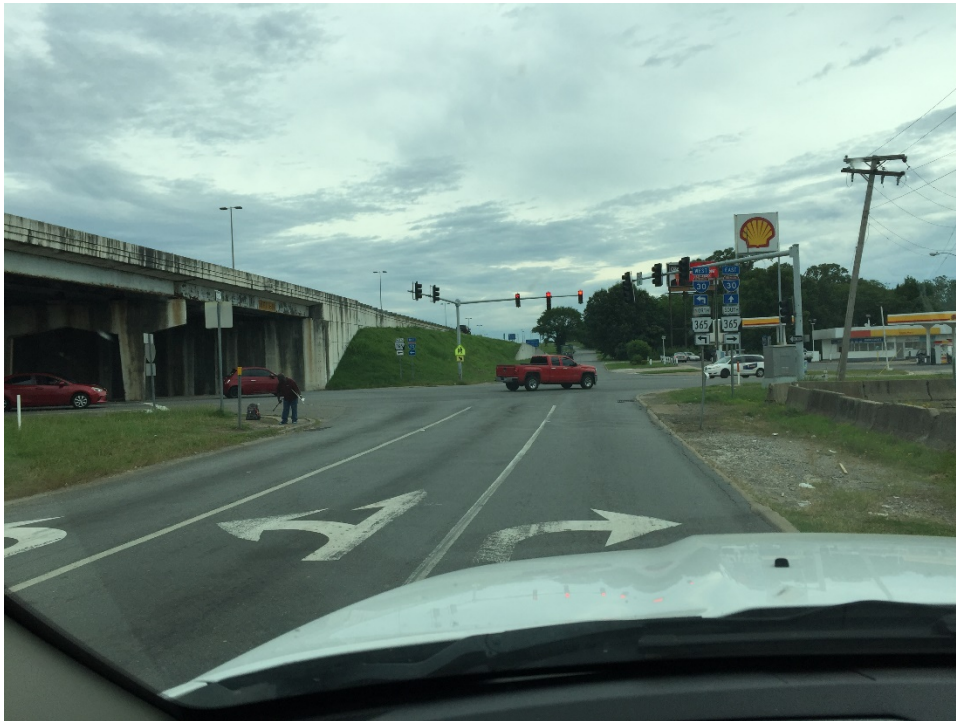
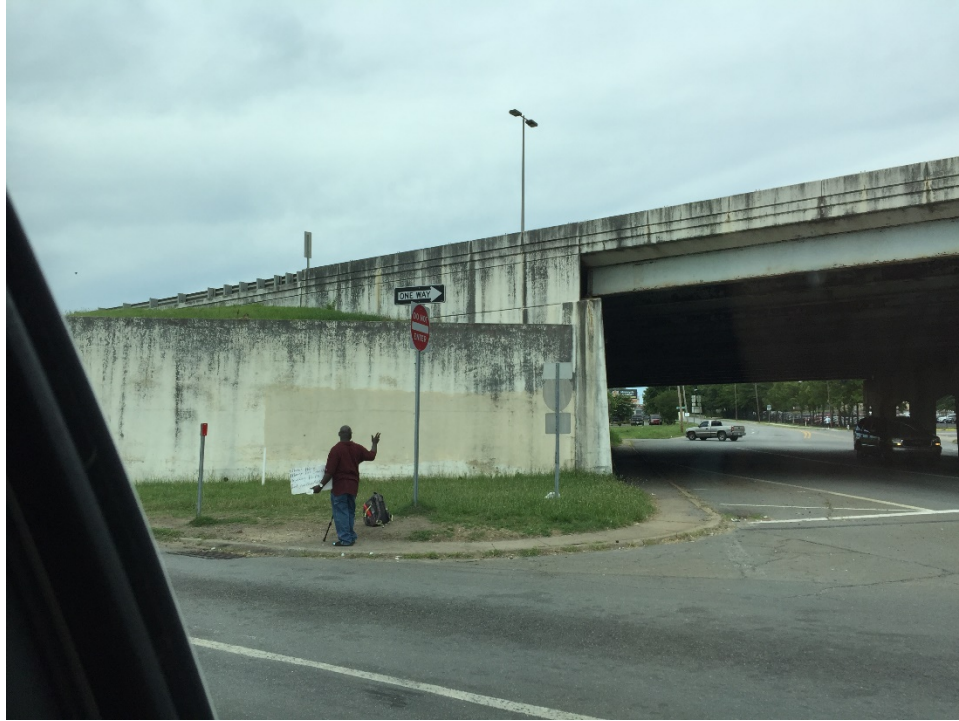
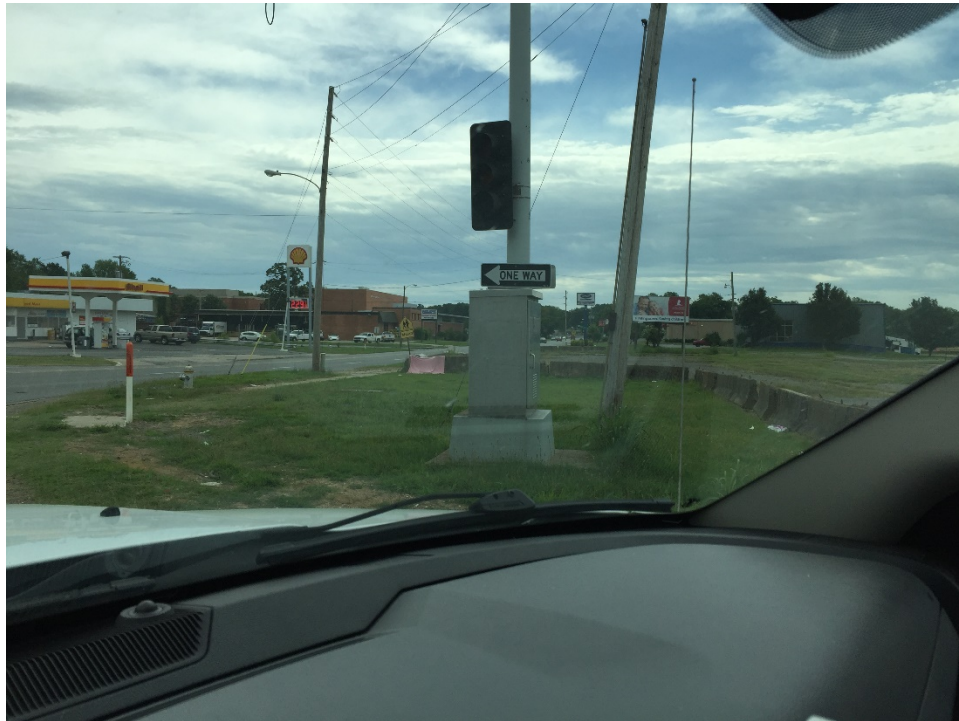
The interchange at Exit 139A was reviewed. Pavement markings and signs were in place and in conformance with MUTCD standards. However, to be consistent with current ARDOT standards and sizes, the 36"x12" "ONE WAY" signs at the ramp will be replaced with 54"x18" signs. The 30"x30" "DO NOT ENTER" signs will be replaced with 36"x36" signs and the 36"x24" "WRONG WAY" sign will be replaced with a 42"x30" sign. These modifications will be implemented by statewide forces as soon as their schedule permits.

The interchange at Exit 140 was reviewed. Pavement markings and signs were in place and in conformance with MUTCD standards. However, the 54"x18" "ONE WAY" signs are missing and will be installed to be consistent with current ARDOT standards. These modifications will be implemented by statewide forces as soon as their schedule permits.

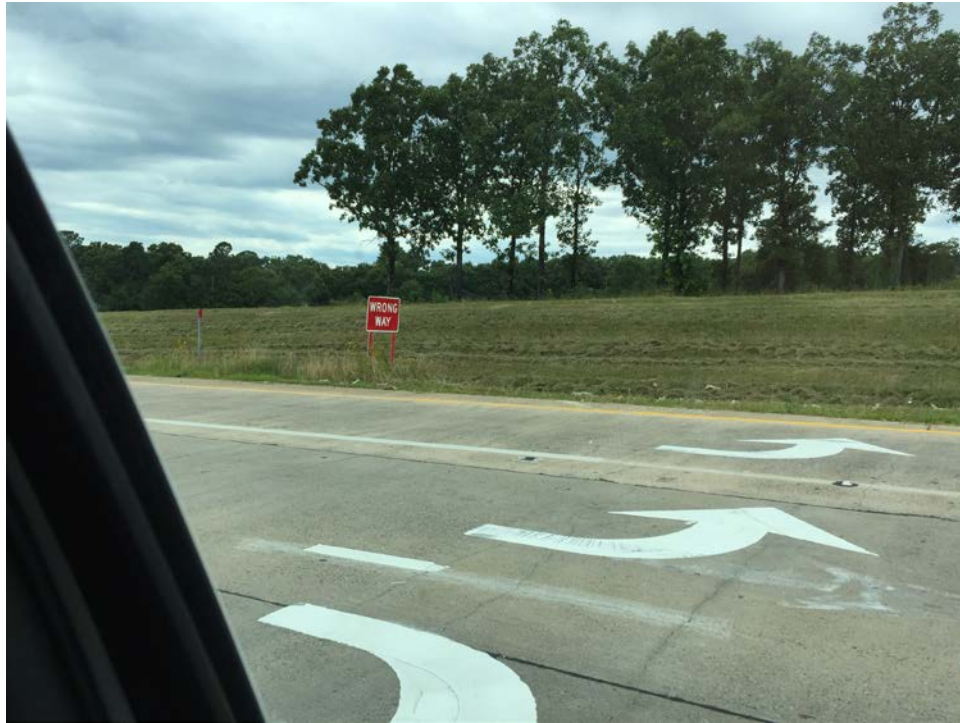
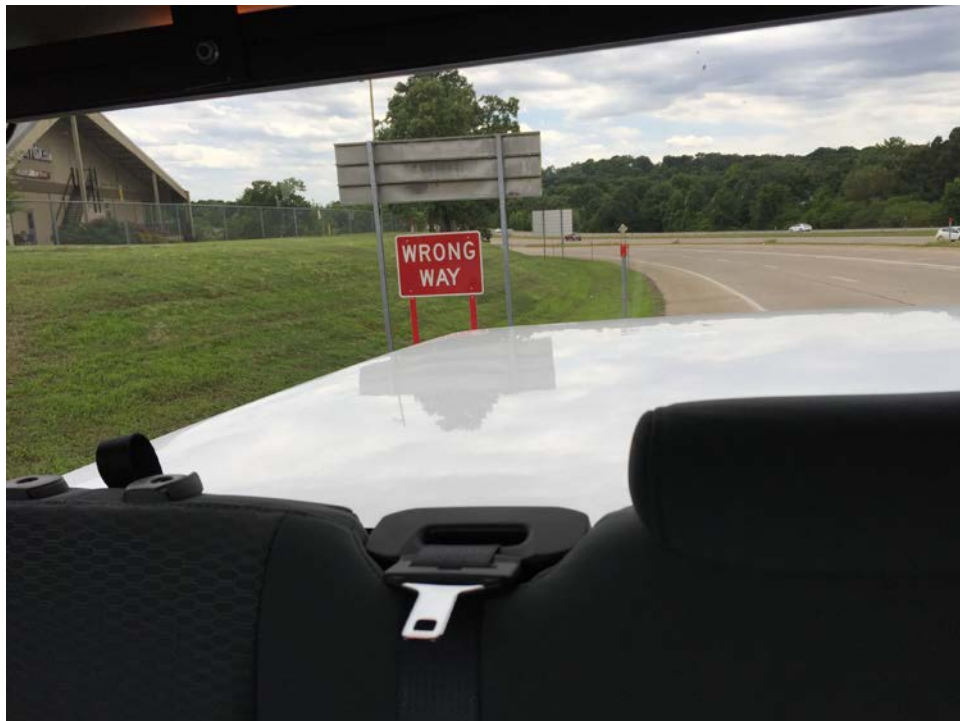
The interchange at Exit 8 was reviewed. Pavement markings and signs were in place and in conformance with MUTCD standards. However, the 48"x48" "DO NOT ENTER" and 54"x18" "ONE WAY" signs will need to be remounted at the exit ramp. The 36"x36" "DO NOT ENTER" signs are missing and will be installed to be consistent with current ARDOT standards. These modifications will be implemented by statewide forces as soon as their schedule permits.

The interchange at Exit 9 was reviewed. Pavement markings and signs were in place and in conformance with MUTCD standards. However, the 36"x12" "ONE WAY" signs at the ramp will be replaced with 54"x18" signs to be consistent with current ARDOT standards and sizes. These modifications will be implemented by statewide forces as soon as their schedule permits.

The interchange at Exit 12 was reviewed. Pavement markings and signs were in place and in conformance with MUTCD and ARDOT standards.
