Bridge Inspection Report

03729
CO RD 184
over
I 40-SEC 43

Structure Number: 03729

Facility Carried: CO RD 184

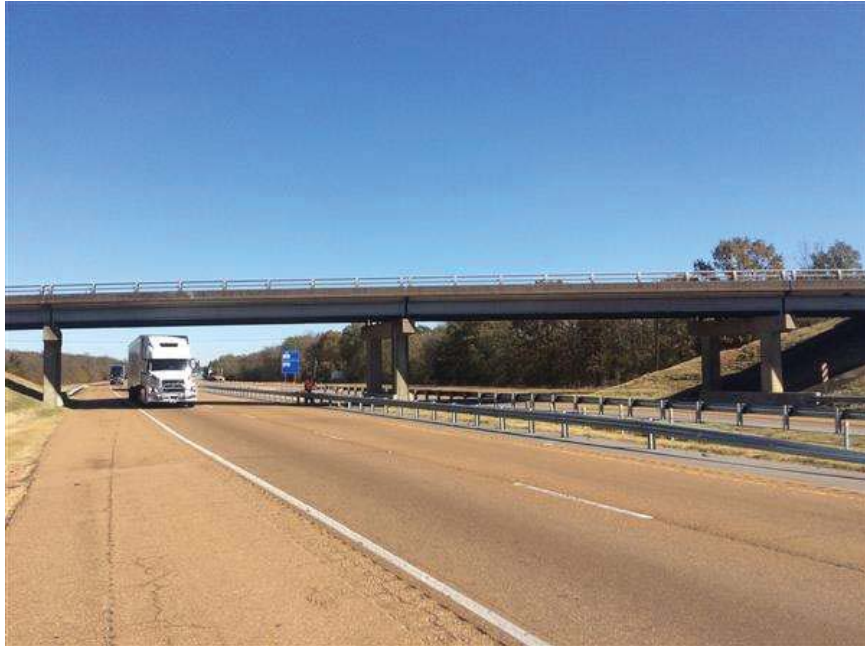
**No overlay on
bridge deck**

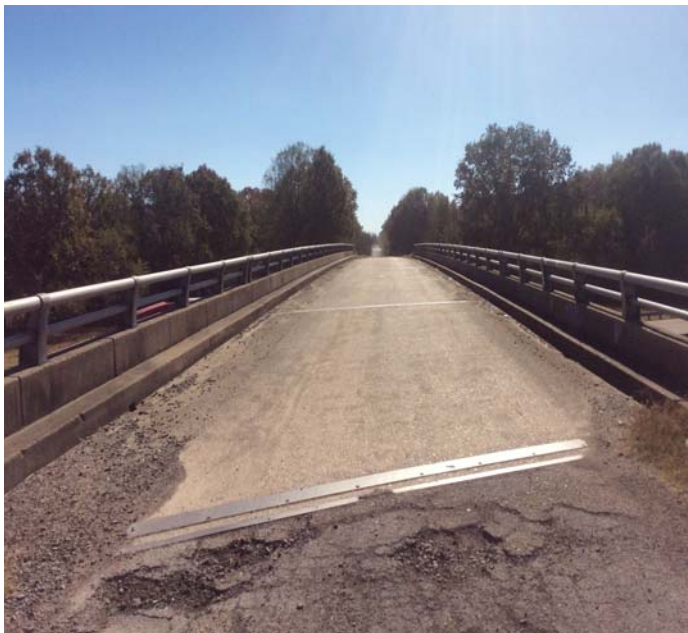
PHOTO 1 Description Top view

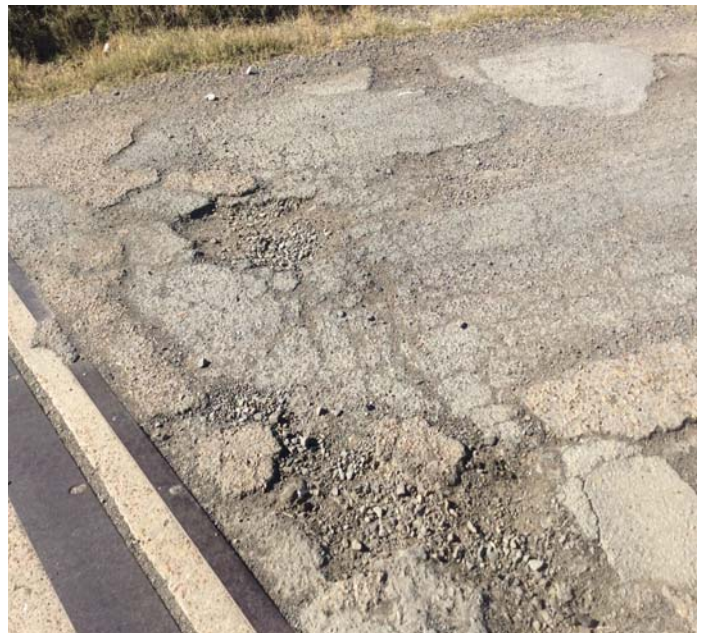
ABUTMENT #1 APPROACH ROADWAY HAS SEVERAL LARGE POTHoles AT BRIDGE END.

PHOTO 2 Description Holes in abutment #1 approach roadway

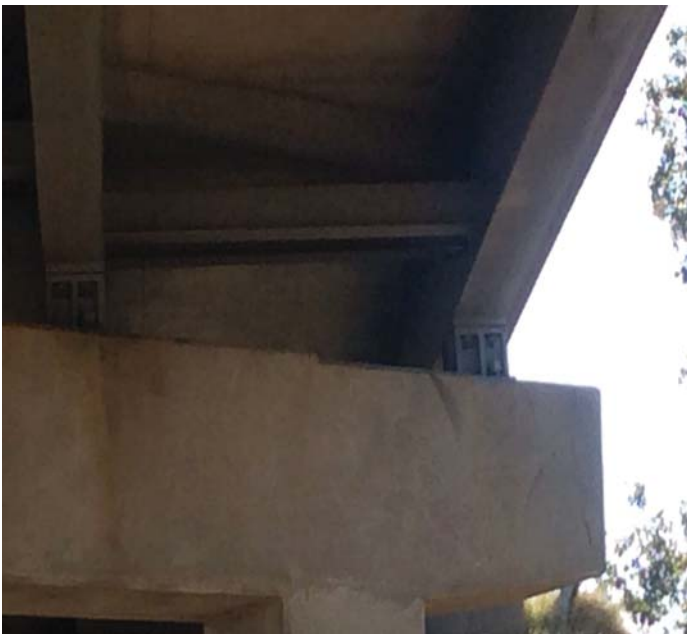
BENTS #2 AND #4
FIXED BEARING ANCHOR BOLTS

NUTS ARE LOOSE ON ALL FOUR BEARINGS, EACH BENT.

PHOTO 1 Description BENTS #2&4 FIXED BEARINGS
ANCHOR BOLT NUTS ARE LOOSE

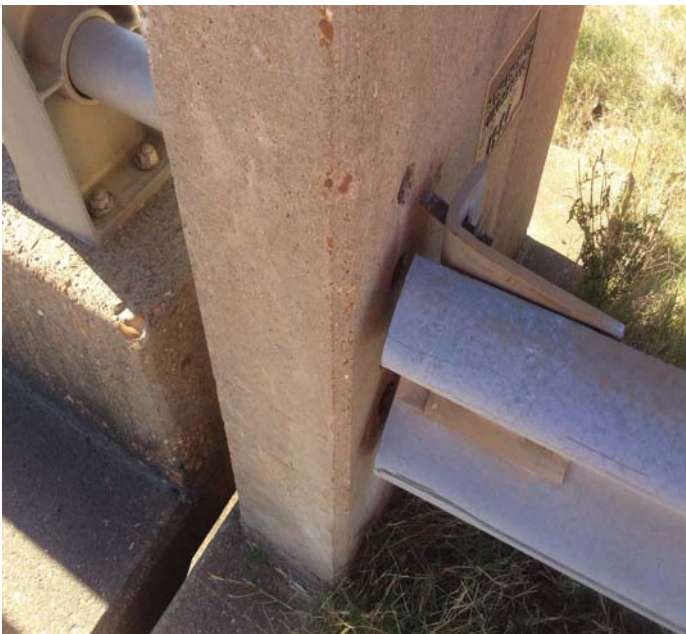
APPROACH RAIL
ABUTMENT #1 RIGHT

RAIL CONNECTION LOOSE.

PHOTO 1 Description Abutment #1 right approach rail loose
at bridge end

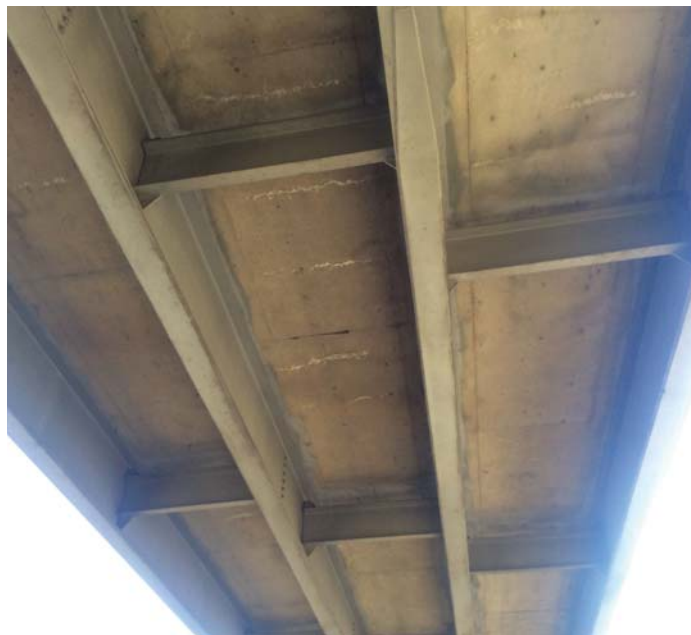
DECK HAS UNSEALED TRANSVERSE CRACKS WITH SOME REFLECTING THROUGH TO SOFFIT WITH EFFLORESCENCE. SPACED 3'+-

PHOTO 1 Description Transverse deck cracks reflecting through to soffit with efflorescence spaced 3'
