Bridge Inspection Report

A3724
I-40, WB LNS
over
BAYOU DEVIEW

Structure Number: A3724

Facility Carried: I-40, WB LNS

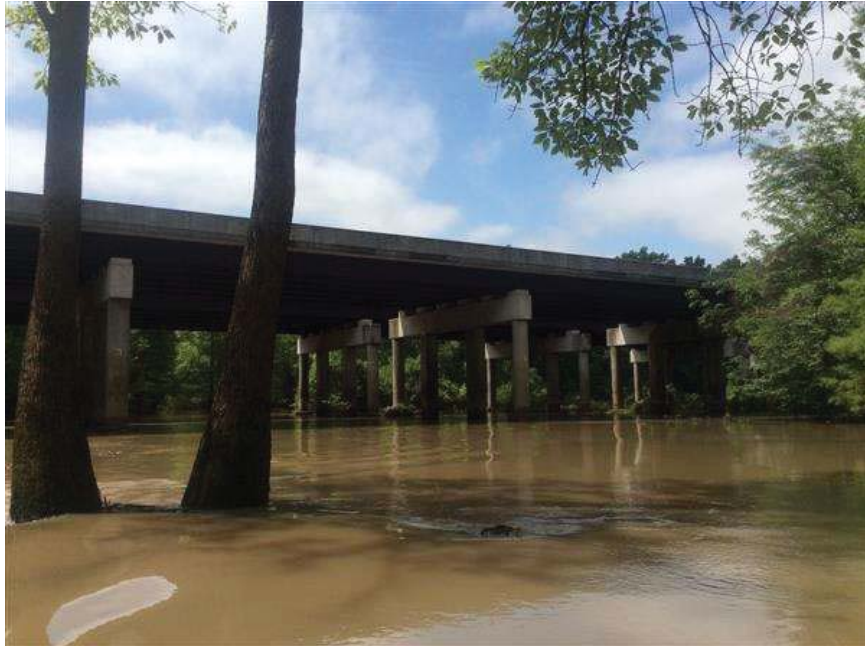
No overlay on Deck

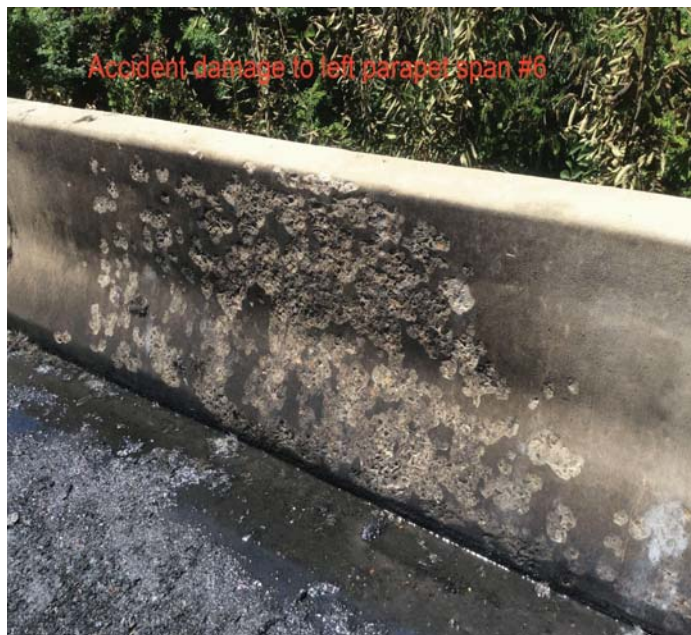
PHOTO 1 Description

JOINTS AT BENTS #5&6 LEFT LANE HAVE 4 SMALL SPALLS DUE TO FIRE FROM ACCIDENT.

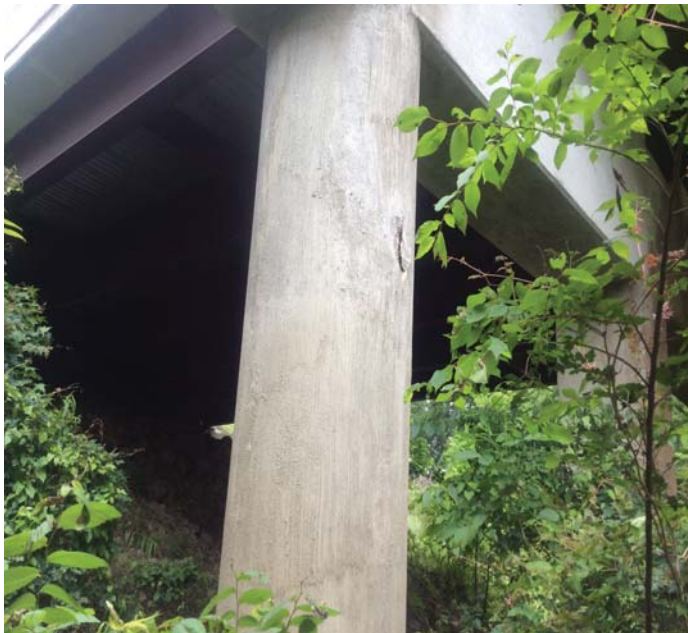
COLUMNS CRACKED AND DELAMINATED AT THESE LOCATIONS

PHOTO 1 Description Bent #2 column #4

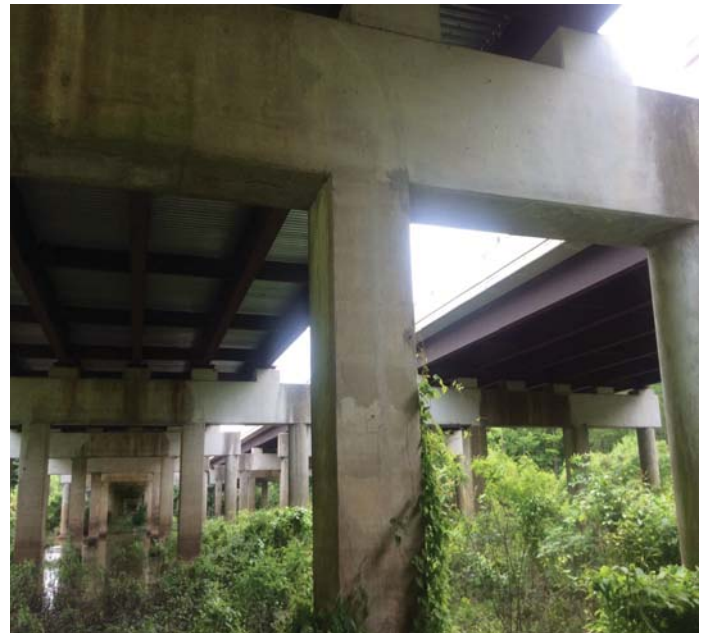
PHOTO 2 Description Bent #3 column #3

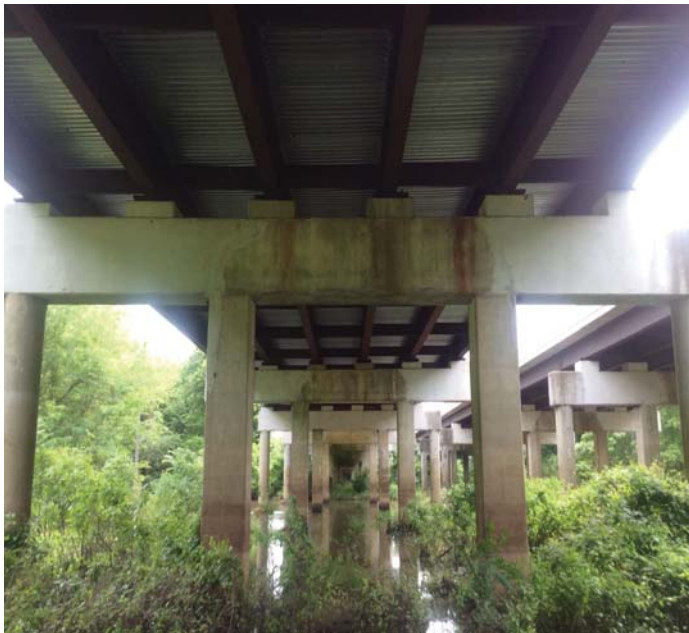
PHOTO 3 Description Bent #4 cap and column #3

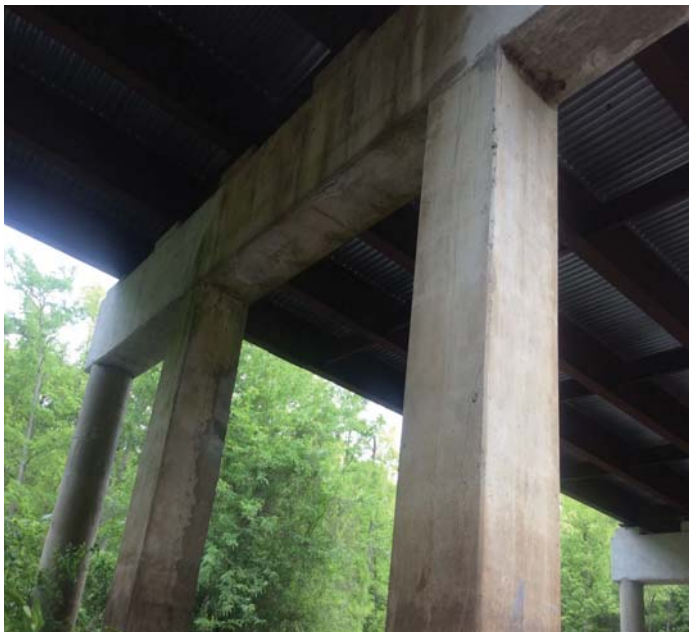
PHOTO 4 Description Bent #5 column #3 and bent #5 cap bottom face

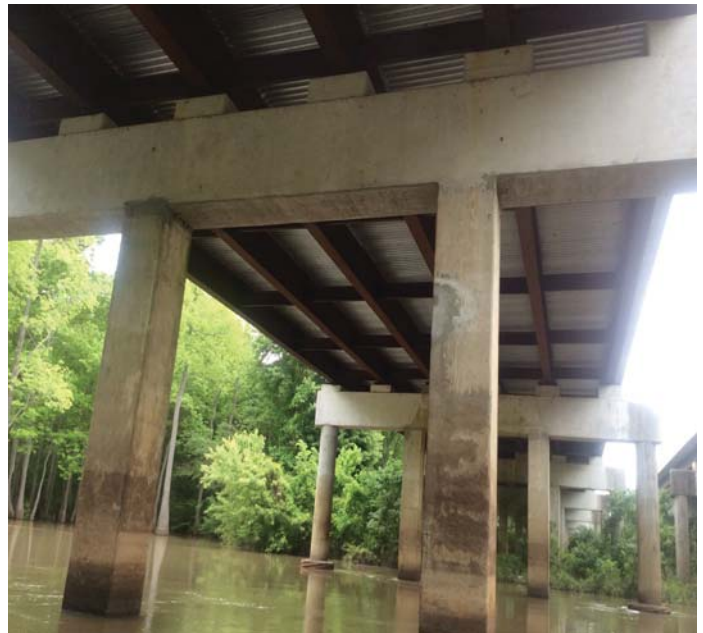
PHOTO 5 Description Bent#6 columns #2&3

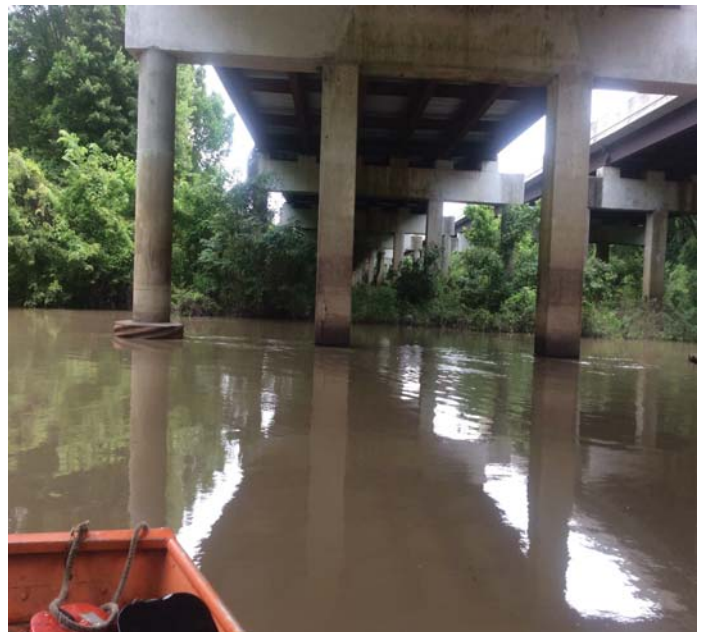
PHOTO 6 Description Bent #7 column #2

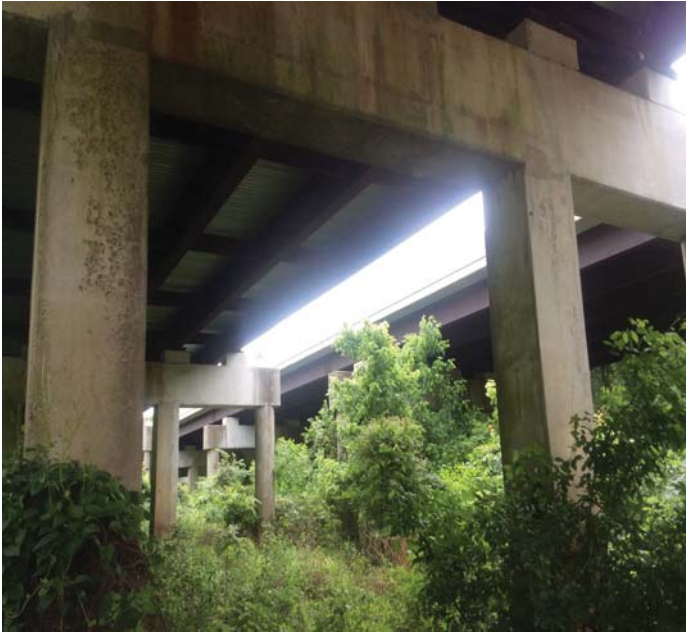
PHOTO 7 Description Bent #8 column #2&3

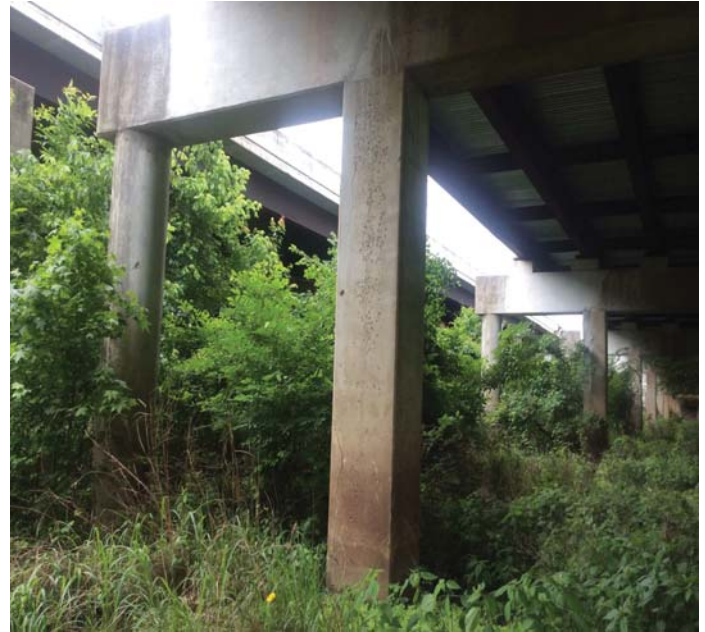
PHOTO 9 Description Bent #13 column #3

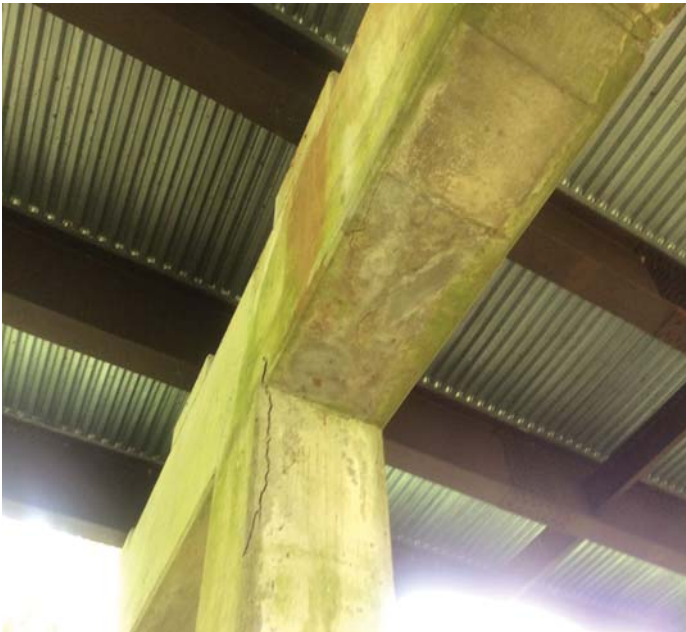
PHOTO 8 Description Bent #10 cap and column #2

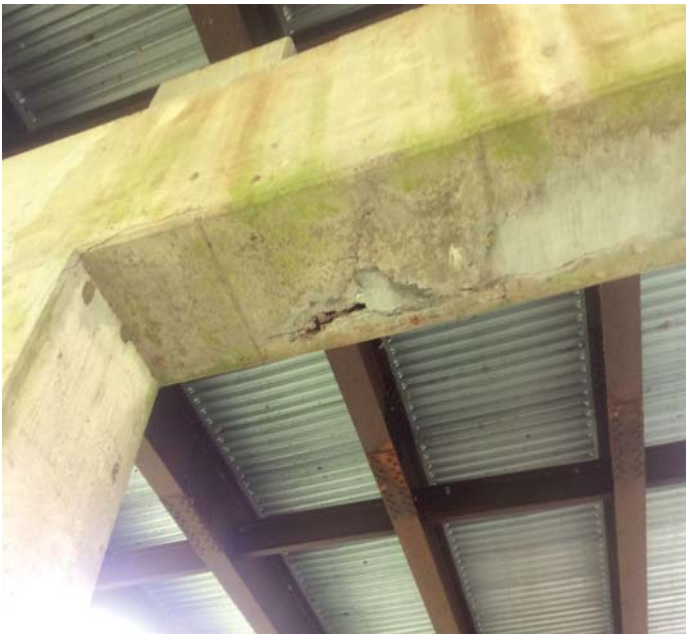
CRACKS, DELAMINATION AND SPALLS TYPICAL ON MOST BENTS BETWEEN COLUMNS 2 AND 3

PHOTO 1 Description Bent #3 cap bottom face between columns #2&3

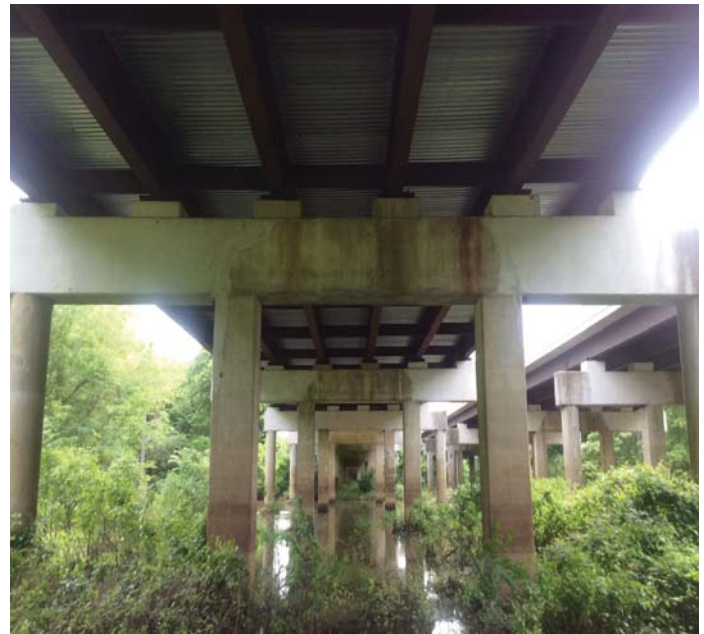
PHOTO 2 Description Bent #4 cap and column #3

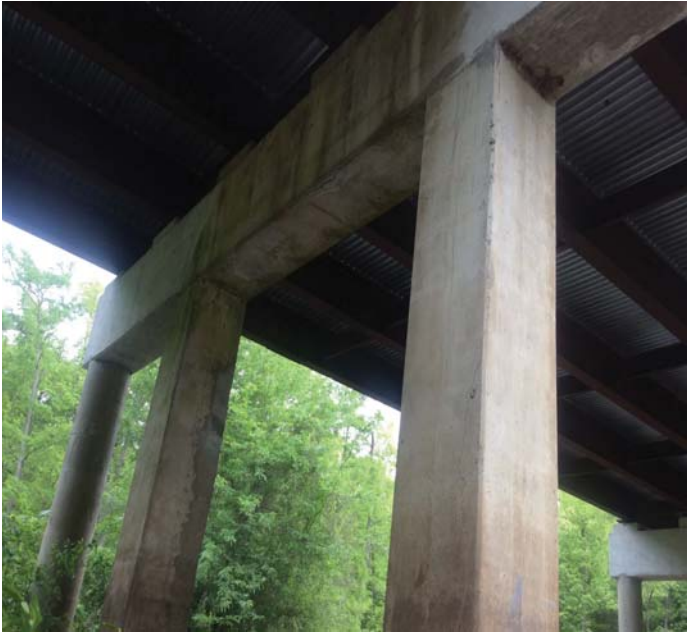
PHOTO 3 Description Bent #5 column #3 and bent #5 cap bottom face

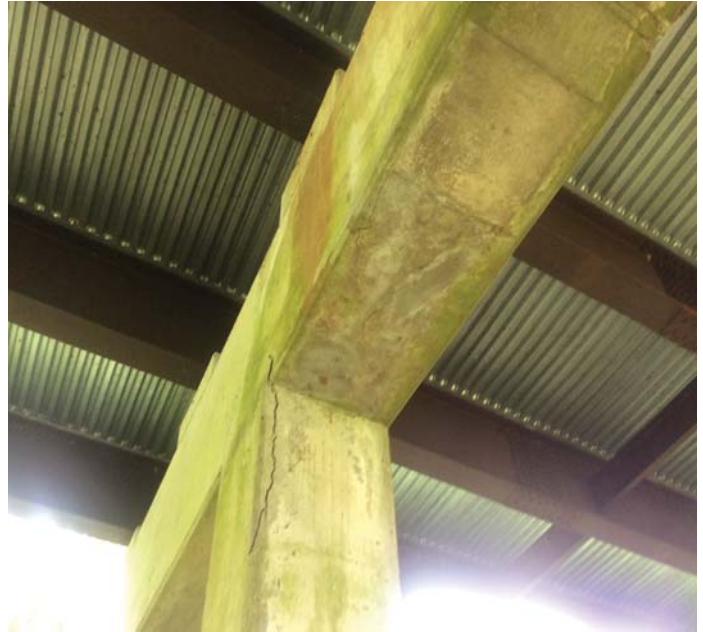
PHOTO 5 Description Bent #10 cap and column #2

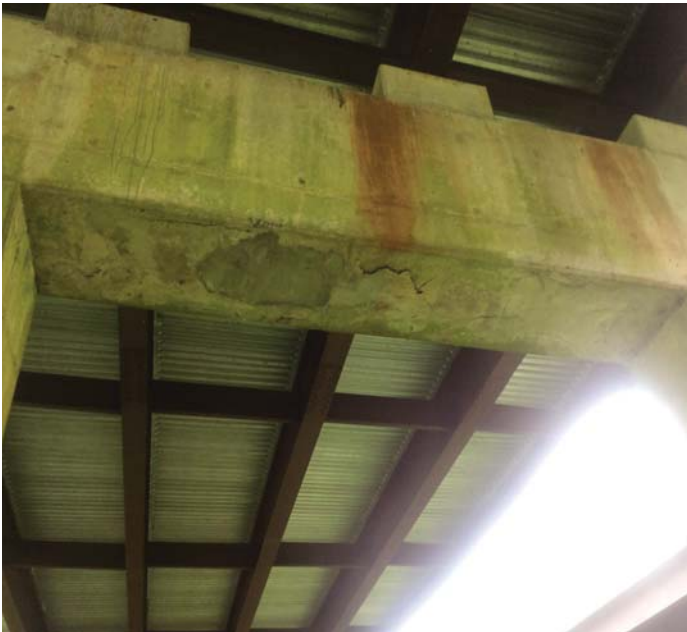
PHOTO 4 Description Bent #9 cap bottom between column #2&3

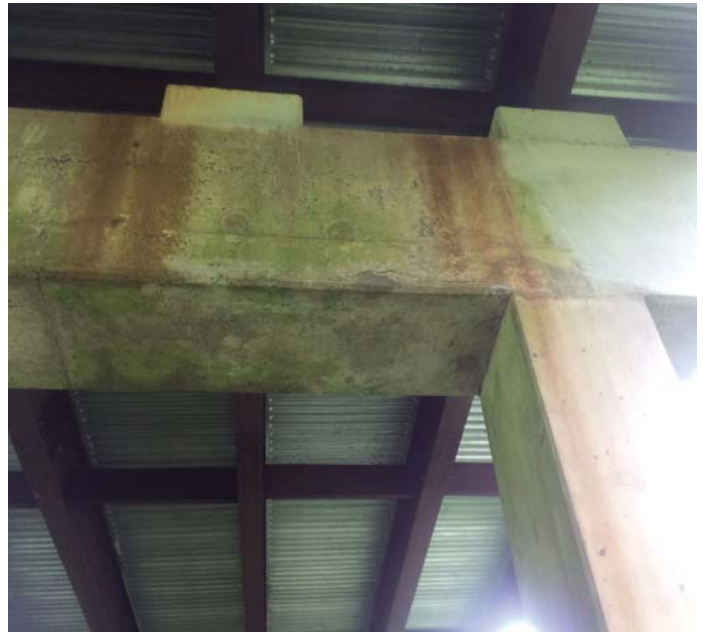
PHOTO 6 Description Bent #11 cap

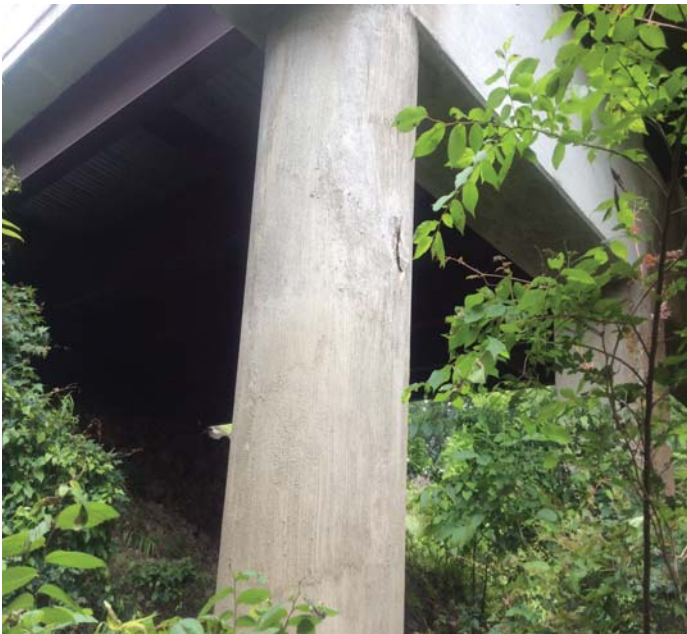
PHOTO 1 Description Bent #2 column #4

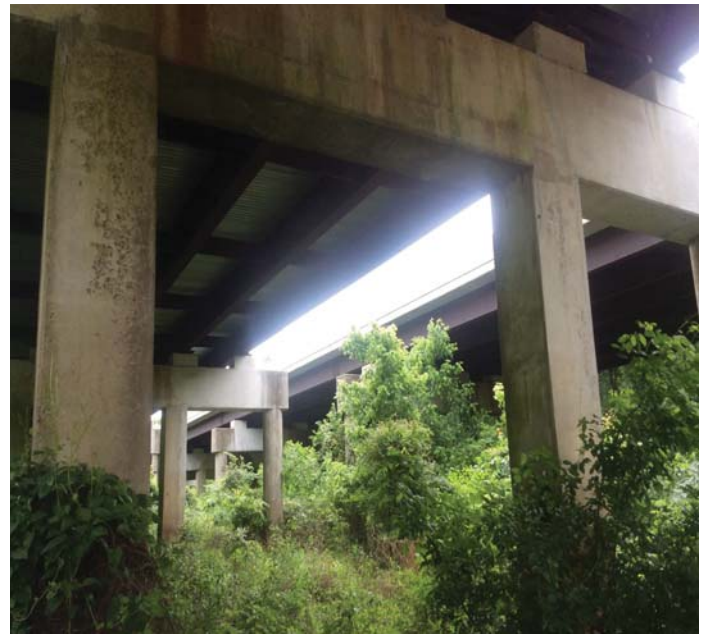
PHOTO 2 Description Bent #8 column #2&3

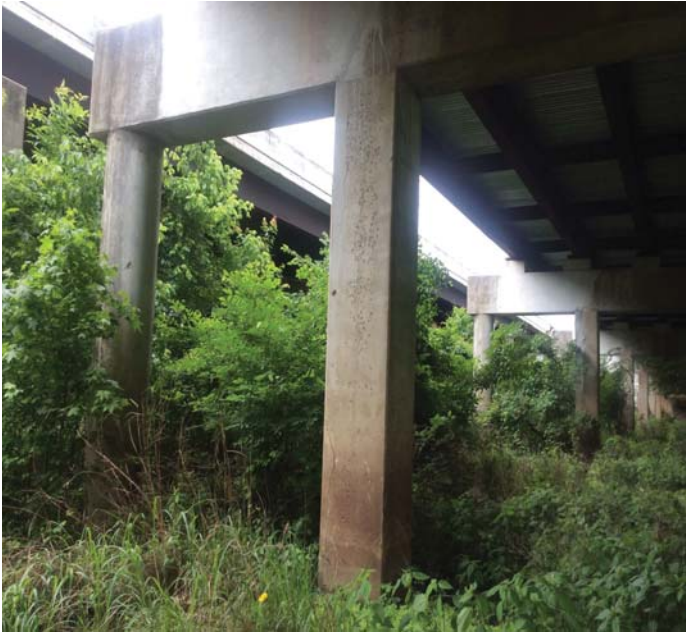
PHOTO 3 Description Bent #13 column #3

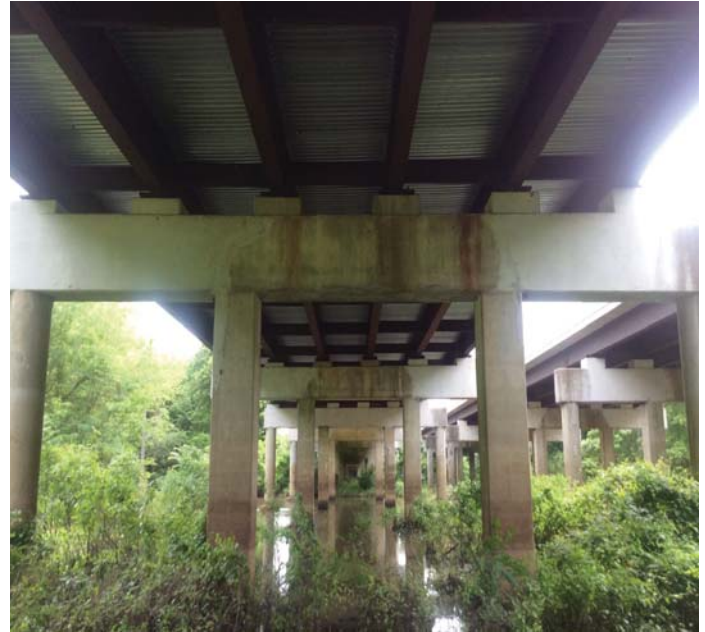
PHOTO 5 Description Bent #4 cap and column #3

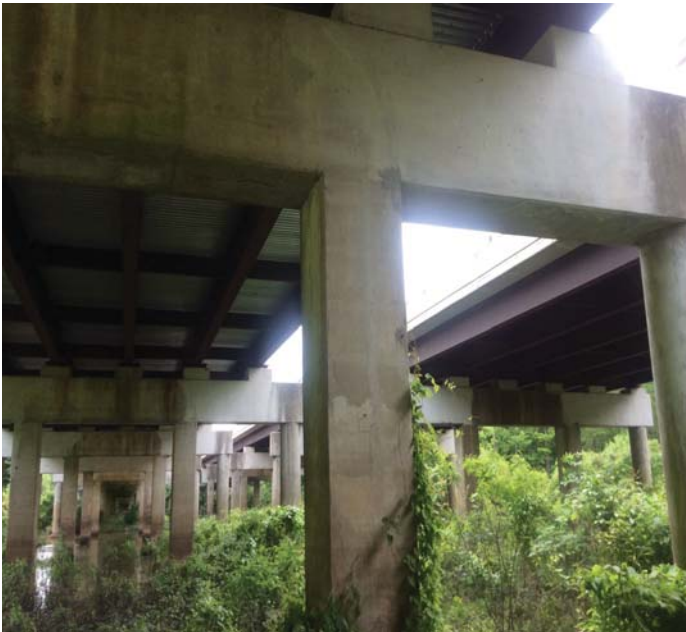
PHOTO 4 Description Bent #3 column #3

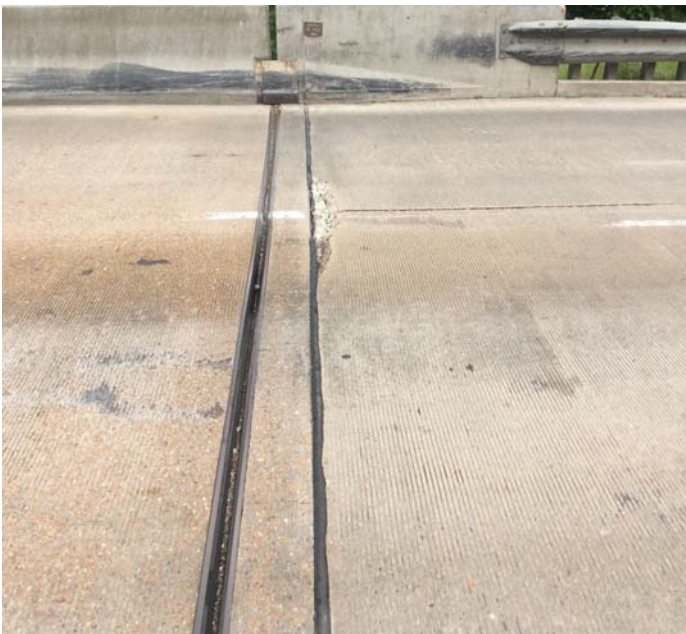
ABUTMENT # 2 LEFT LANE @ BRIDGE END IS CRACKED AND SPALLED.

PHOTO 1 Description Abutment #2 approach slab left lane at bridge end
