Bridge Inspection Report

A3727
I-40 WEST BND LNS
over
CREEK

Structure Number: A3727

Facility Carried: I-40 WEST BND
LNS

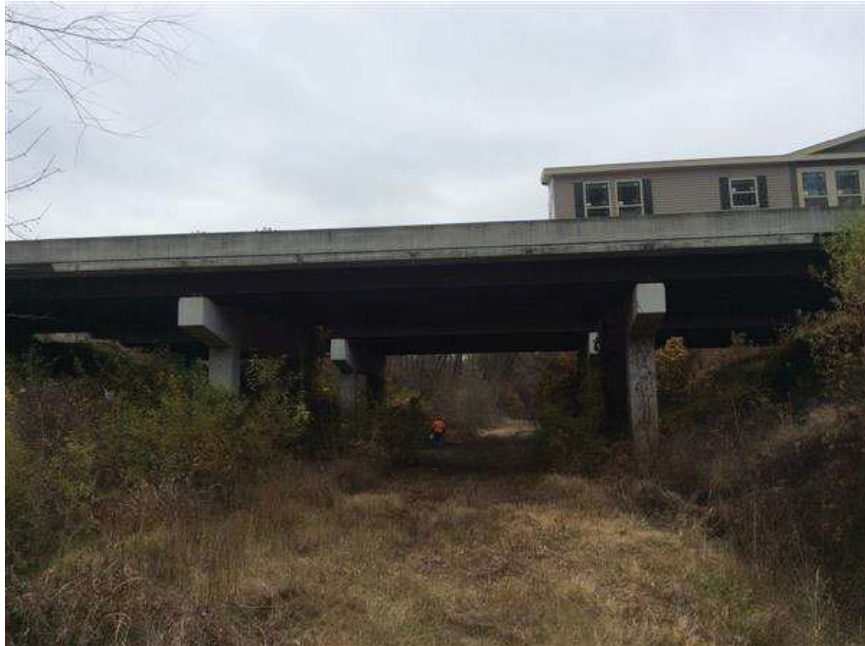
No overlay on Deck

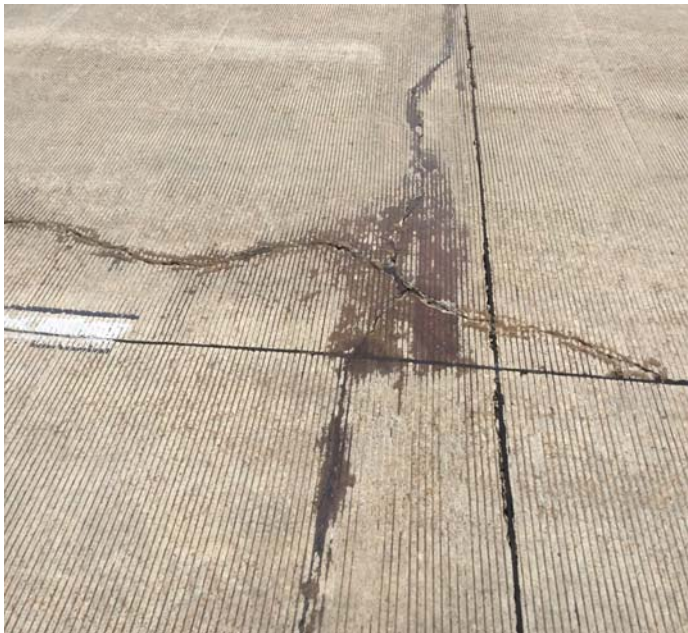
PHOTO 1 Description

APPROACH SLAB

ABUTMENT #1,2

APPROACH SLABS CRACKS NEED RESEALED.

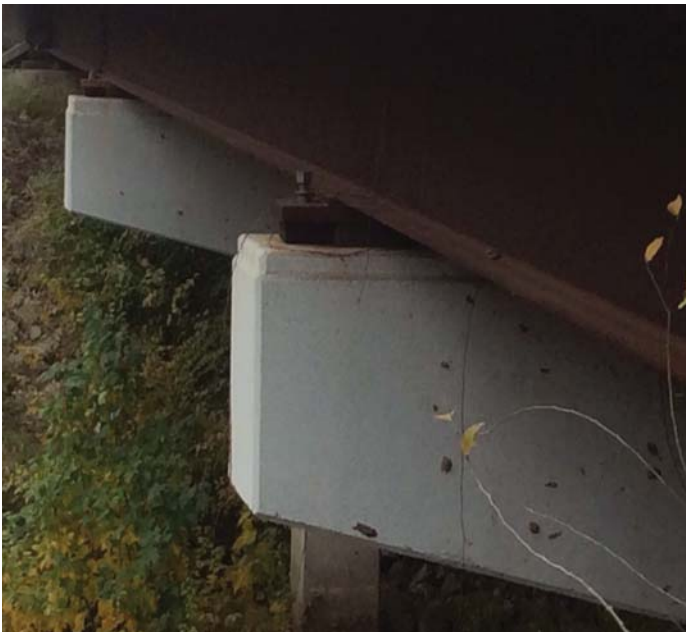
PHOTO 1 Description

ANCHOR BOLT

BENT #2 GIRDER #1
OUTSIDE ANCHOR BOLT

BOLT IS WORKING UP OUT OF CAP.

BENT #2 GIRDER #1
BENT #3 GIRDER #4

LOOSE NUTS.

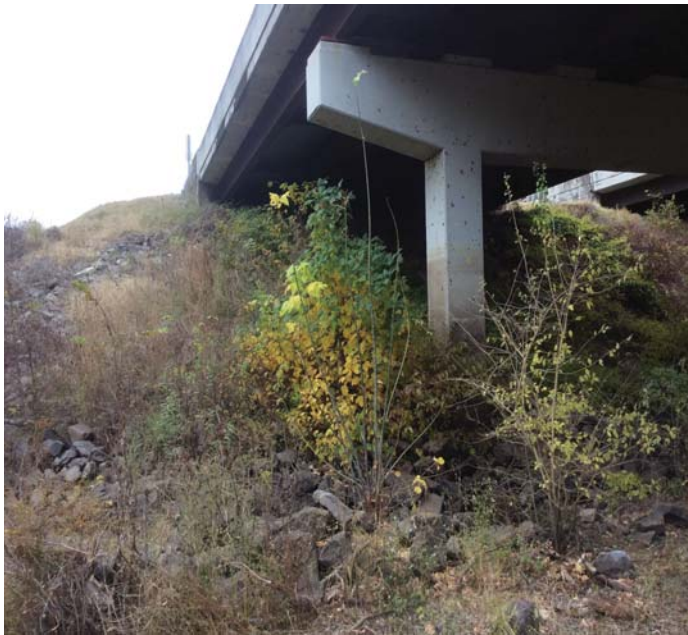
PHOTO 1 Description

VEGETATION

ABUTMENT #1

BRUSH GROWING IN MEDIAN BESIDE BRIDGE.
