Bridge Inspection Report

A3731
I 40-SEC 43; WB LN
over
CO RD 179, RR

Structure Number: A3731

Facility Carried: I 40-SEC 43; WB
LN

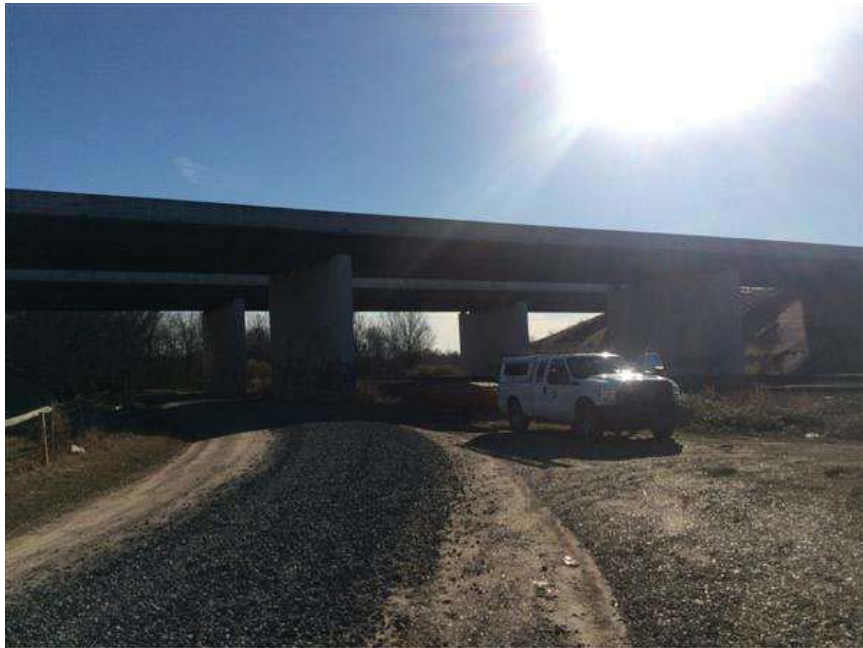
No overlay on
bridge Deck

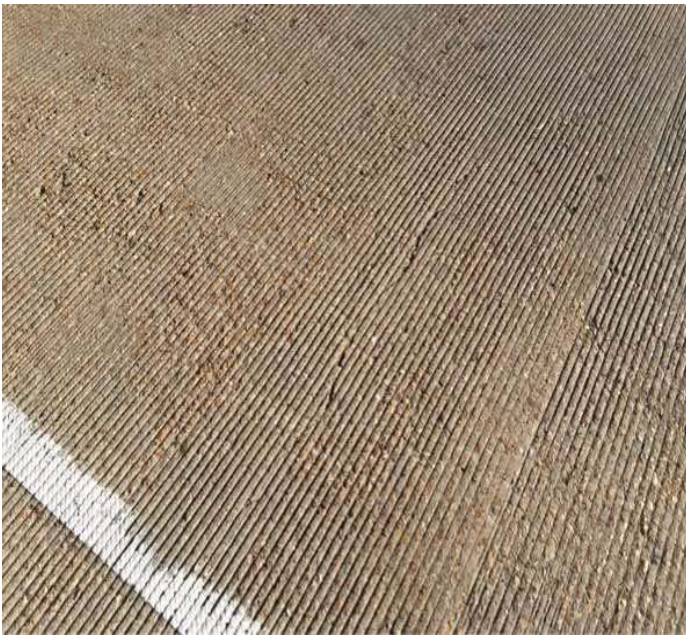
PHOTO 1 Description

DECK

ALL SPANS

ALL SPANS HAVE OPEN TRANSVERSE CRACKS SPACED AT 6'+-.

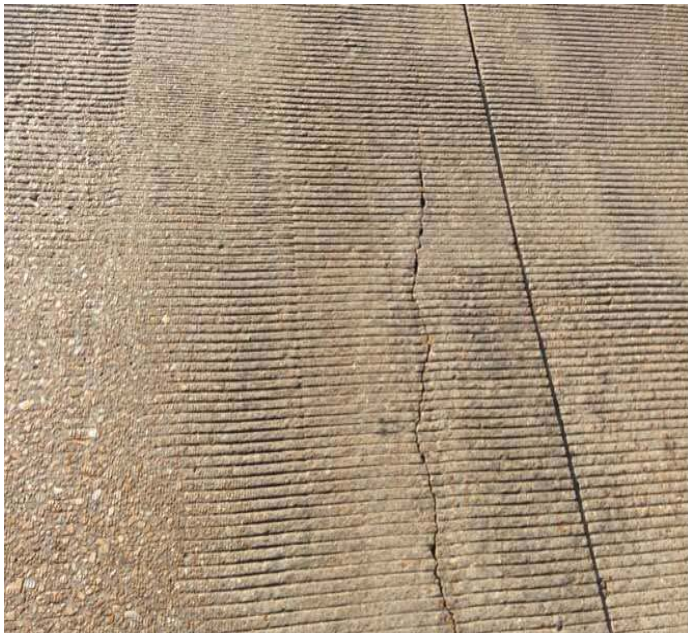
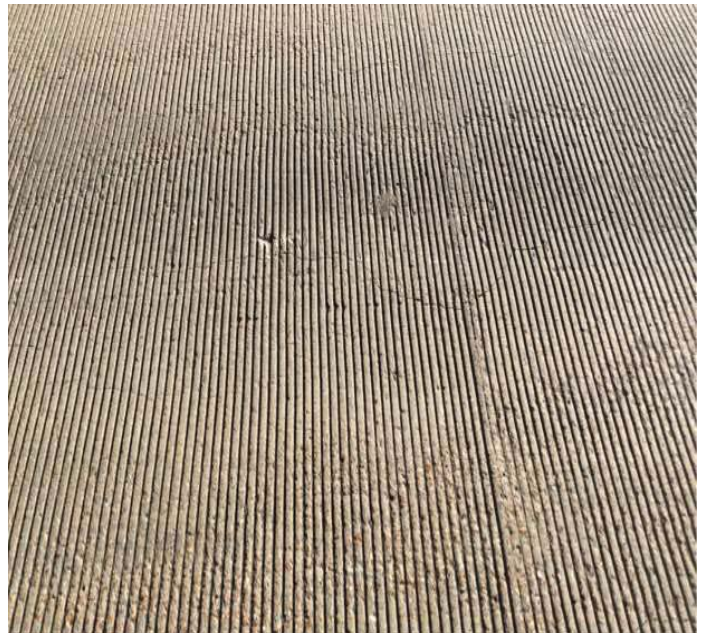
APPROACH SLABS

ABUTMENTS #1 AND #2

APPROACH SLABS HAVE UNSEALED LONGITUDINAL CRACKS.

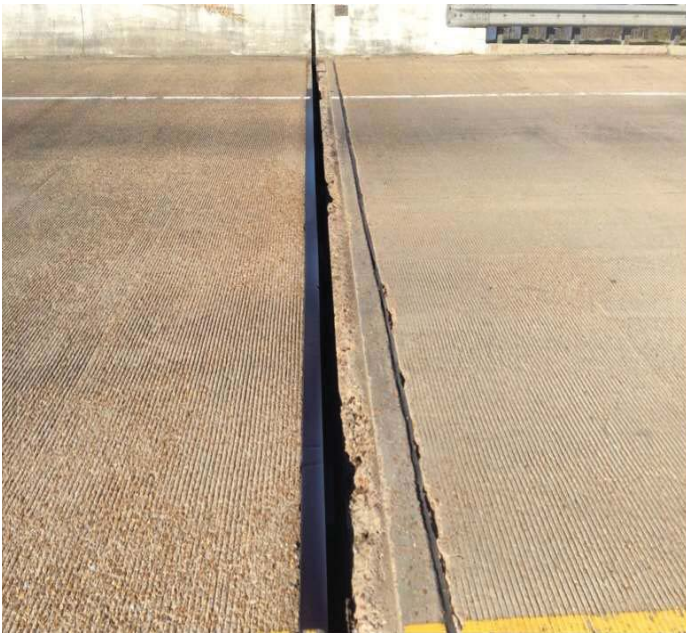
PHOTO 1 Description

ABUTMENT #2

JOINT

ROAD IRON HAS BEEN REMOVED AND JOINT DRAIN HAS FAILED ALLOWING WATER, DIRT AND DEBRIS TO FALL THROUGH JOINT ONTO CAP.

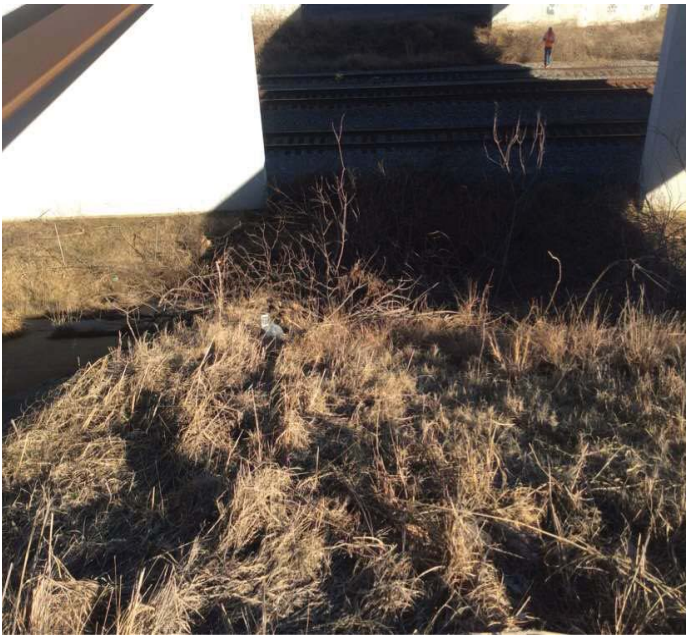
PHOTO 1 Description

ABUTMENT #1

RIGHT SIDE

SMALL TREES GROWING RIGHT SIDE OF BRIDGE.
