Bridge Inspection Report

**B3724
I- 40, EB LNS
over
BAYOU DEVIEW**

Structure Number: B3724

Facility Carried: I- 40, EB LNS

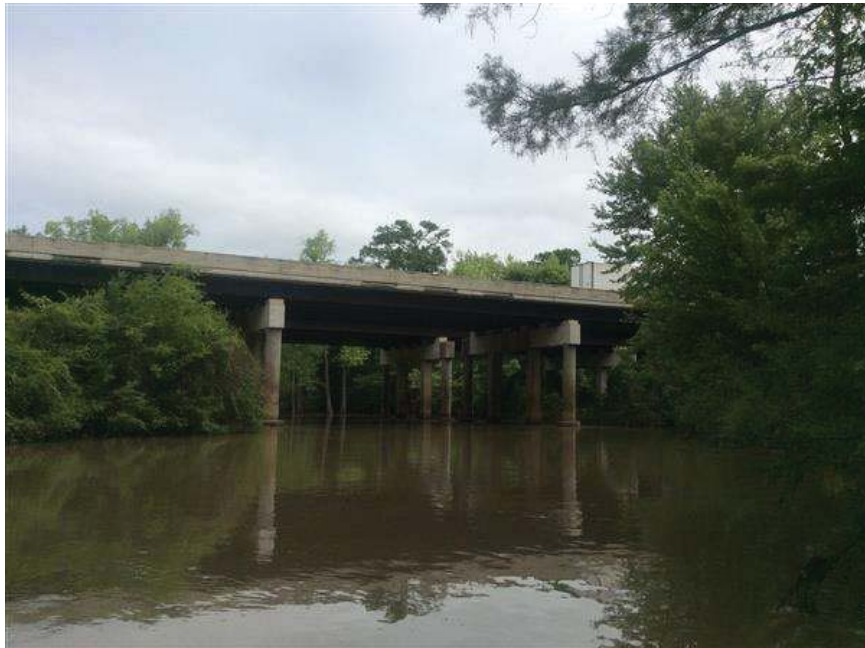
**No overlay on
bridge Deck**

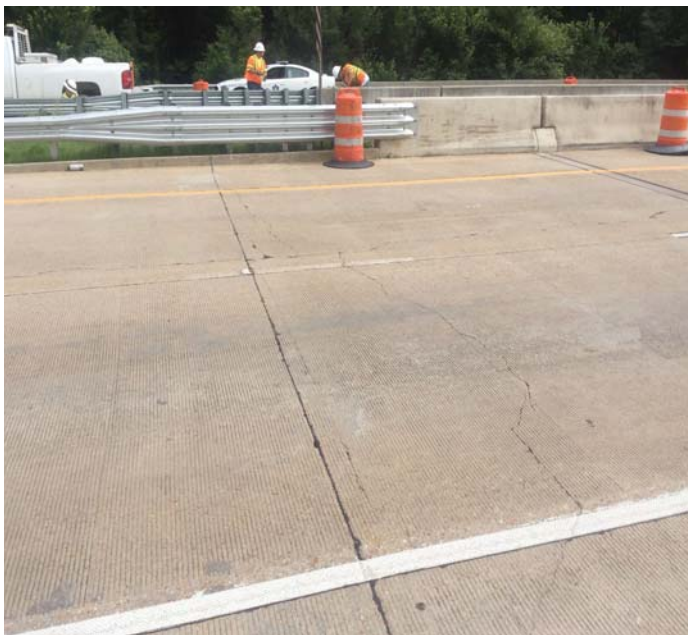
Approach slabs

Both approach slabs have open transverse and longitudinal cracks

PHOTO 1 Description Abutment#1 approach slab

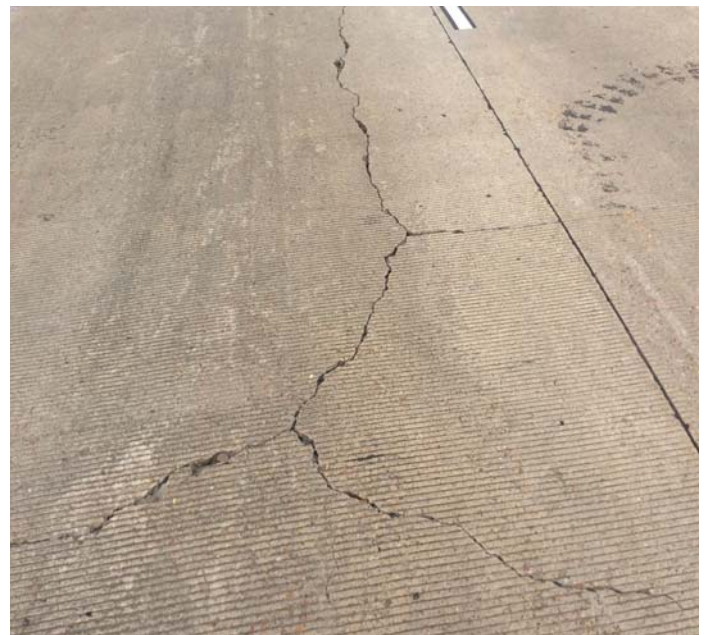
PHOTO 2 Description Abutment #2 approach slab

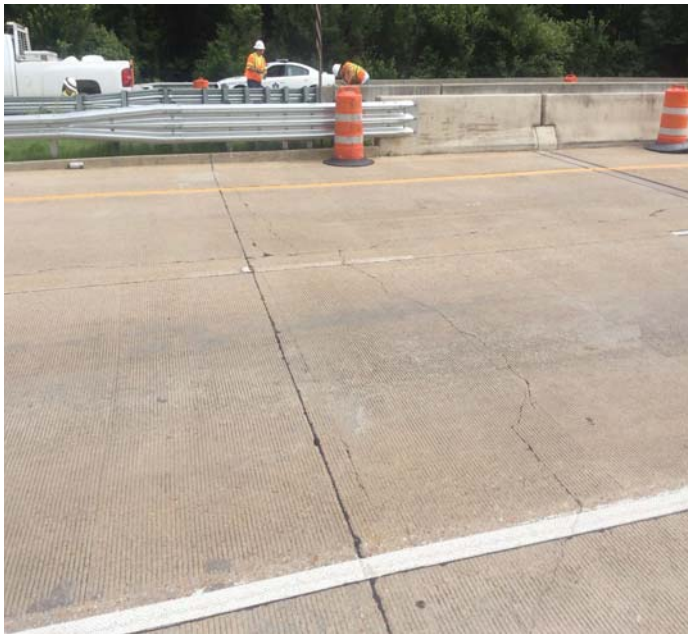
APPROACH SLABS

SLABS HAVE OPEN TRANSVERSE AND LONGITUDINAL CRACKS

PHOTO 1 Description Abutment#1 approach slab

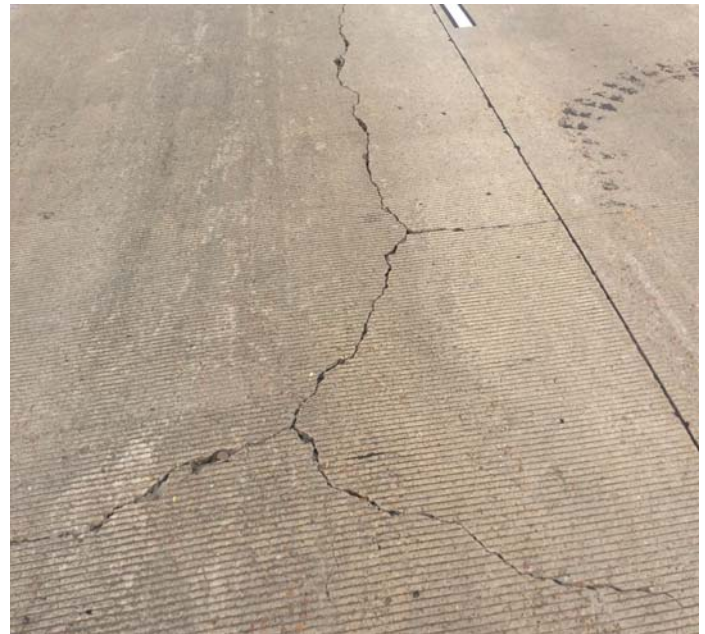
PHOTO 2 Description Abutment #2 approach slab

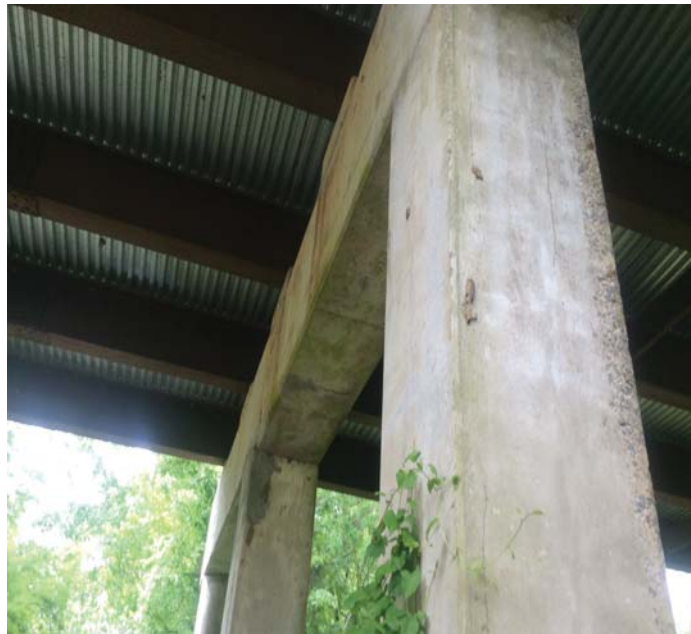
CRACKS, DELAMINATION AND SPALLS TYPICAL ON BENTS BETWEEN COLUMNS 2 AND 3

PHOTO 1 Description Bent #14 cap and column #2&3

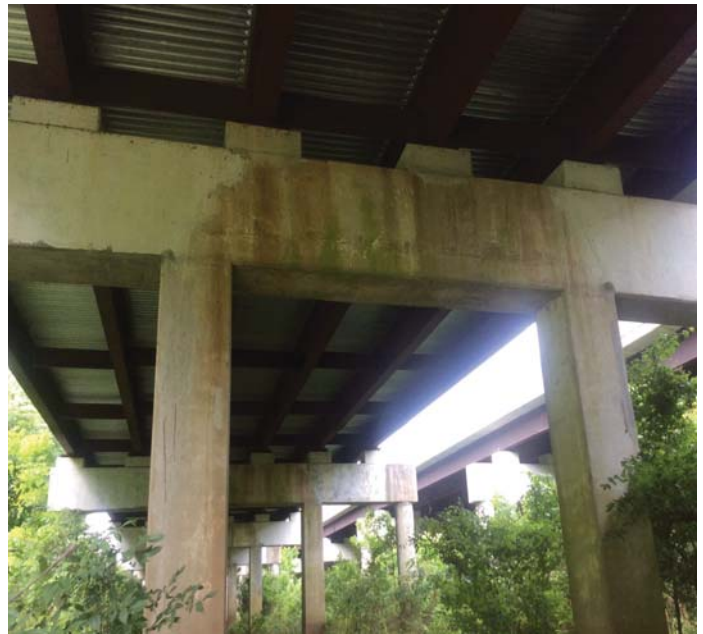
PHOTO 2 Description Bent #12 cap and column 2&3 cap
condition typical for other caps in report

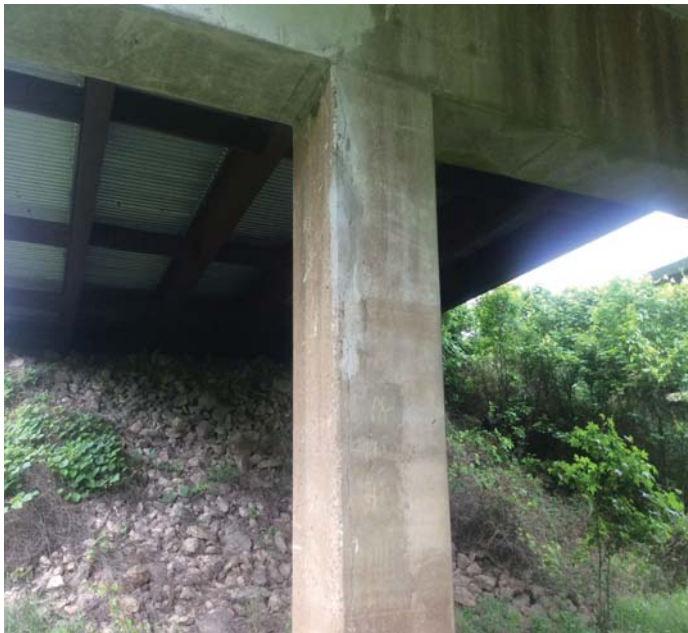
COLUMNS ARE CRACKED AND DELAMINATED

PHOTO 1 Description Bent #2 column #3 front face

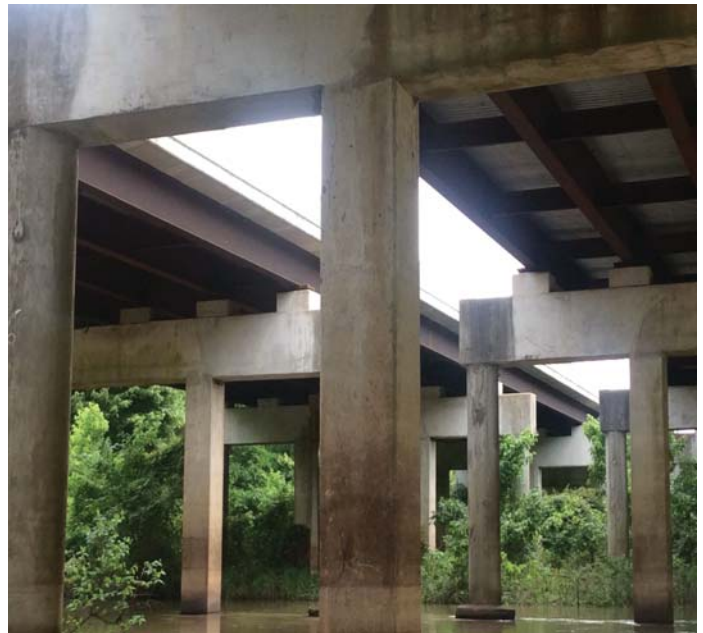
PHOTO 2 Description Bent #6 column#2

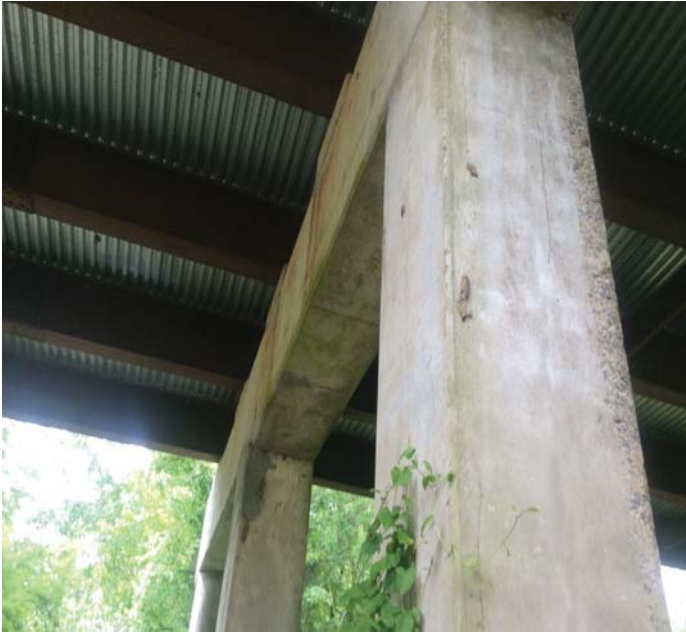
PHOTO 3 Description Bent #14 cap and column #2&3

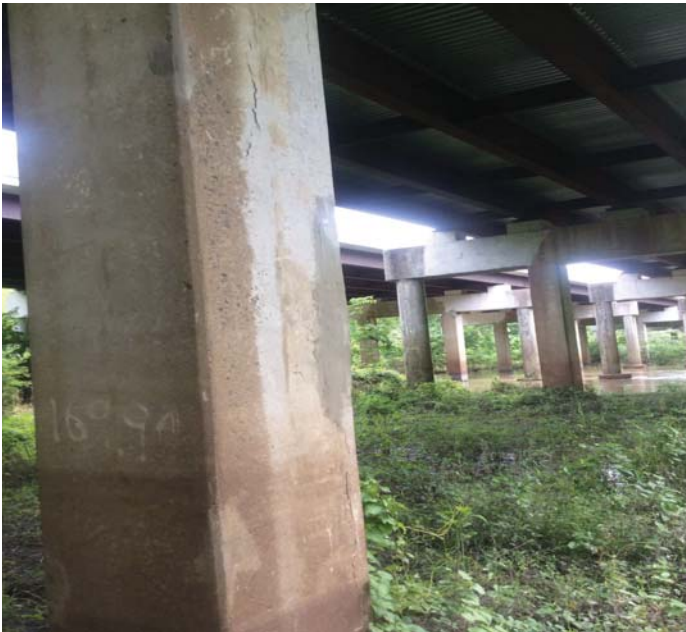
PHOTO 4 Description Bent #13 column #3

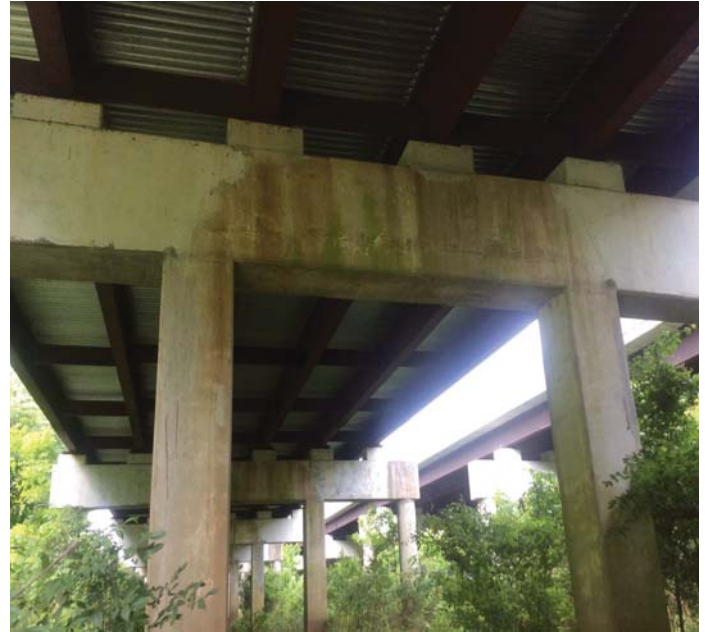
PHOTO 5 Description Bent #12 cap and column 2&3 cap condition typical for other caps in report

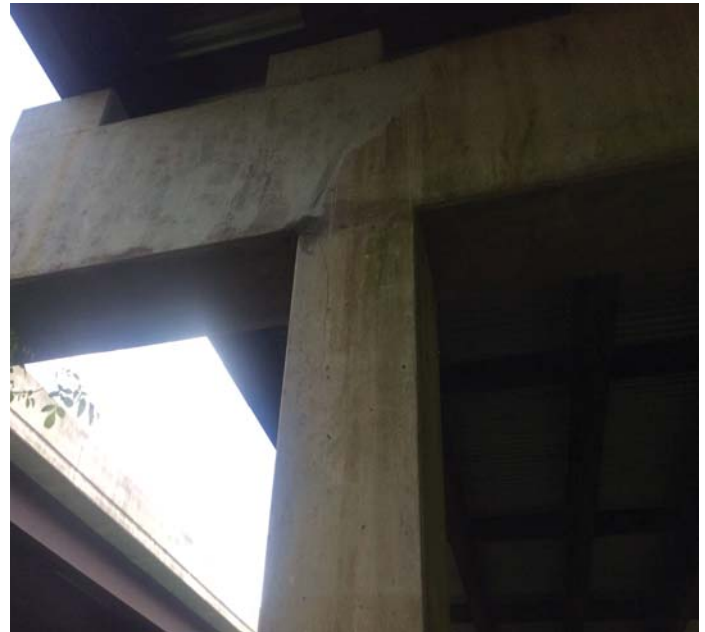
PHOTO 6 Description Bent #11 column #2

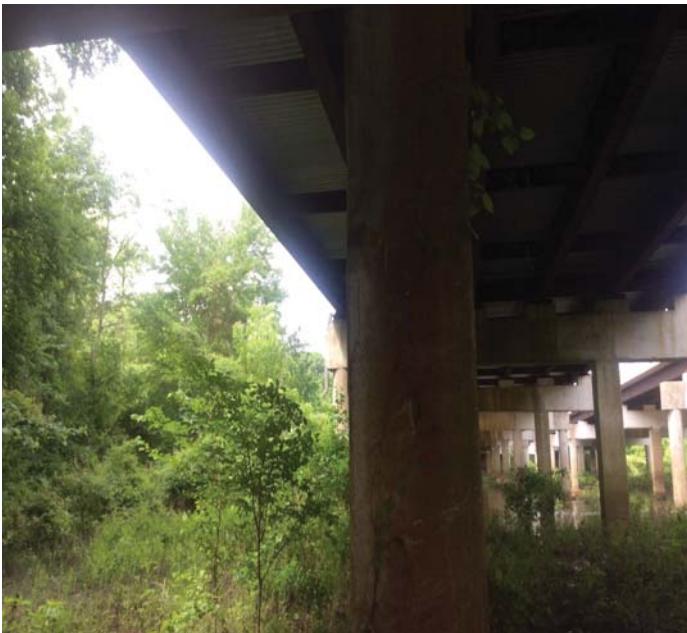
PHOTO 7 Description Bent #9 column #3

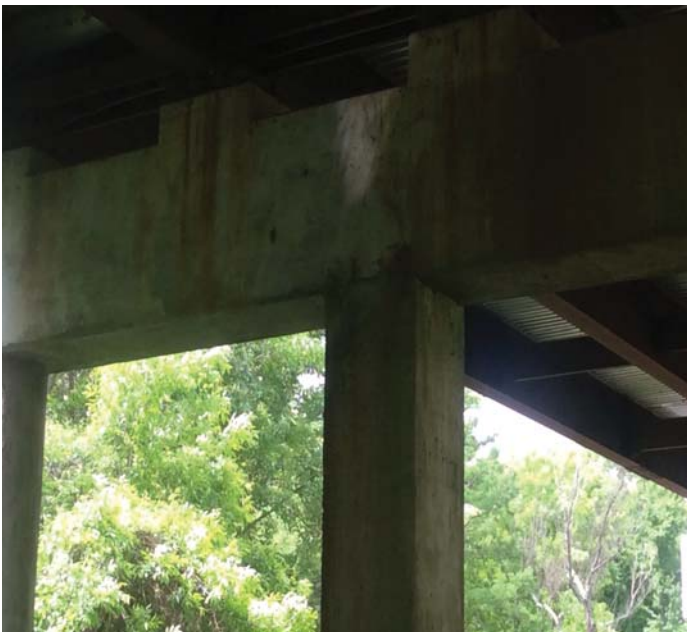
PHOTO 8 Description Bent #8 column #3

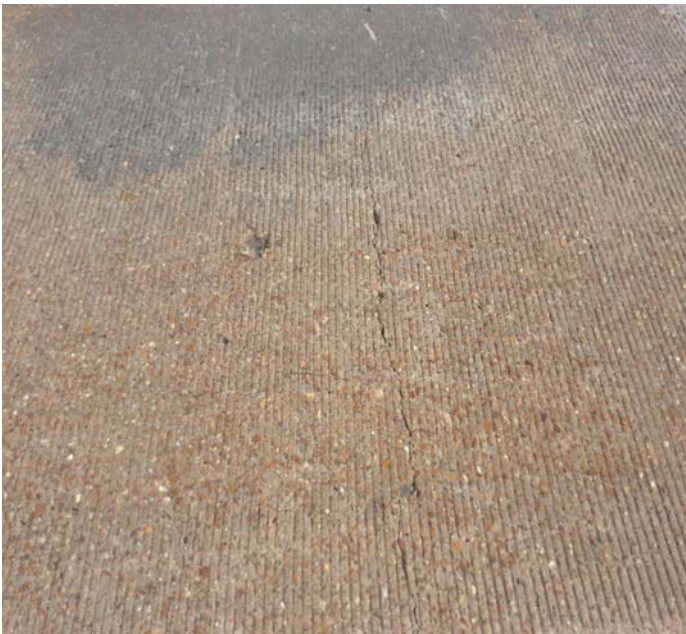
DECK
ALL SPANS
OPEN TRANSVERSE CRACKS

PHOTO 1 Description Typical transverse deck crack
