Bridge Inspection Report

B3727
I- 40 EAST BND LNS
over
CREEK

Structure Number: B3727

IDENTIFICATION		INSPECTIONS	
(1) STATE CODE	056 - Arkansas	(90) INSPECTION DATE	12/07/2016
(8) STRUCTURE NUMBER	B3727	(91) DESIGNATED INSPECTION FREQUENCY	24

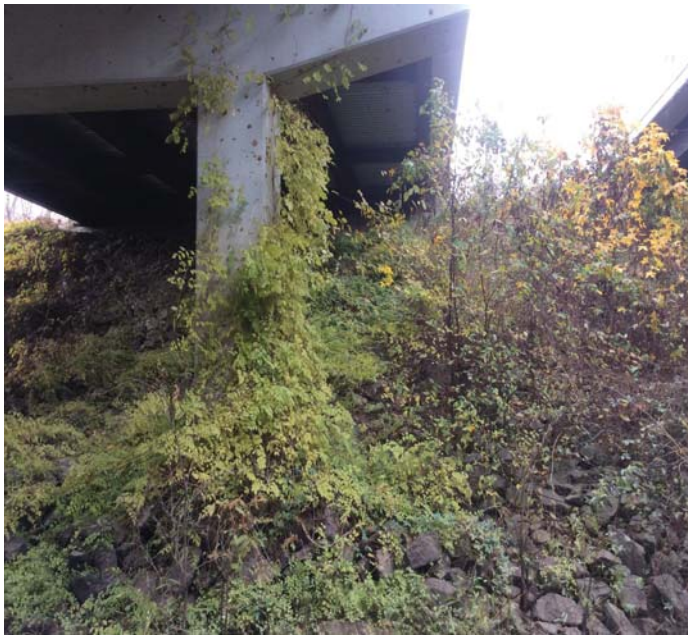
PHOTO 1 Description

VEGETATION

ABUTMENT #1

BRUSH GROWING IN MEDIAN BESIDE BRIDGE AND UP BENT #2&3 COLUMNS.

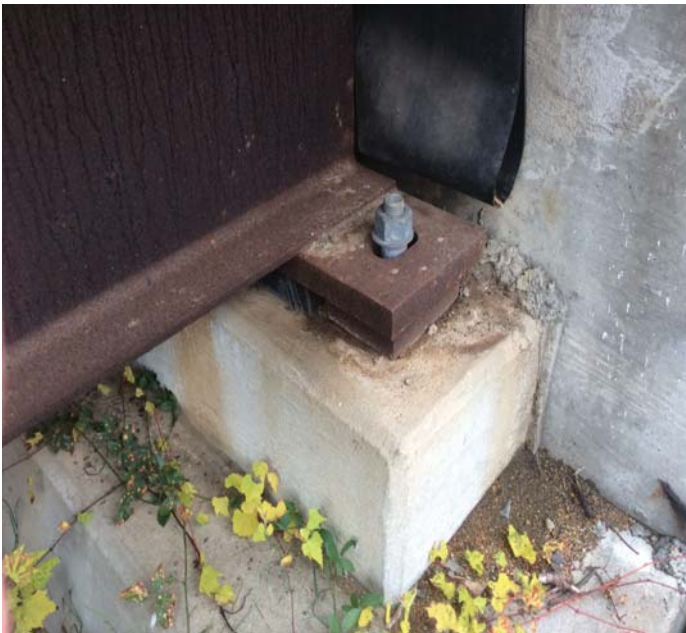
ANCHOR BOLT

BENT #1 GIRDER #1

ANCHOR BOLT BACKING OUT.

PHOTO 1 Description Abutment #1 left anchor bolt backed out.

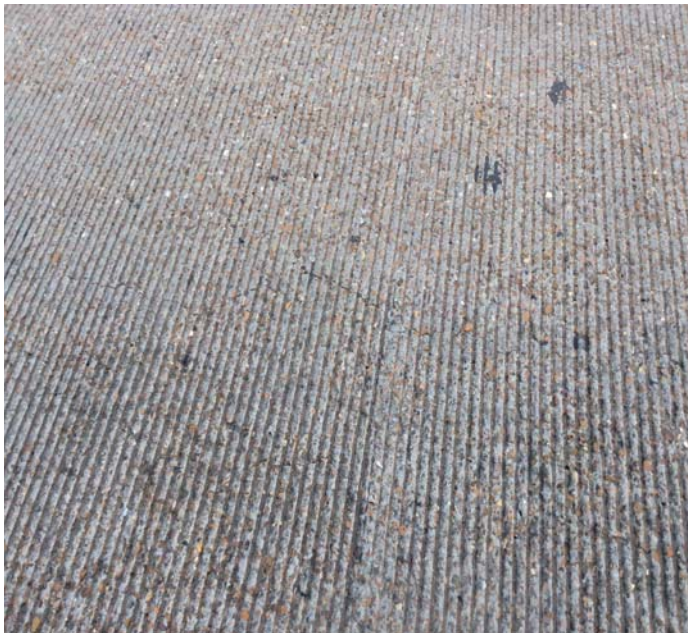
DECK HAS UNSEALED TRANSVERSE AND LONGITUDINAL CRACKS.

PHOTO 1 Description Typical longitudinal deck crack.

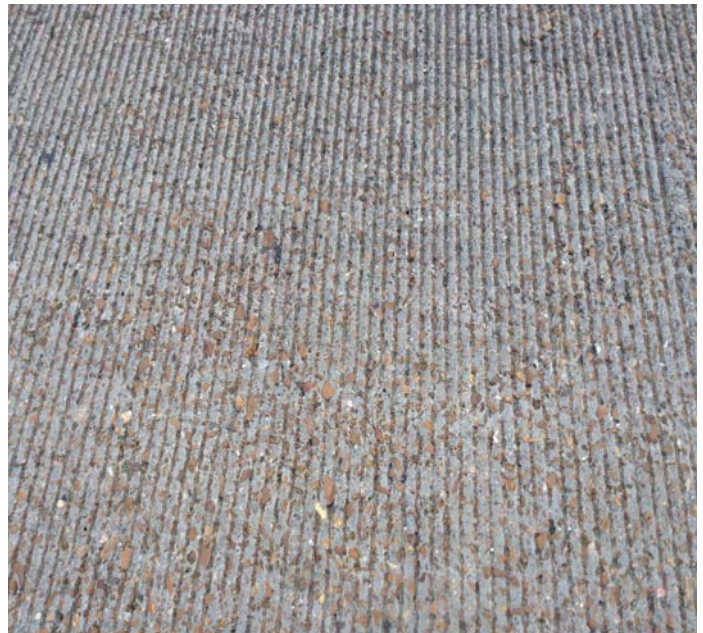
PHOTO 2 Description Typical transverse deck crack.

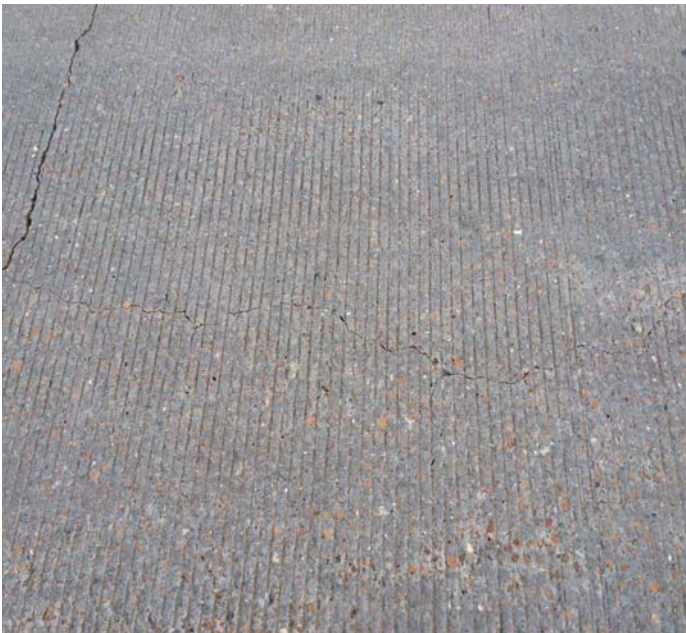
APPROACH SLAB CRACKS NEED RESEALED.

PHOTO 1 Description Abutment #1 approach slab typical transverse and longitudinal cracks.
