# Bridge Inspection Report

**B3731**

**I 40-SEC 43; EB LN**

**CO RD 179, SLSW RR**

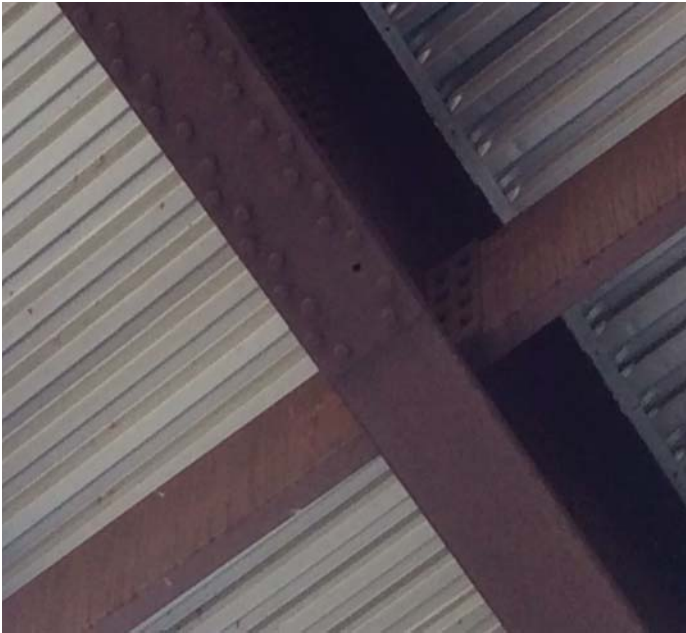
SPAN # 2 GIRDER # 4 1ST SPLICE

FIELD SPLICE

BOTTOM PLATE HAS BOLT MISSING

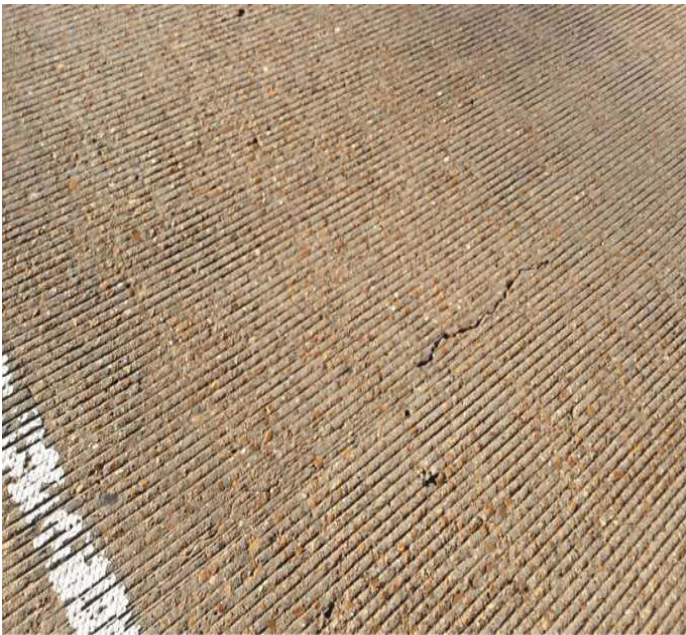
Environment	Total Quantity	Units	Condition State 1	Condition State 2	Condition State 3	Condition State 4
<b>12 - Reinforced Concrete Deck</b>	1- Ben.	11206	sq. ft.	9274	1932	0	0
	SOFFIT OVERHANGS HAVE TRANSVERSE CRACKS WITH EFFLORESCENCE. ALL SPANS HAVE TRANSVERSE CRACKS SPACED AT 6'+-.						
1120 - Efflorescence/Rust Staining		64			64		
1130 - Cracking (RC and Other)		1868			1868		
<b>107 - Steel Open Girder/Beam</b>	1- Ben.	1560	ft.	1559	1	0	0
	SPAN #2 GIRDER # 4 AT FIRST BOTTOM SPLICE PLATE THERE IS ONE BOLT MISSING.						
1020 - Connection		1			1		
515 - Steel Protective Coating		13822	sq. ft.	13822			
<b>210 - Reinforced Concrete Pier Wall</b>	1- Ben.	82	ft.	82			
<b>215 - Reinforced Concrete Abutment</b>	1- Ben.	136	ft.	130	6	0	0
	ABUTMENTS #1 AND #2 HAVE VERTICAL HAIRLINE CRACKS WITH EFFLORESCENCE.						
1120 - Efflorescence/Rust Staining		6			6		
<b>302 - Compression Joint Seal</b>	1- Ben.	86	ft.	86

DECK

DECK HAS UNSEALED TRANSVERSE CRACKS ALL SPANS.

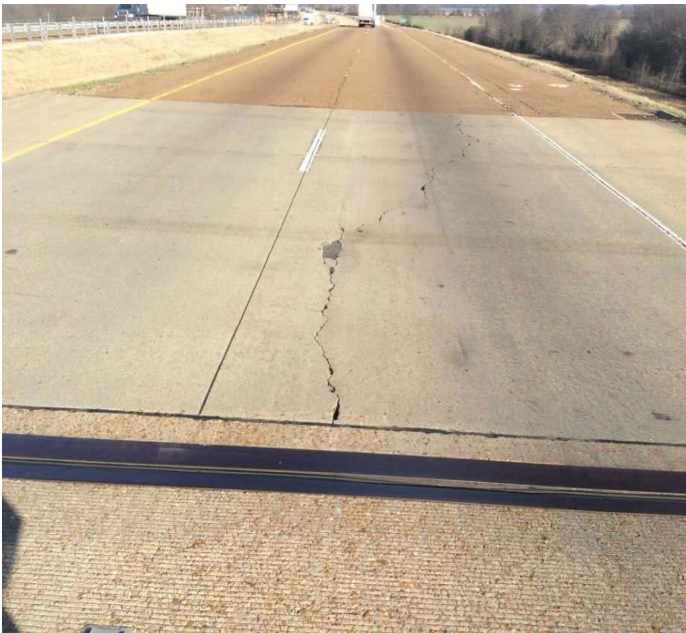
515 - Steel Protective Coating		172	sq. ft.	172			
<b>310 - Elastomeric Bearing</b>	1- Ben.	24	each	24			
<b>321 - Reinforced Concrete Approach Slab</b>	1- Ben.	1752	sq. ft.	1647	70	35	0
	ABUTMENT #1 APPROACH SLAB HAS ONE LONGITUDINAL CRACK ABUTMENT #2 APPROACH SLABS HAVE LARGE LONGITUDINAL CRACKS						
1130 - Cracking (RC and Other)		105			70	35	
<b>331 - Reinforced Concrete Bridge Railing</b>	1- Ben.	520	ft.	520

APPROACH SLAB

RIGHT LANE

APPROACH SLAB HAS LARGE UNSEALED LONGITUDINAL CRACK.

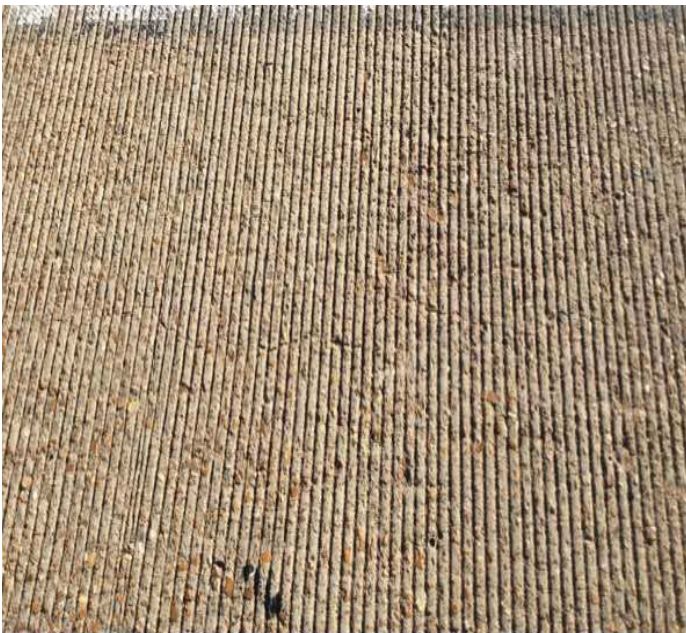
EACH SPAN HAS 4 LONGITUDINAL UNSEALED CRACKS
