Bridge Inspection Report

03609

I 540-District 4

SH 59, ARK RIV/R.R.

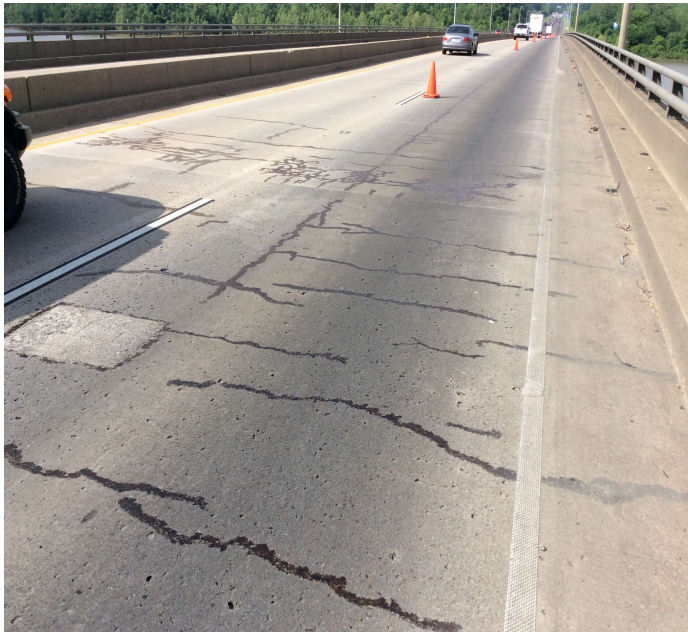
Numerous deck cracks in all spans. Some of the cracks have been sealed with epoxy.

PHOTO 1 Description Southbound lanes. This is a common condition of the deck. Most of the transverse and longitudinal cracks have been sealed.

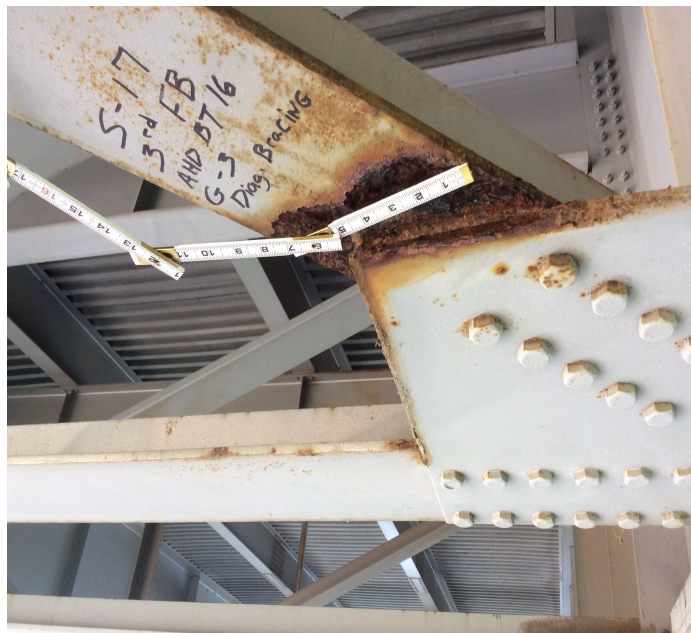
Joint 10A, 13A, 17A and 20A: Pack rust between the lateral brace and the gusset plate has deformed the gusset plate.

PHOTO 1 Description Span 17, girder 3 ,3rd floor beam at the diagonal bracing connection: Section loss up to 1/4 inch in a 7" x 3" area. Pack rust distorting gusset plate at this location.

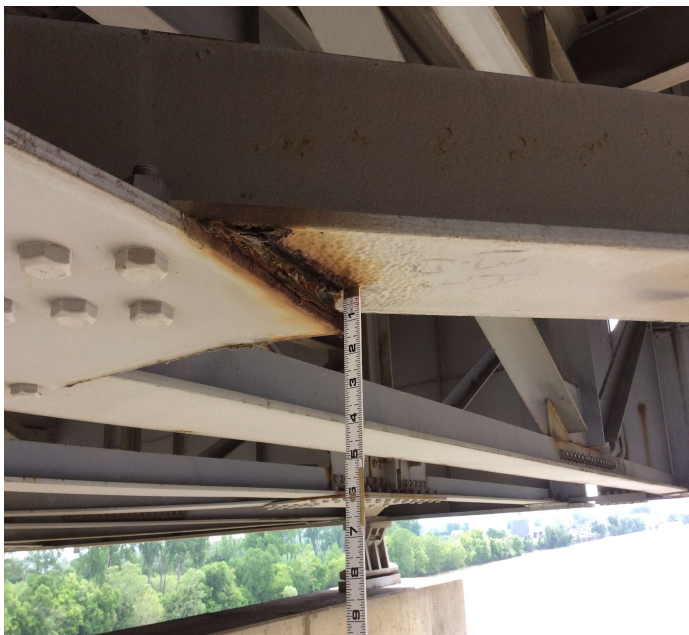
PHOTO 3 Description 13A Girder3 at the bracing and gusset plate connection has pack rust which is distorting the plate.

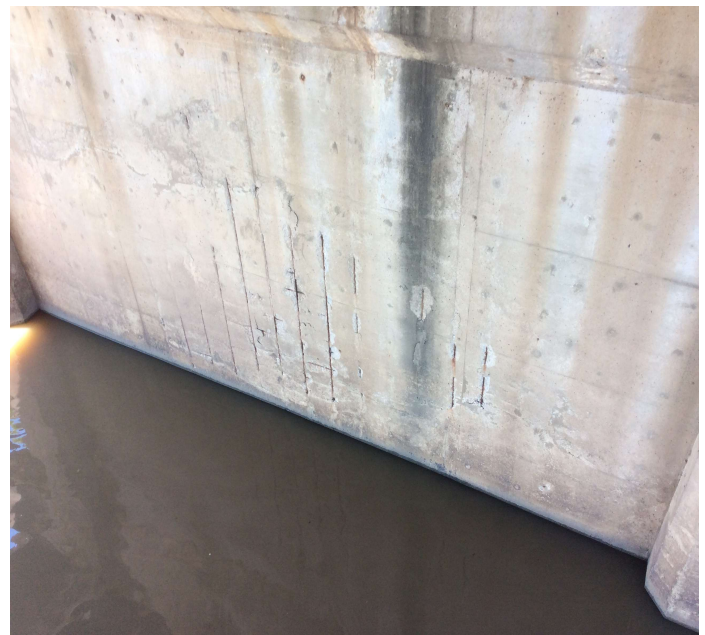
Shallow spalls with 40' exposed rebar on the ahead face of pier 1.

PHOTO 2 Description Pier wall: 1 spall with reinforcing steel exposed.

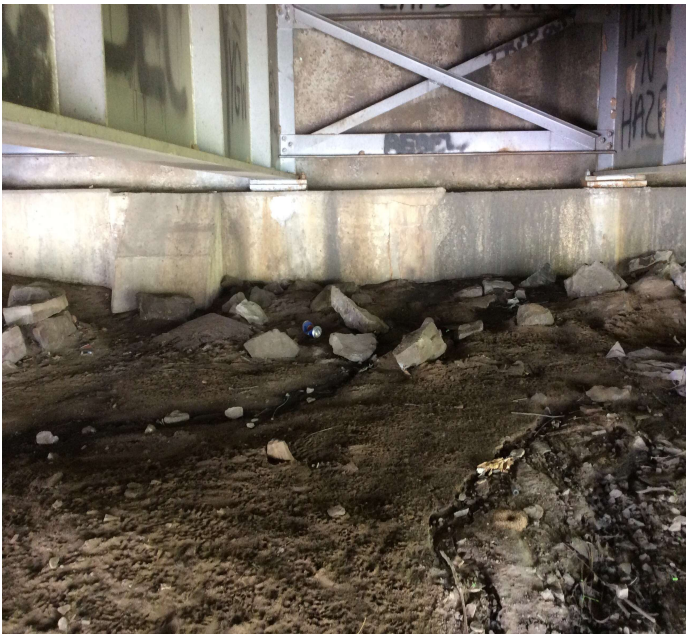
PHOTO 1 Description Abutment 1 Horizontal cracking in face.

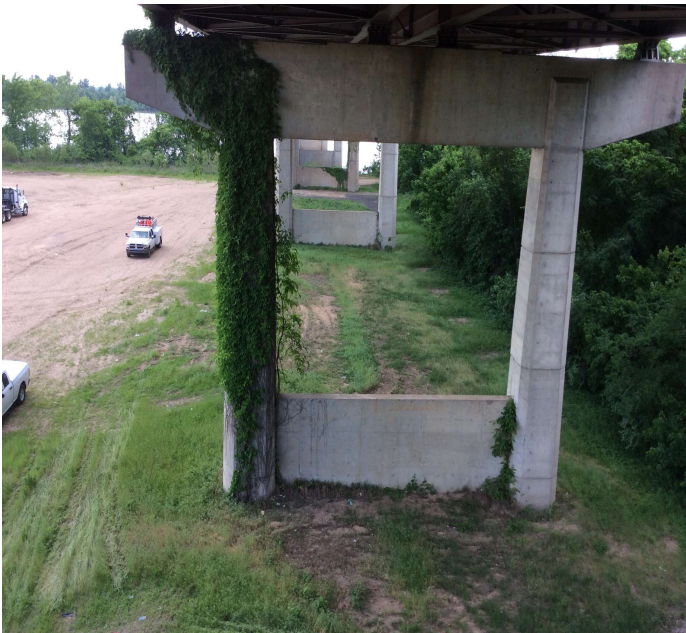
Vines growing on Piers 16, 18, 21 and 22.

PHOTO 1 Description Ahead side pier 18 vines climbing up column onto the cap.

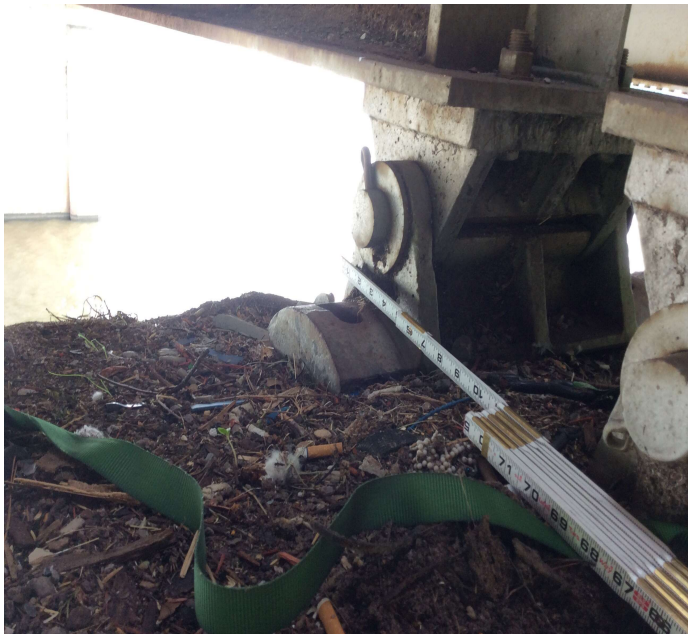
Pier 2: Two broken anchor bolts girder 5.

PHOTO 1 Description Pier 2 girder 5 both anchor bolts are missing at this bearing.

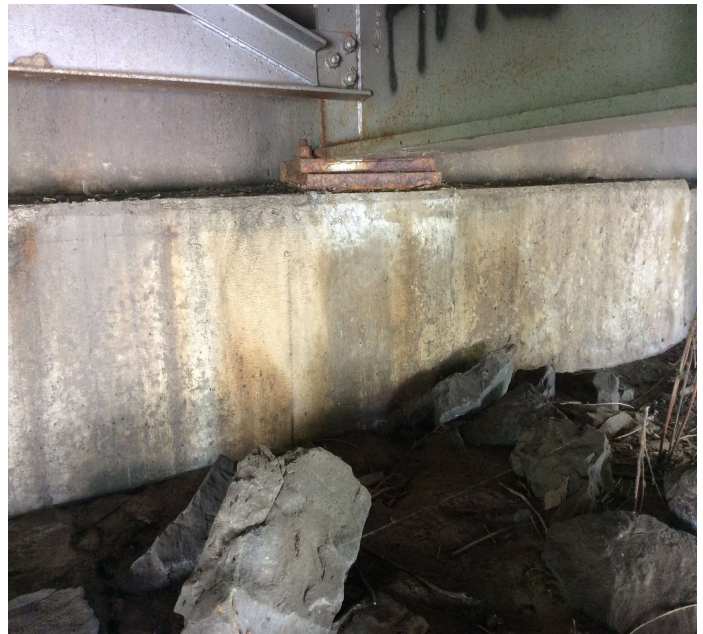
Bearings at Pier 1 thru 7 and at abutment 1 and 2 are rusting and corroding.

PHOTO 2 Description Abutment 1 girder 2: active corrosion and laminating rust to bearing, this is a typical condition of bearings at this abutment.

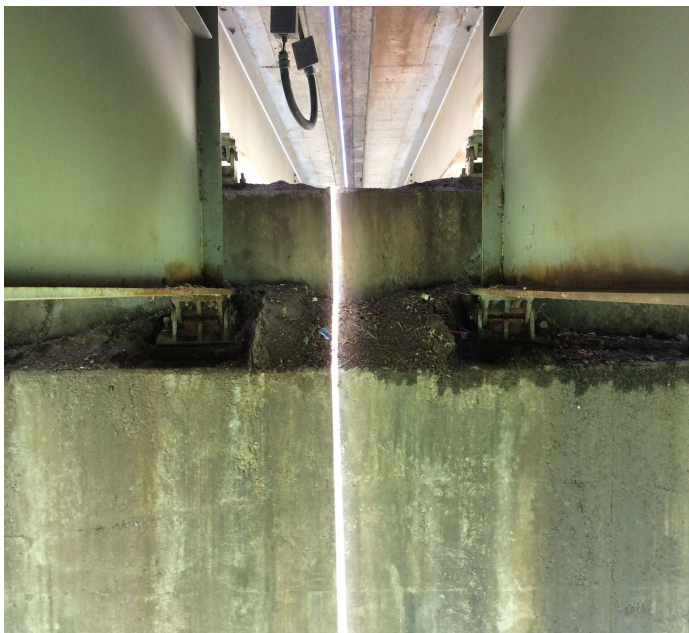
PHOTO 3 Description Debris has accumulated from the joint on to the backside of pier 23 between girders 4 and 5.

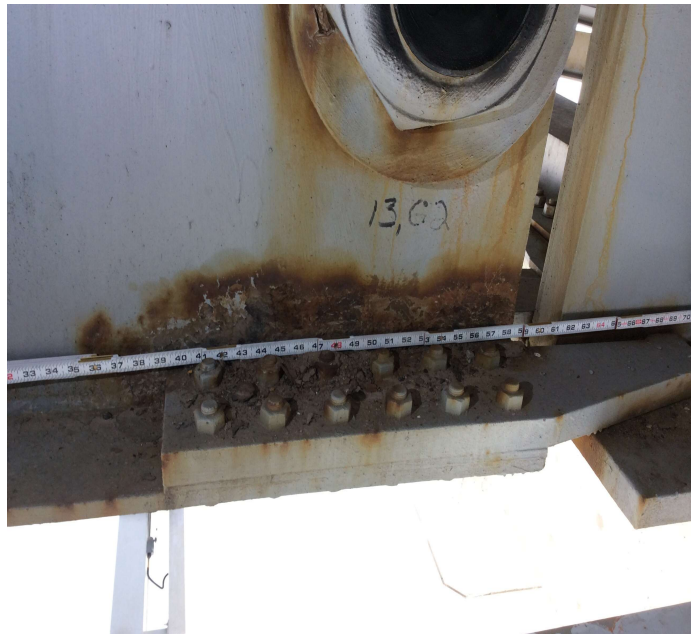
The wind locks have debris accumulating and active corrosion. Some of the bolts have up to 90% section loss.

PHOTO 1 Description 13A, girder 2 above the wind lock: a 20" long by 4" high area of laminating rust. Typical condition to all wind locks.

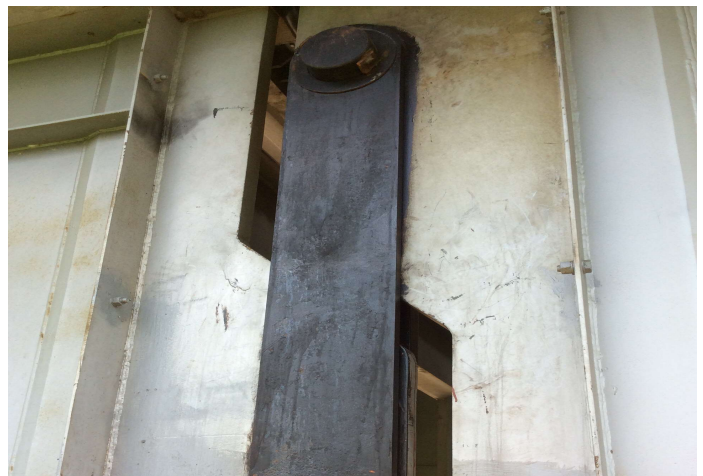
PHOTO 1 Description 17A girder 1, This pin and hanger assembly has been repaired. This picture represents the repair work performed.

17A pin and hanger assemblies have been repaired by HBM.

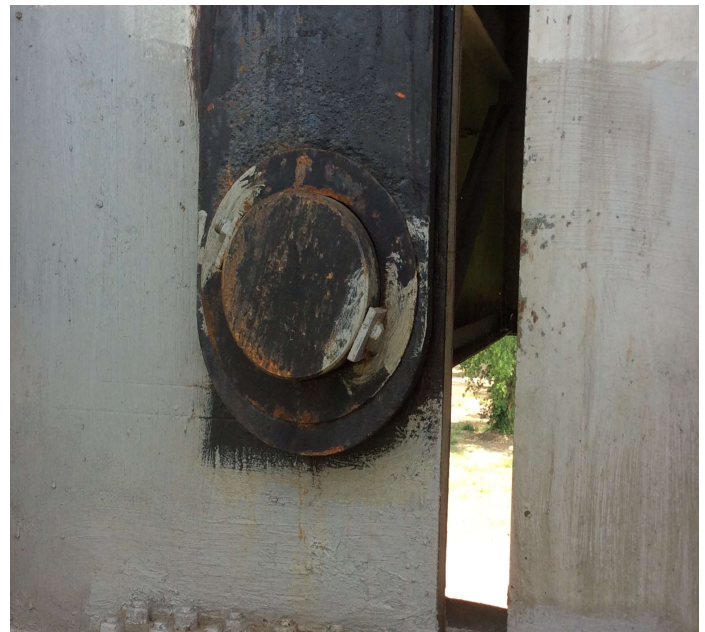
PHOTO 4 Description 17A girder 1 bottom pin. These pin and hanger assemblies have been repaired. This picture represents the repair work performed.

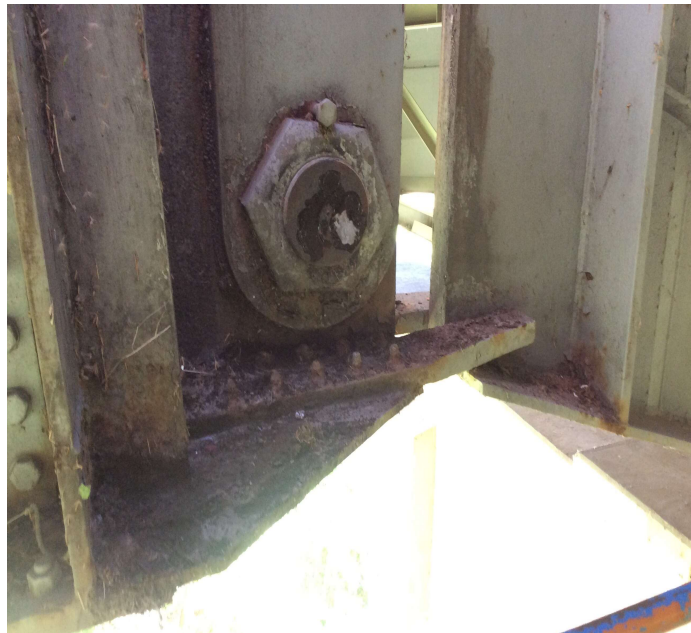
G1, G2, G3 & G4: Active corrosion. Pack rust between the web and the hanger bar. 1/16" to 1/8" section loss to the hanger. Not functioning. Frozen from corrosion.

PHOTO 5 Description Joint 20a Girder 3 active corrosion, nuts reduced to nodes.

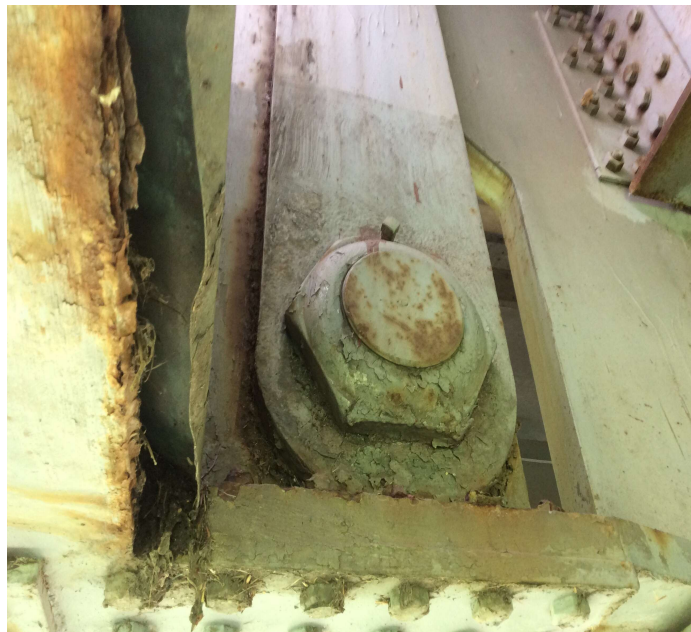
PHOTO 6 Description Joint 20a Girder 2 Pack rust in the hanger bars with section loss.

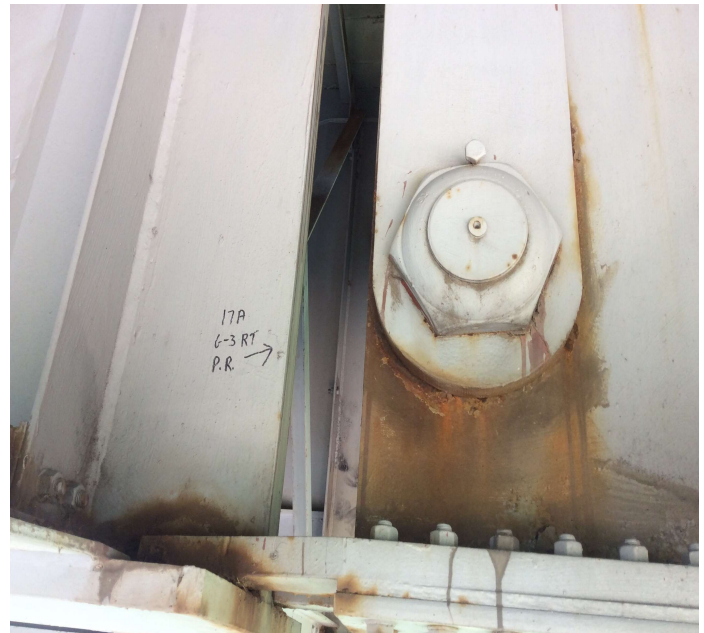
PHOTO 7 Description 17a Girder 3 pack rust with section loss in the hanger.

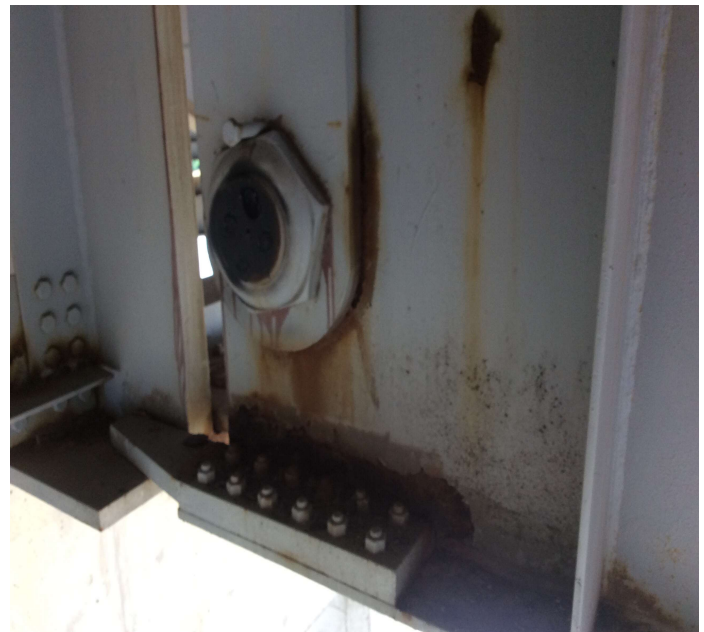
PHOTO 8 Description 13A Girder 3 1/8" section loss to web and 1/16" section loss to hanger bar. 1/4 pack rust

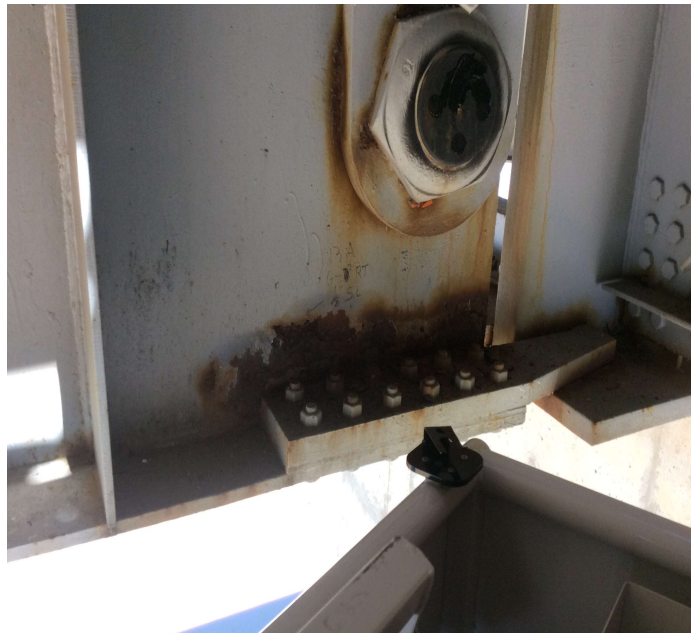
PHOTO 9 Description 13A Girder 2. 1/8 section loss to Girder 1/16 section loss to hanger bar.

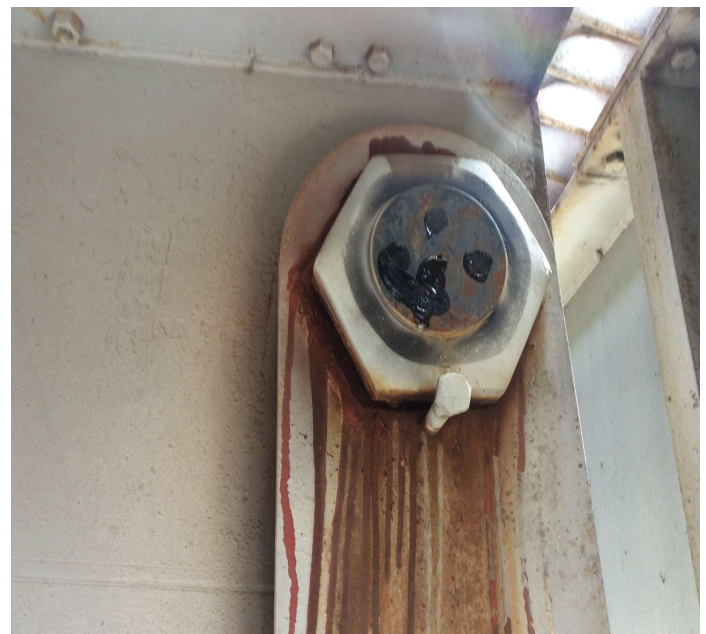
PHOTO 12 Description Joint 10A Girder 3. 3/16 section loss to the hanger bar.

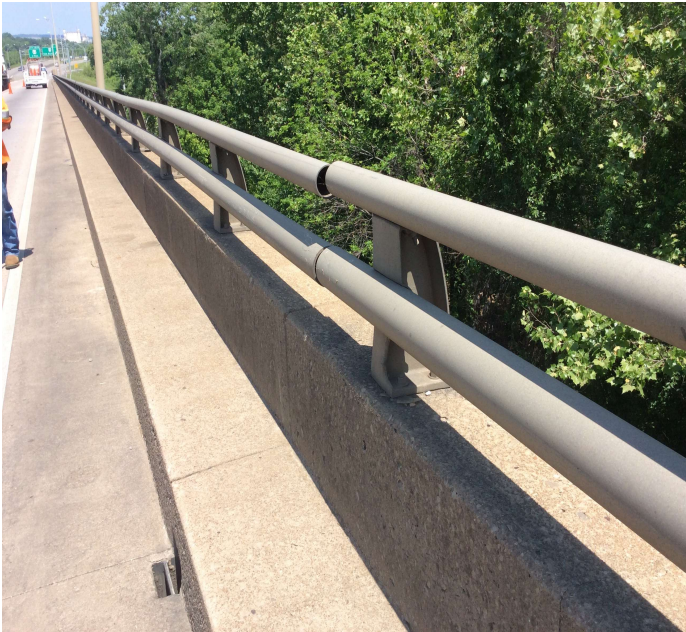
PHOTO 1 Description Span 20 Northbound loose bridge rail connections.

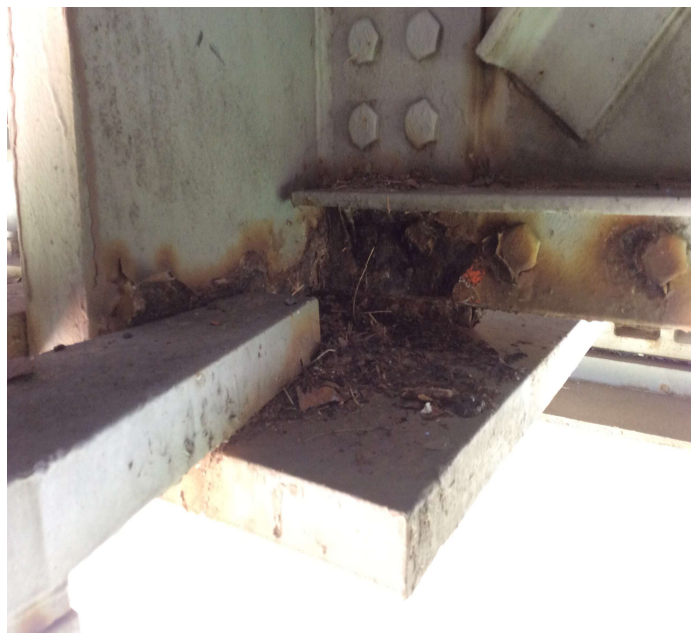
PHOTO 3 Description Joint 17A Girder 3 bolted connection reduced to nodes on two of four bolts.

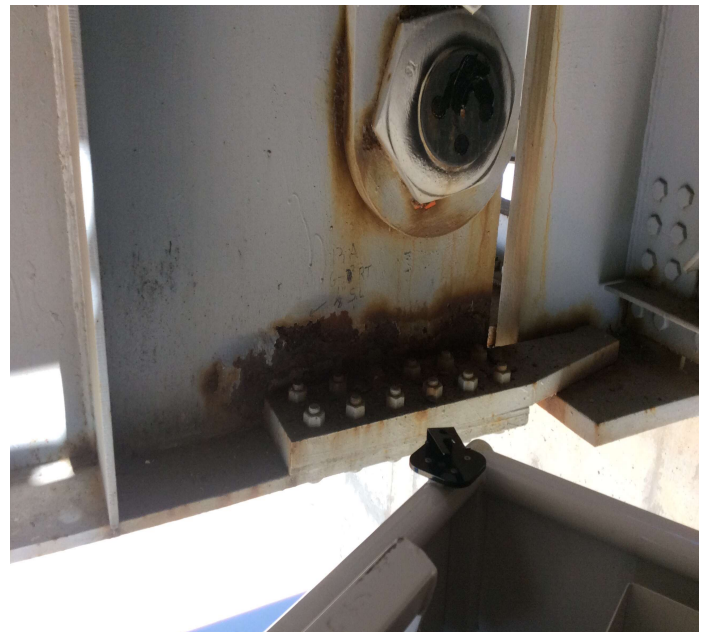
PHOTO 5 Description 13A Girder 2. 1/8 section loss to Girder 1/16 section loss to hanger bar.

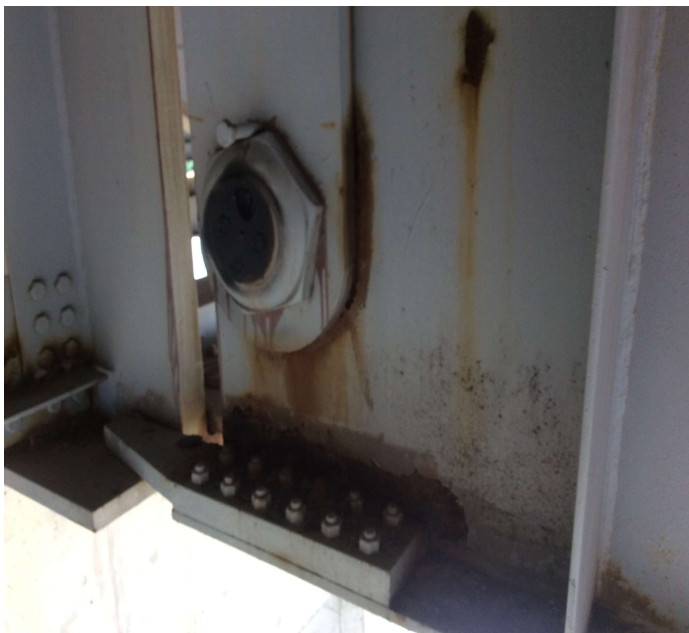
PHOTO 6 Description 13A Girder 3 1/8" section loss to web
and 1/16" section loss to hanger bar.
1/4 pack rust

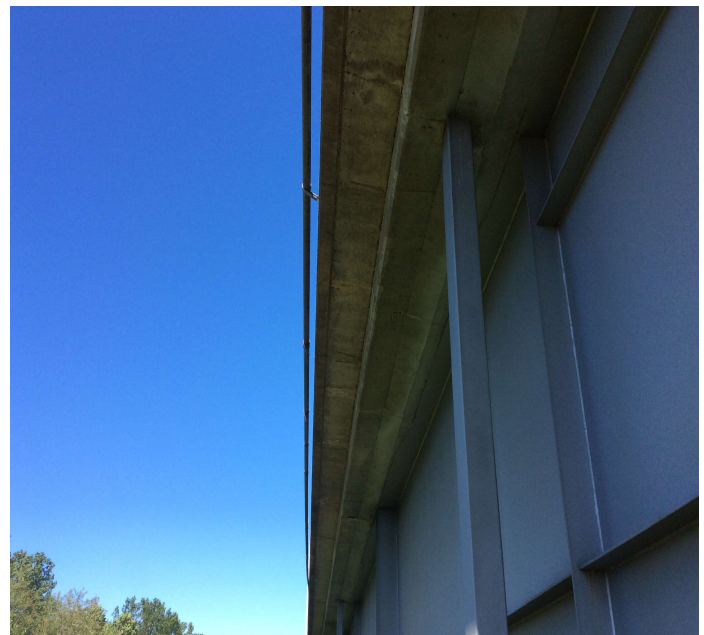
PHOTO 2 Description Span 17 loose utilities attachment.

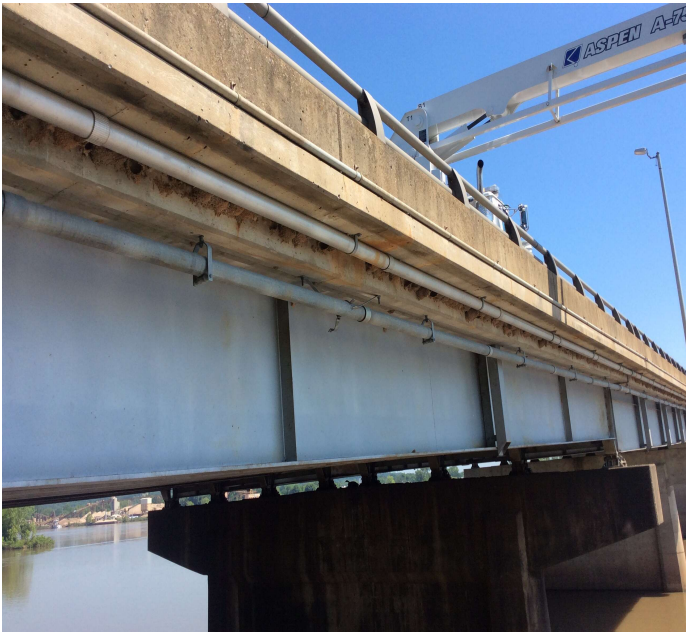
PHOTO 4 Description Missing brackets

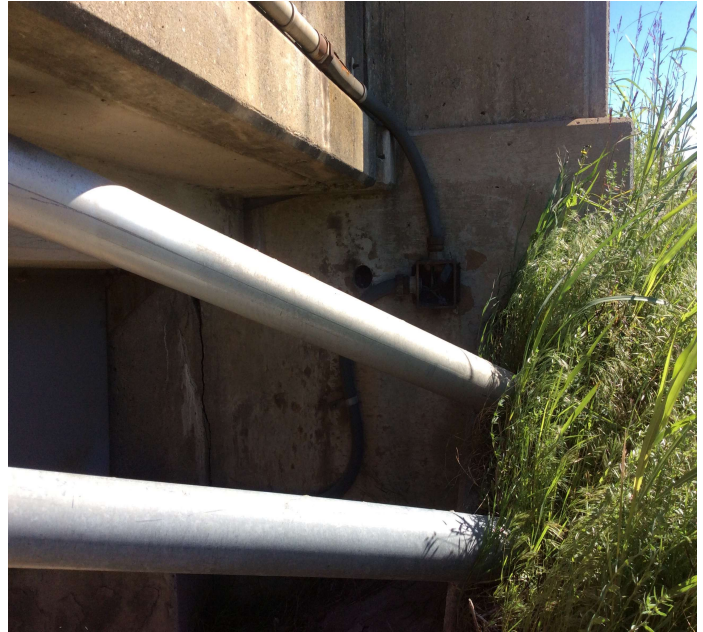
PHOTO 5 Description Abutment 2 right open junction box.

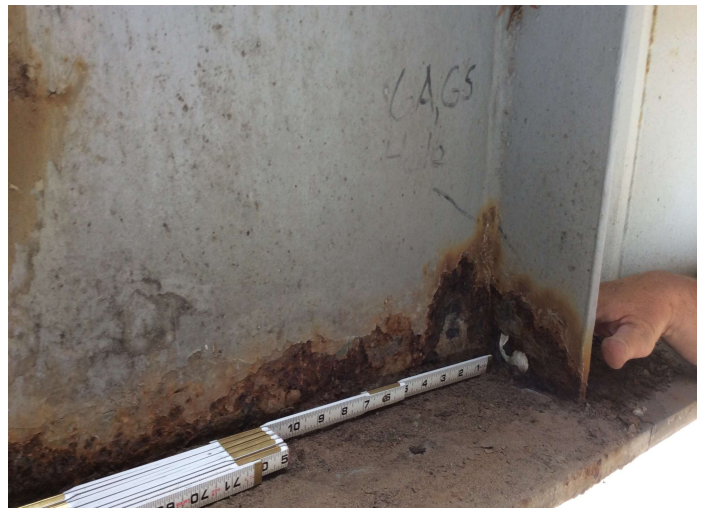
Sp. 6, Joint 6A, G5: 3" hole corroded through bottom of vertical stiffener. The bottom of the girder's web and the bottom flange has active corrosion and 1/8" to 1/4" section loss.

PHOTO 1 Description Left side of Girder 5 span 6 the last stiffener from the joint. Severe section loss to the lower section of the stiffener creating a 2" x 1 1/2" hole. Section loss also to the web and to the top of the bottom flange toward the joint at a length of 20". This is similar to Right side of girder 5 in the same span.

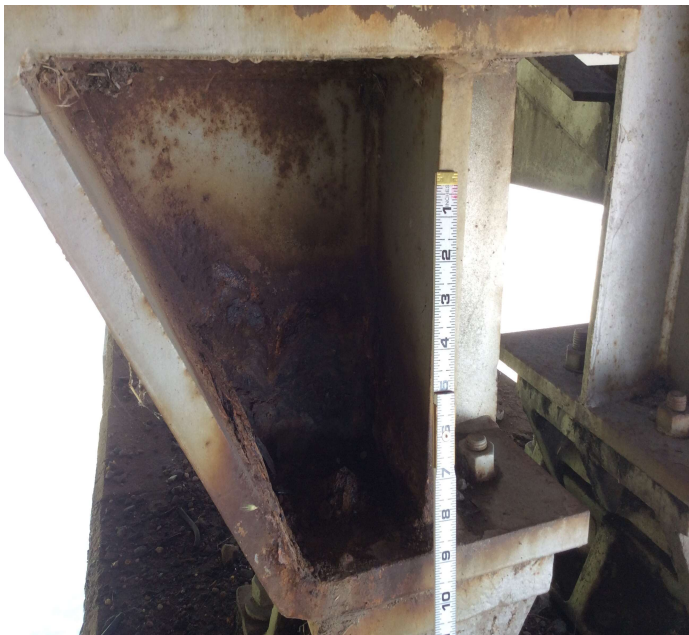
PHOTO 2 Description Span 2 girder 4 in the built up section at the end of the girder at pier 2. Dirt and debris from the joint is causing laminating rust at this location and also at girder 5.

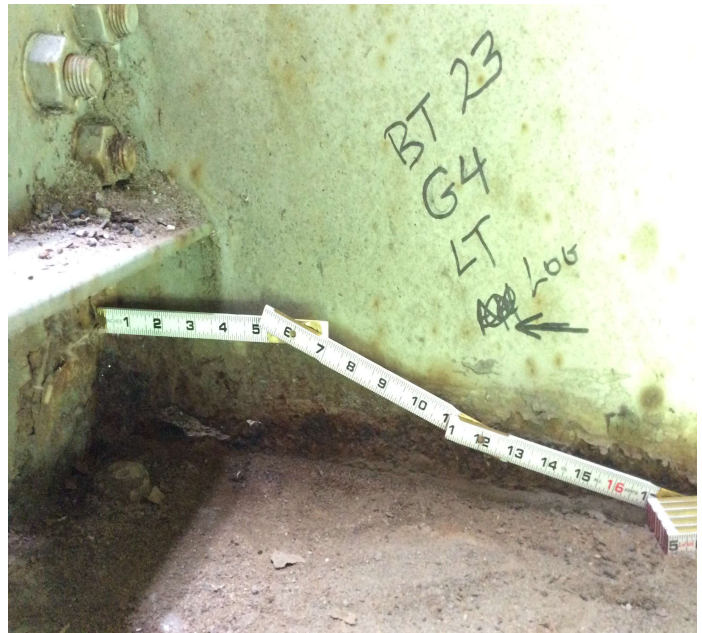
Bent 23, Girder 4: A 4"x1" hole in the web. Deep pitting to the lower web and flange.

Girder 3 at this bent has deep pitting and section loss to its lower web and top of the bottom flange.

PHOTO 3 Description Bent 23, Girder 4: A 4"x1" hole in the web. Deep pitting to the lower web and flange. Girder 3 at this bent has deep pitting and section loss to its lower web and top of the bottom flange.

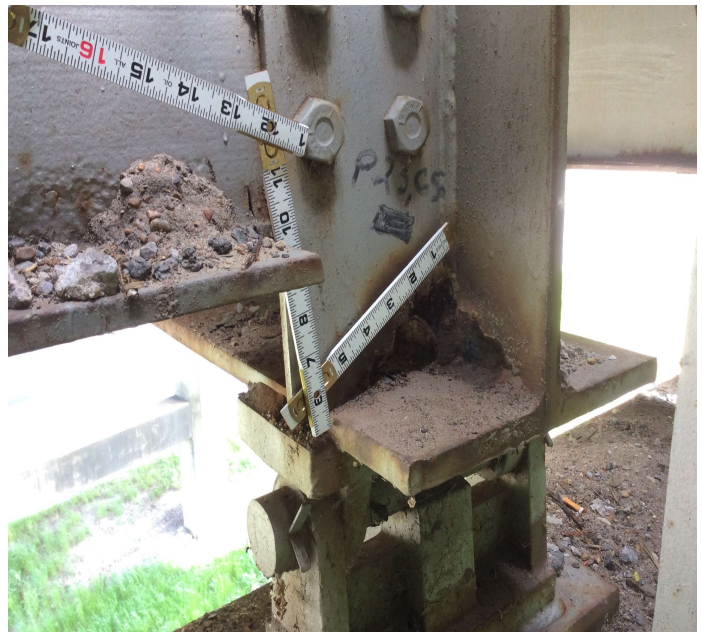
PHOTO 4 Description Pier 23 girder 5: a 2 3/4" by 1 1/2" hole at the bottom of the stiffener.

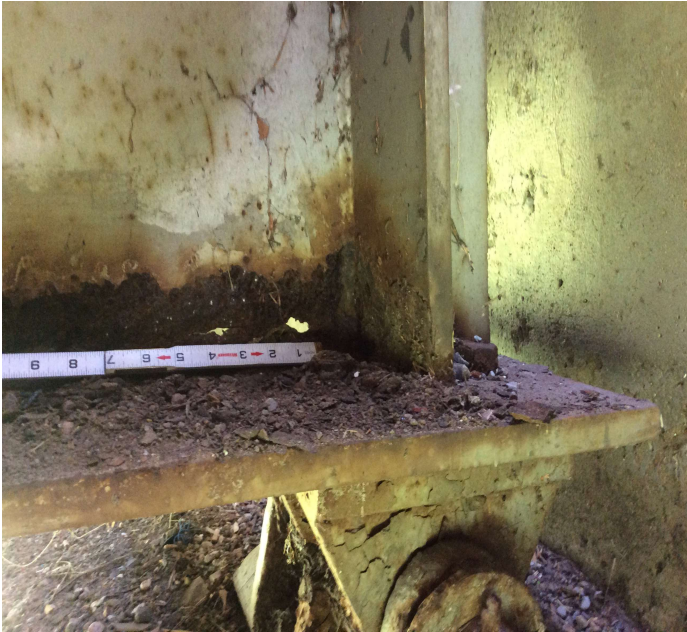
PHOTO 5 Description Pier 23 back Girder 4: Hole in Bottom of web 4 1/2" x 1".

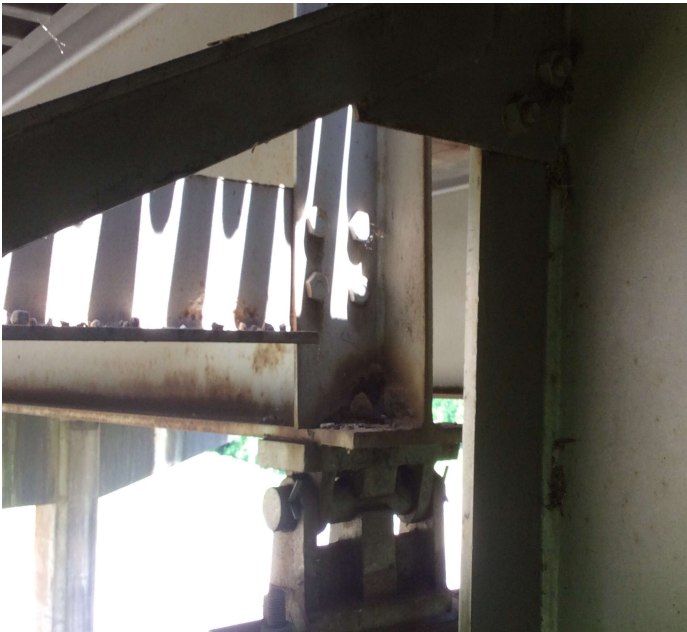
Pier 23, G5, Ahd: 3" hole corroded through bottom of girders vertical stiffener in bearing area. The bottom of the girder's web and the bottom flange has active corrosion and 1/8" to 1/4" section loss.

PHOTO 6 Description Pier 23: G5, Ahd: 3" hole corroded through bottom of girders vertical stiffener in bearing area.

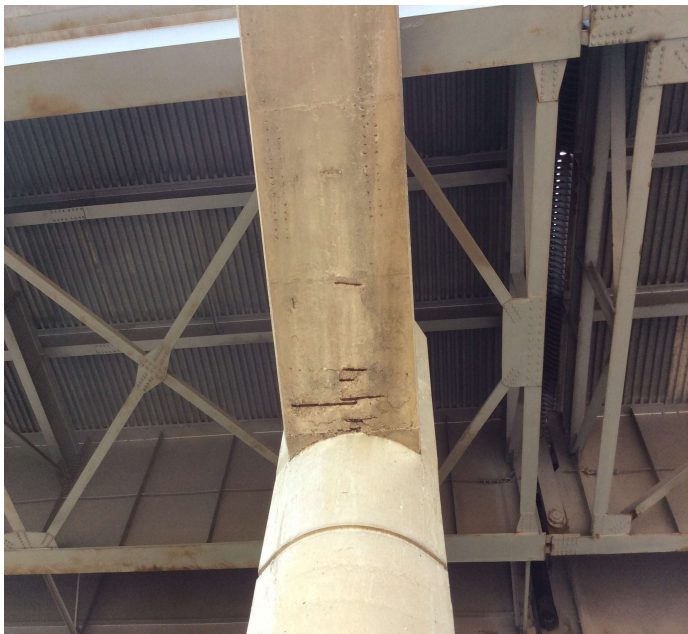
8' exposed rebar on the underside of the cap right end of pier 16.
Debris on seat at Pier 1, 2, and 23.

PHOTO 1 Description Bent 16 bottom cap right side Spalls with exposed rebar. This is the worst condition at this structure.

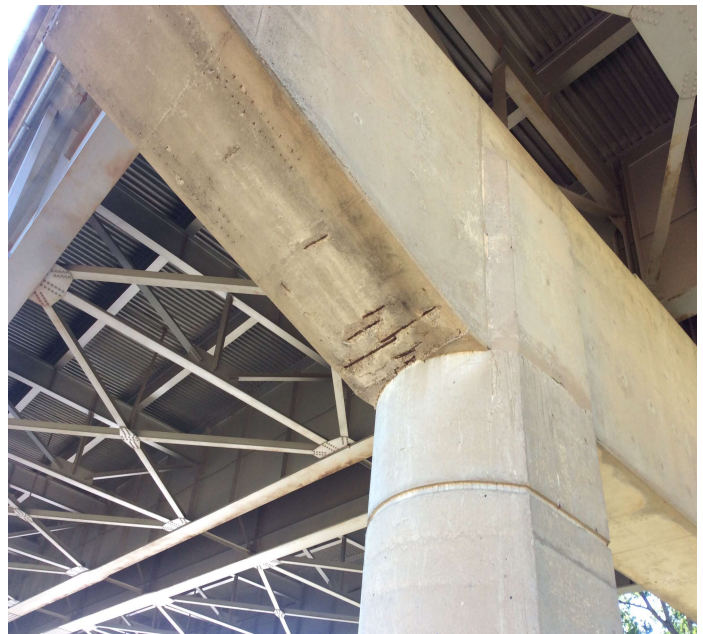
PHOTO 2 Description Bent 16 Right cap spalling with exposed reinforcing steel in under side of cap.

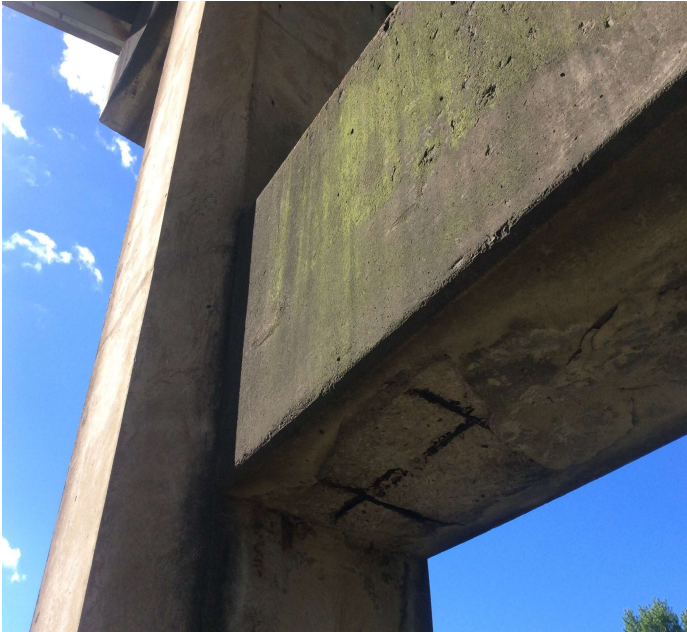
PHOTO 3 Description Pier 24 Spalling with exposed reinforcing steel on under side of cap.

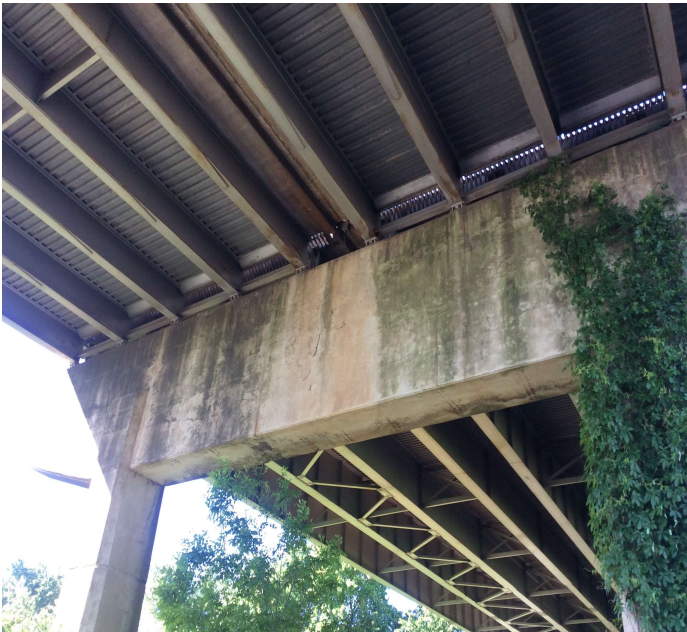
PHOTO 4 Description Pier 23 Delaminations in the face of cap.

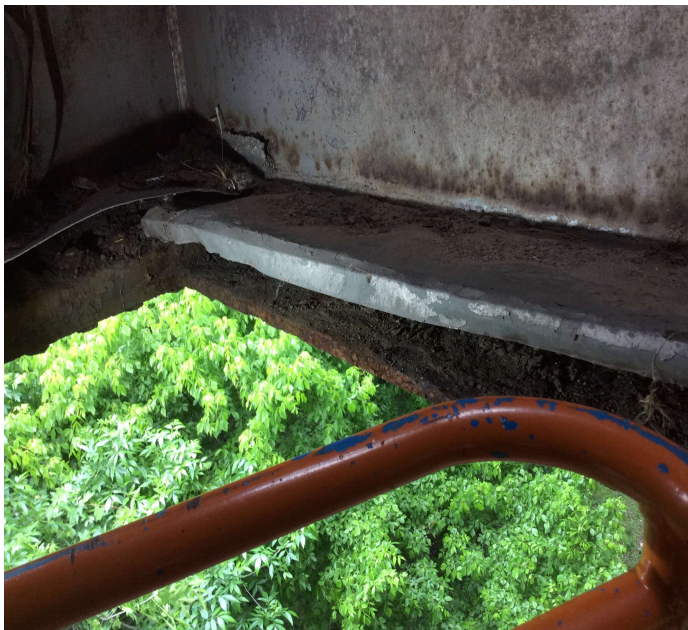
Span 20, Joint 20A: The floorbeams have section loss from 1/16" to 1/8" to the bottom member at the floorbeam to girder connections. The bottom flange of the floorbeam on the backside has sheet metal installed to prevent debris from accumulating on the flange. 1/8" section loss has occurred to the bottom flange under this plate. Debris has accumulated on all horizontal surfaces. Typical condition at these locations.

Joint 20A the bottom flange of floor beam under the protective sheet metal shield has active corrosion with section loss up to 1/8". This condition is typical to 10A, 13A, and 17A floor beams.

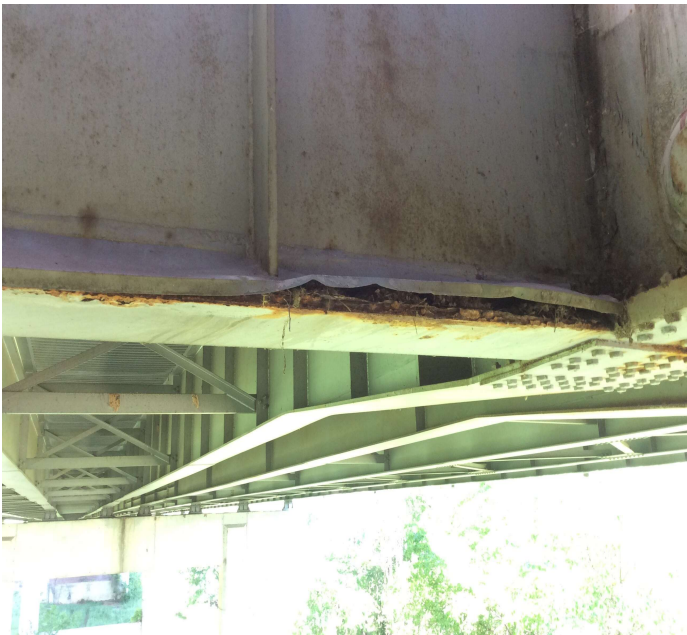
PHOTO 6 Description Joint 20A Protective cover failing active corrosion.

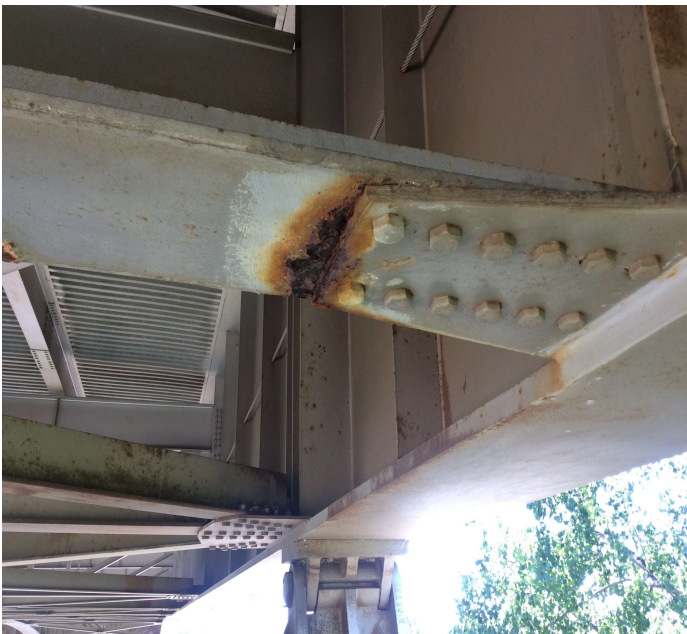
PHOTO 7 Description Span 17 Girder 1 joint 17A active corrosion with section loss to stringer connection.

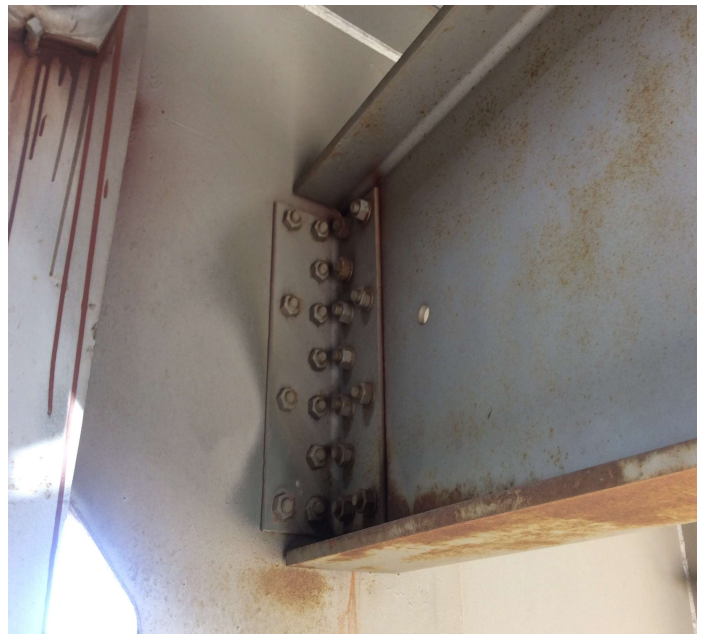
PHOTO 9 Description Pier 10 First Floor beam back on Girder 1 loose bolted connection.

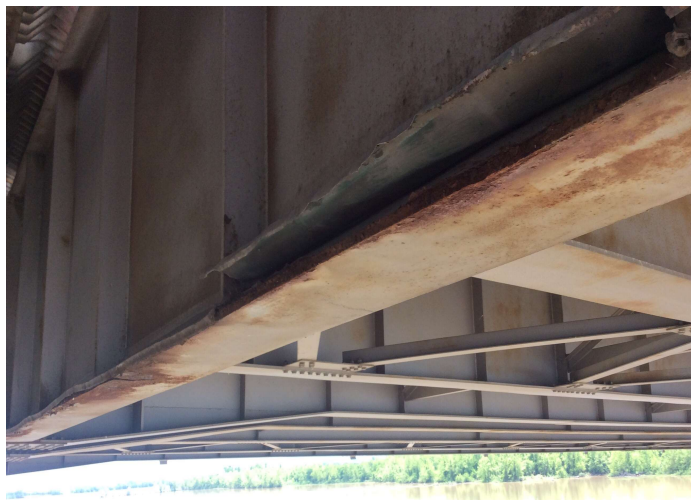
PHOTO 10	Description	Spire 10 Second floor beam. Back flaking rust with up 1/8 section loss
----------	-------------	--
