Bridge Inspection Report

A3604
I 540, SB LNS
over
Free Ferry St. Seb. Co.

Structure Number: A3604

Facility Carried: I 540, SB LNS

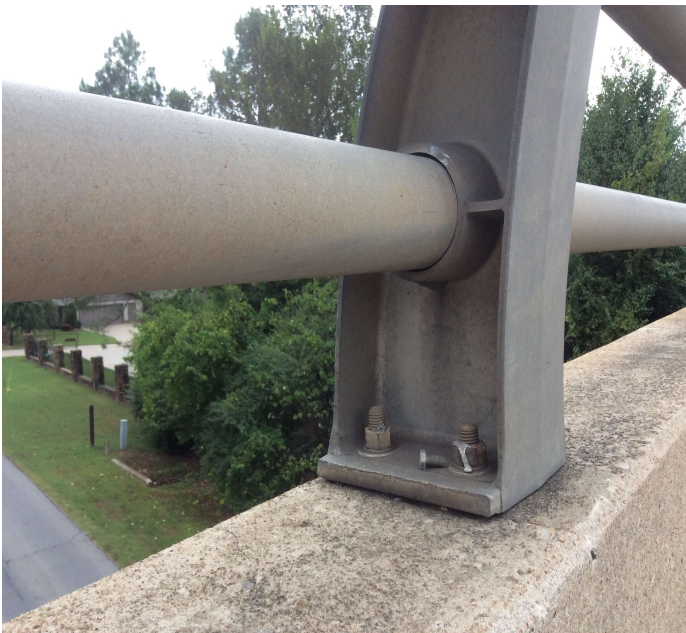
The metal portions of the bridge railing have loose connections.

PHOTO 1 Description Loose bridge rail. Connection bolt laying on the base of the post.

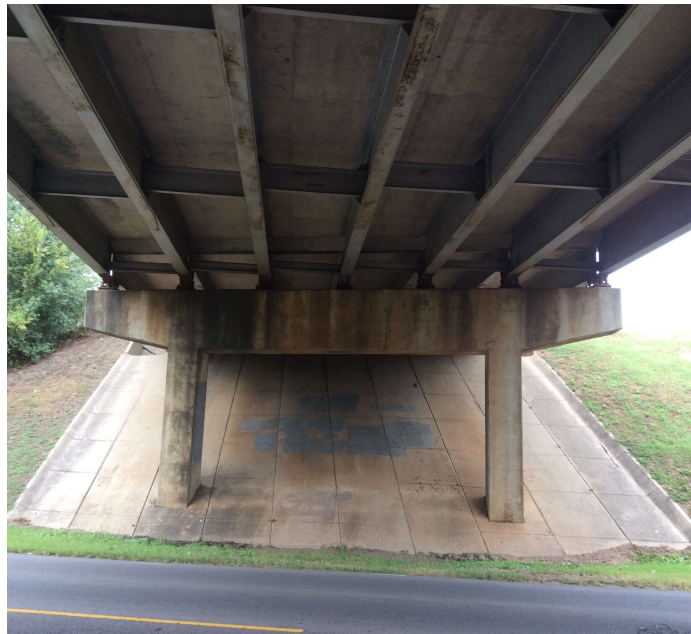
The paint system is deteriorating and flaking off in locations with rust forming. The ends of beams over the intermediate bents are the most extreme case. The top flanges have isolated areas of active corrosion.

PHOTO 1 Description Bent 3. Typical

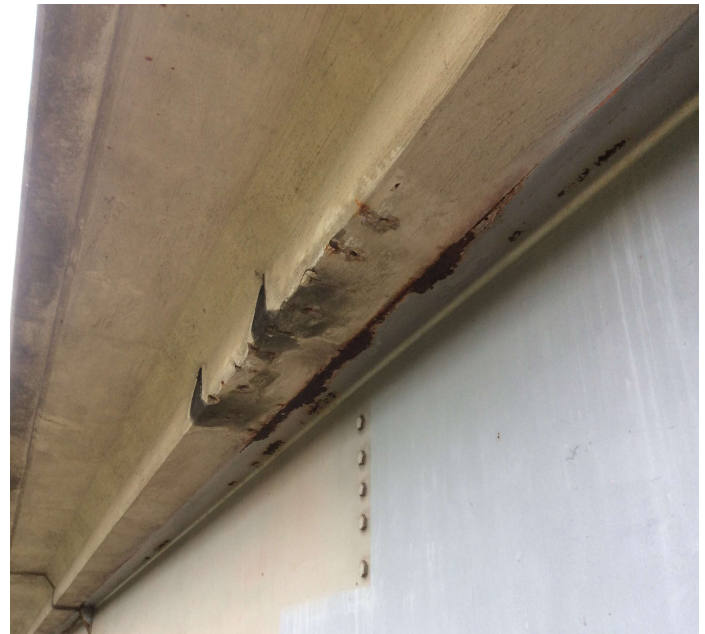
PHOTO 2 Description Span 3. Right side

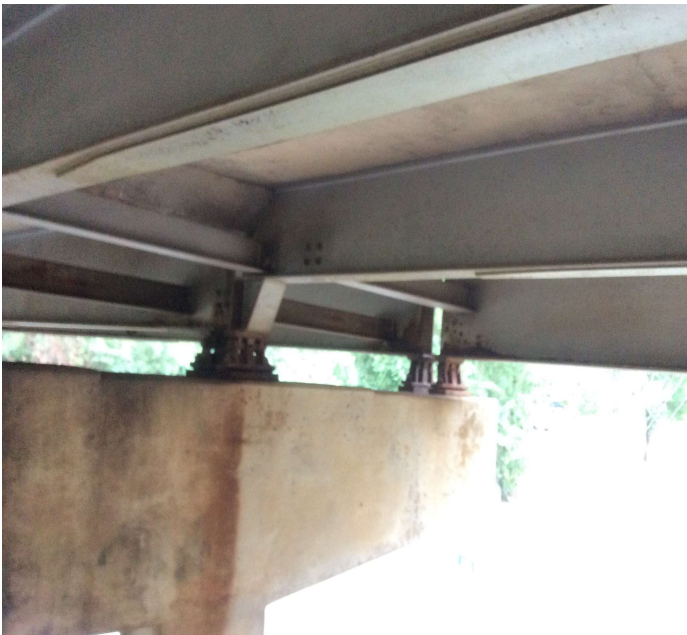
PHOTO 3 Description Bent 3 Beams 1&2 corrosion

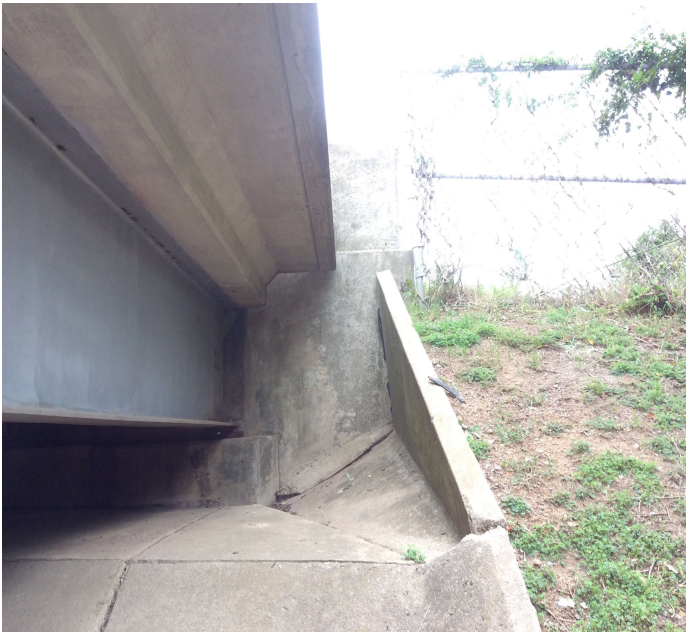
The left earth retaining walls adjacent to Bents # 1 & 4 have settled and are leaning.

PHOTO 1 Description Bent 1 Left retaining wall

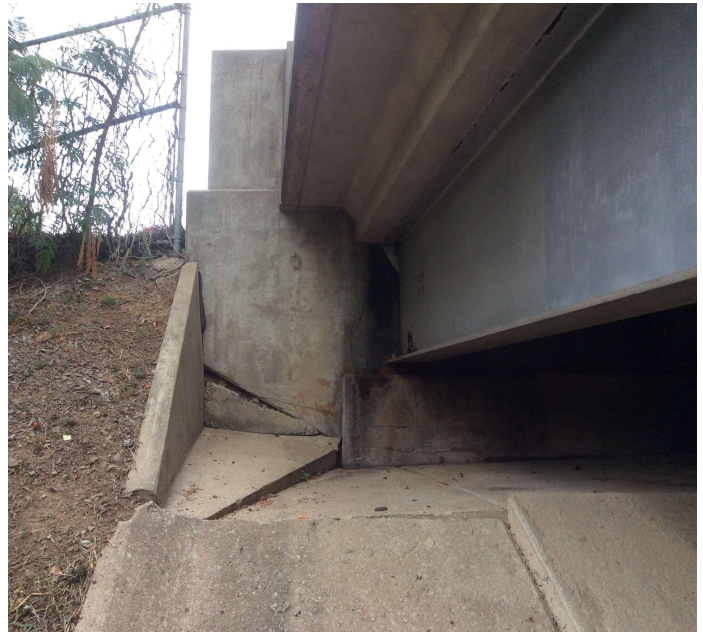
PHOTO 2 Description Bent 4. Left side

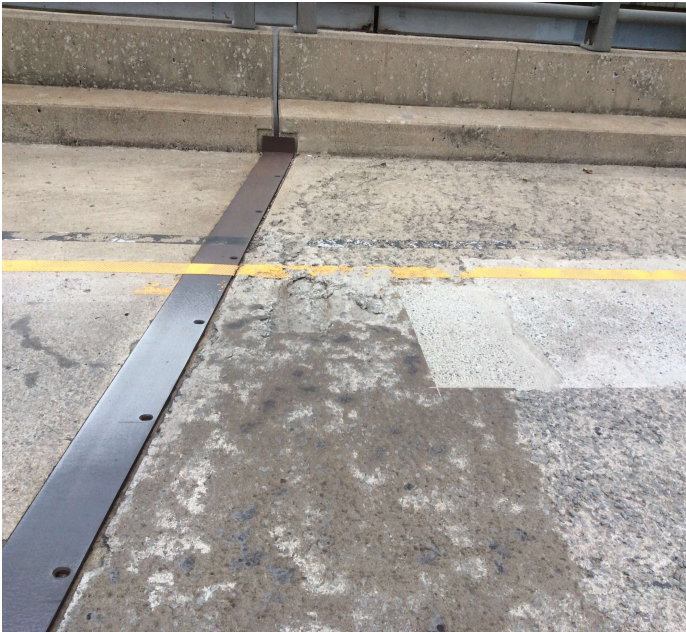
The driving surface of the deck has a spall in the Right lane of Span # 1 near the yellow line and adjacent to Bent # 2. The area surrounding the spall is delaminated.

PHOTO 1 Description Right side of span 1. Spall with exposed reinforcing steel

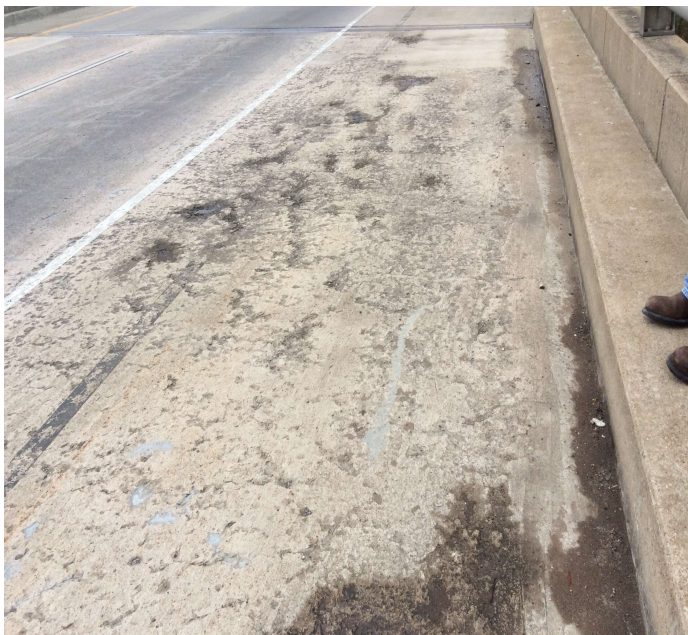
PHOTO 1 Description Span 1, Left gutter

The driving surface of the deck has medium / heavy scaling in the gutters.

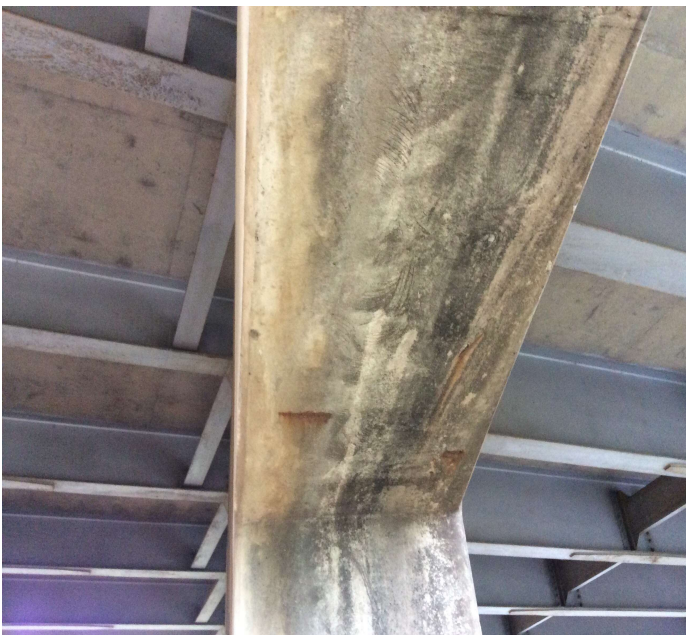
PHOTO 1 Description Bent 3, Undersurface of the Left side of cap.

Bent # 3 has shallow spalling in the undersurface of the cap on the left side.
