Bridge Inspection Report

B3604
I 540, NB LNS
over
Free Ferry St. Seb. Co.

Structure Number: B3604

Facility Carried: I 540, NB LNS

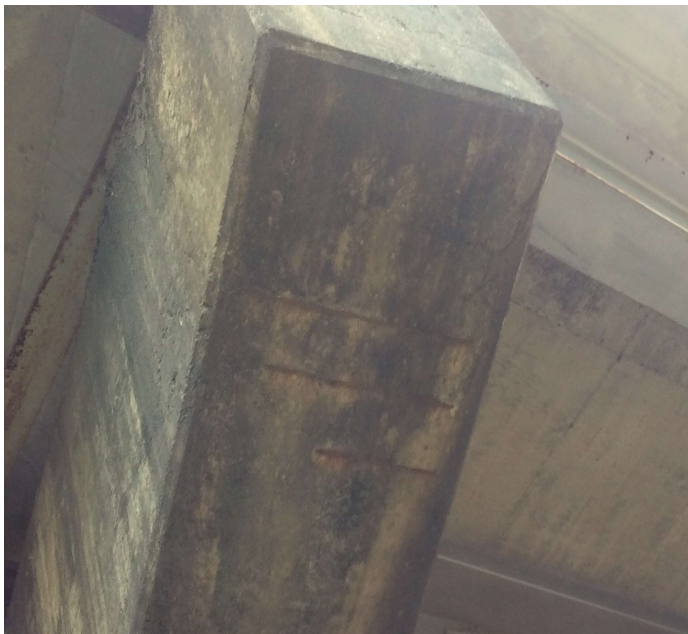
PHOTO 1 Description

Bent # 3 has shallow spalling with exposed reinforcing steel in the undersurface of the cap on the right side.

The back wall of the south abutment has several shallow baseball size spalls with exposed reinforcing steel at the juncture of the bridge seat.

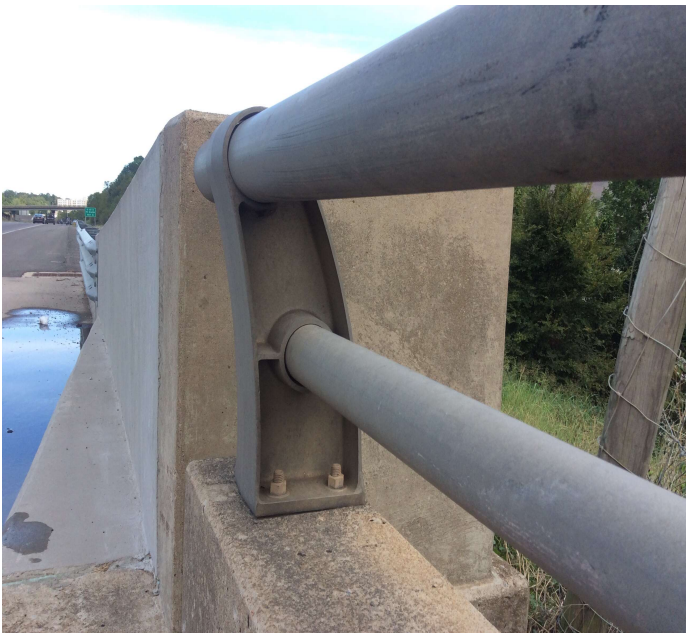
The metal portions of the bridge railing have loose connections.

PHOTO 1 Description Loose bridge railing.

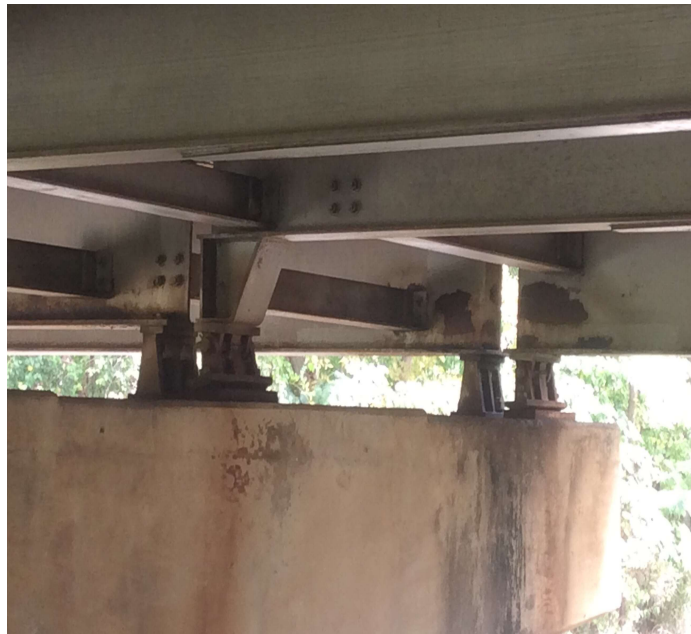
The superstructure paint system is failing with areas of flaking paint and active corrosion. The beam ends over the intermediate bents are the most extreme case.

PHOTO 1 Description Beams 6&7. Bent 2

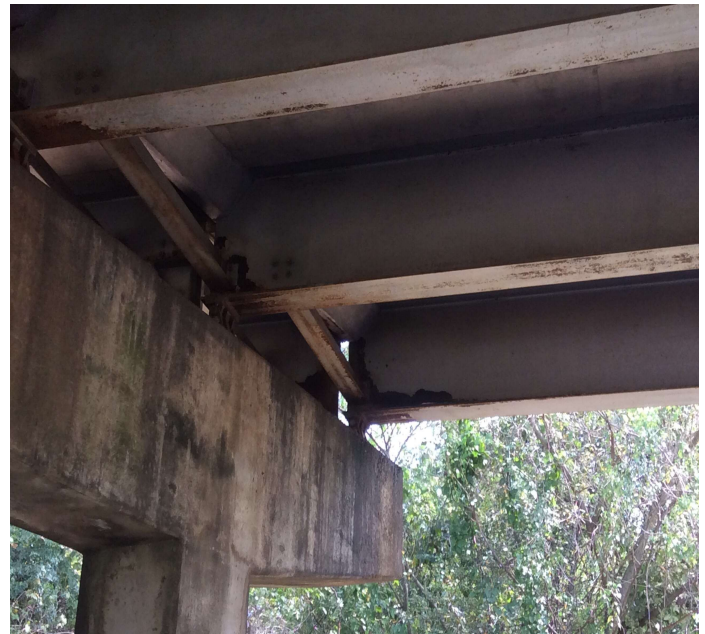
PHOTO 2 Description Bent 3. Beam 7

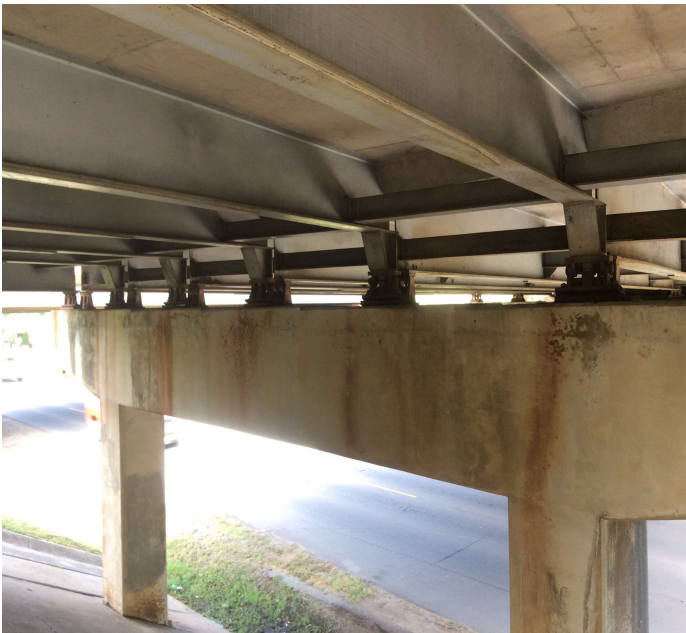
PHOTO 3 Description Bent 2. Typical

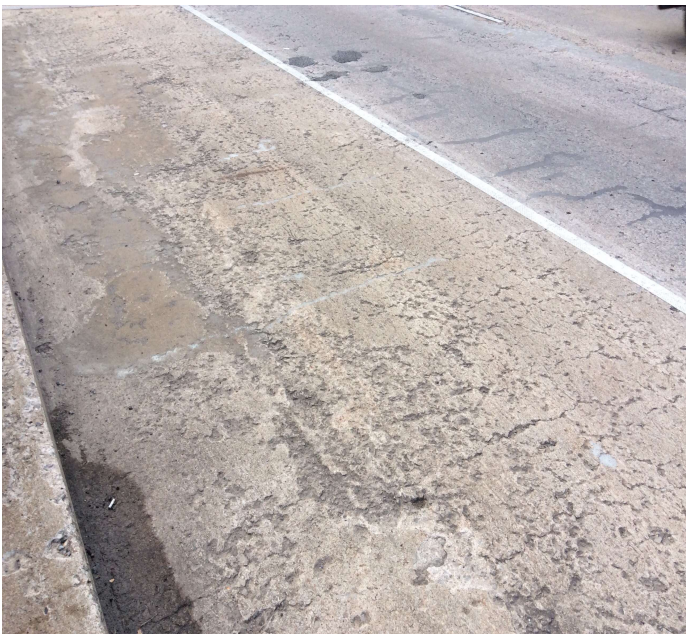
The driving surface of the deck has areas of heavy mapcracking with delaminated areas and spalls in the right lane of spans # 1 and # 3. The gutters have medium / heavy scaling with delaminated areas. The undersurface of the deck has mapcracking in several locations.

PHOTO 1 Description Span 3. Right gutter

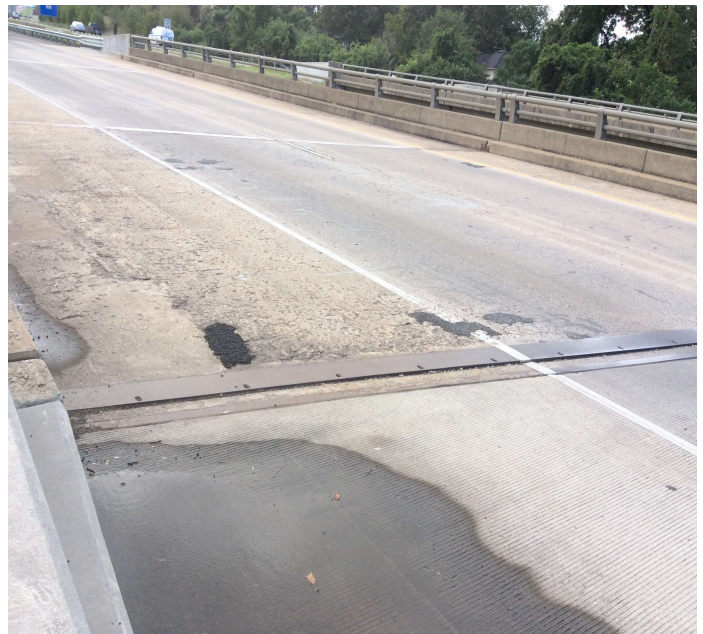
PHOTO 2 Description Span 3. Typical

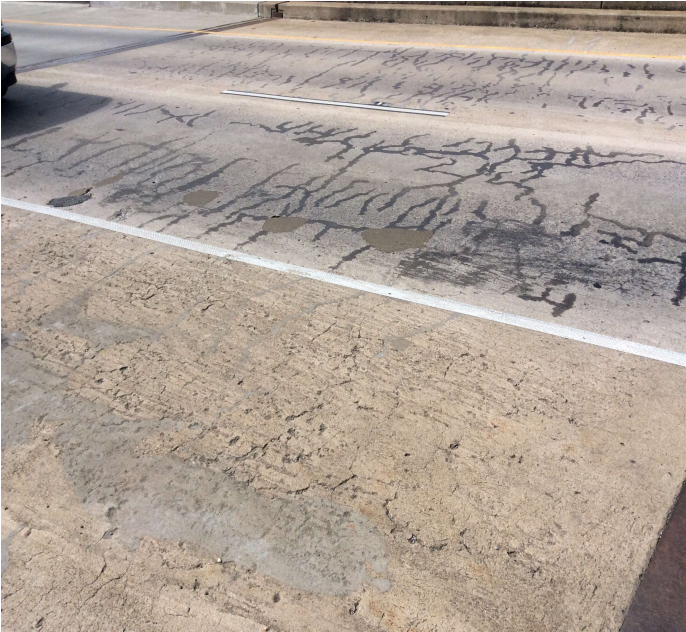
PHOTO 3 Description Span 1. Typical

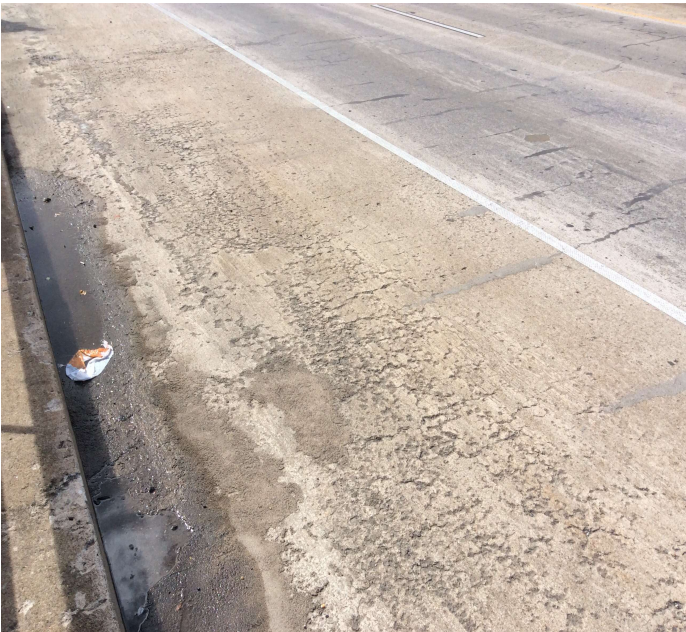
PHOTO 4 Description Span 2. Right gutter

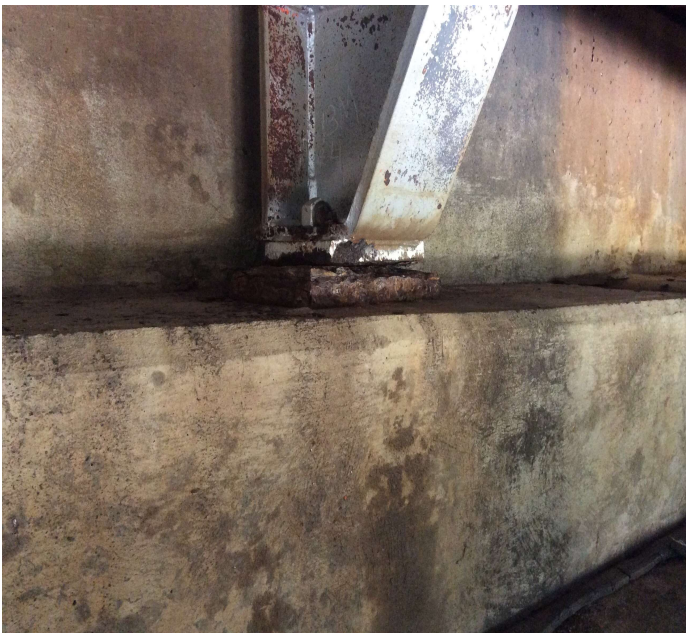
Bearings - The bearings for beams # 2, 3, 4, 5, and 6 have sheared anchor bolts at the south abutment.

PHOTO 1 Description Bent 1. Beam 4.
