Bridge Inspection Report

A3956

Interstate 540 SB

Flat Rock Creek-Crawford

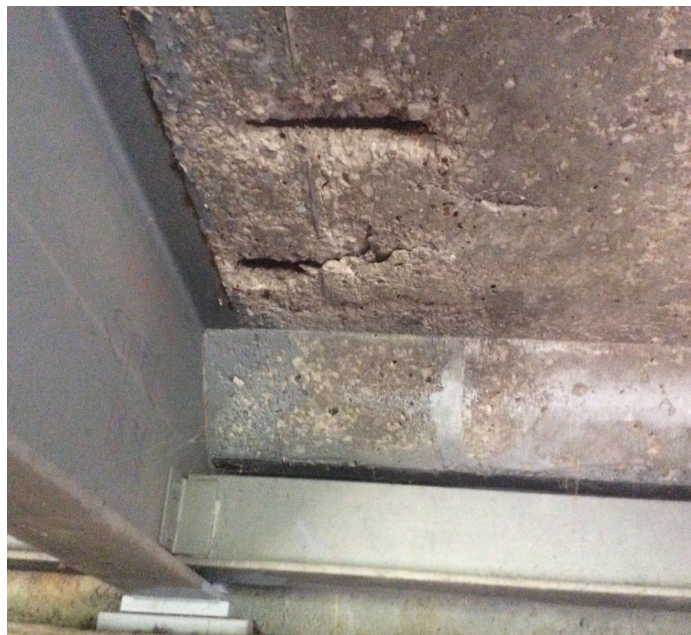
PHOTO 1 Description The undersurface of the deck in Bay 1 of Span 1 near the South abutment has an area of spalling with exposed reinforcing steel with the area surrounding the spall is delaminated in locations.

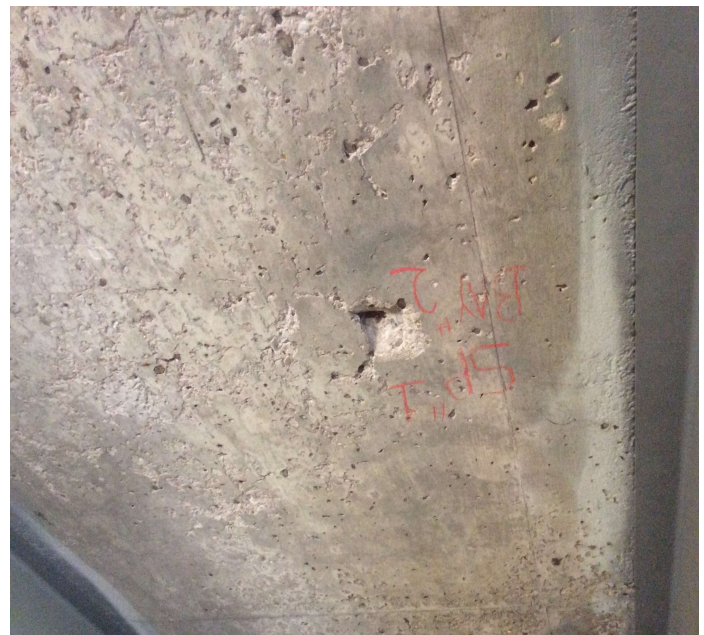
PHOTO 2 Description The undersurface of the deck in Bay 2 of Span 1 has an area of spalling with exposed reinforcing steel.

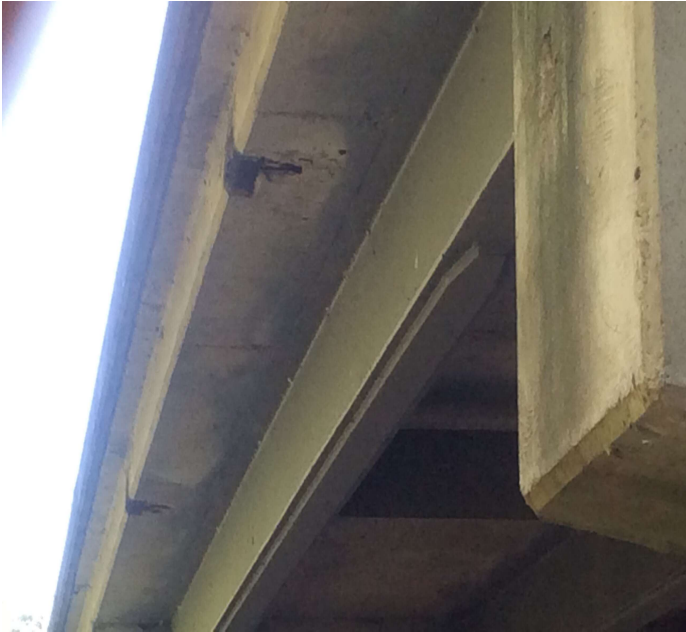
PHOTO 3 Description The overhang portion of the deck on the Lt side has spalling with exposed reinforcing steel adjacent to deck drains.

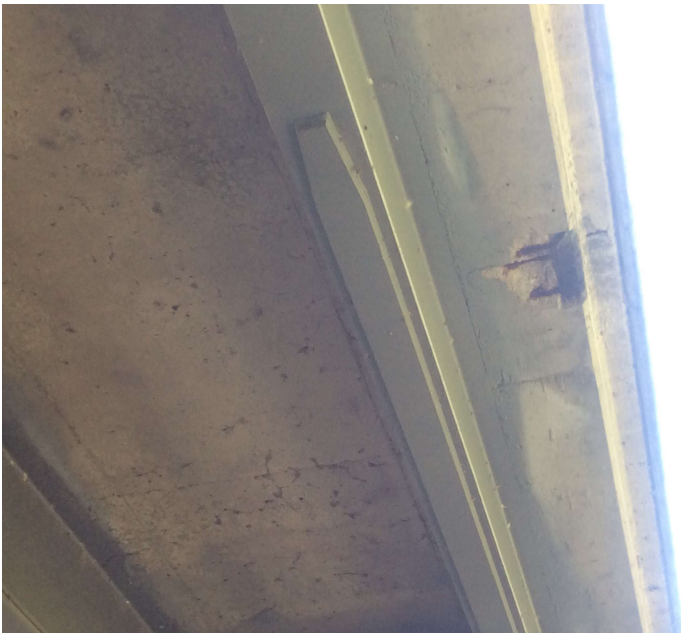
PHOTO 4 Description The overhang portion of the deck on the Lt side has spalling with exposed reinforcing steel adjacent to deck drains.

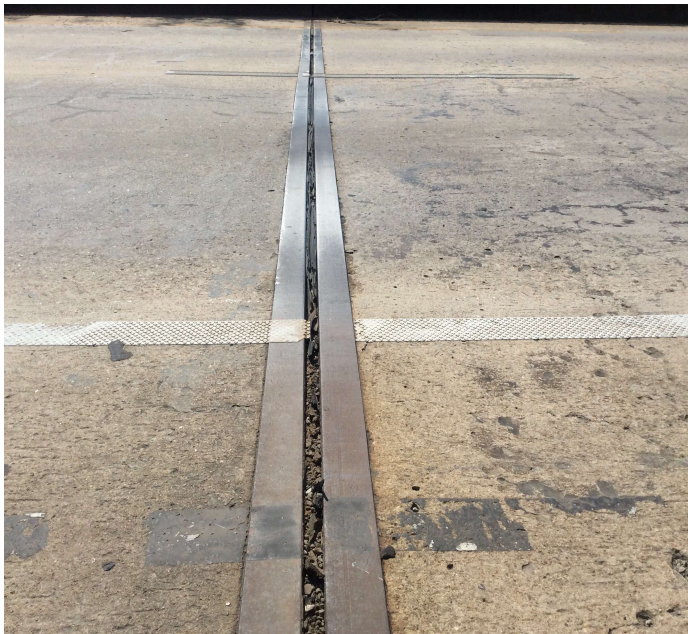
PHOTO 1 Description Compression seals are deteriorated and torn in locations.

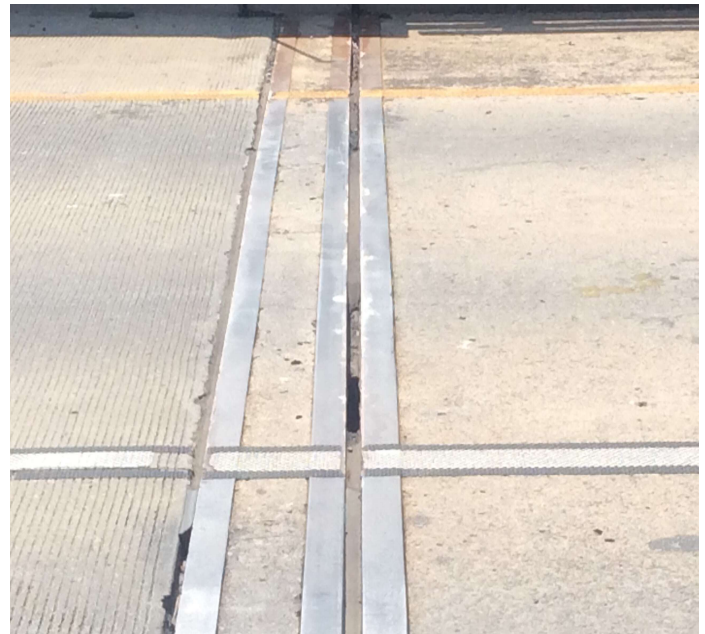
PHOTO 2 Description The poured silicone seal at Bent 4 has adhesion failure in locations.

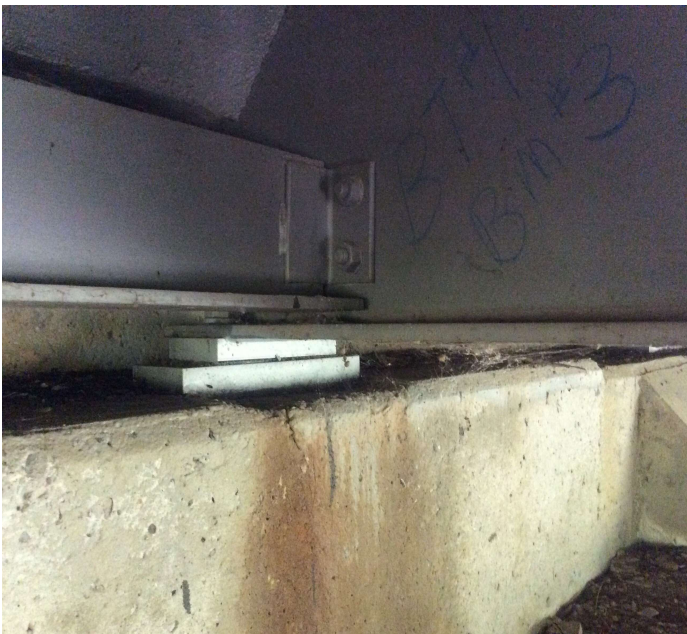
PHOTO 1	Description	Bearings have fine metal powder between the masonry plates and the sole plates indicating excessive movement during traffic impacts. Visible (Approximately 1/16") movement in the bearing at Bent 1, Beam 3 during traffic impact at this inspection.
---------	-------------	--

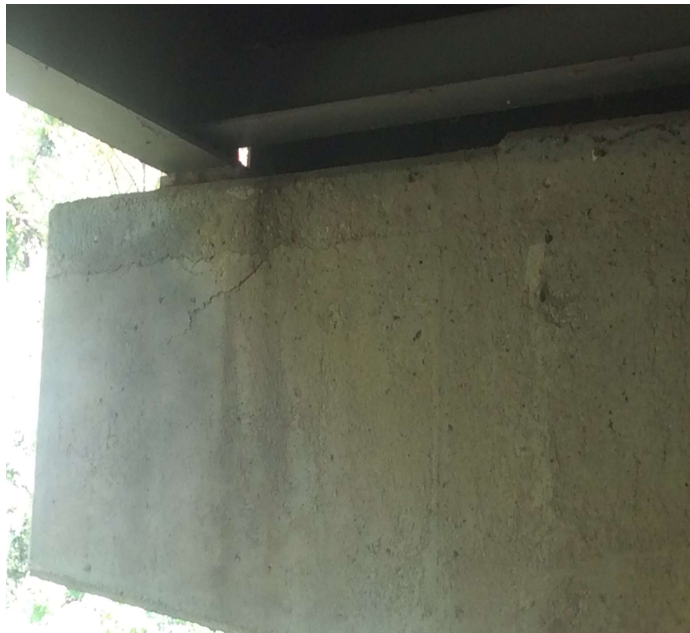
PHOTO 1 Description The Lt end of Bent 2 cap has a 4' long horizontal crack located approximately 8" below the top of cap.

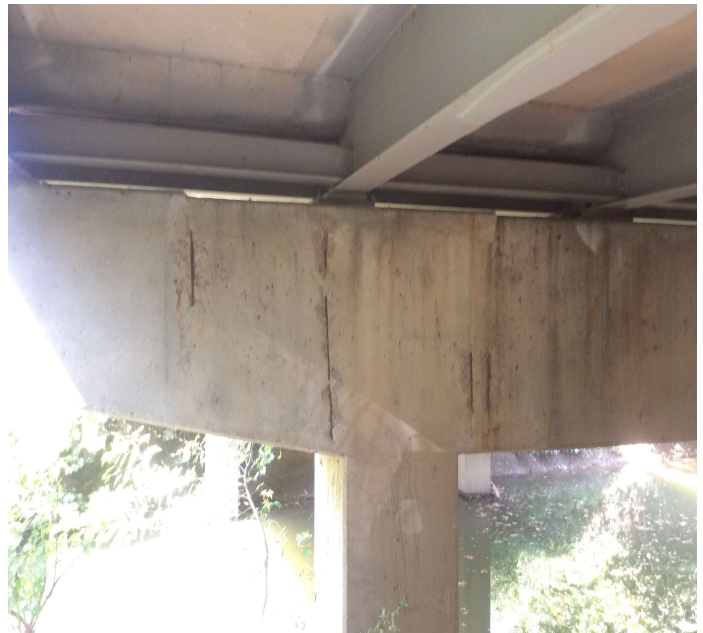
PHOTO 2 Description Span 3 side of Bent 3 cap has delaminated areas and shallow spalling with exposed reinforcing steel where steel was placed against the forms during the construction process.

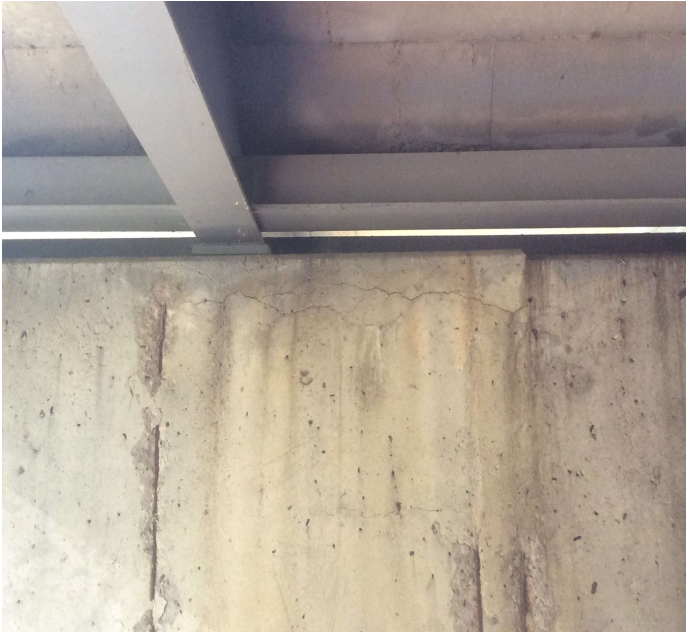
PHOTO 3 Description There is a 3' area of map cracking in the bearing area of Beam 6.

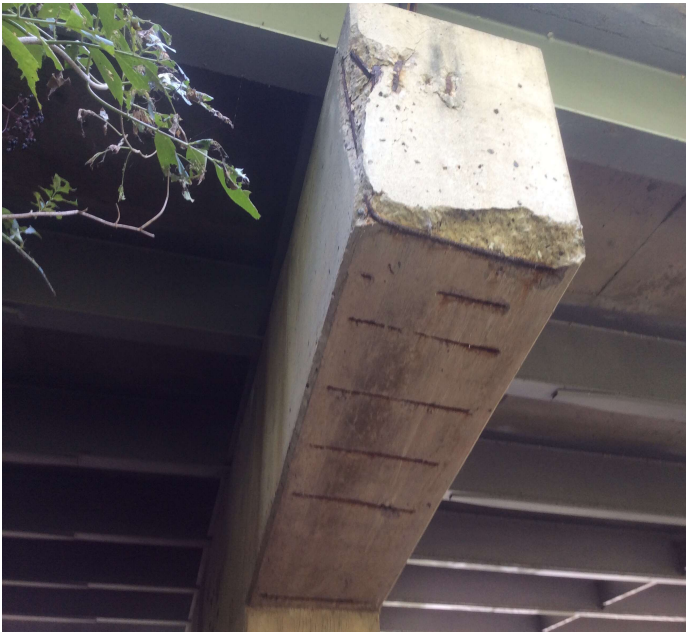
PHOTO 4 Description The undersurface of Bent 3 cap has shallow spalls with exposed reinforcing steel outside both columns. Exposed reinforcing steel appears to be #4 bands that have up to initial section loss.

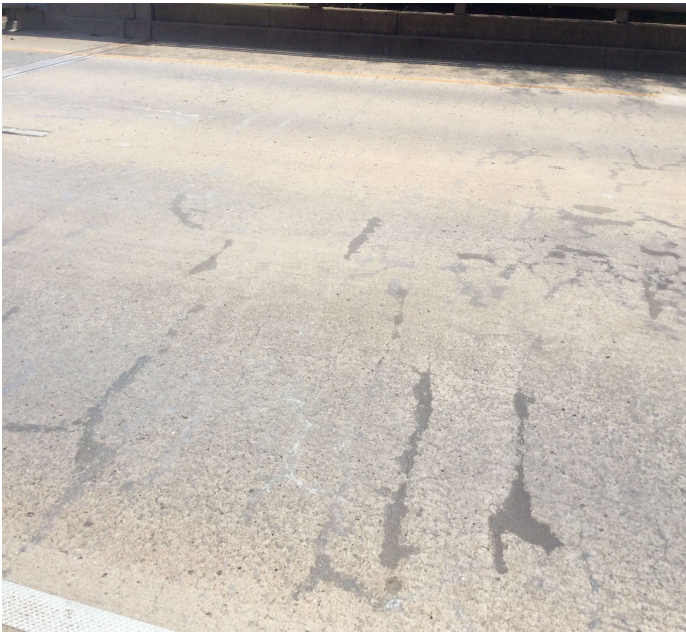
PHOTO 1 Description The driving surface of the deck has sealable cracking.

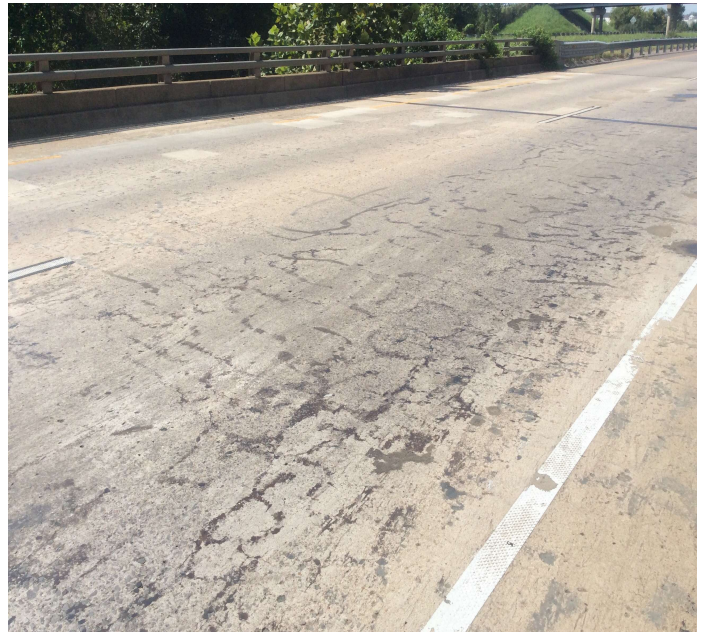
PHOTO 2 Description The driving surface of the deck has sealable cracking.
