Bridge Inspection Report

B3956
I-540 SEC 2 NB LN
over
FLAT ROCK CR. Crawford

Structure Number: B3956

Facility Carried: I-540 SEC 2 NB LN

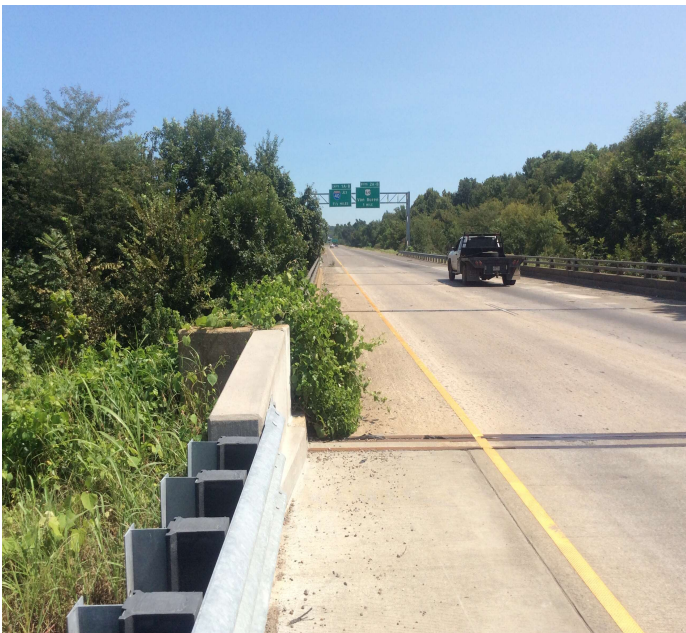
Vegetation beginning to grow into the edge of the shoulders on the bridge railing.

PHOTO 1 Description Vegetation beginning to grow into the edge of the shoulders on the bridge railing.

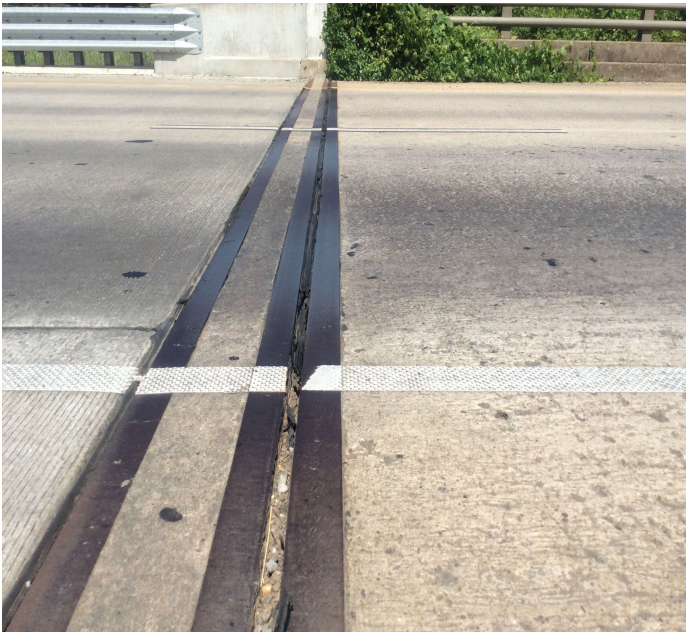
Deck Joint Seals -
Compression seals are deteriorated and torn.

PHOTO 1 Description Compression seals are deteriorated and torn.

Work Code: Replace

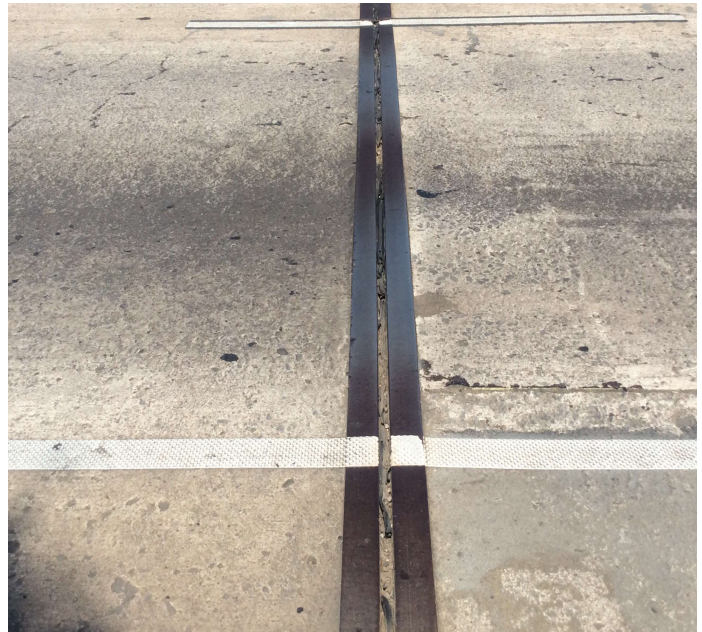
PHOTO 2 Description Compression seals are deteriorated and torn.

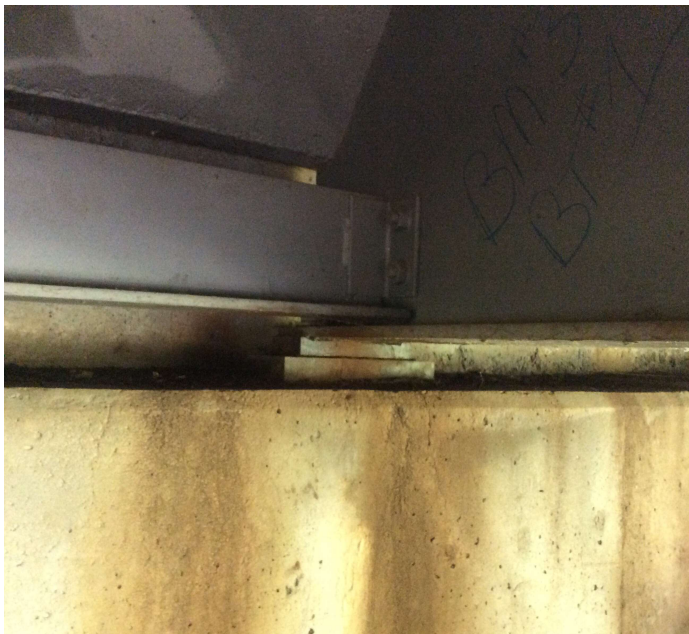
Some Bearings have fine metal powder between the masonry plates and the sole plates indicating excessive movement during traffic impacts. Visible movement in the bearing at Bent 1, Beam 3 during traffic impact at this inspection. Bent 4, Beam 7 bearing has approximately 1/8" of pack rust.

PHOTO 1	Description	Some Bearings have fine metal powder between the masonry plates and the sole plates indicating excessive movement during traffic impacts. Visible movement in the bearing at Bent 1, Beam 3 during traffic impact at this inspection.
---------	-------------	---

Work Code: Repair

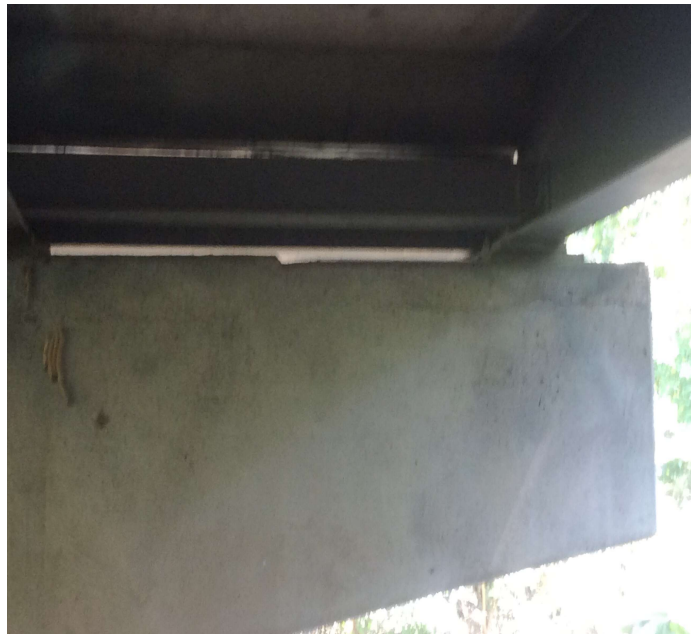
The Rt side of Bent 2 cap has horizontal cracking approximately 6" below the top of the cap on the Span 1 and Span 2 sides. The Span 2 side has a diagonal crack that propagates from the horizontal crack.

PHOTO 1 Description The Rt side of Bent 2 cap has horizontal cracking approximately 6" below the top of the cap on the Span 1 and Span 2 sides.

Work Code: Repair

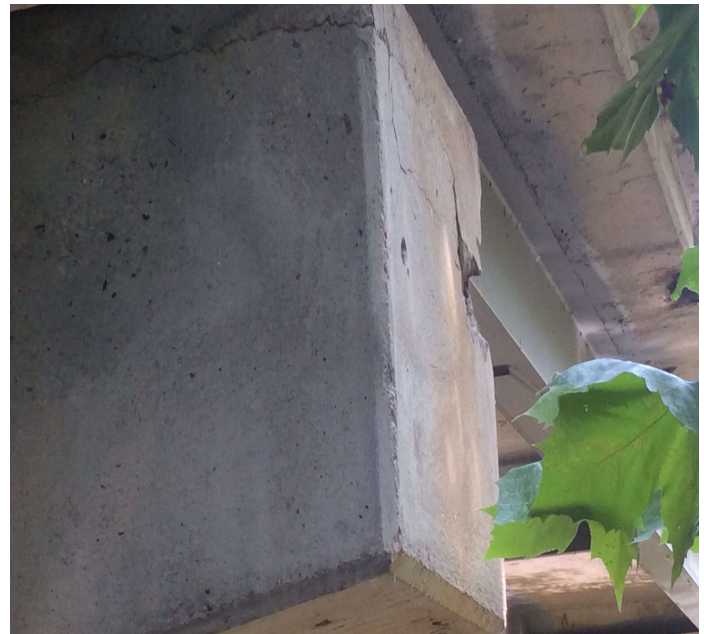
PHOTO 2 Description Bent 2 has a 16" delaminated area in the Rt end of cap.

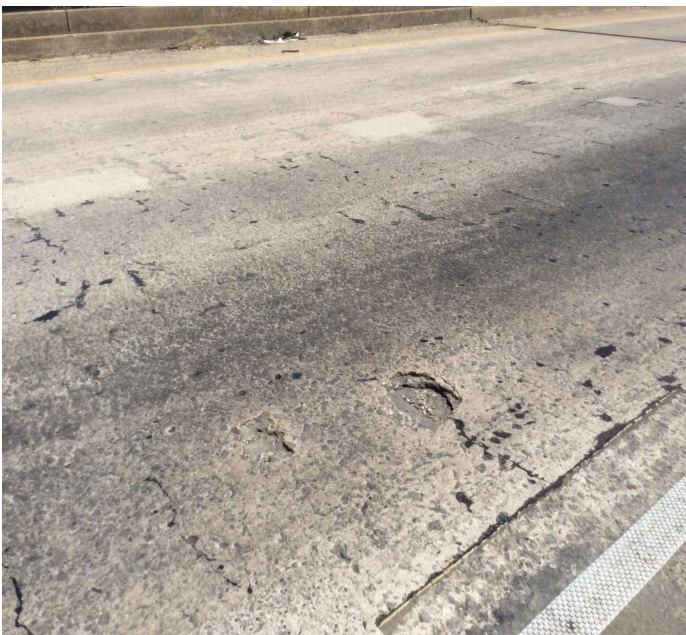
The driving surface of the deck has spalling with delaminated areas in the right lane and gutter.

PHOTO 1 Description The driving surface of the deck has spalling with delaminated areas in the right lane and gutter.

Work Code: Repair
