# Bridge Inspection Report

**A3957**  
**I 540 SB-Crawford**  
**over**  
**State Highway 162**

03/06/2018 - EJW - Routine Inspection conducted on this date. Underclearance measurements verified on this date.

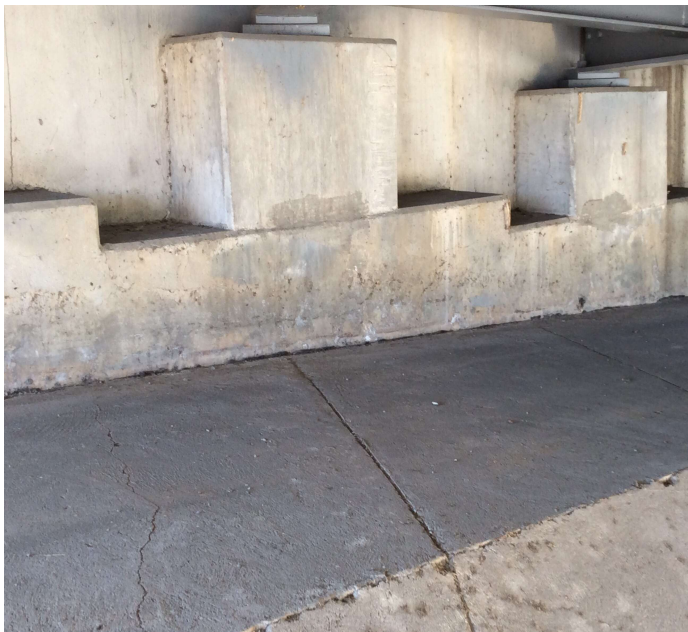
The substructure has shallow spalling with exposed reinforcing steel, shallow concrete delamination's, vertical and horizontal cracking, and light surface scale that appears to have been caused from previous deck joint seal leakage.

PHOTO 1      Description      Bent # 1 vertical and horizontal cracking.

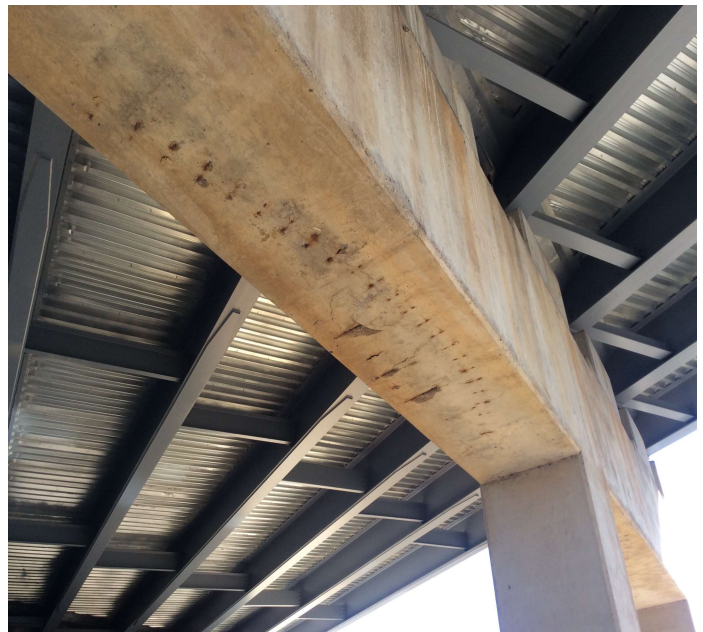
234 - Reinforced Concrete Pier Cap	1- Ben.	90	ft.	64	16	10	0
-Bent 3 has water stains on the cap where the deck joint seals have leaked in the past. -The Left end of cap has shallow spalls that expose the ends of the primary reinforcing steel which has no apparent section loss. -The undersurface of the cap has numerous 12" delaminated areas and spalls with exposed secondary reinforcing steel. Exposed reinforcing steel has active corrosion with initial section loss. -Some vertical delaminated areas are visible in the North face of cap.							
1080 - Delamination/Spall/Patched Area		12			8	4	
1090 - Exposed Rebar		7			1	6	
1130 - Cracking (RC and Other)		7			7		
302 - Compression Joint Seal	1- Ben.	180	ft.	135	0	45	0
-The compression joint seals are in place at this inspection. -The compression joint seal at Bent 3 has adhesion failure and leaks water and debris. The seal has several areas with up to 1/2" wide gaps between the seal and the expansion joint.  Seal adhesion = 16'

PHOTO 2      Description      Bent # 3 spalling on the undersurface of the bent cap that exposes reinforcing steel with active corrosion.
