Bridge Inspection Report

B3957
I 540 NB-Crawford
over
State Highway 162

Structure Number: B3957

03/06/2018 - EJW - Routine Inspection conducted on this date. Underclearance measurements verified.

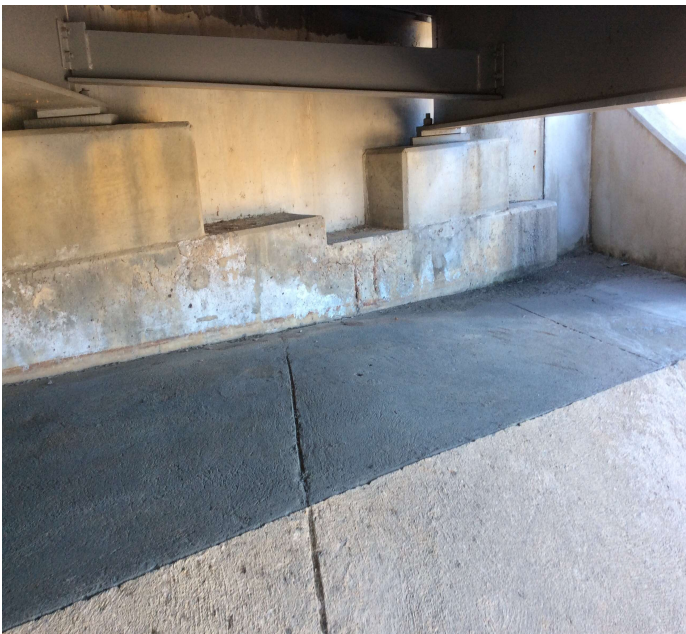
234 - Reinforced Concrete Pier Cap	1- Ben.	90	ft.	63	15	12	0
-Bents # 2 & 3 have numerous shallow spalls with exposed reinforcing steel and numerous delaminated areas and horizontal cracks. -The top of Bent # 3 cap has an apparent cold joint with numerous shallow delaminated areas and horizontal cracking that appears to have been caused from previous joint leakage. -Bent # 2 has a horizontal crack that appears to be a cold joint. -The caps have areas of light scale that appears to have been caused from previous joint leakage.							
1080 - Delamination/Spall/Patched Area		9			2	7	
1090 - Exposed Rebar		8			3	5	
1130 - Cracking (RC and Other)		10			10		
302 - Compression Joint Seal	1- Ben.	180	ft.	138	42	0	0
-The compression joint seals are in place and appear to be functioning as designed. The joint seal at Bent # 3 has dropped approximately 1" lower than its original location inside the travel lanes but is still in the joint. -The compression joint seal on the Lt side over Bent 2 is approx. 1" smaller than the joint between the bridge rails which may allow dirt and water to leak on the end of the cap, beams and bearings. -The joint anchorages appear sound at this inspection.

The substructure has shallow spalling with exposed reinforcing steel, shallow concrete delamination's, vertical and horizontal cracking, and light surface scale that appears to have been caused from previous deck joint seal leakage.

PHOTO 1 Description Bent # 1 left end of the cap spalling with exposed reinforcing steel.

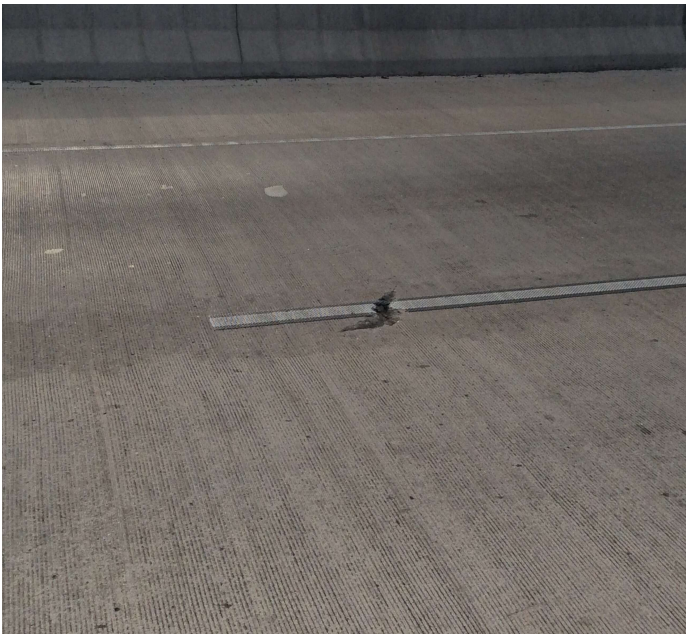
The driving surface of the deck has a spall approximately 12" long and 2" deep located near centerline of span # 3.

PHOTO 1 Description Spall in the driving surface of span # 3
at centerline.
