Bridge Inspection Report

A5098
I-540 Southbound
over
Phoenix Street - Seb Co.

Structure Number: A5098

Facility Carried: I-540 Southbound

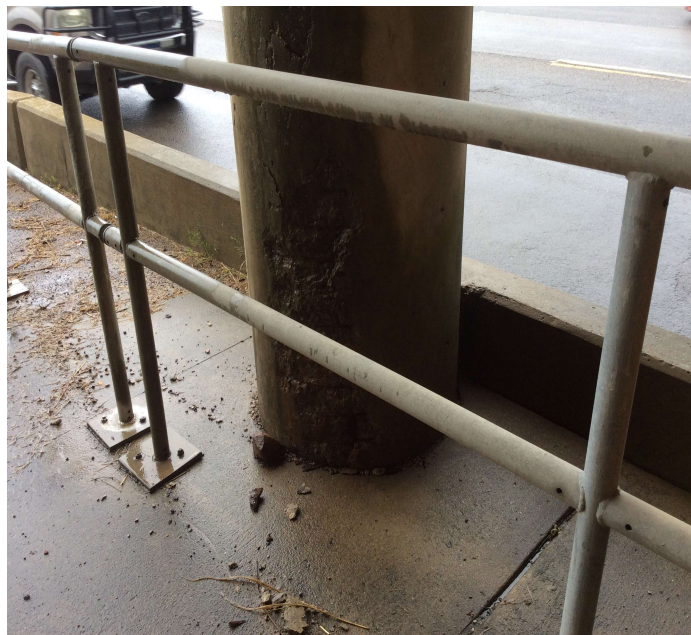
205 - Reinforced Concrete Column	1- Ben.	8	each	2	2	4	0
	06/06/2017 - JCJ & JML - Bent # 2, Columns 1 & 3 have light scale on exterior side of columns. Bent # 2, Column # 1 has a 12" X 5' delaminated area with spalls that have exposed reinforcing steel. Exposed reinforcing steel has initial section loss at this inspection. Bent # 3, Column # 1 has a 9' vertical crack and a 12" Wide X full height of Column delaminated area that has a spall with exposed reinforcing steel. Bent # 3, Centerline median column has a 24" spall with exposed reinforcing steel.						
1090 - Exposed Rebar		3				3	
1130 - Cracking (RC and Other)		3			2	1

Bent #2, Columns 1 & 3 have light scale on exterior side of columns. Bent #2, Column #1 has a 12" X 6' delaminated area with spalls that have exposed reinforcing steel. Exposed reinforcing steel has initial section loss at this inspection. Bent #3, Column #1 has a 9' vertical crack and a 12" X 6' delaminated area that has a spall with exposed reinforcing steel. Bent #3, Centerline median column has a 24" spall with exposed reinforcing steel. Bent #1 has debris accumulation that covers the bearing and end of Beam #7 at this inspection. Bent #2 cap has light scale with water stains. Bent #3 Centerline median cap has a 2' spall with exposed reinforcing steel, a 1' spall with exposed reinforcing steel, and a softball size spall with exposed reinforcing steel. Exposed reinforcing steel has up to initial section loss at this inspection.

PHOTO 1 Description Bent #2 Column #1 Spalling with exposed reinforcing steel

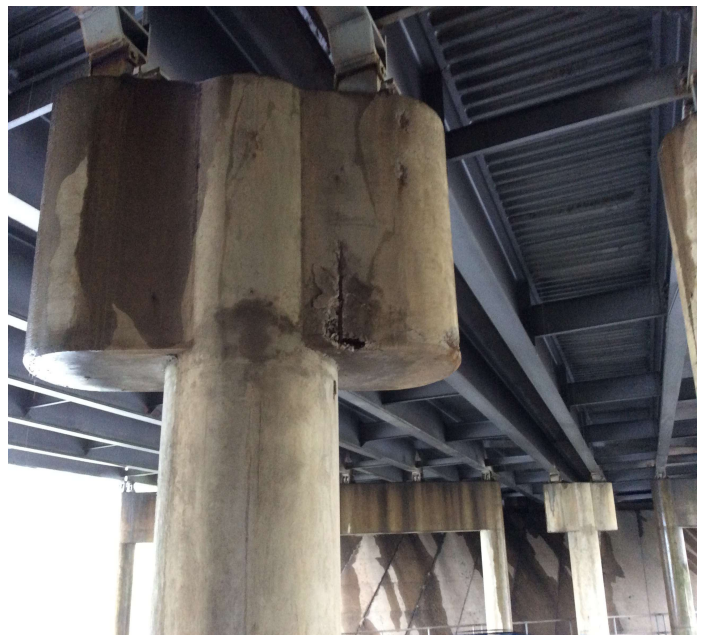
Bridge A5098 Bents 2 & 3 , Column 4 is the same as Bridge B5098 Bents 2 & 3 column 1. The same column and cap located at the centerline median is shared by both bridges.

PHOTO 2 Description Bent #3 Column #4 Spalling with exposed reinforcing steel.

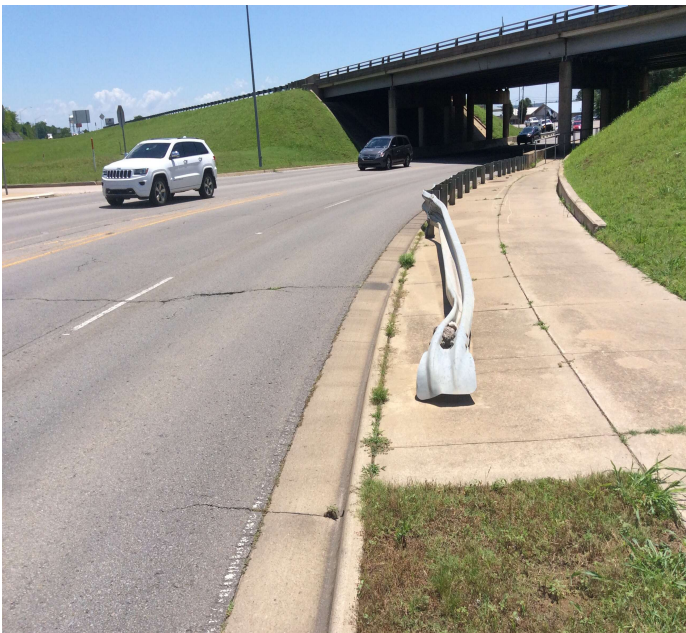
PHOTO 1 Description

The West approach guardrail has collision damage with out of plane bending.

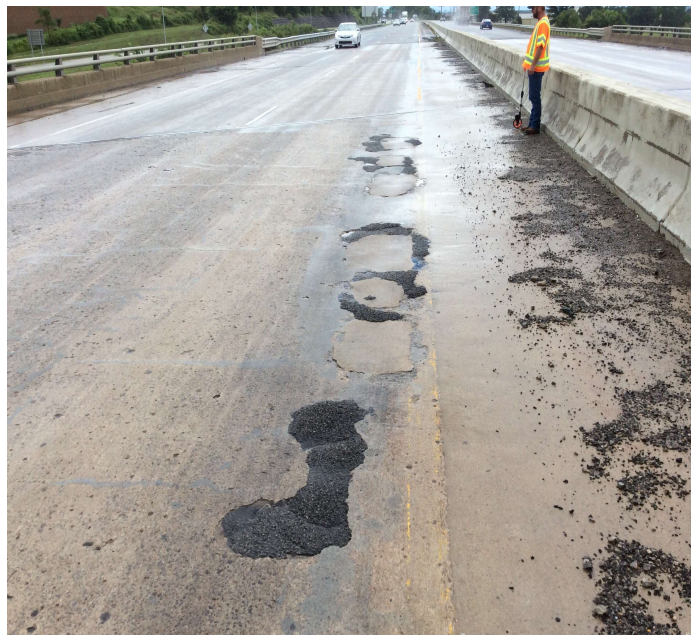
Driving surface of the deck has areas with map cracking and sealable transverse cracks at approximately 5' centers. Maintenance forces have sealed the cracks in the Right lane only. There is medium scale in the Left lane and Left shoulder. There are minor concrete spalls adjacent to the deck drains. The Left side of the deck joint over Bent # 3 is closed and makes contact at the exterior edge of deck at approximately 81 degrees Fahrenheit. The Left exterior edge of deck is offset approximately 1 1/2" at this inspection. The Right edge of deck where the structure was widened (Median) appears to be in good alignment with no apparent noteworthy offset.

PHOTO 1 Description Span # 1 Pothole repairs

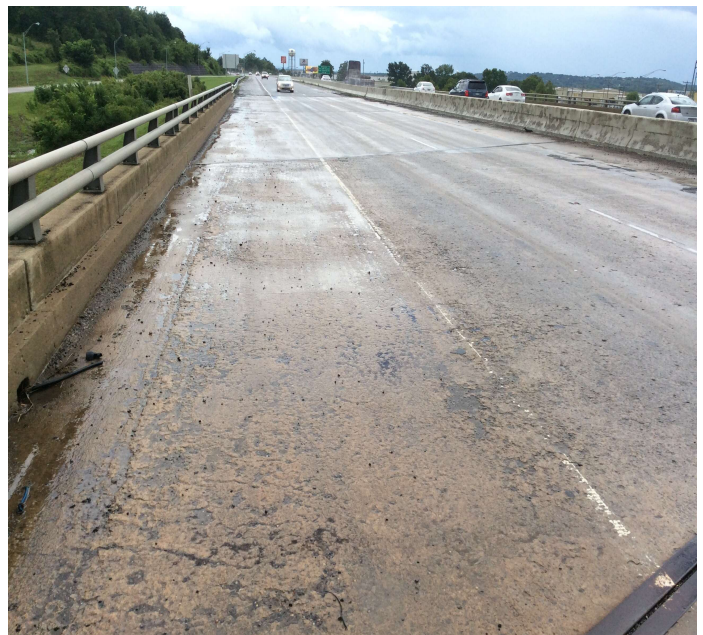
PHOTO 2 Description Span # 1 Scale in the driving surface

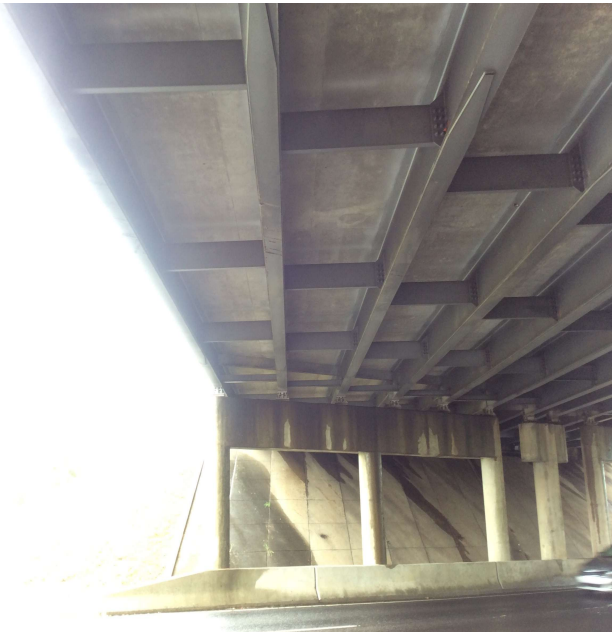
Span # 2, Beams # 1, 2, 3, 4, 5, & 6 have insignificant dents and scrape marks on the bottom flanges due to traffic impacts. No apparent out of plane bending caused by traffic impact at this inspection.

PHOTO 1 Description Span # 2 insignificant scrape marks.

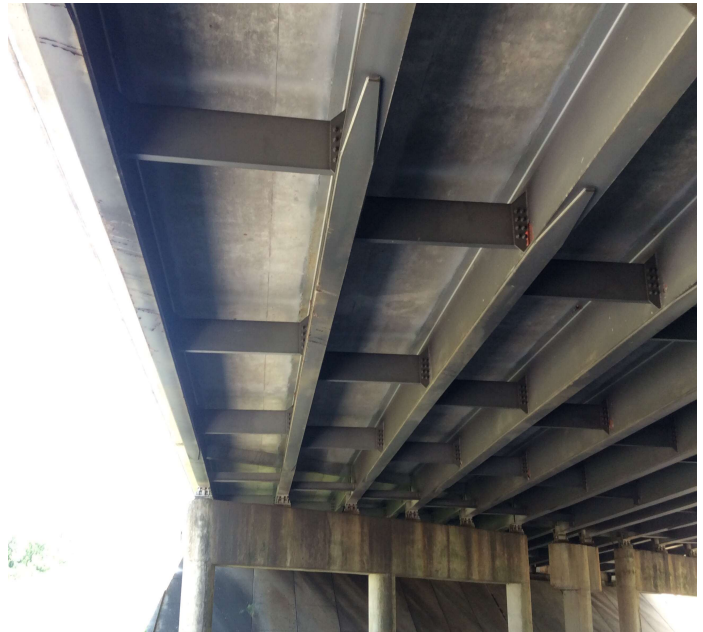
PHOTO 2 Description Span 2. Insignificant scrape marks due to traffic impacts.

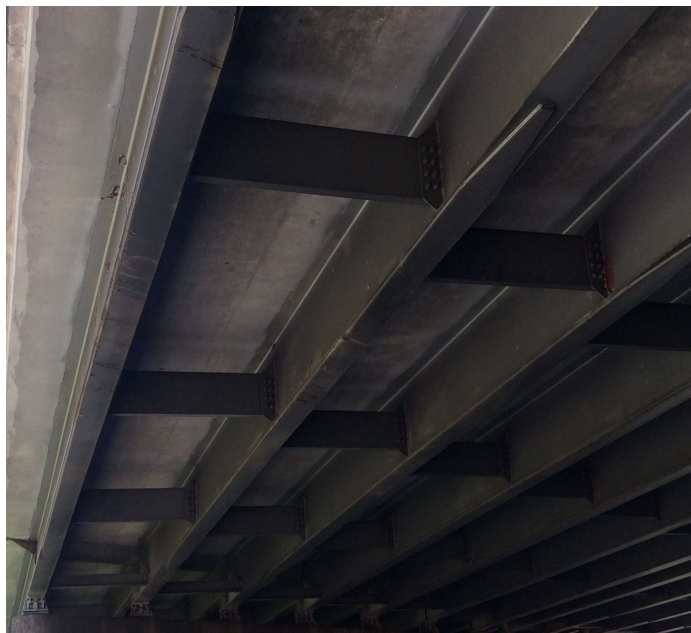
PHOTO 3 Description Span 2 scrape marks.

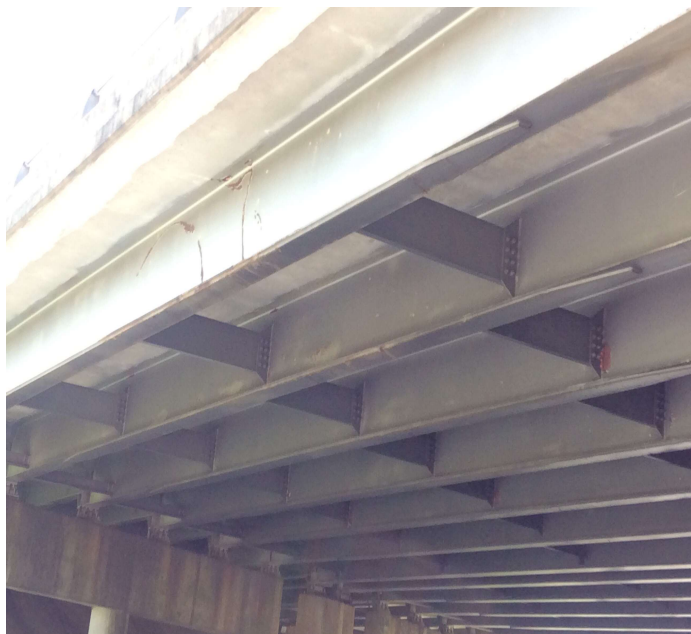
PHOTO 4 Description Span 2 scrape marks.

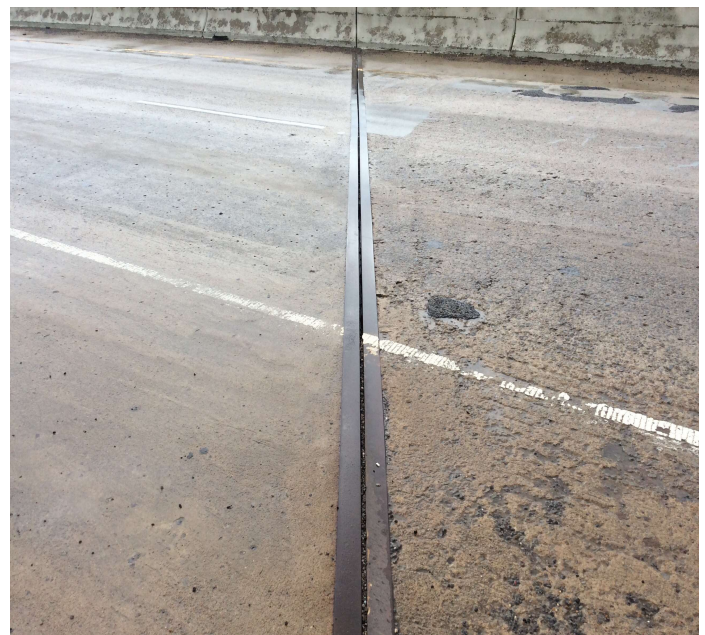
1080 - Delamination/Spall/Patched Area		10			6	4	
1090 - Exposed Rebar		3				3	
302 - Compression Joint Seal	1- Ben.	170	ft.	1	125	24	20
06/06/2017 - JCJ & JML - shallow Spalls adjacent to the expansion joint anchorage. Bents # 2 & 3 joints seals are deteriorated in the shoulders and missing in the driving lanes and allowing a free flow of water onto the bent caps.							
2310 - Leakage		144			100	24	20
2360 - Adjacent Deck or Header		25			25		
311 - Movable Bearing	1- Ben.	21	each	0	21	0	0
06/06/2017 - JCJ & JML - Some bearings have pack rust between the masonry plate and the bearing. Fretting is visible in some of the pin connections in the expansion bearings indicating minor movement. No significant changes are apparent since the last inspection.							
1000 - Corrosion		21			21		
313 - Fixed Bearing	1- Ben.	21	each	0	21	0	0
06/06/2017 - JCJ & JML - Bearings have minor pack rust between the masonry plate and the bearing. The most extreme case is Bent #4, Beam #6. No apparent noteworthy changes since last inspection. JPB 06152011-No significant changes since last inspection.

Deck joint seals are missing in locations.

PHOTO 2 Description Bent # 2 Missing joint seal.

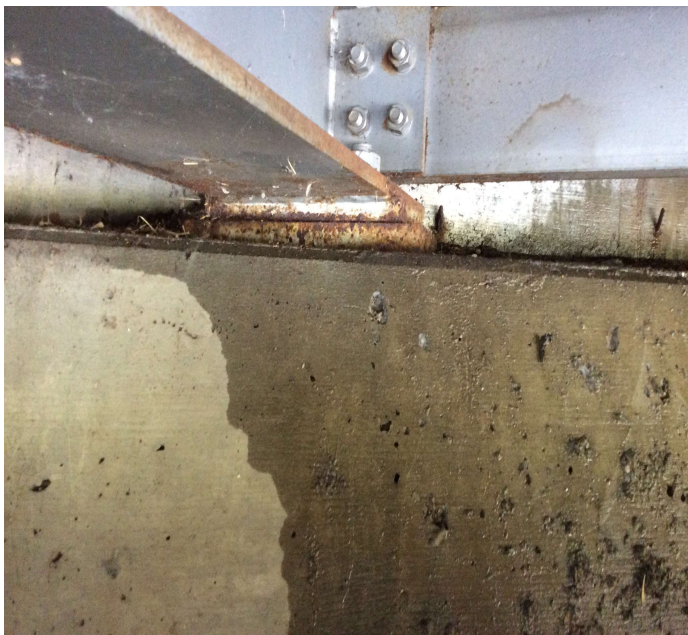
Some bearings have pack rust between the masonry plate and the bearing. Fretting is visible in some of the expansion bearings indicating minor movement.

PHOTO 1 Description Bent # 1 Beam # 7 Active corrosion in the bearings

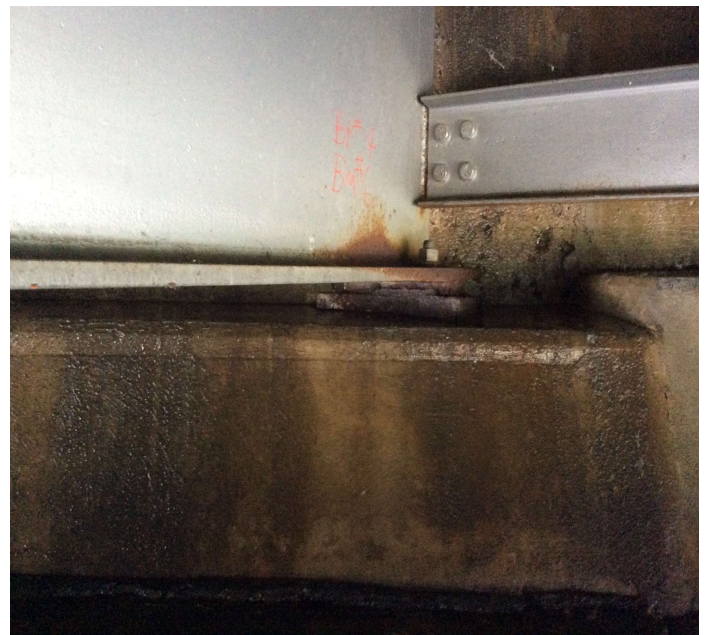
PHOTO 2 Description Bent # 4 Beam # 6 Active corrosion in the bearings.

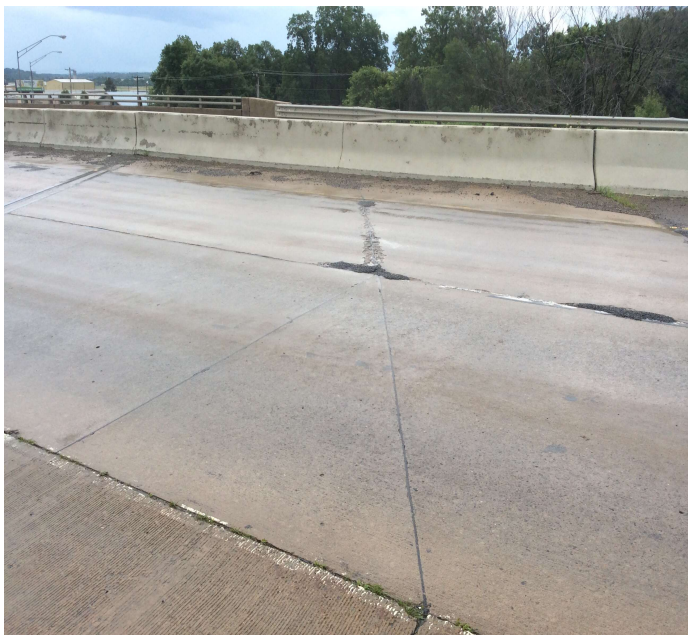
1000 - Corrosion		21			21		
321 - Reinforced Concrete Approach Slab	1- Ben.	1836	sq. ft.	1818	18	0	0
06/06/2017 - JCJ & JML - Bent # 1 has small potholes filled with temporary asphalt patches. No apparent significant settlement problems at this inspection.

The south Concrete Approach Slab has Spalls with temporary asphalt patches.

PHOTO 1 Description Bent # 1 Approach slab spalling
