# Bridge Inspection Report

**B5098**

**I-540 Northbound**

**Phoenix Street - Seb. Co**

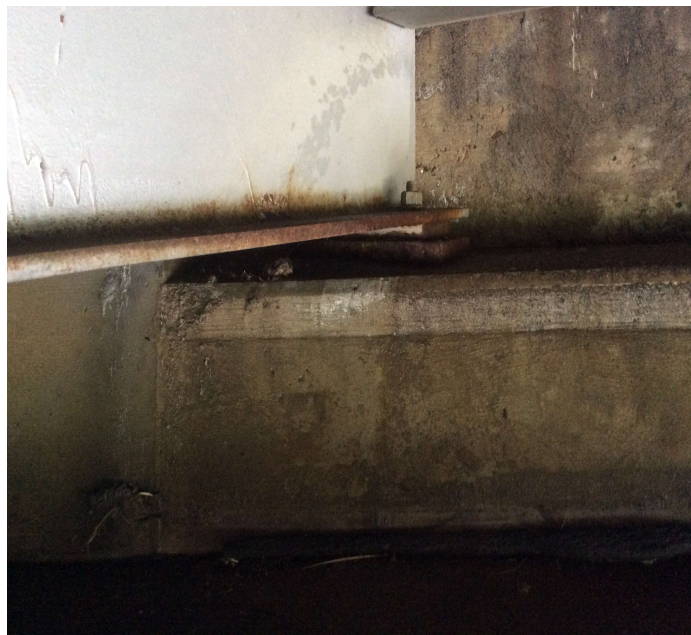
The ends of the beams and the bearings have areas of active corrosion and rust forming.

PHOTO 1 Description Bent # 4 Beam # 2 Active corrosion in the bearings

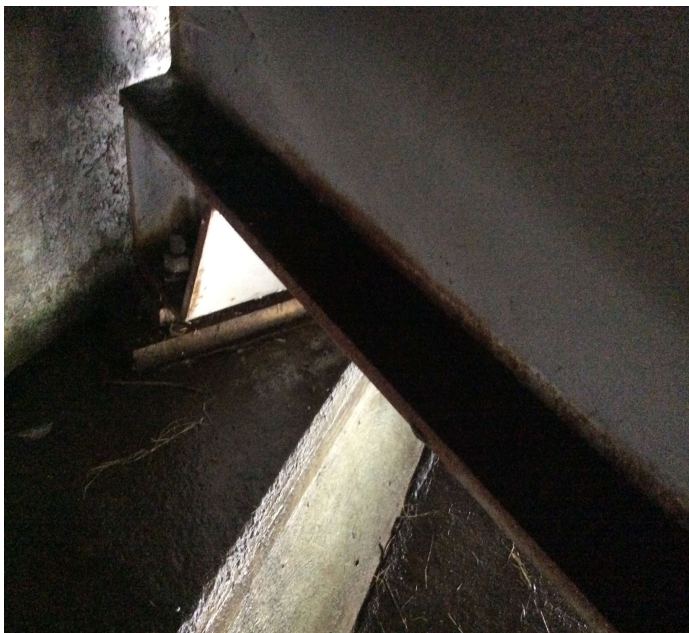
PHOTO 7	Description	Bent # 4 Beam #4 Active corrosion in the beam end
---------	-------------	---

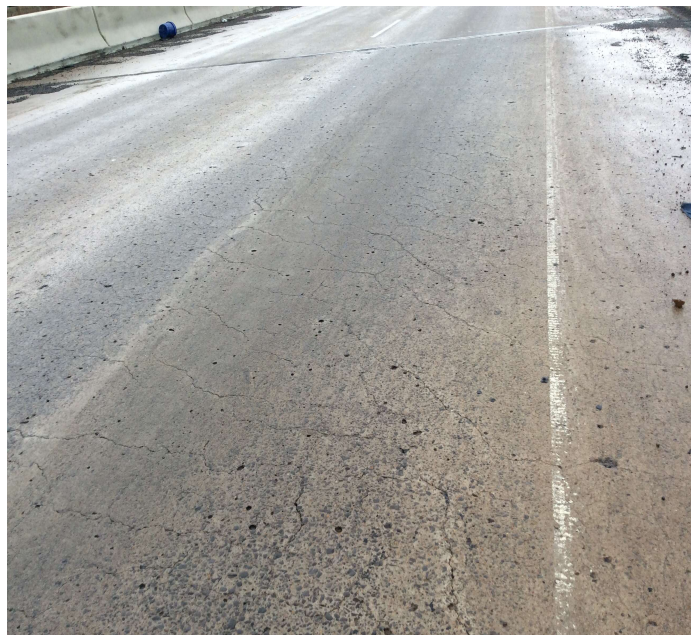
Driving surface of the deck has medium scale in the gutters and light / medium wear on the driving surface. There is sealable map cracking and sealable transverse cracking that ranges from 1' to 5' centers. Span # 1, Bay # 6 has a basketball size spall with exposed reinforcing steel located approximately 10' from Bent # 1 that is visible from the undersurface of the deck. Exposed reinforcing steel has initial section loss at this inspection. There is minor concrete cracking and spalling adjacent to the deck drains. There is 1 basketball size shallow spall with no exposed reinforcing steel near the centerline of the roadway. There is 1" offset visible in the exterior edge of deck over Bent # 2.

PHOTO 1      Description      Span # 1 Heavy map cracking in the driving surface

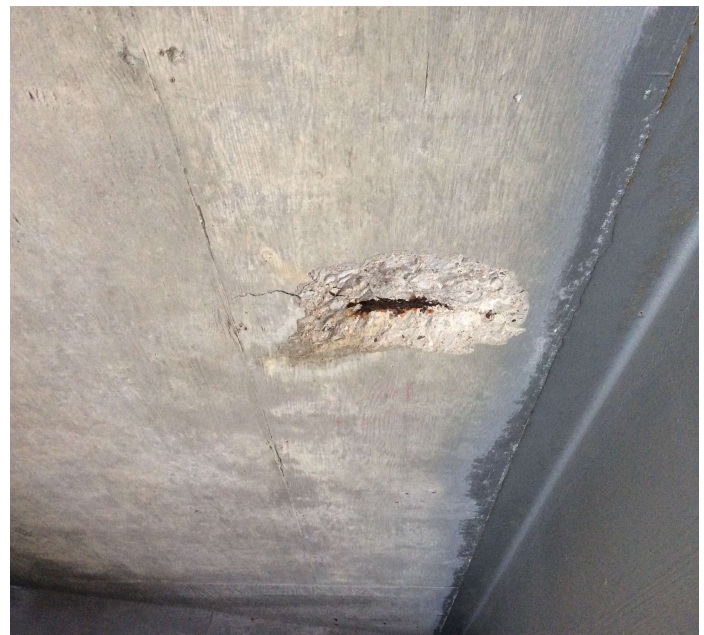
PHOTO 2      Description      Span # 1 Bay # 6 Spalling with exposed reinforcing steel in the undersurface.

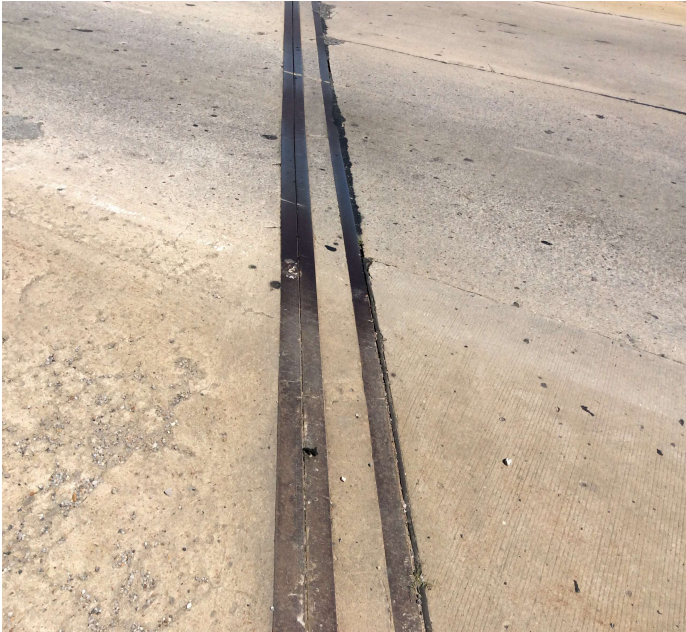
PHOTO 3 Description Expansion joint at Bent 4.

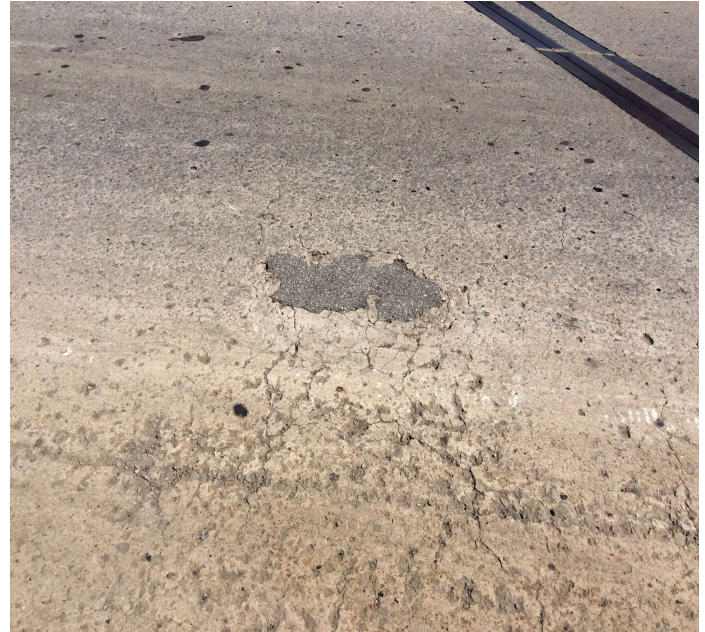
PHOTO 5 Description Spall with asphalt patch in Span 3.

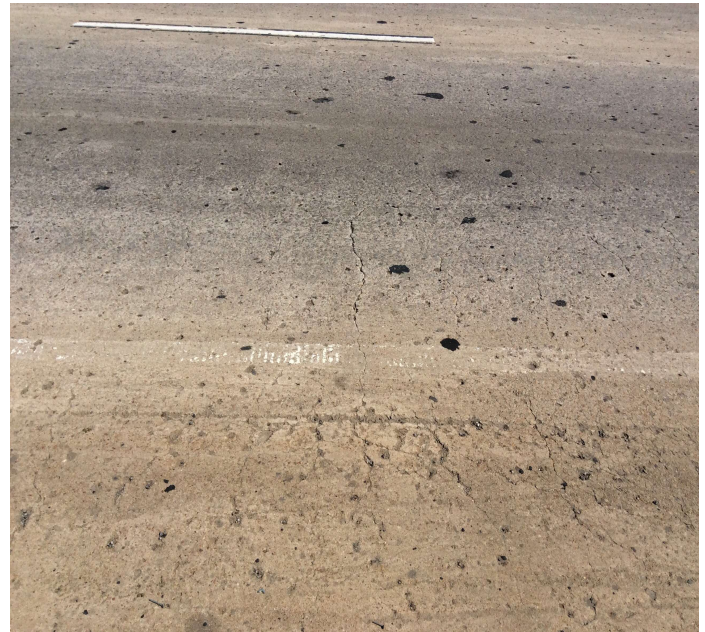
PHOTO 6 Description Sealable deck cracks Span 3

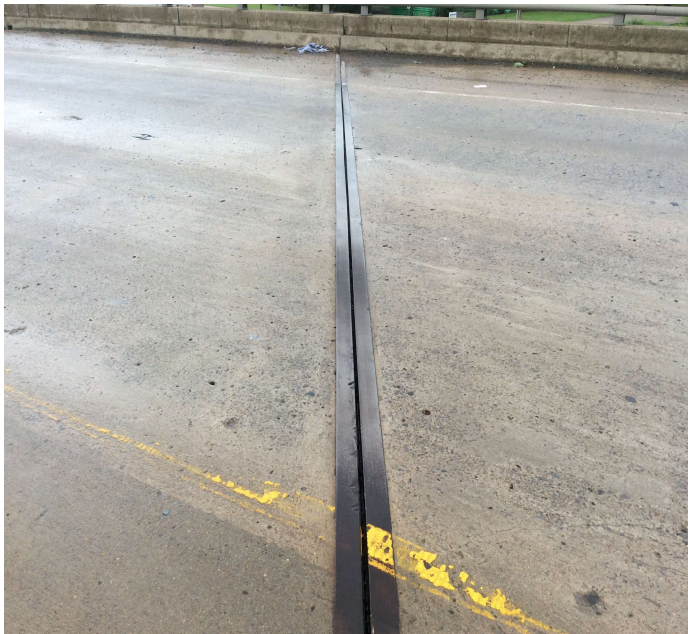
Portions of the deck joint seals are missing. There are spalls in the outside curb and bridge railing over the expansion joint at Bent # 2, which is completely closed along the exterior edge of deck at approximately 81 degrees Fahrenheit.

PHOTO 1      Description      Bent # 3 missing joint seal

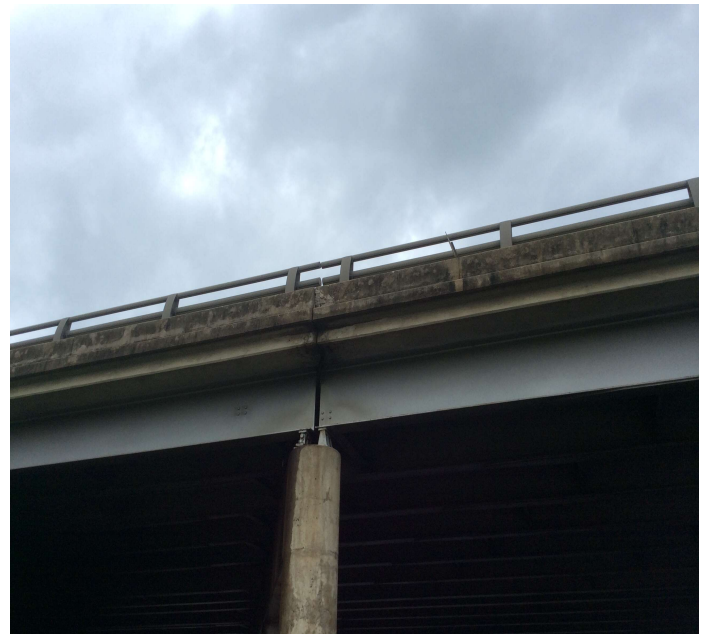
PHOTO 2      Description      Span # 2 Spalling in the bridge rail

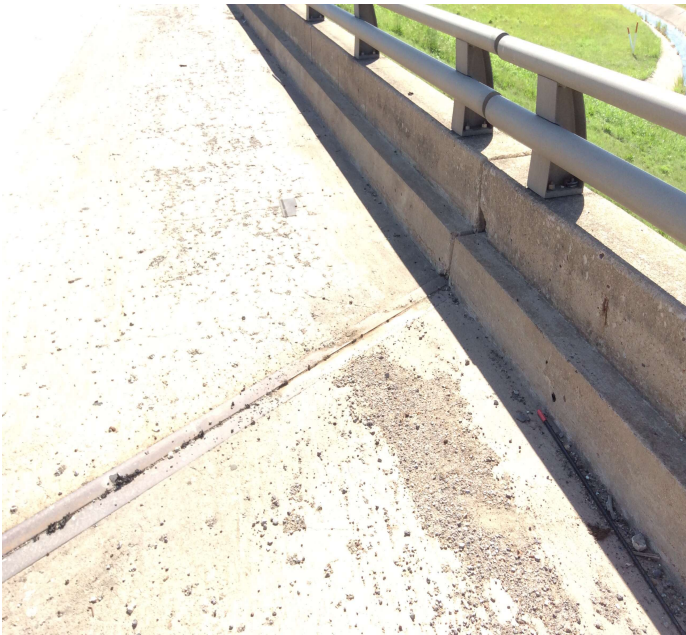
PHOTO 3      Description      Expansion joint over Bent 3. Fully closed with a 1/4" elevation difference in the Right gutter.

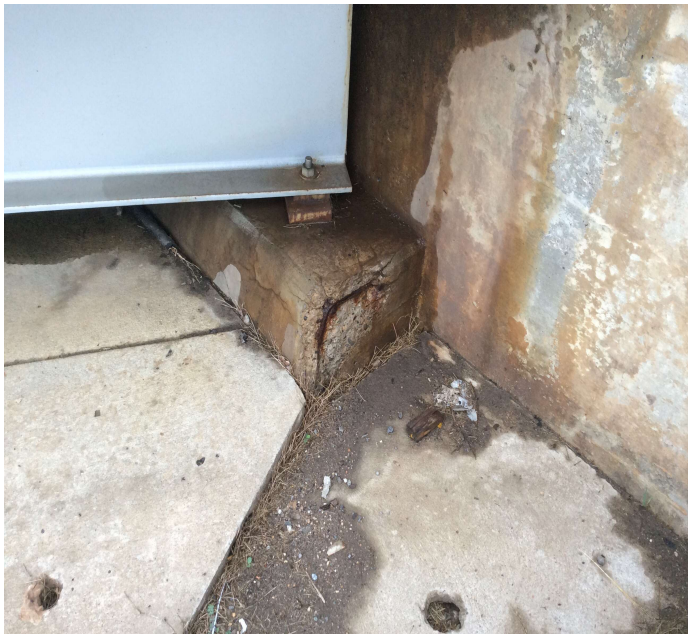
The Right end of Bent # 4 has a basketball size spall that is 2" deep with exposed reinforcing steel. Exposed reinforcing steel has initial section loss at this inspection. Bent # 3 has two 12" delaminated areas visible from the undersurface of the cap.

PHOTO 1      Description      Bent # 4 Bridge seat spalling with exposed reinforcing steel

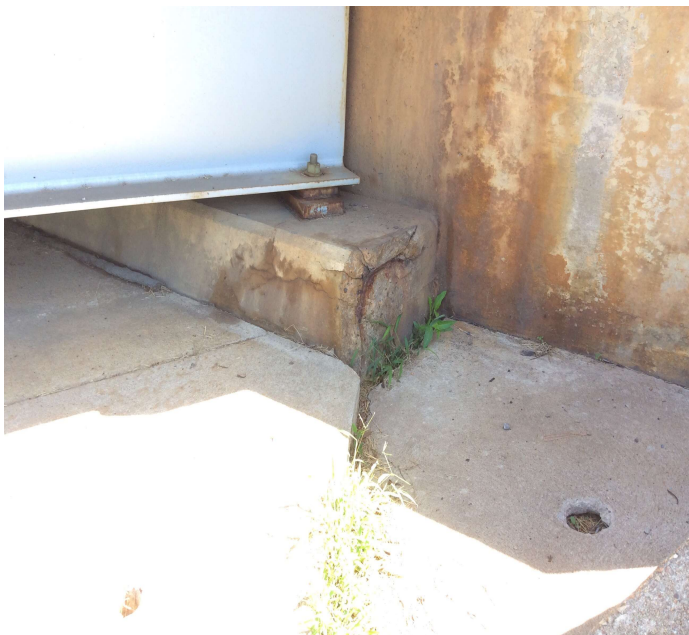
PHOTO 3 Description Right end of Bent 4.

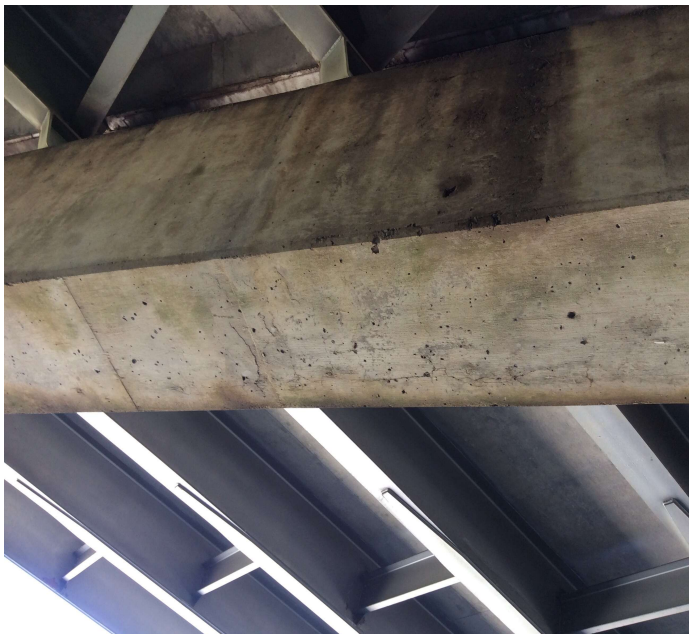
PHOTO 4 Description Delaminated areas under Bent 3 cap.

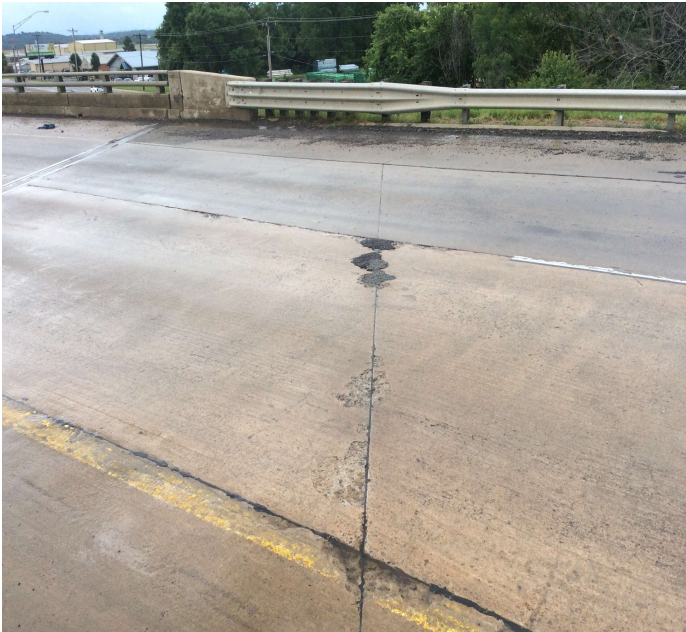
There are 4 Spalls with asphalt patches near centerline of roadway. The South approach slab appears to be approximately 1 1/2" below the asphalt roadway.

PHOTO 1      Description      Bent # 1 Approach slab scaling with repairs

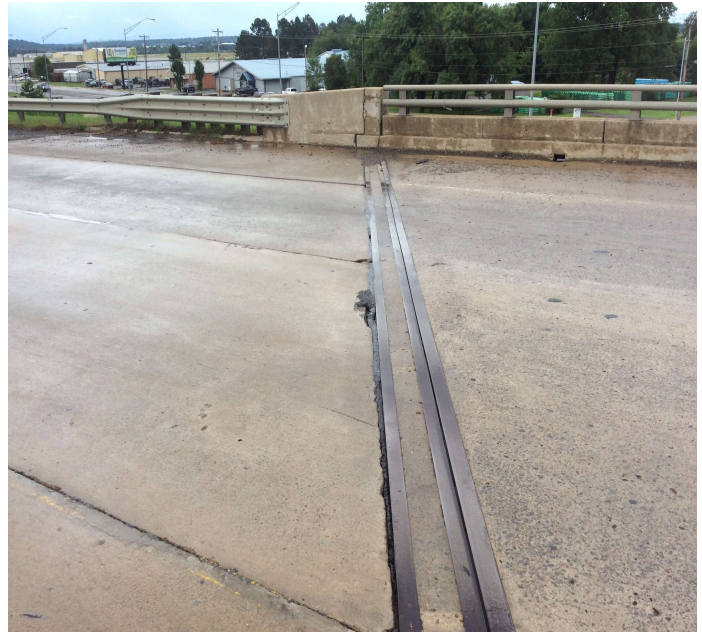
PHOTO 2      Description      Bent # 4 Approach potholes
