# Bridge Inspection Report

**A5100**  
**I-540, WB LNS**  
**over**  
**Ft Smith Railroad Seb Co**

Structure Number: A5100

Facility Carried: I-540, WB LNS

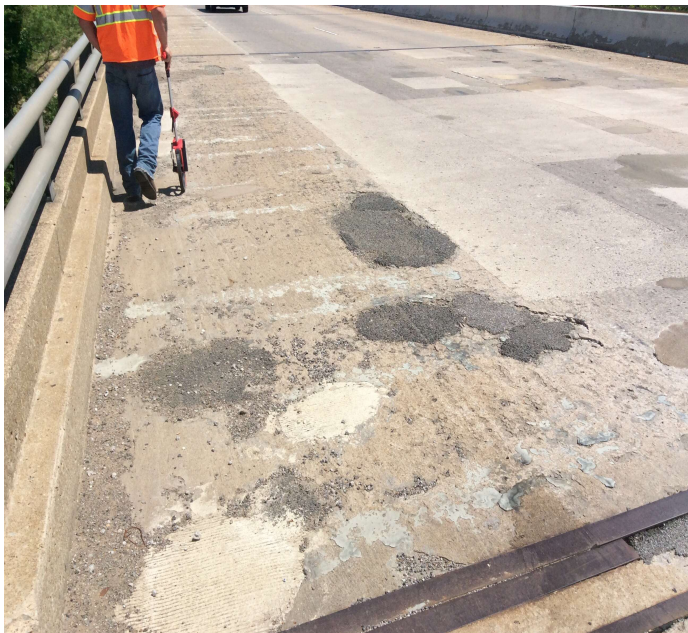
There are spalls and delaminated areas on the driving surface of the deck.

PHOTO 1 Description Span 1. Left gutter

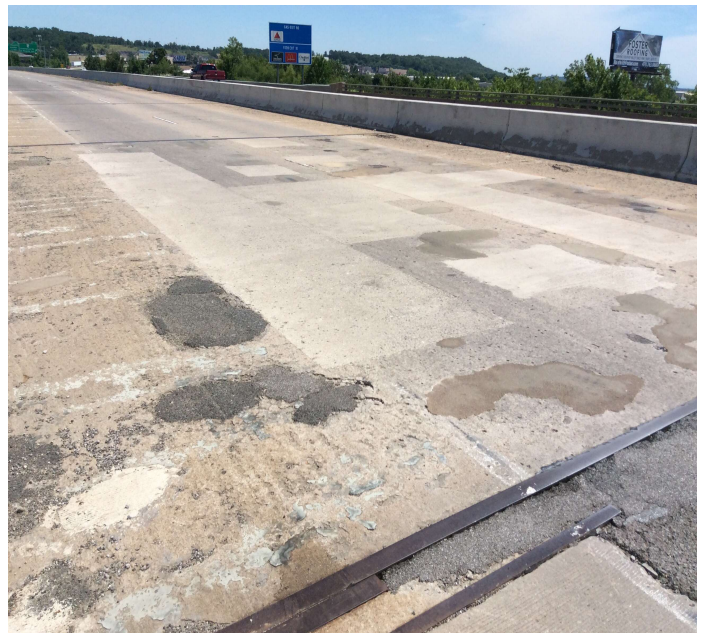
PHOTO 2 Description Span 1. Typical

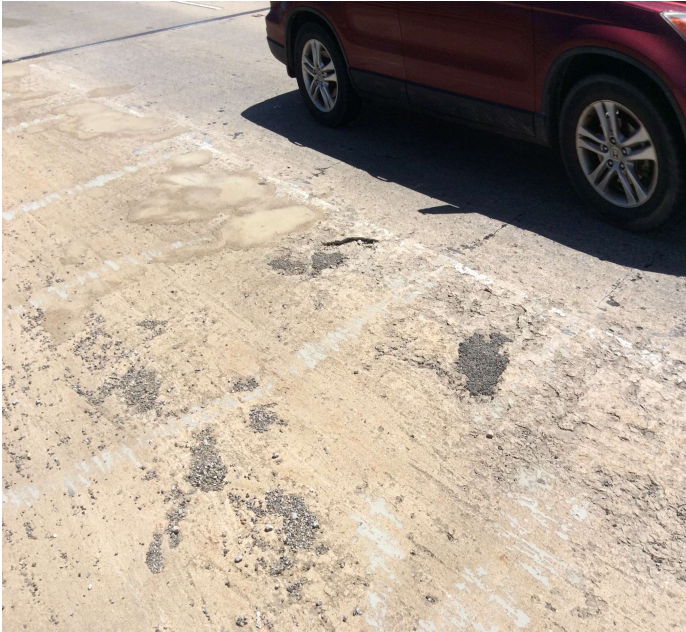
PHOTO 3    Description    Span 2.

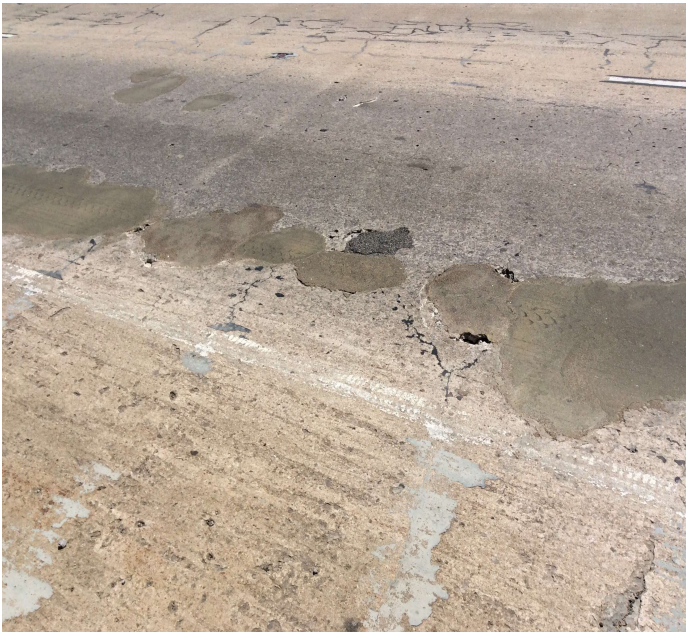
PHOTO 4    Description    Span 3.

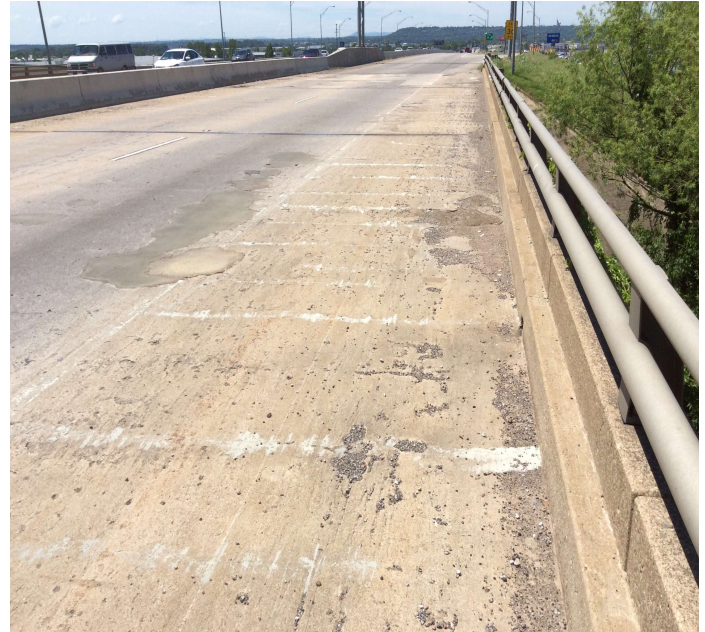
PHOTO 5    Description    Span 3. Left gutter

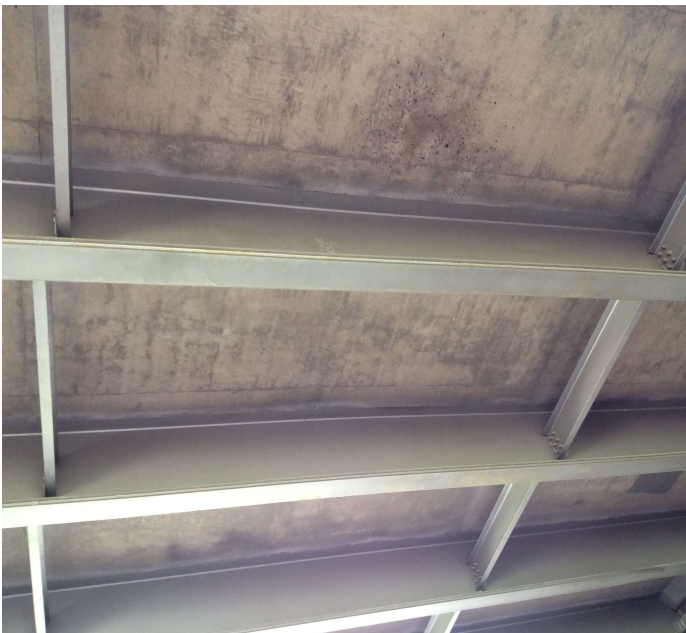
The driving surface has sealable transverse and map cracking.

PHOTO 1 Description Span 3 deck soffit

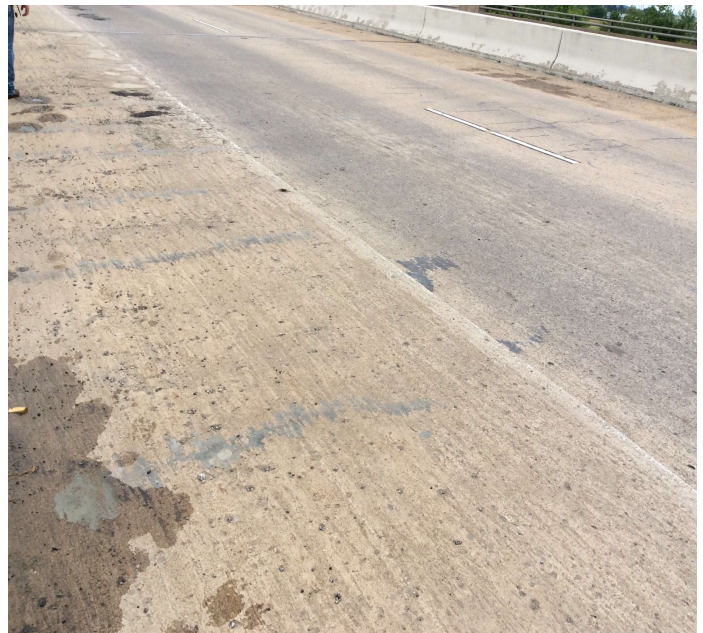
PHOTO 2 Description Span 2. Typical

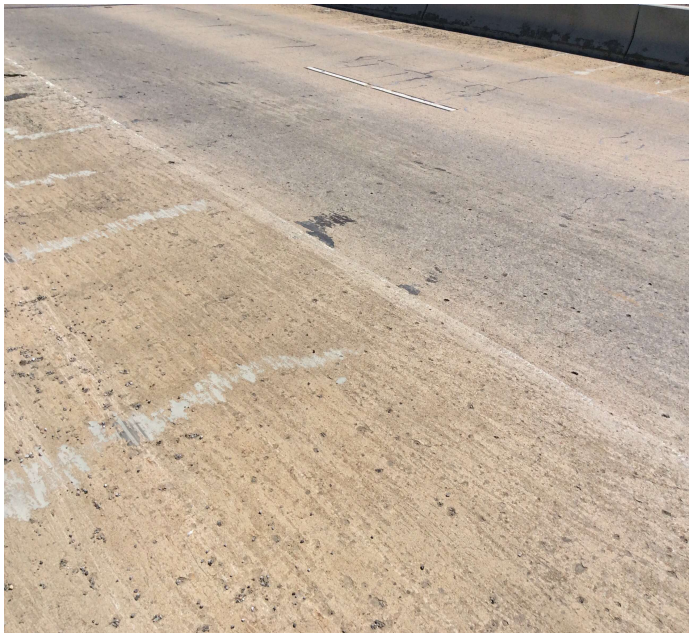
PHOTO 3 Description Span 2.

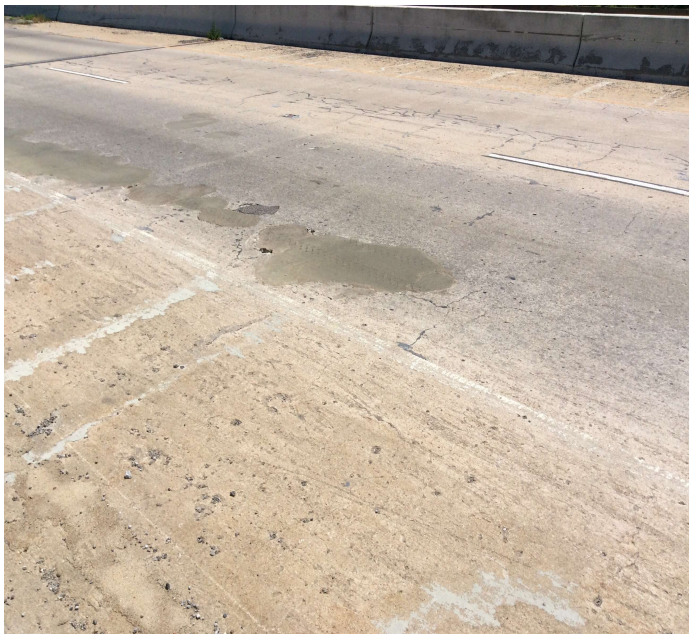
PHOTO 4 Description Span 3.

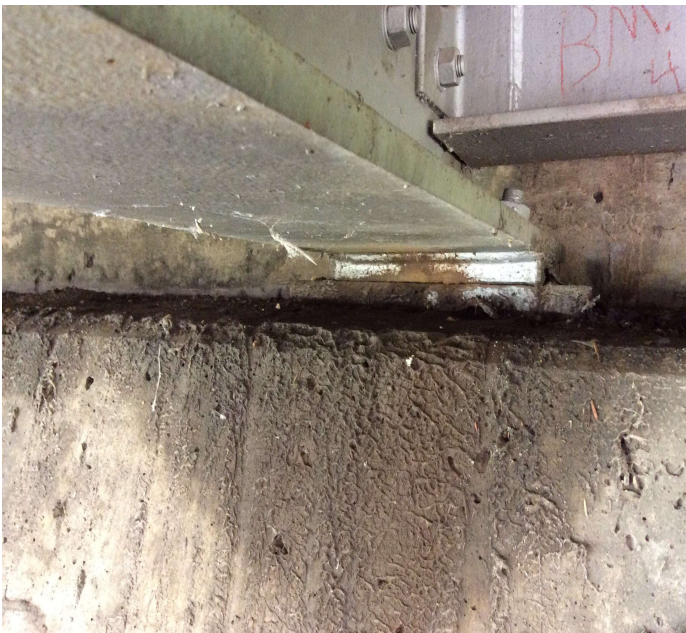
The compression joint seals leak water and debris on the substructure.

PHOTO 1      Description      Bent 4. Beam 3 bearing is fretting.

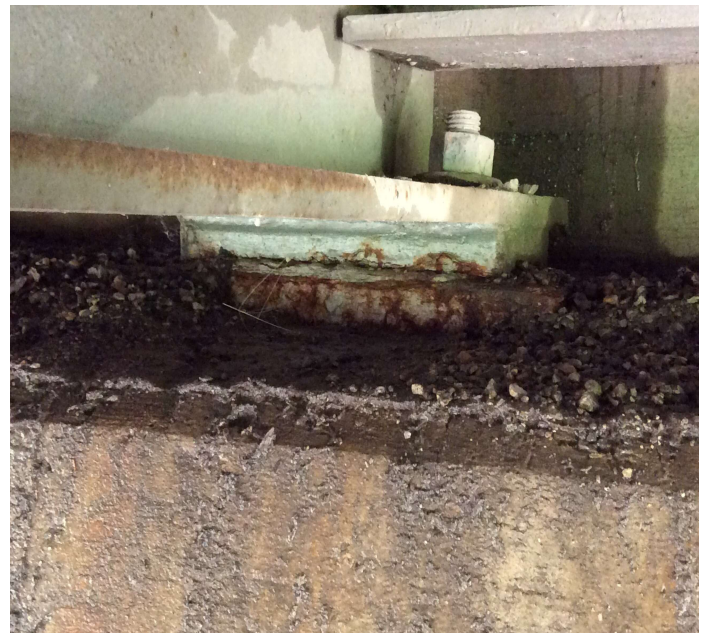
PHOTO 2      Description      Bent 1. Beam 5. Bearing corrosion.

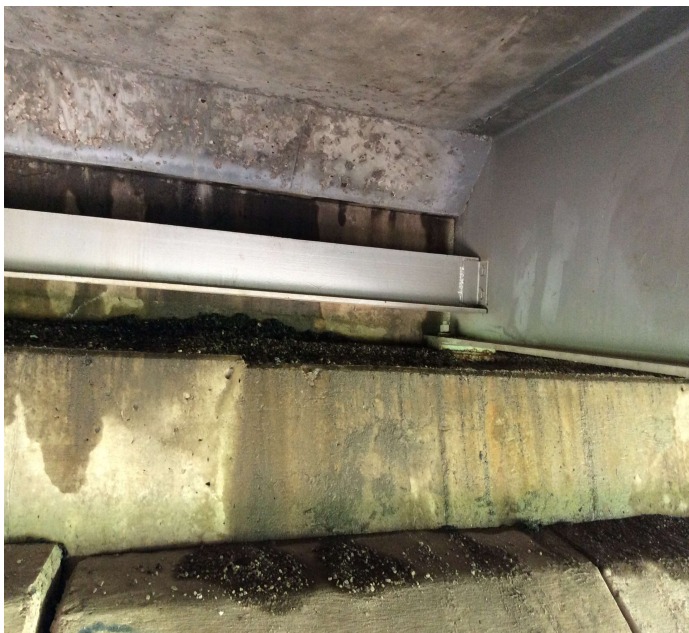
PHOTO 3    Description    Bent 1 debris on cap.

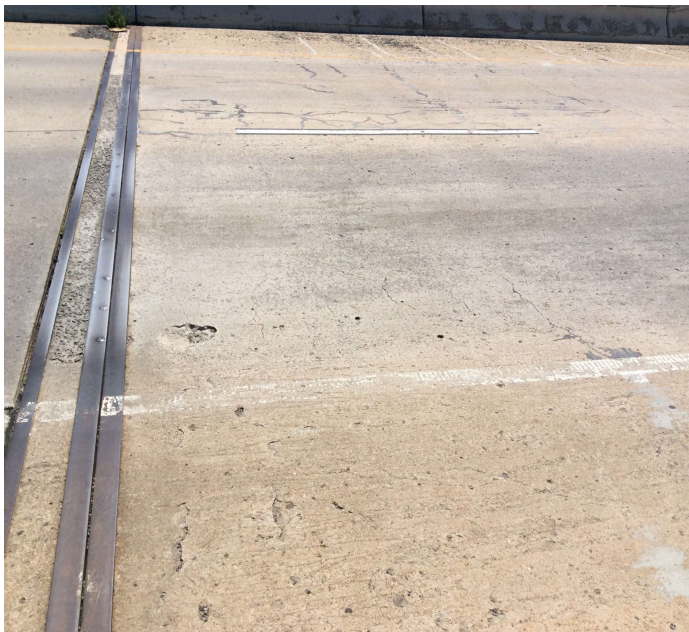
PHOTO 4    Description    Span 3 at Bent 4.

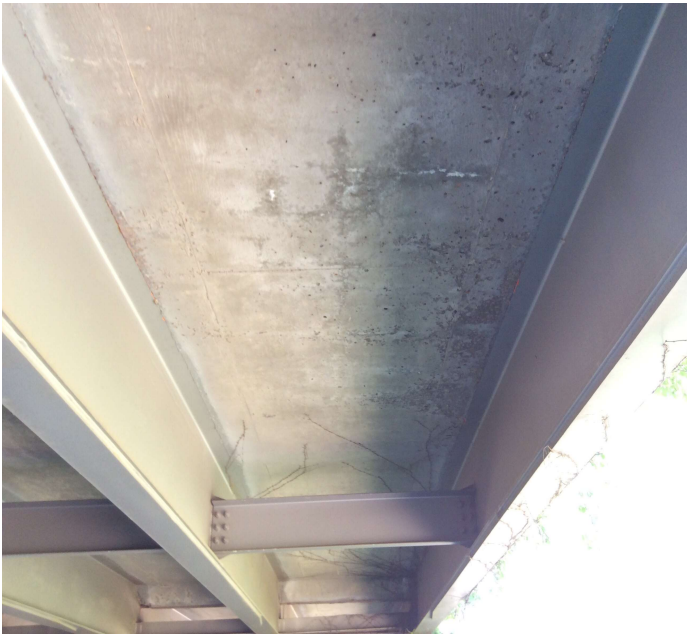
The undersurface of the deck has leaching, light scale, and map cracking in areas that correspond with the areas of distress on the driving surface.

PHOTO 1      Description      Deck soffit. Span 3, Bay 6.
