# Bridge Inspection Report

**B5100**  
**I-540, EB LNS**  
**over**  
**Ft Smith Railroad Seb Co**

Structure Number: B5100

Facility Carried: I-540, EB LNS

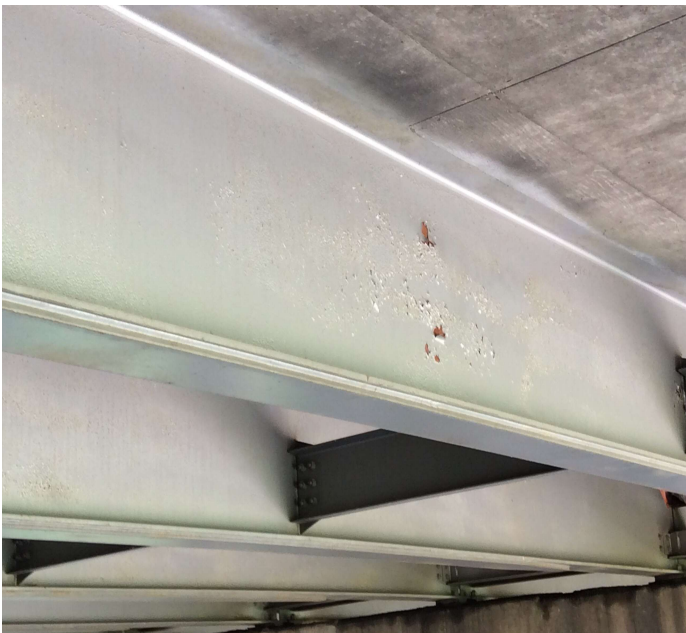
The superstructure paint system is peeling in areas.

PHOTO 1      Description      Paint. Span 1. Beam 5.

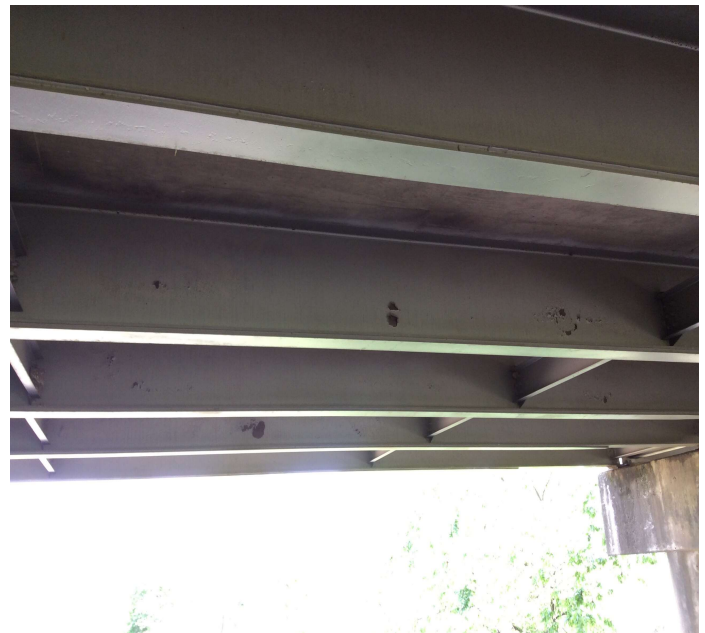
PHOTO 2      Description      Span 3 paint system.

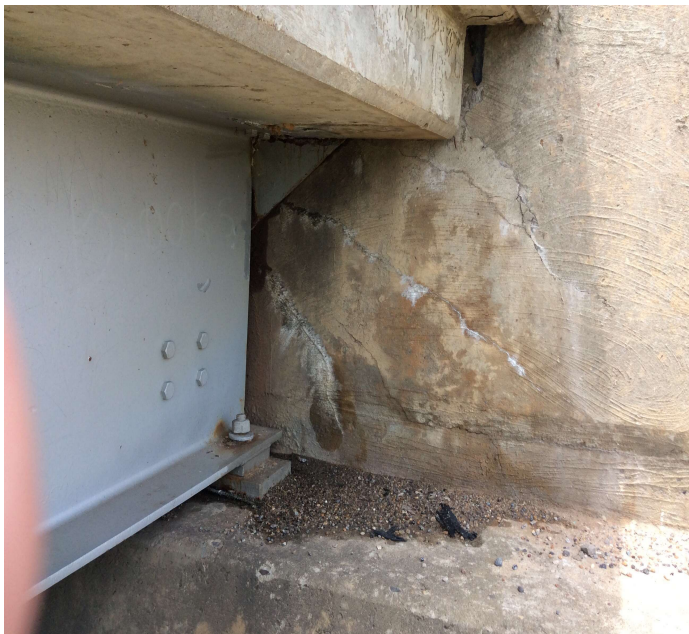
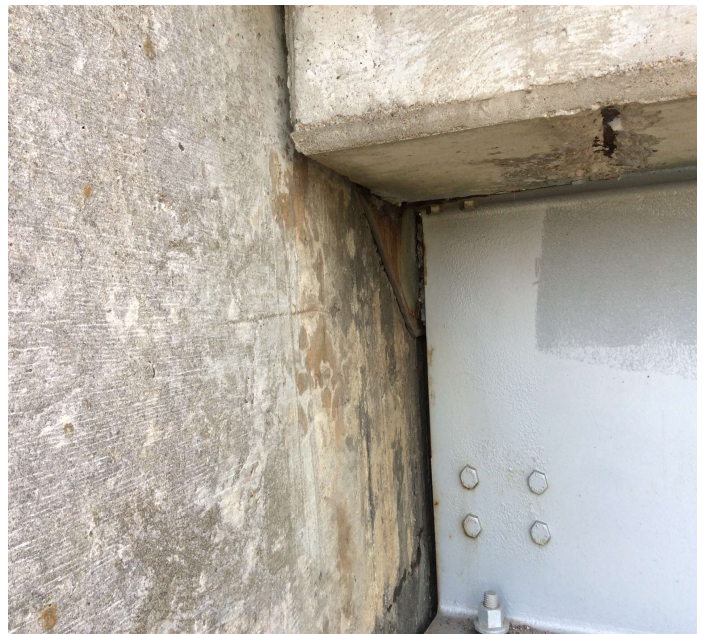
Portions of the expansion joint anchorage is missing at the abutments with asphalt patches. The expansion joints appear to be closed tight with the rubber gaskets only visible protruding from the exterior edges of the deck. The abutment expansion joints appear to be closed and make contact with the abutment backwalls. There are cracks with light efflorescence propagating from the point of contact in the Backwall of Bent 4, Right side of structure.

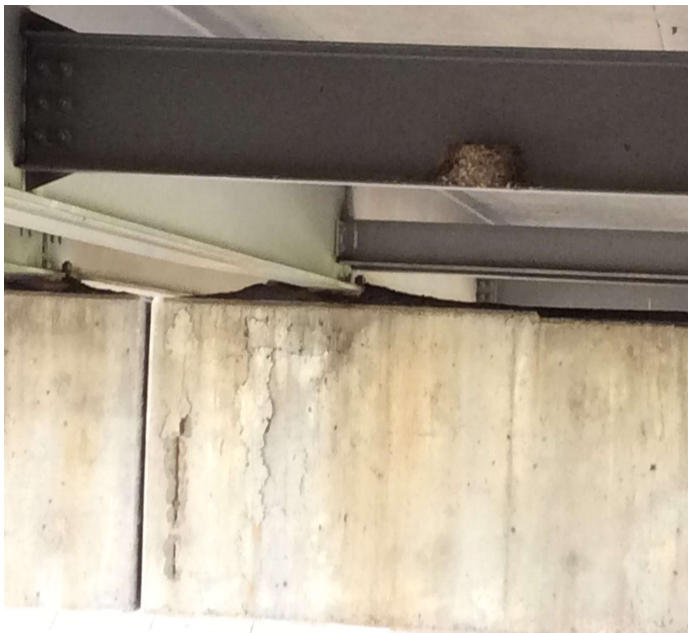
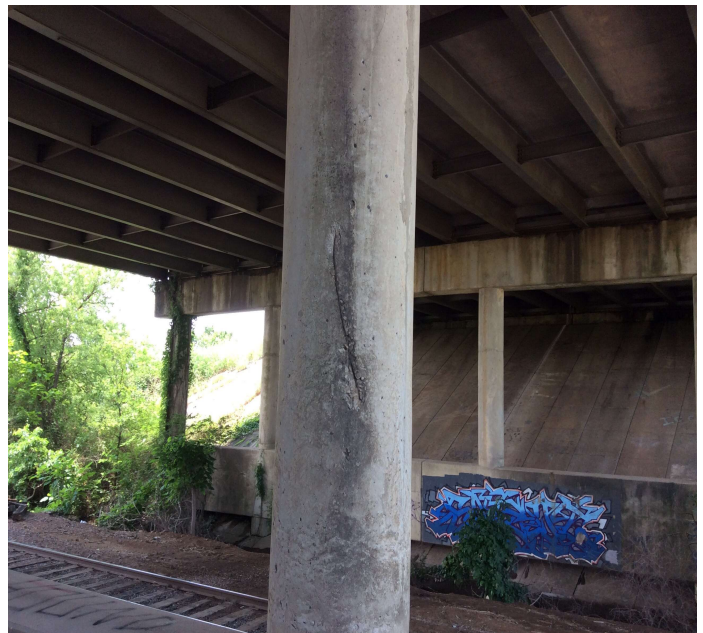
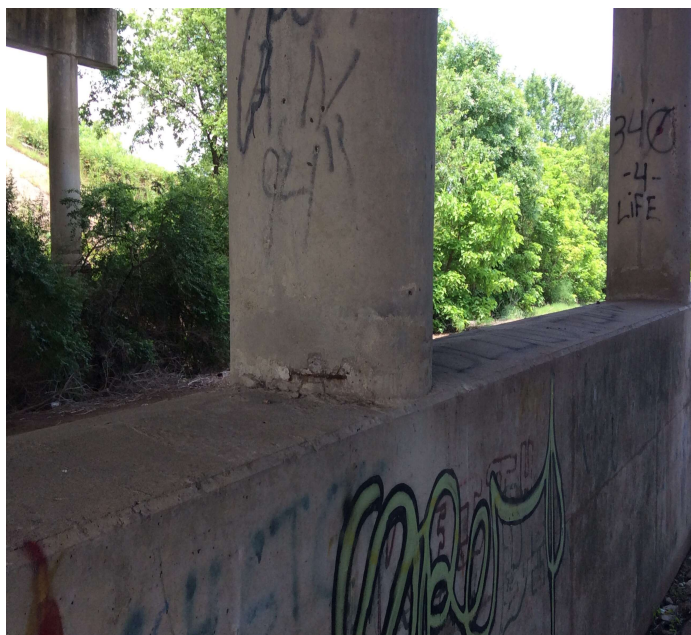
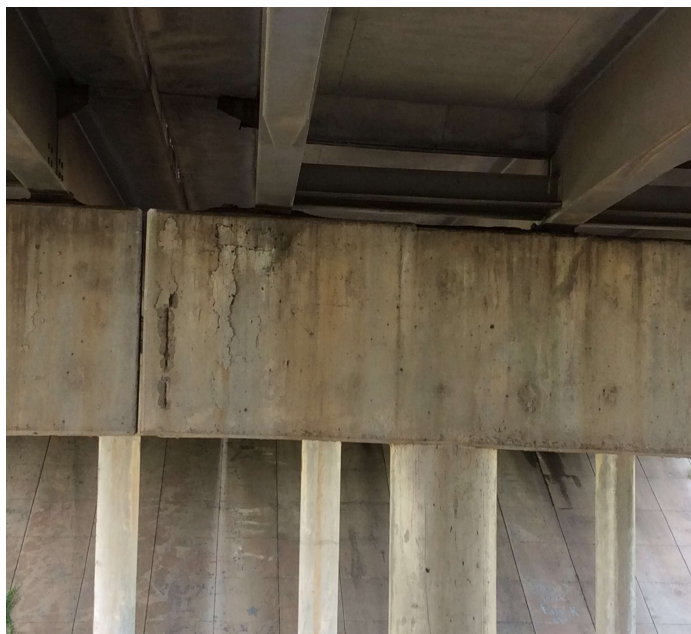
The substructure has isolated spalls with exposed reinforcing steel and delaminated areas.

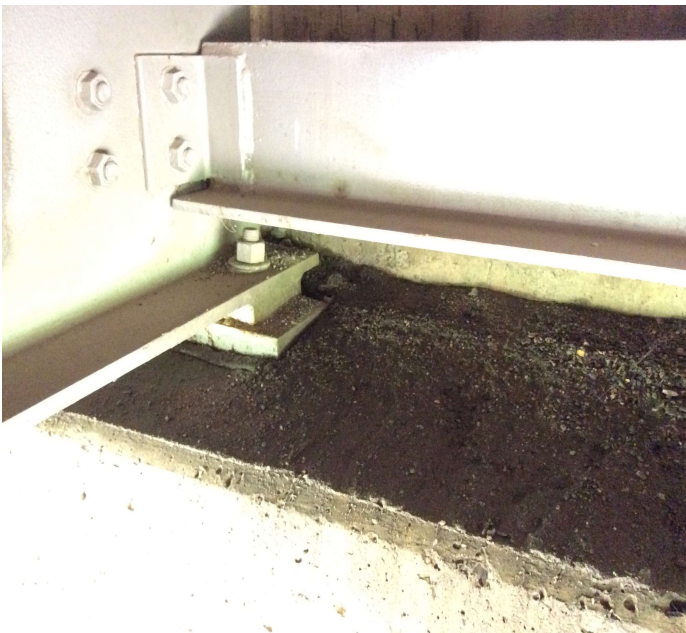
The compression deck joint seals leak water and debris on the caps.

PHOTO 1      Description      Bent 1 cap.

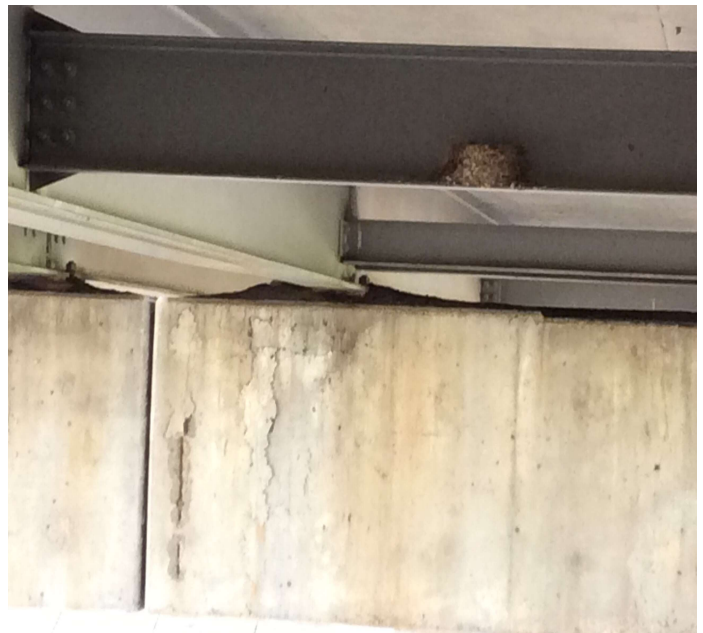
PHOTO 2      Description      Debris on bent 2 cap.

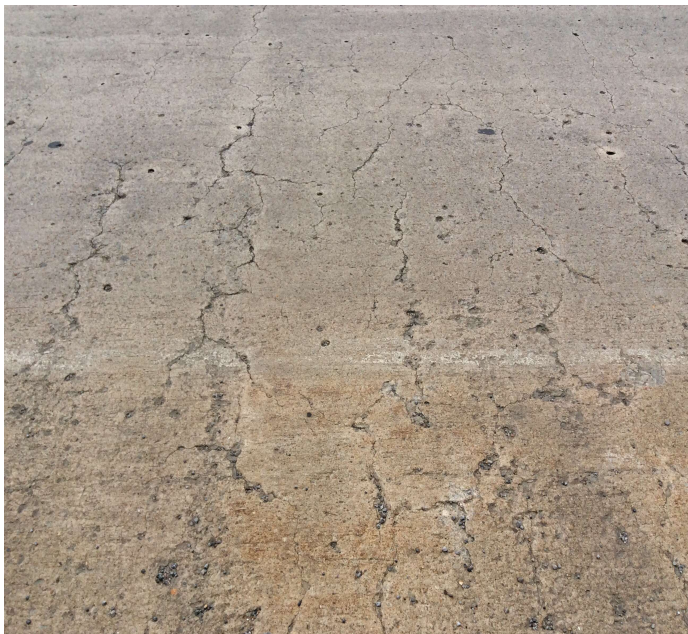
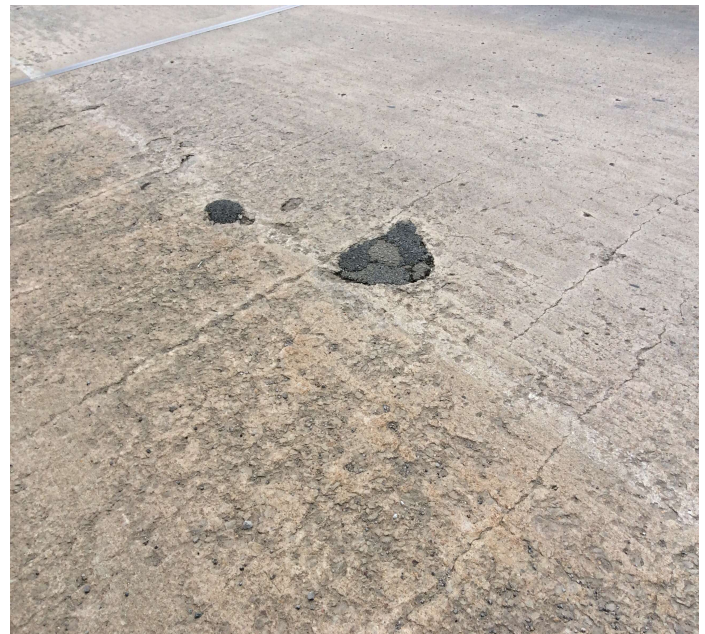
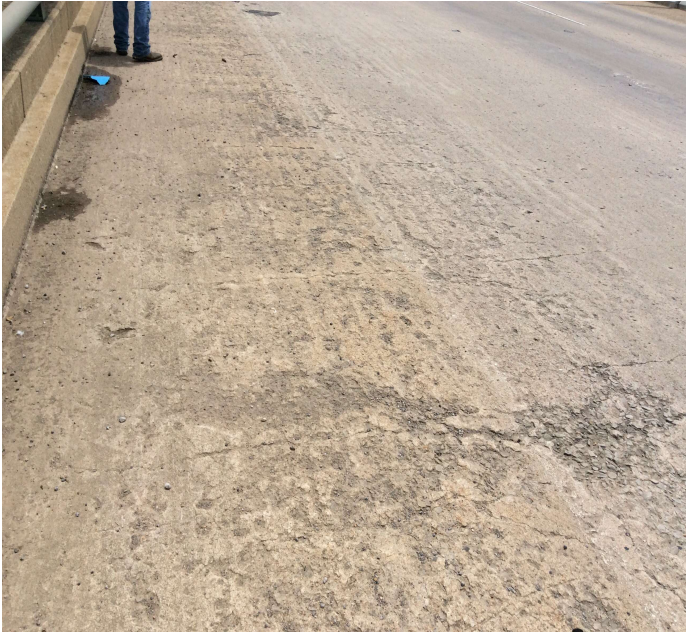
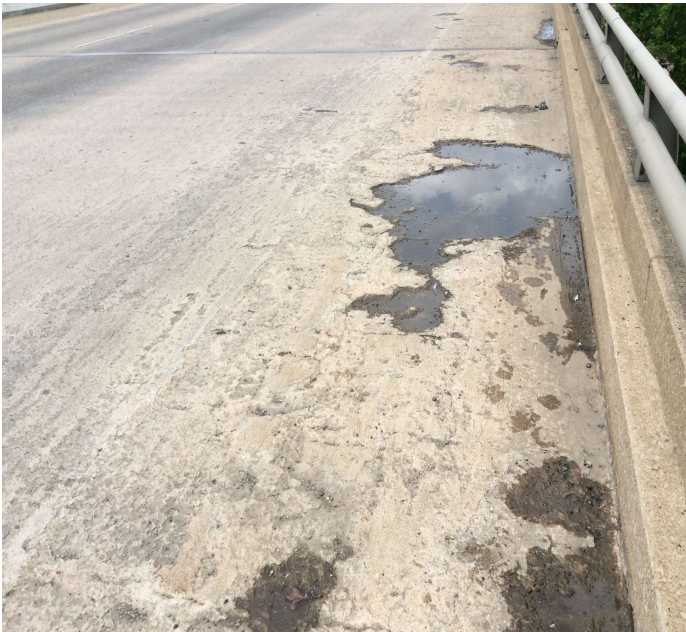
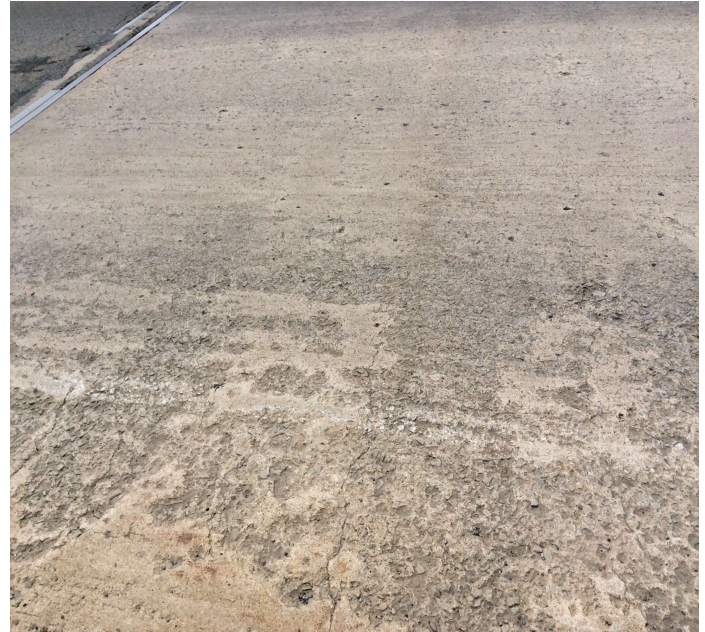
Driving surface of the deck has sealable cracks on all Spans and the Right gutterline on Span 1 has up to 1" scaling. There are delaminated areas and spalls with temporary asphalt patches on the driving surface of the deck.

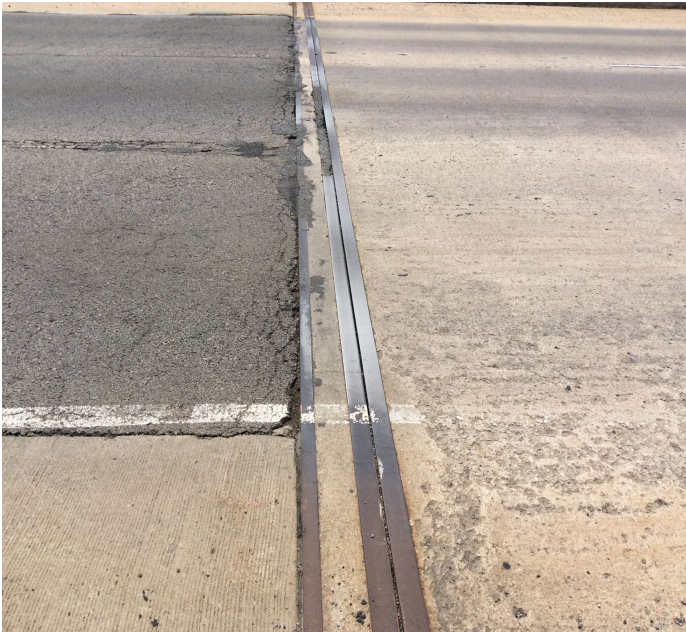
Asphalt repairs to the top of the head wall at Bents 1 & 4 are deteriorating.

PHOTO 1      Description      Bent 1. Typical top of backwall

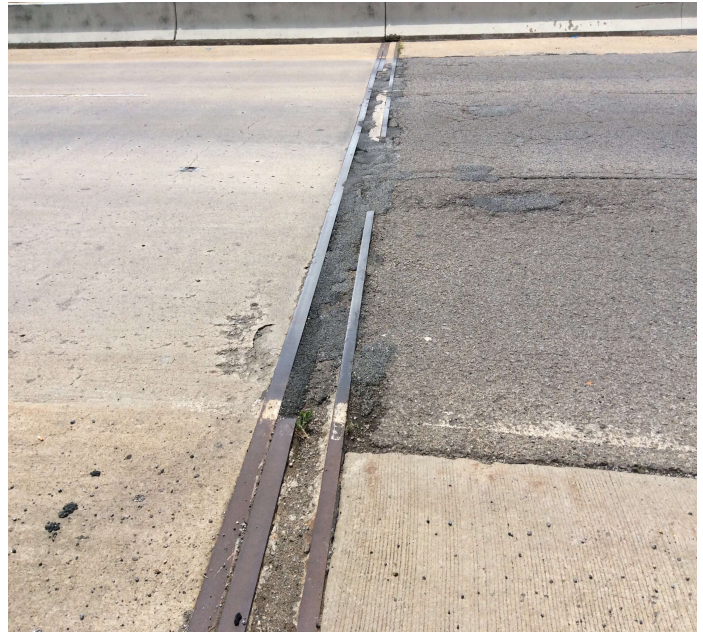
PHOTO 2      Description      Bent 4. Top of Backwall
