Bridge Inspection Report

A5101
I 540-SEC 1, SB LN
over
SH 255 Sebastian Co.

Structure Number: A5101

09/25/2017 - JCJ & JML - Special Recurring Inspection - Item 58, Deck has a NBIS Rating of 4. See Photos, Maintenance needs, and notes in the Element Inspection for additional information. Maintenance Forces have removed most of the delaminated areas over the traffic since the last inspection. There are no apparent significant changes since the last inspection.

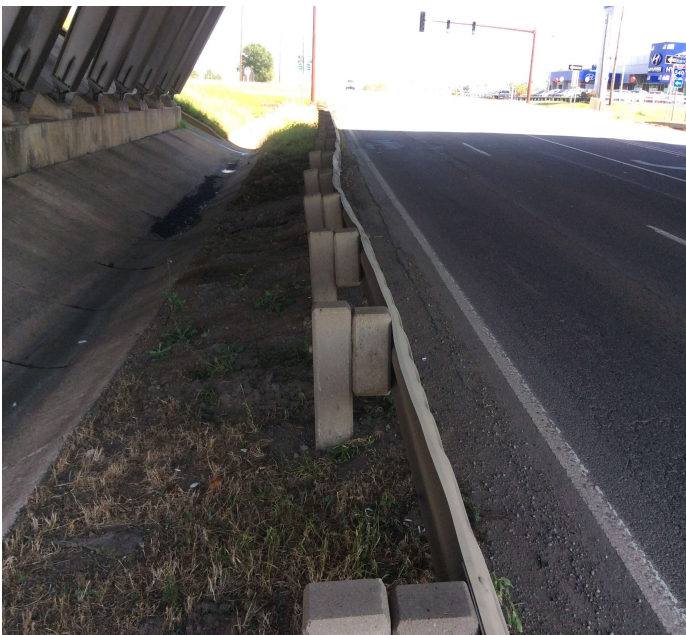
PHOTO 1 Description

Guard rail -

The guard rail under the structure adjacent to Bents # 2 and # 3 has collision damage.

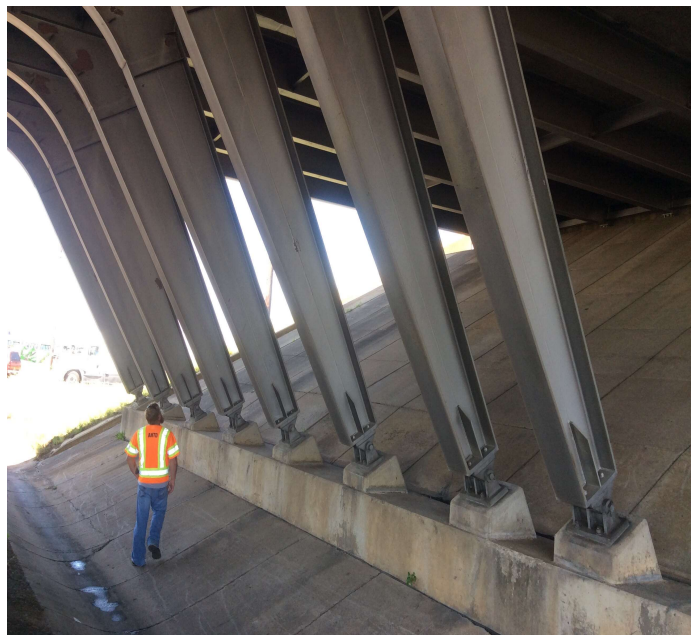
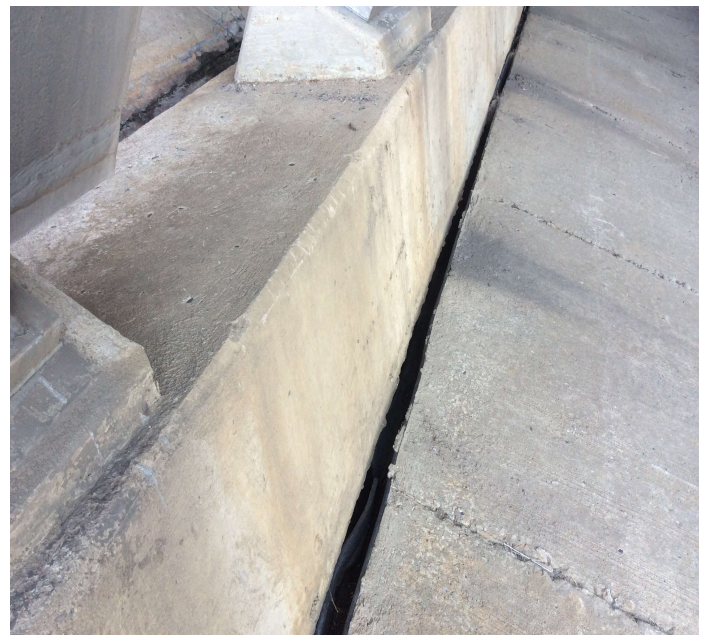
North embankment -

The compacted embankment has settled under the pile cap at Bent # 3.

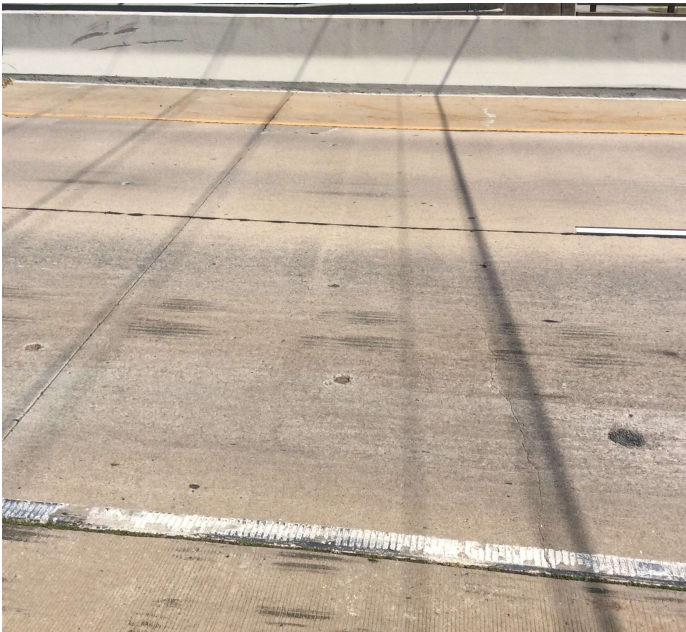
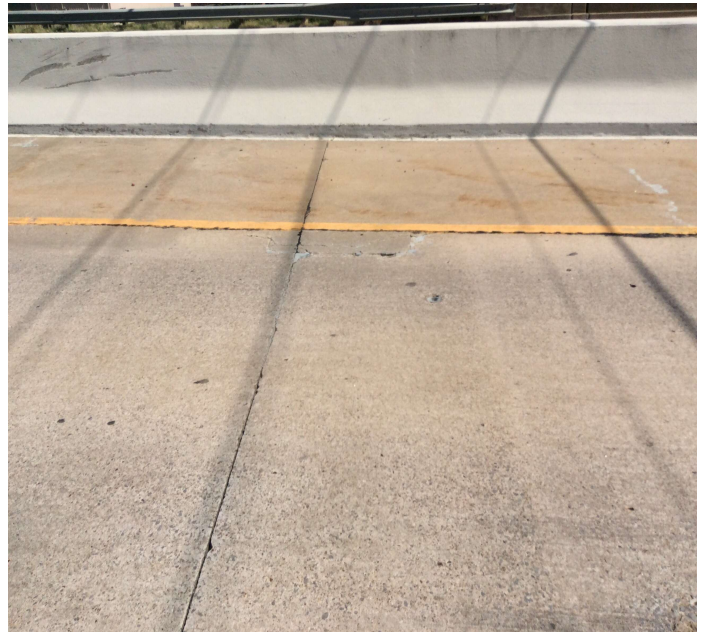
The North approach slab has two sealable transverse cracks. There is a 2' X 3' area where the concrete is fractured in the East edge of the North approach slab. Expansion joint material is missing from the North approach slab.

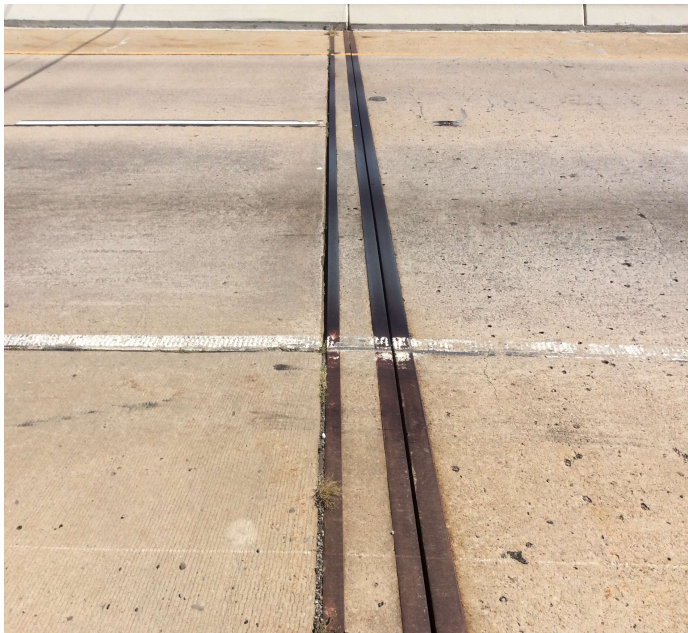
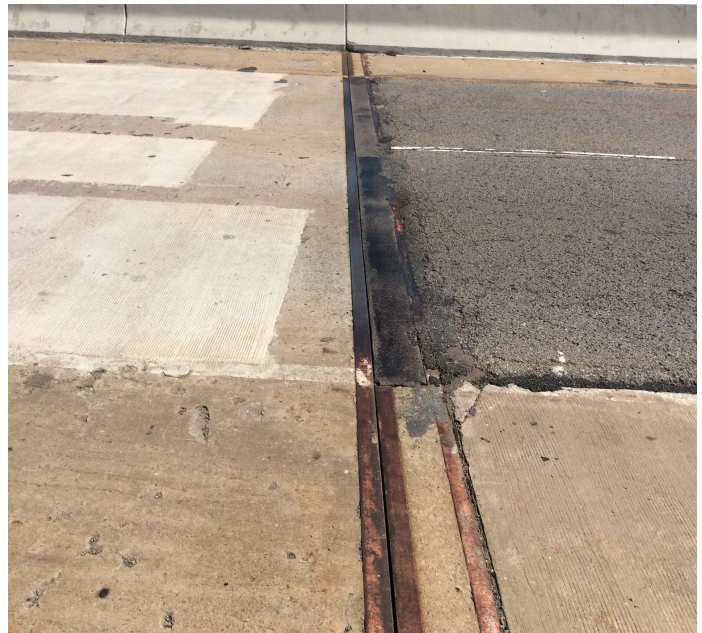
Expansion joints / South approach roadway-

The expansion joints have deteriorated seals and allow water, dirt and debris to leak onto the substructure and accumulate against the steel superstructure promoting corrosion. The poured type joint sealant between the north abutment backwall and the approach slab has failed and is missing in locations.

The asphalt driving surface of the south approach roadway is beginning to come apart at the bridge end allowing potholes to form in the driving surface.

PHOTO 1 Description Bent 4 expansion joint

PHOTO 2 Description Bent 1 expansion joint.

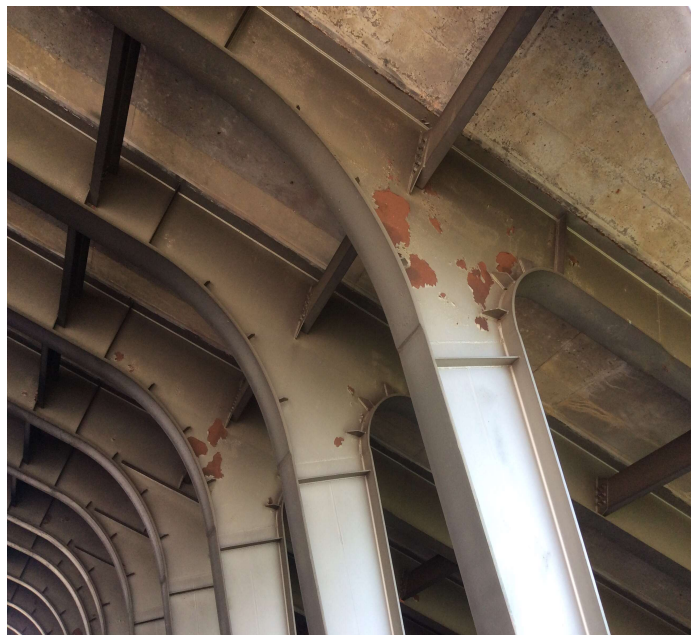
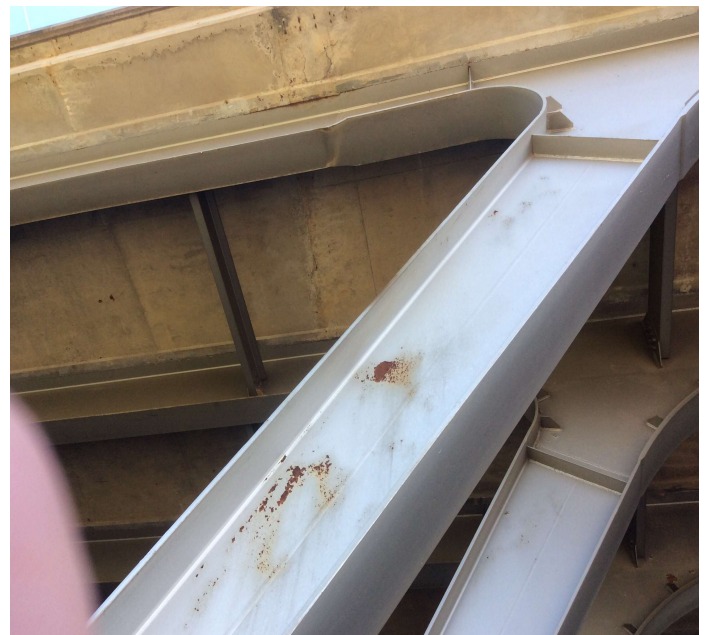
Superstructure -

The superstructure paint system has peeled and is missing in areas.

PHOTO 1 Description Bent 2. Beams 3,4,&5

PHOTO 2 Description Bent3. Beam 1.

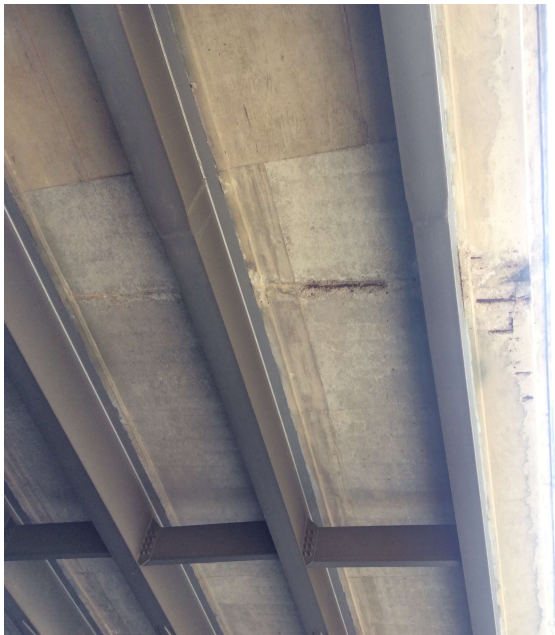
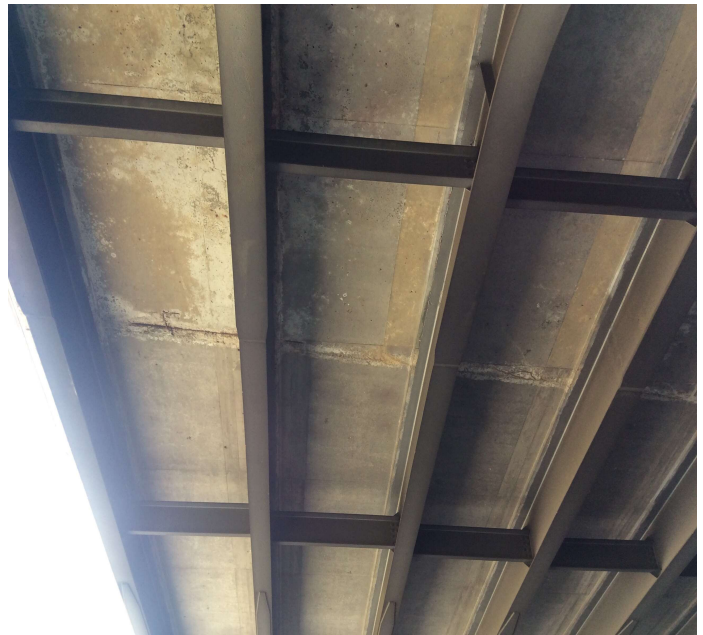
Deck Soffit -

The undersurface of the deck has delaminated areas. There are shallow spalls with exposed reinforcing steel on Span 2, Bays 1 & 2 at the construction joint. Span 1, Bay 3 has an area of leaching / scaling on the undersurface near Bent 1. Span 1 has a spall with exposed reinforcing steel visible from the undersurface of the Right edge of deck where the deck makes contact with the backwall of Bent 1.

PHOTO 1 Description Span2. Left edge of deck.

PHOTO 2 Description Span 2 deck soffit.

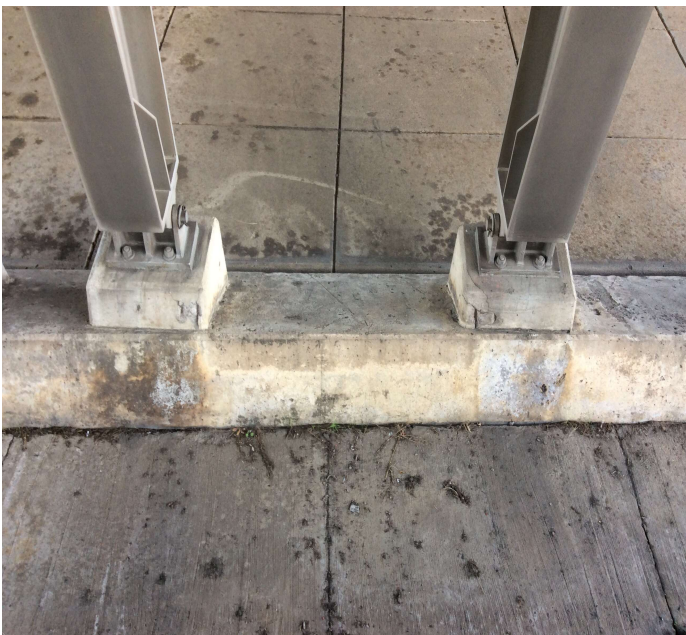
234 - Reinforced Concrete Pier Cap	1- Ben.	90	ft.	75	15	0	0
09/21/2016 - JCJ & JML - Baseball size spalls with exposed reinforcing steel in Bent # 2 Pedestals, in the bearing area of Beams # 1, 2, 3, 4, 5, 6 & 7. No apparent section loss to the exposed reinforcing steel. No significant changes since the last inspection. -The concrete portions of both bents have a few vertical hairline cracks at variable spacing. -Bent 3 has 2 shallow superficial spalls with no exposed reinforcing steel. -The compacted embankment has settled under the pile cap at Bent # 3.							
1080 - Delamination/Spall/Patched Area		2			2		
1090 - Exposed Rebar		8			8		
1130 - Cracking (RC and Other)		5			5		
302 - Compression Joint Seal	1- Ben.	90	ft.	0	0	0	90
09/21/2016 - JCJ & JML - - Compression joint seals not visible at this inspection.							
2330 - Seal Damage		90					90
311 - Movable Bearing	1- Ben.	14	each	5	9	0	0
09/21/2016 - JCJ & JML - - The bearings are approximately 90% expanded at Bent # 4, the temperature was approximately 90 degrees at the time of the inspection. The masonry plates at the abutments have active corrosion forming and are beginning to rust. Red rust (fretting) is visible at this inspection from the bearing pins. All pins are in place at this inspection.

Pedestals at bent # 2 -

The pedestals at bent # 2 have areas of spalling with exposed reinforcing steel.

PHOTO 1 Description Bent 2. Pedestals at Beams 6 & 7

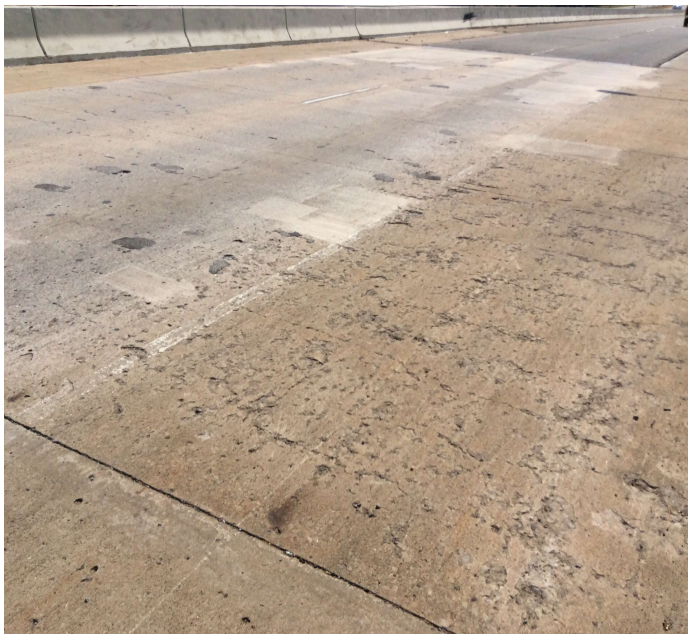
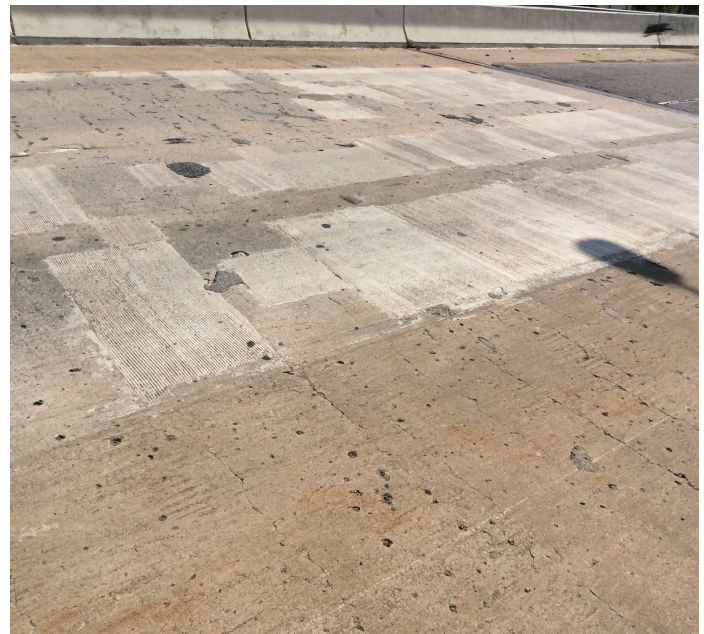
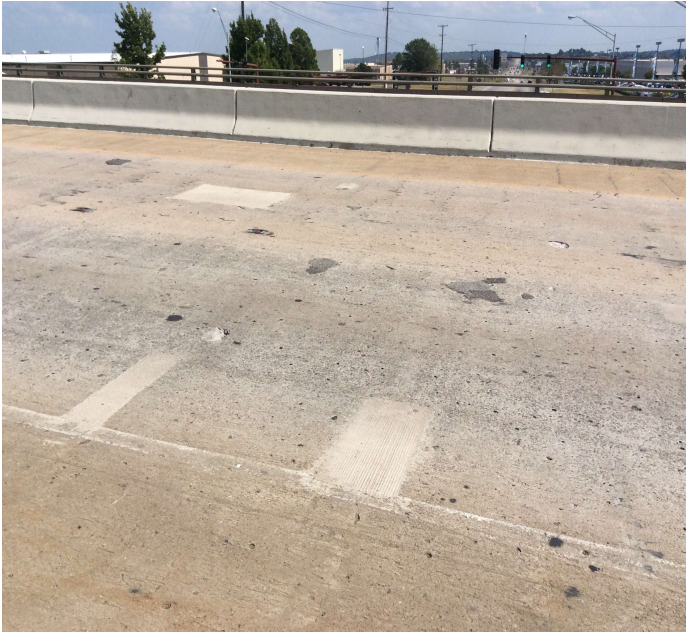
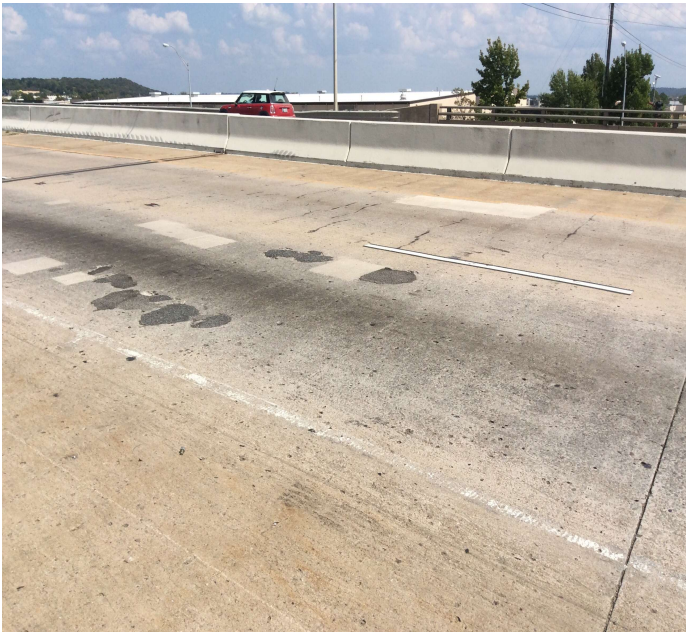
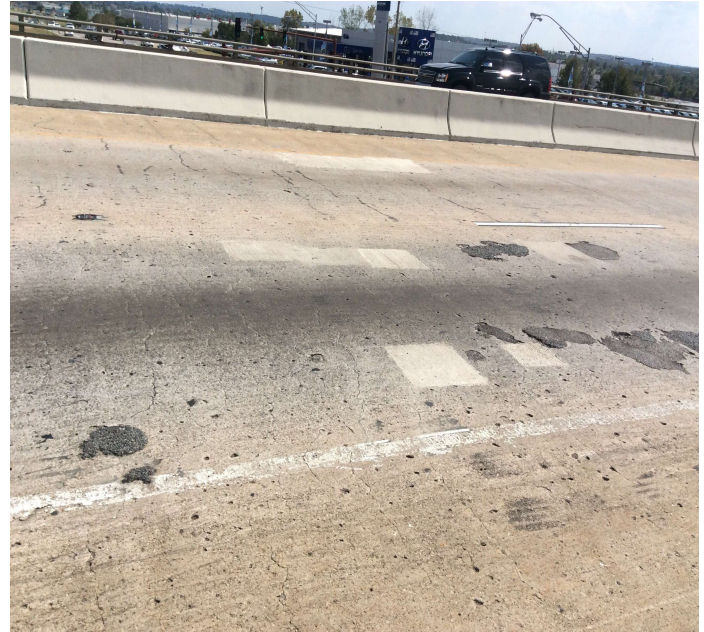
The driving surface of the deck has sealable transverse cracking over the reinforcing steel and numerous areas with temporary asphalt patches. Span 1 has numerous areas of spalling, delamination, and patched areas in various stages of disrepair. Spans 2 & 3 have addition areas of transverse cracking, delaminated areas, and spalls. Span 2 Left shoulder area has light to medium scaling.
