Bridge Inspection Report

B5101
I 540-SEC 1, NB LN
over
SH 255 Sebastian Co.

Structure Number: B5101

Facility Carried: I 540-SEC 1, NB LN

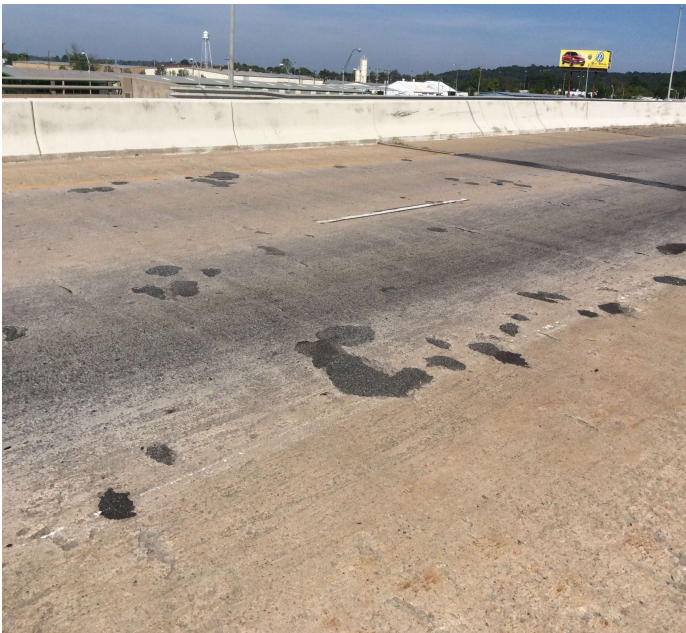
The driving surface of the deck has cracking with areas of scaling that has created potholes in the driving surface. The gutters have light to medium scaling with numerous delaminated areas.

The undersurface of the deck has spalling with exposed reinforcing steel in span # 1 bay # 3, and span 3 bay # 6. The undersurface of span # 3 bay # 3 has a delaminated area. The overhang portion of the deck on the right side of span # 1 has shallow spalling with exposed reinforcing steel adjacent to the south abutment.

PHOTO 1 Description Span 3.

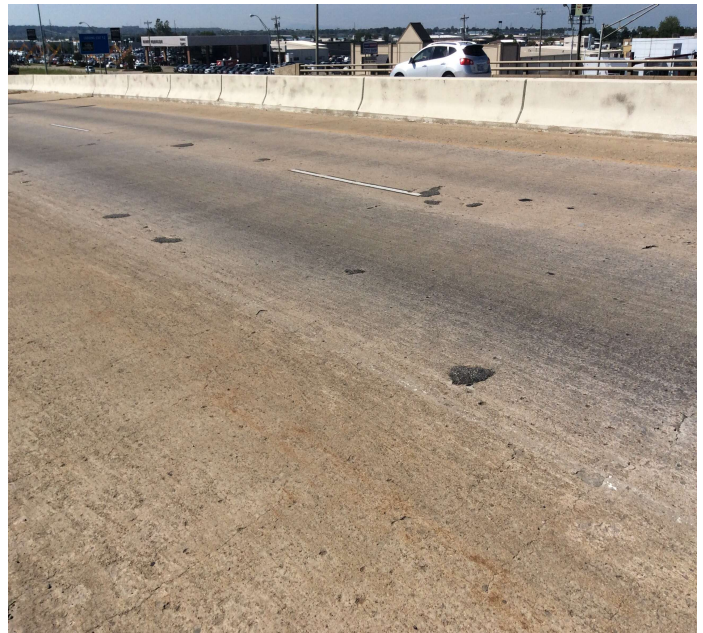
PHOTO 2 Description Span 2. Typ

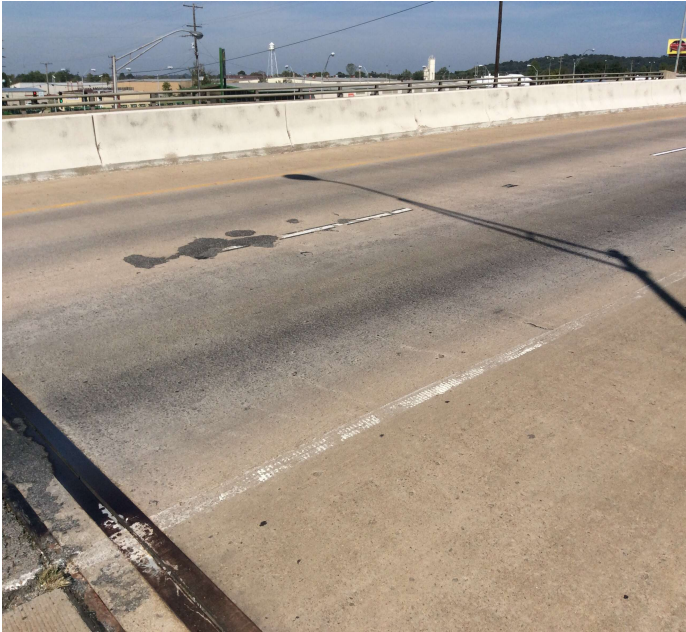
PHOTO 3 Description Span 1. Typical

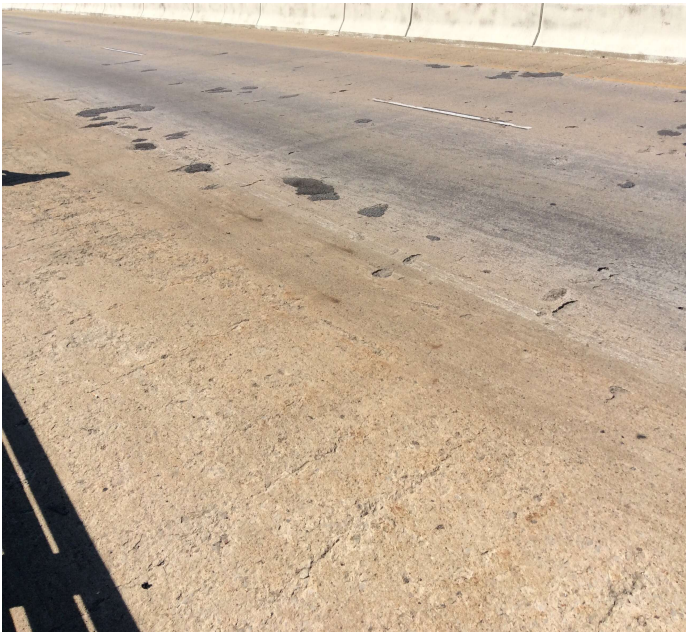
PHOTO 4 Description Span 3. Typical

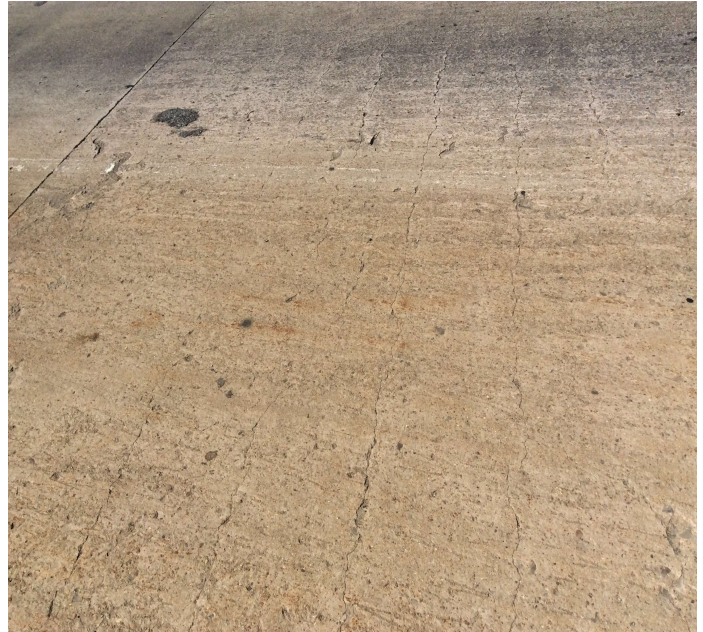
PHOTO 5 Description Span 2

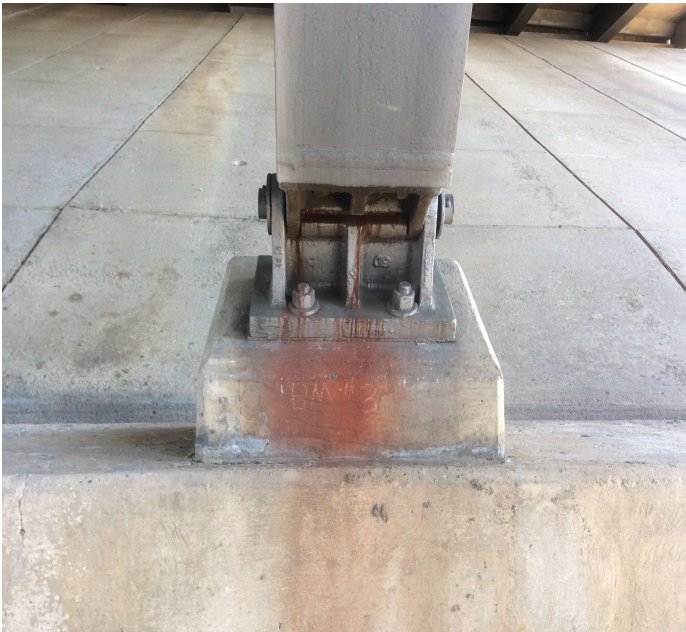
The pins are showing signs of fretting and have red rust leaching from the pin connections.

PHOTO 1 Description Bent 3. Column 3. Fretting

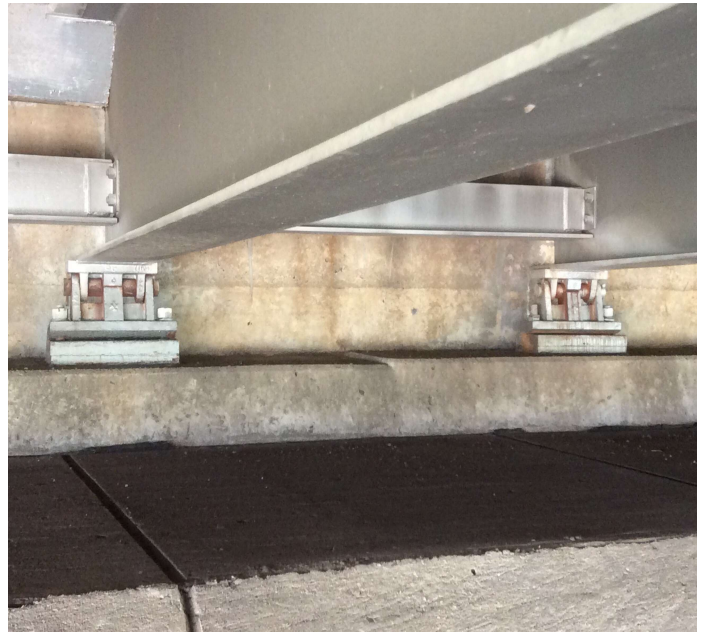
PHOTO 2 Description Bent 1. Bearings at beams 3 & 3. Fretting.

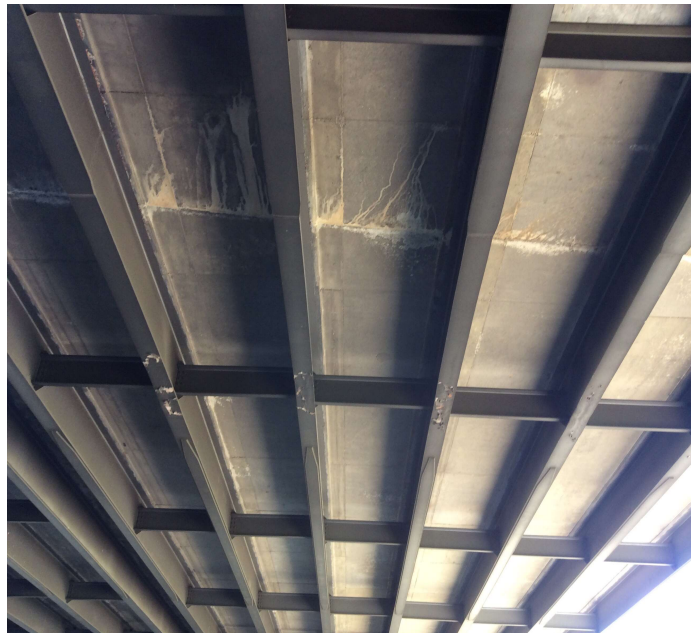
09/21/2016 - JCJ & JML - A Priority Maintenance Need - There are several delaminated areas separating from the undersurface of the deck over the traffic using State Highway 255.

PHOTO 3 Description Span 2 Deck soffit over Eastbound lanes.

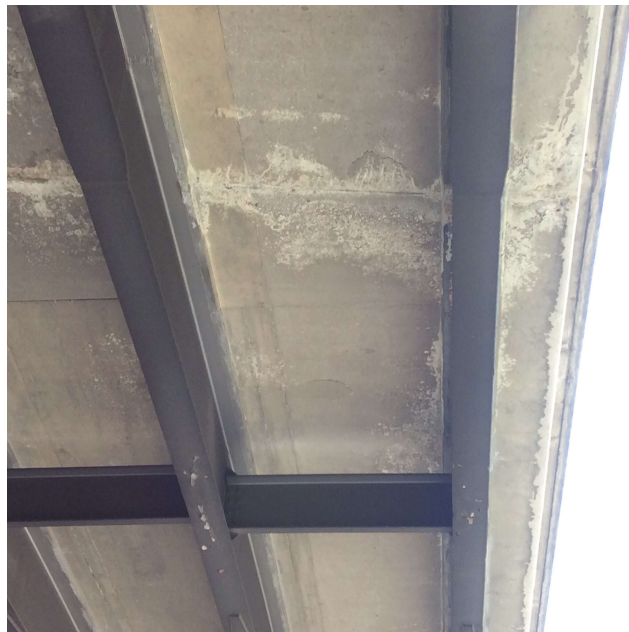
PHOTO 4 Description Delaminated areas over Eastbound lanes.

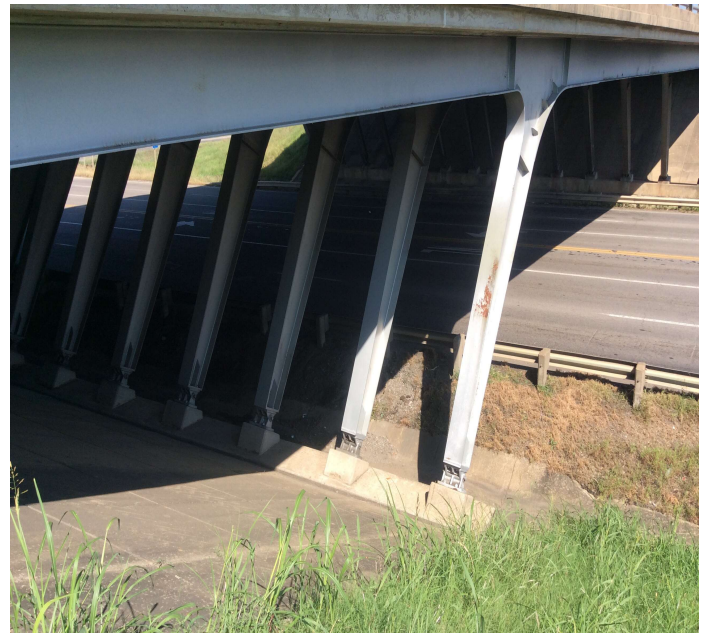
The superstructure paint system is beginning to deteriorate and has areas that are peeling and flaking. The top flanges of beams have active corrosion in random locations. The end of beam # 7 of span # 1 at the south abutment has active corrosion to the top flange and upper portion of the web adjacent to the expansion joint assembly.

PHOTO 5 Description Bent 2, Beam 6. Corrosion.

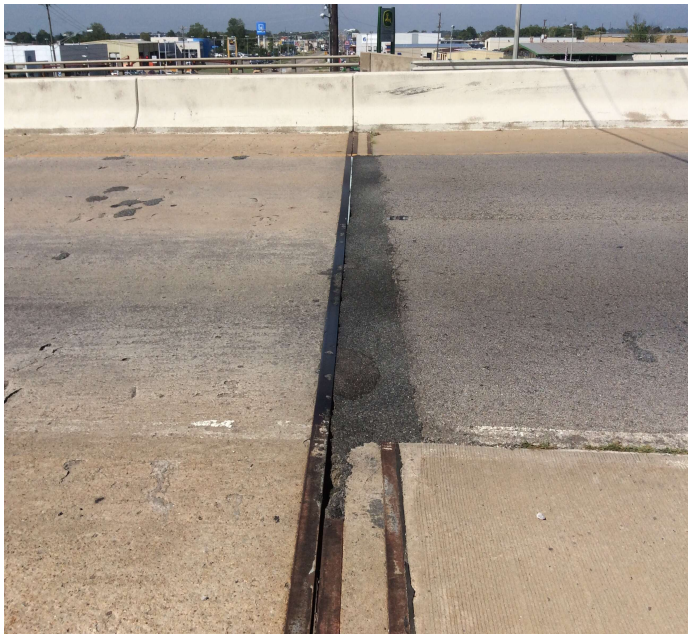
The expansion joint seals at the north and south abutments are deteriorated / partially missing and allow water, dirt and debris to leak onto the substructure.

PHOTO 1 Description Bent 4. Expansion joint

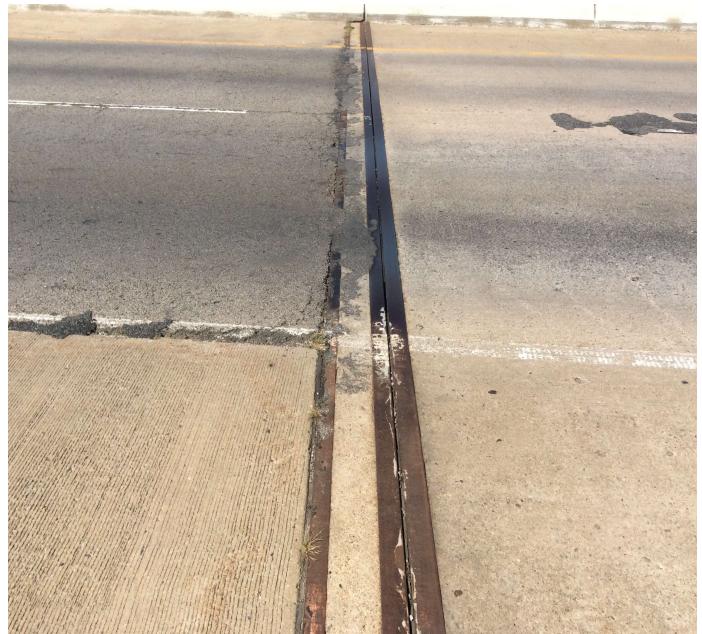
PHOTO 2 Description Bent 1. Expansion joint
