Bridge Inspection Report

A5102
I 540-SEC 1, WB LN
over
US 71-SEC 14, RR

Structure Number: A5102

Facility Carried: I 540-SEC 1, WB
LN

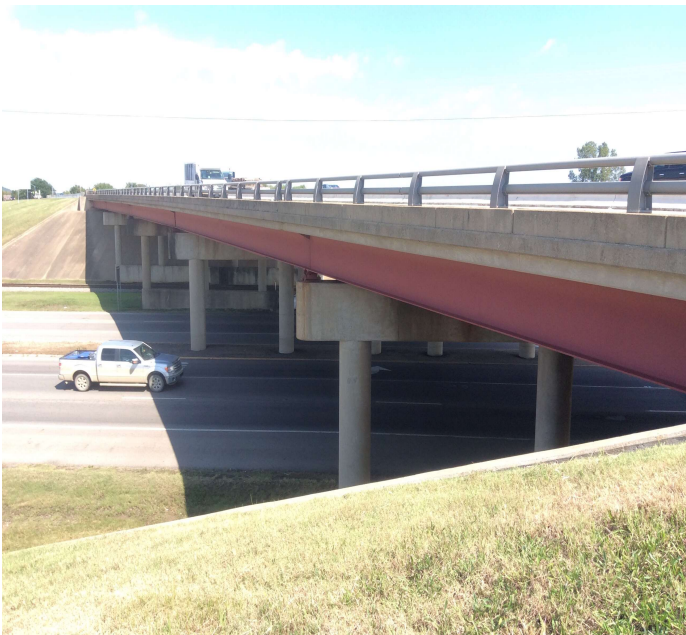
PHOTO 1 Description

The metal portions of the bridge railing have some loose connections.

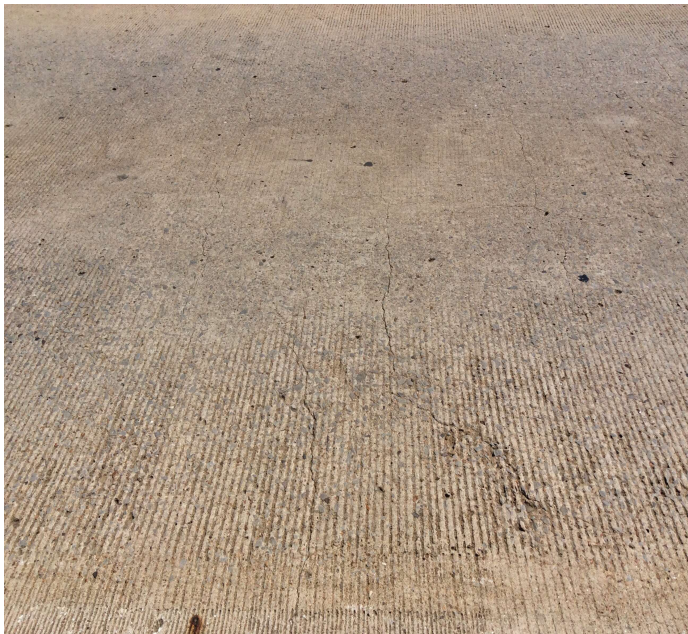
The driving surface of the deck has sealable transverse, longitudinal and map cracking. Span # 3 has delaminated areas with shallow spalling.

PHOTO 1 Description Span 1. Sealable deck cracks.

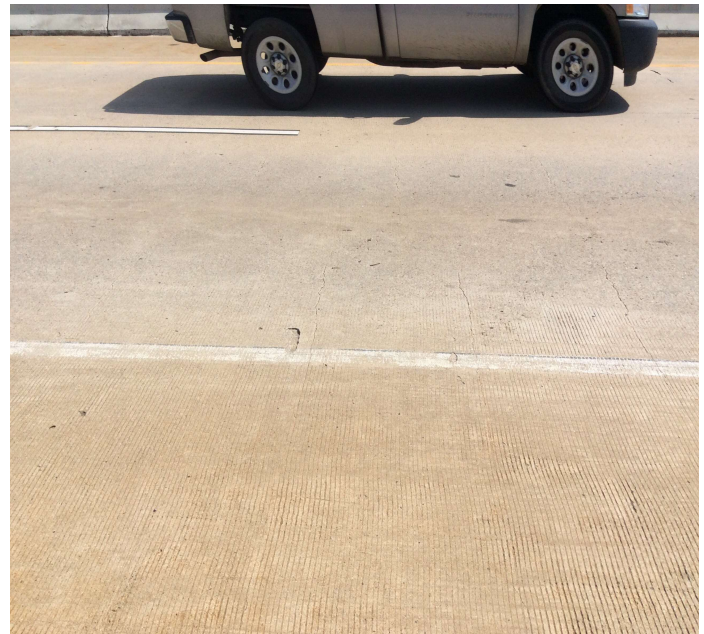
PHOTO 2 Description Span 3 delaminated area.

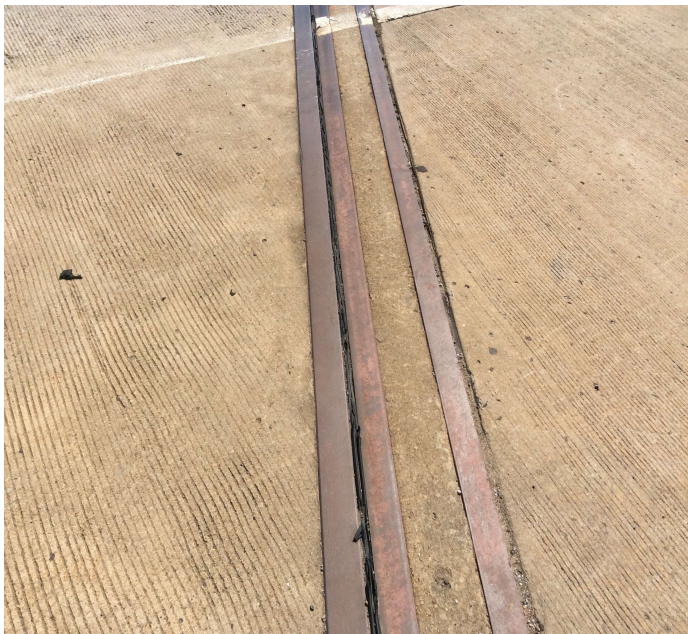
The pourable type compression joint seals at the abutments between the backwall's and the approach slabs have deteriorated and appear to leak water. The compression joint seal has failed at Bent # 4 allowing water to leak onto the substructure. Deck joint seals have areas that are torn and leak.

PHOTO 1 Description Span 1 deck joint seal

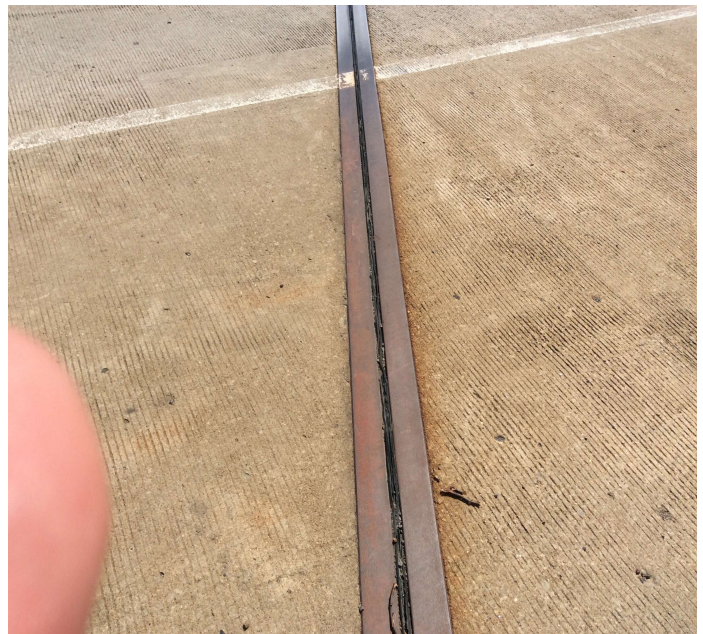
PHOTO 2 Description Span 2 deck joint seal

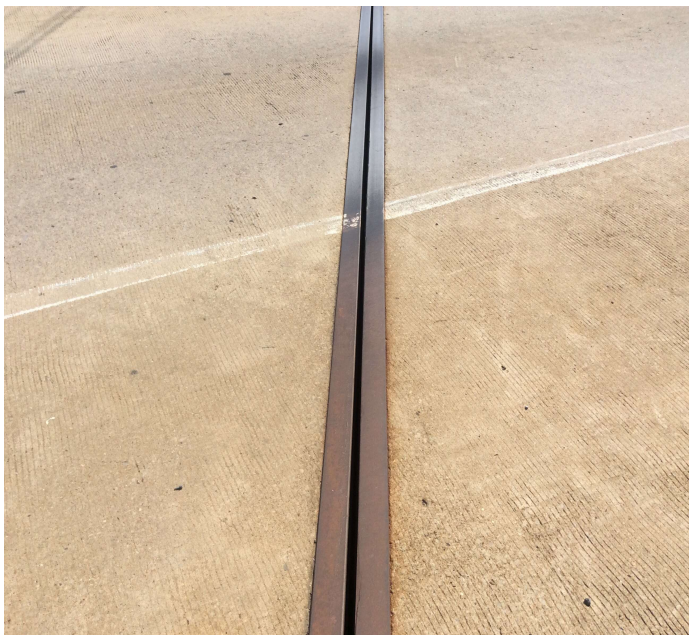
PHOTO 3 Description Bent 4 deck joint seal is missing.

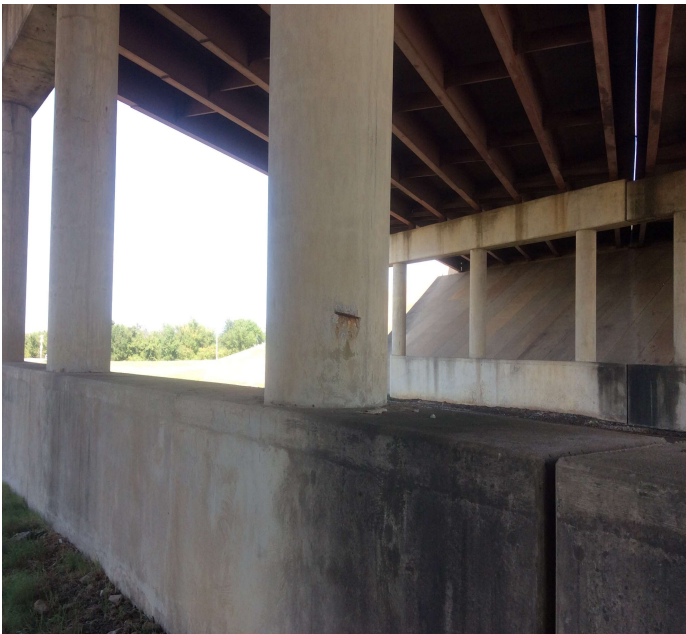
PHOTO 1 Description Bent 4. Column 3.

Column # 3 of bent # 4 has an area of spalling approximately 6" X 6" that exposes reinforcing steel in the lower portion of the column. The exposed reinforcing steel has active corrosion with initial section loss.

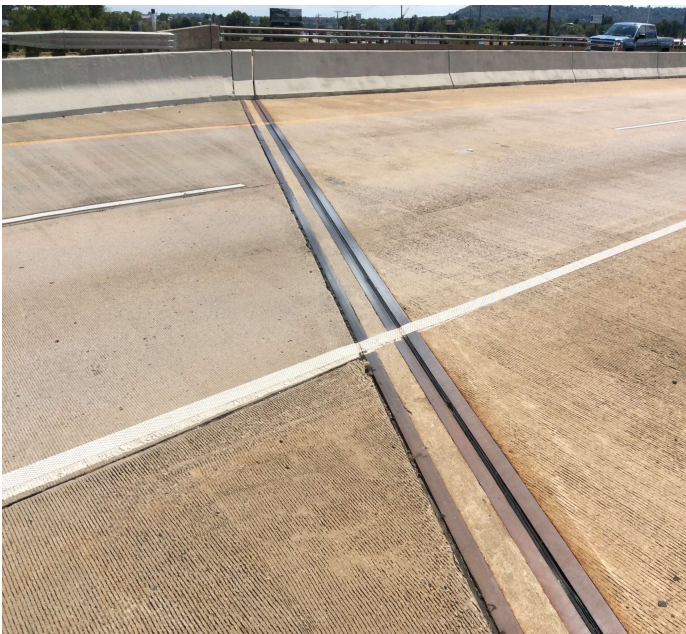
PHOTO 1 Description North abutment expansion joint

The armored compression joint assembly at the north abutment is noisy when impacted by traffic. Sounding the assembly indicated that the assembly anchorage is loose on the backwall portion of the assembly the full width of the left lane and approximately 50% of the right lane. No apparent cracks in the assembly at this inspection.
