Bridge Inspection Report

B5102
I 540-SEC 1, EB LN
over
US 71-SEC 14, RR

Structure Number: B5102

Facility Carried: I 540-SEC 1, EB LN

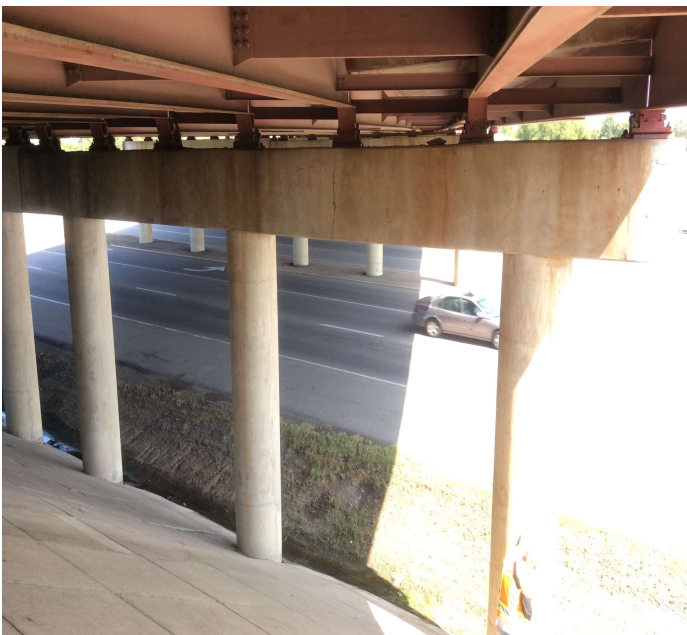
PHOTO 1 Description

Bearings -

The bearings have a failing paint system and active corrosion with pack rust between the sole and masonry plates.

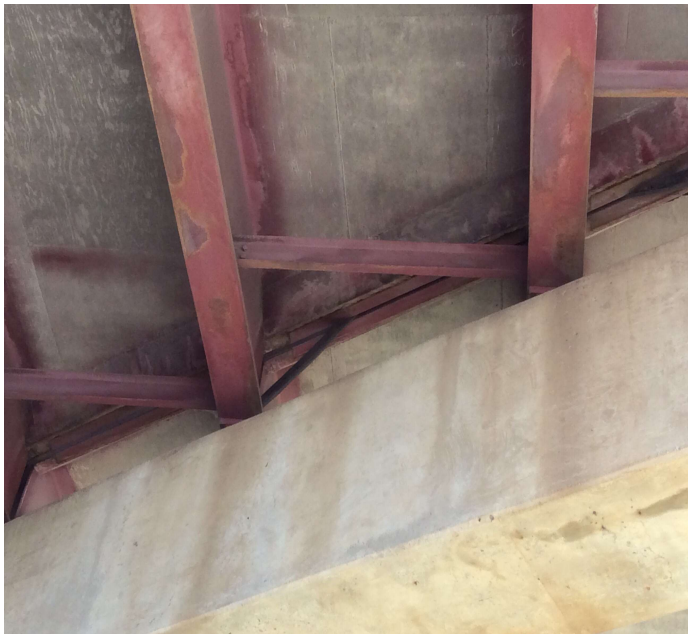
The compression joint seals have failed at Bents # 2, 4 & 5. The pourable type compression joint seals are beginning to deteriorate at the abutments between the backwall's and the approach slabs.

PHOTO 1 Description Bent 4 deck joint seal.

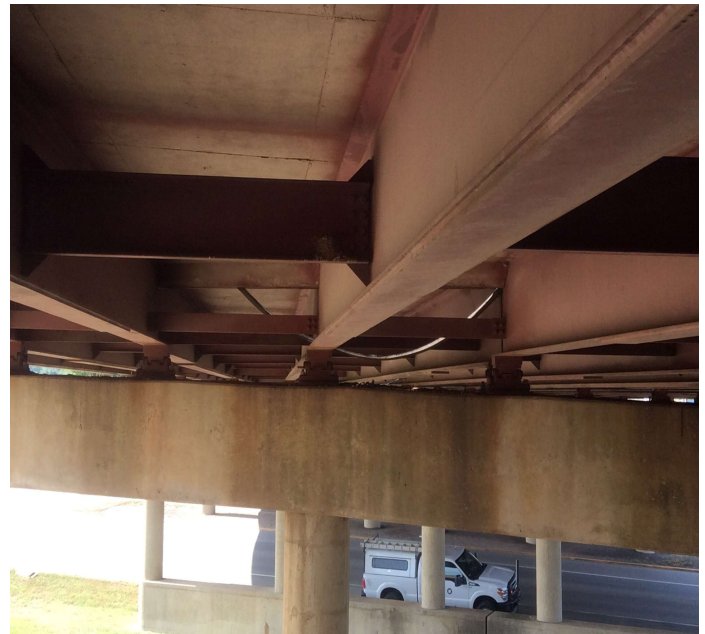
PHOTO 2 Description Bent 5 deck joint seal

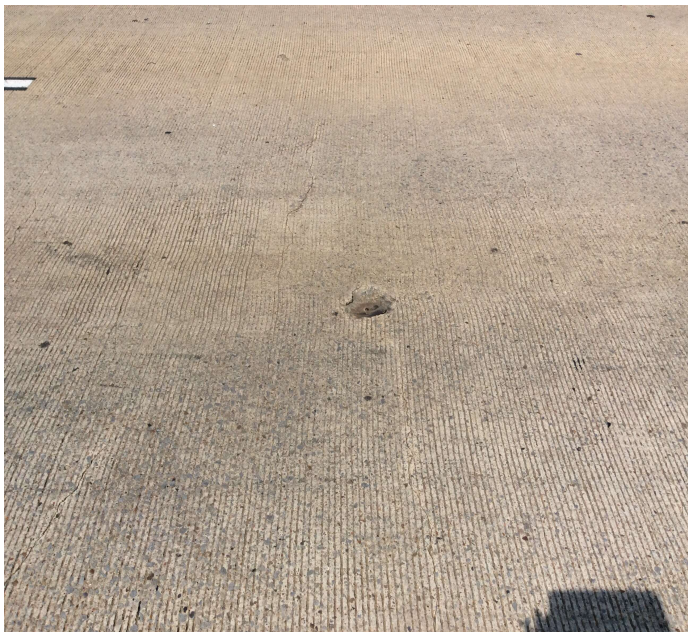
The Right lane of Span # 4 has an unknown metal object visible in a shallow spall that was apparently cast into the deck during the construction process. The metal object does not appear to be loose at this inspection.

PHOTO 1 Description Span 4 debris cast in the deck.

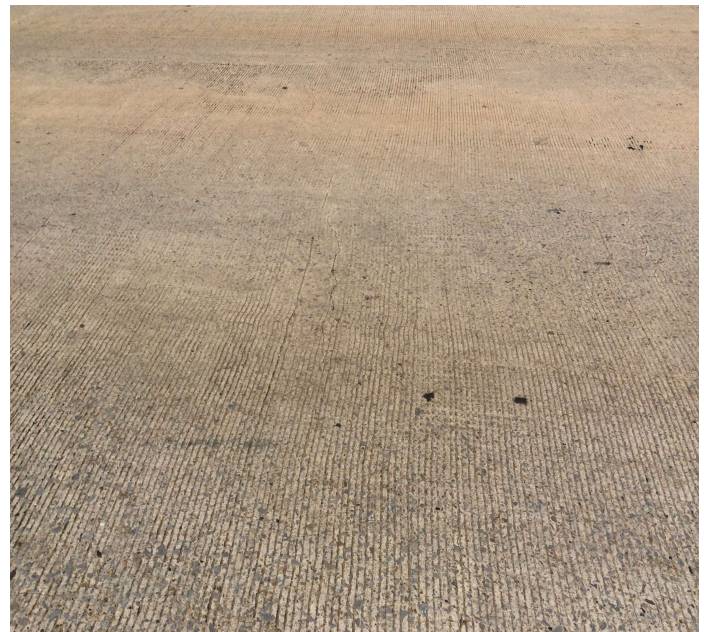
PHOTO 2 Description

The driving surface of the deck has sealable cracking in all spans.

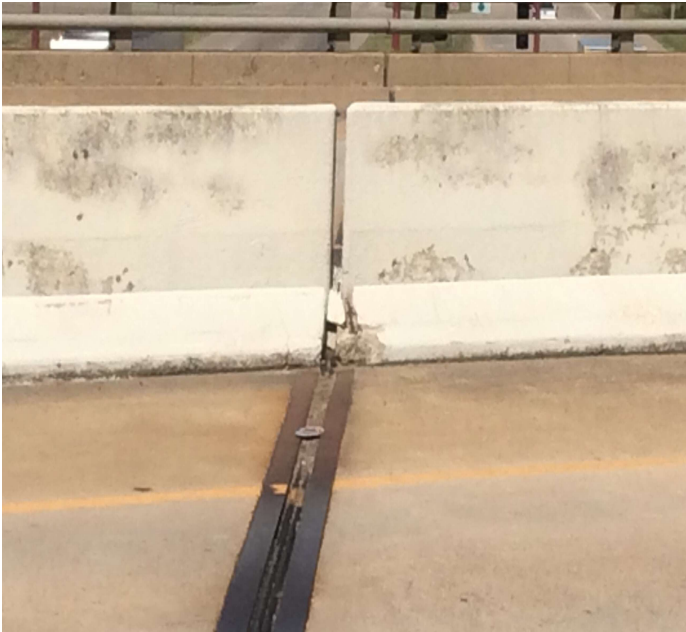
1020 - Connection		3			3		
1900 - Distortion		12			12		
331 - Reinforced Concrete Bridge Railing	1- Ben.	347	ft.	270	76	1	0
The curb at Span 3 Lt at Bent 2 has a spalled corner with exposed rebar.							
1080 - Delamination/Spall/Patched Area		1				1	
1090 - Exposed Rebar		3			3		
1130 - Cracking (RC and Other)		73			73

The concrete curb on the left side of structure adjacent to the median barrier has apparent collision damage that has created spalling with exposed reinforcing steel in span # 1 at south abutment and in span # 3 at bent # 2.

PHOTO 1 Description Median Barrier wall. Span 3 at Bent 2.

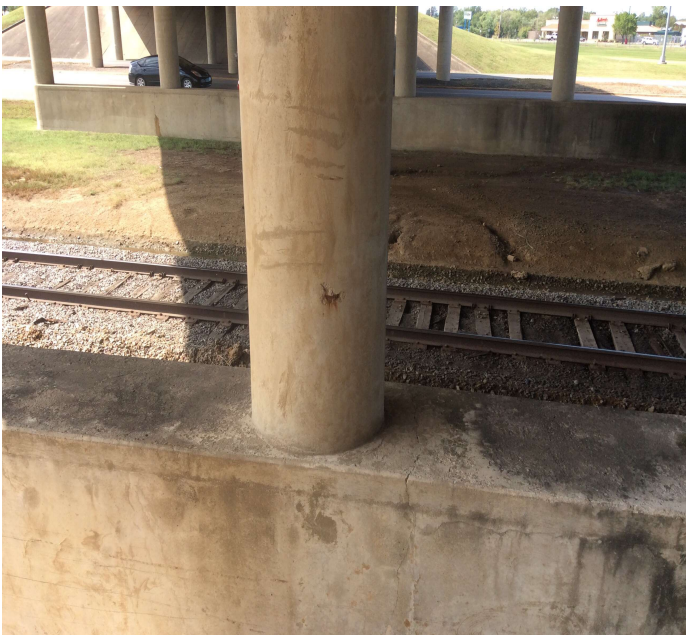
PHOTO 1 Description Bent 5, Column 2.

The substructure has areas of spalling with exposed reinforcing steel, and delaminated areas.

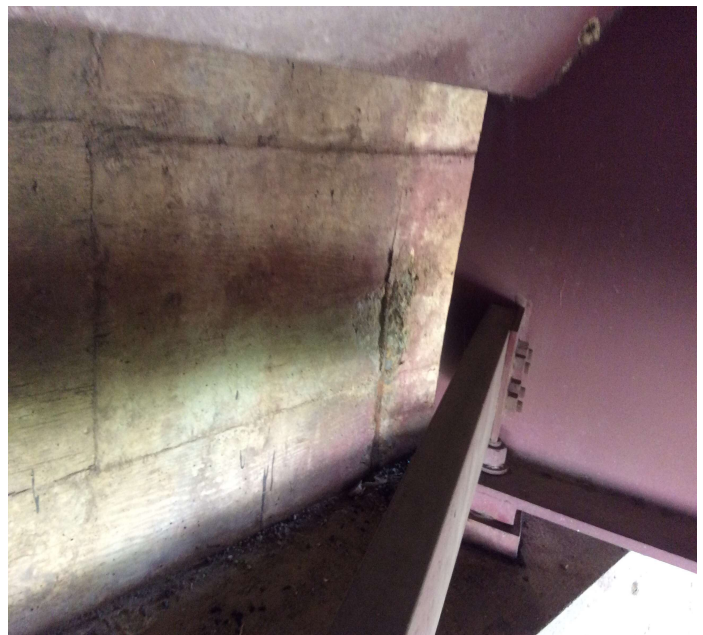
PHOTO 2 Description Bent 6 Backwall

09/19/2016 - JCJ & JML - The abutments and their backwalls have vertical and horizontal cracks. -The top of Bent # 1 backwall has an 8" shallow spall with no exposed reinforcing steel in the driving surface of the backwall. -Bent 6 backwall has a 4" spall with exposed reinforcing steel behind Beam 5 and a 14" spall with exposed reinforcing steel behind Beam 6.						
1080 - Delamination/Spall/Patched Area		1				1	
1090 - Exposed Rebar		2			2		
1130 - Cracking (RC and Other)		24			24
