# Bridge Inspection Report

**A5629**  
**I 540-SEC 1, WB LN**  
**over**  
**Jenny Lind Street**

Structure Number: A5629

Facility Carried: I 540-SEC 1, WB  
LN

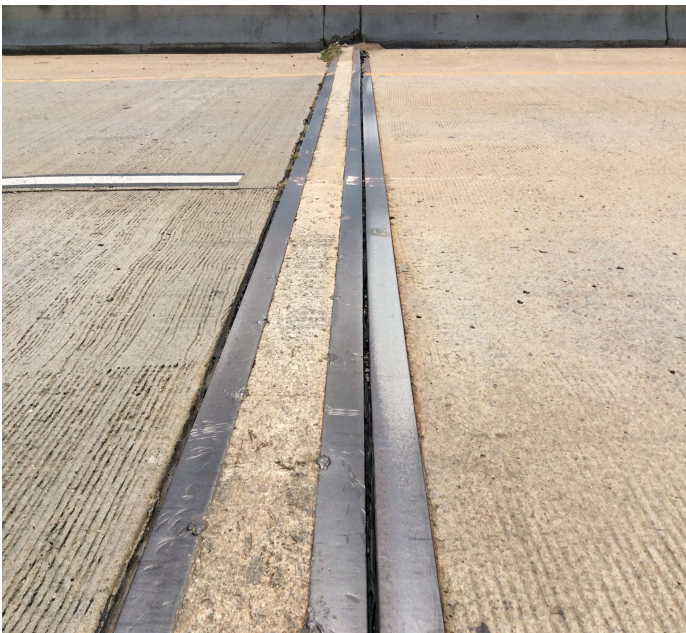
1080 - Delamination/Spall/Patched Area		17			4	3	10
1090 - Exposed Rebar		1				1	
1130 - Cracking (RC and Other)		30			30		
302 - Compression Joint Seal	1- Ben.	84	ft.	42	0	42	0
	07/19/2016 - JCJ & RSM - The compression joint at Bent 1 has been replaced with a pourable type silicone joint. The compression seal at Bent 2 is deteriorated, cracked with tears and leaks water on the substructure.						
2340 - Seal Cracking		42				42	
311 - Movable Bearing	1- Ben.	7	each	0	6	1	0
	07/19/2016 - JCJ & RSM - Bearing #6 at Bent #2 has visible fretting. Bearings appear to be fully expanded at this inspection. Bearings have minor rust between rockers and masonry plates.						
1000 - Corrosion		2			1	1	
2210 - Movement		2			2

The compression joint seal at Bent # 2 is ripped, torn and leaks water onto the superstructure.

PHOTO 1 Description Bent 2 expansion joint deteriorated.

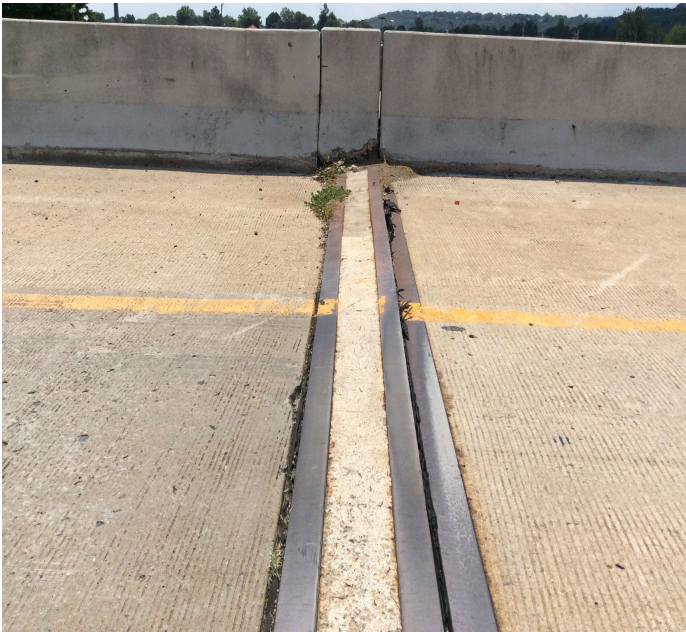
07/19/2016 - JCJ & RSM - The top of backwall located on the Right side of Bent 2 is delaminated adjacent to the median barrier wall with no repairs since the last inspection.

Right side of Bent # 2, top of backwall is delaminated and raised approximately 3" above the driving surface of the deck adjacent to the median parapet wall.

PHOTO 1 Description Bent 2 Right side.

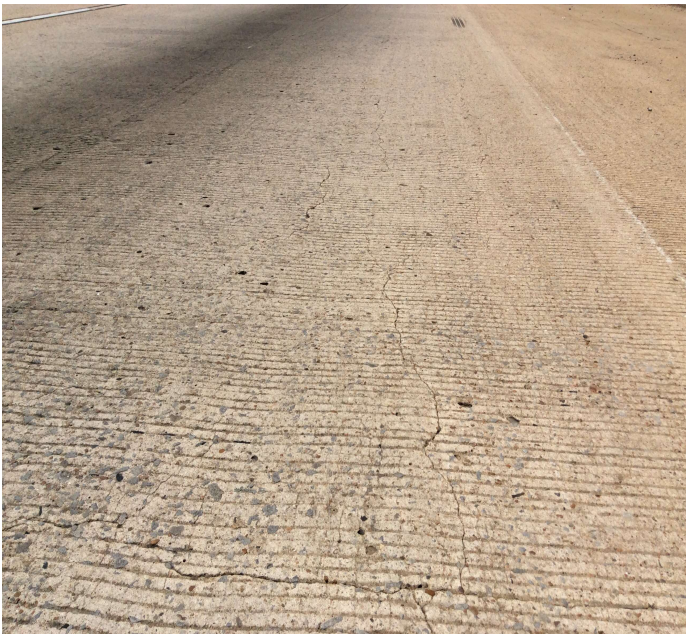
Driving surface has sealable transverse and longitudinal cracking.

PHOTO 1      Description      Deck cracking typical

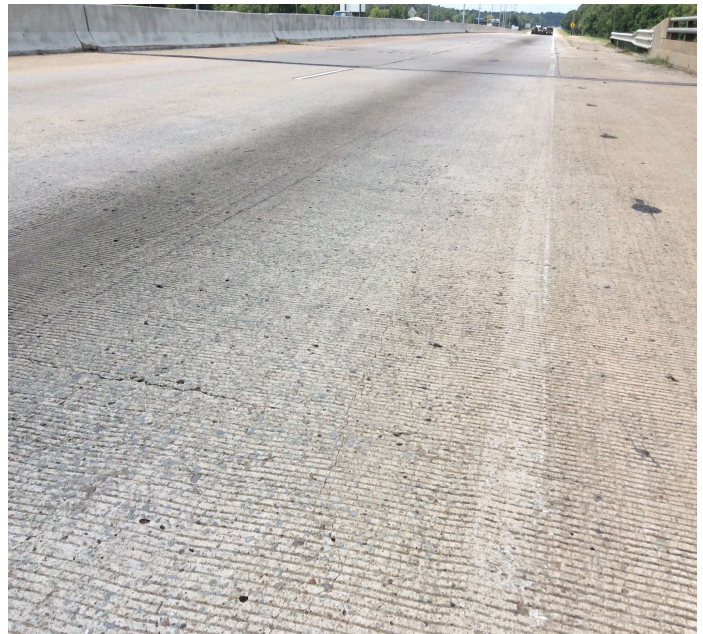
PHOTO 2      Description      Span 1 Left lane Sealable map cracking.
