Bridge Inspection Report

B5629
I-540 NB-Sebastian
over
Jenny Lind Street

Structure Number: B5629

Facility Carried: I-540 NB-Sebastian

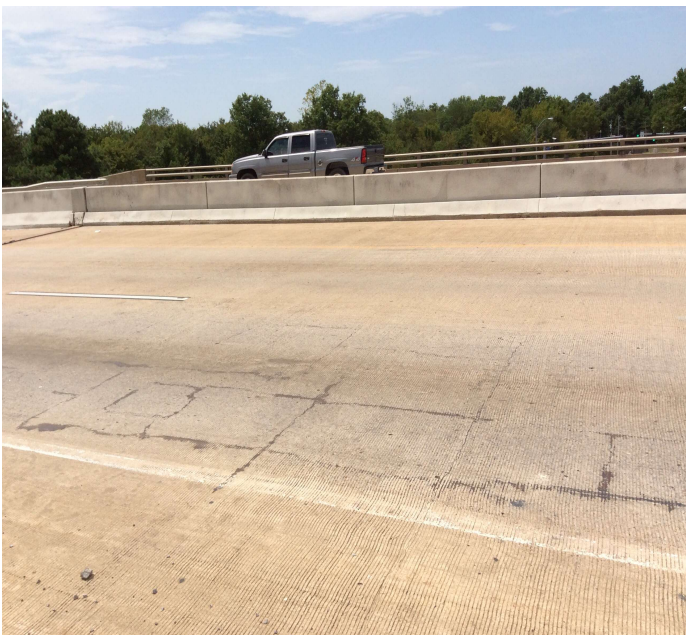
The deck has sealable cracking in the Inside lane

PHOTO 1 Description Unsealed cracks in the Left Lane.

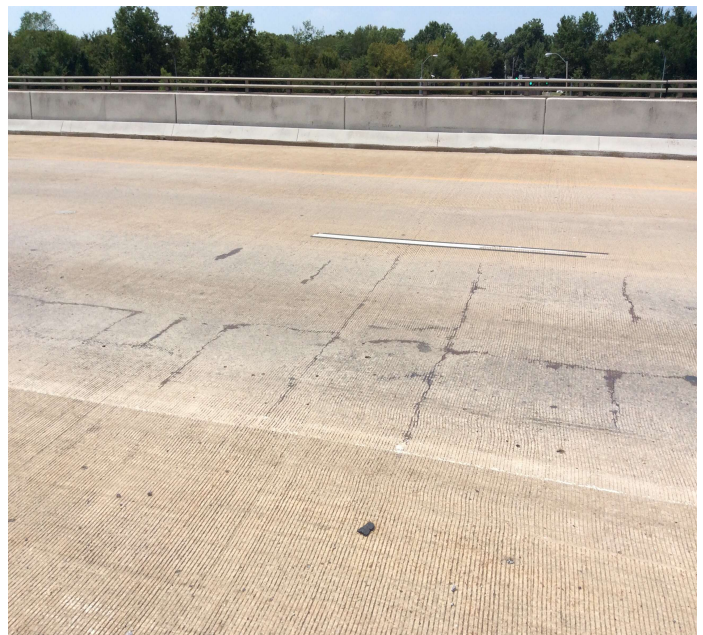
PHOTO 2 Description Right lane epoxy repairs.

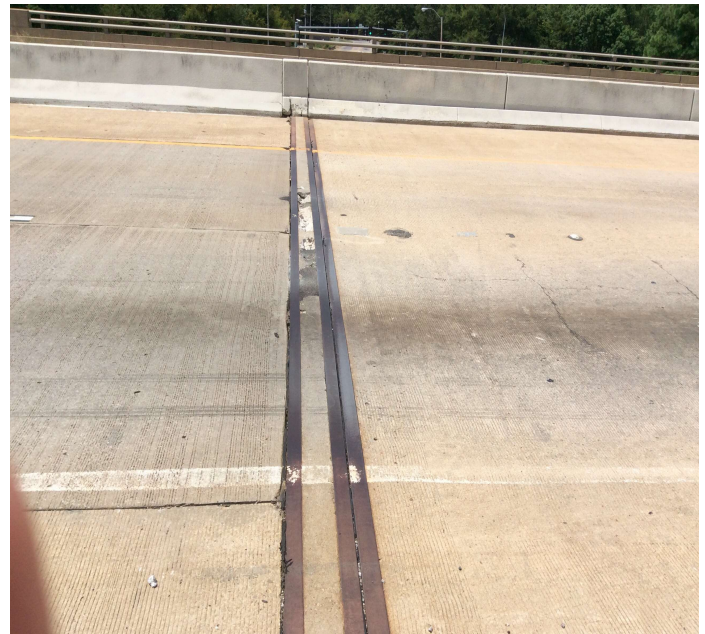
The armored expansion joint compression seal at the West bridge end has deteriorated and is allowing water, dirt and debris to leak onto the south abutment bridge seat.

PHOTO 2 Description Bent 1. Top of backwall is breaking apart

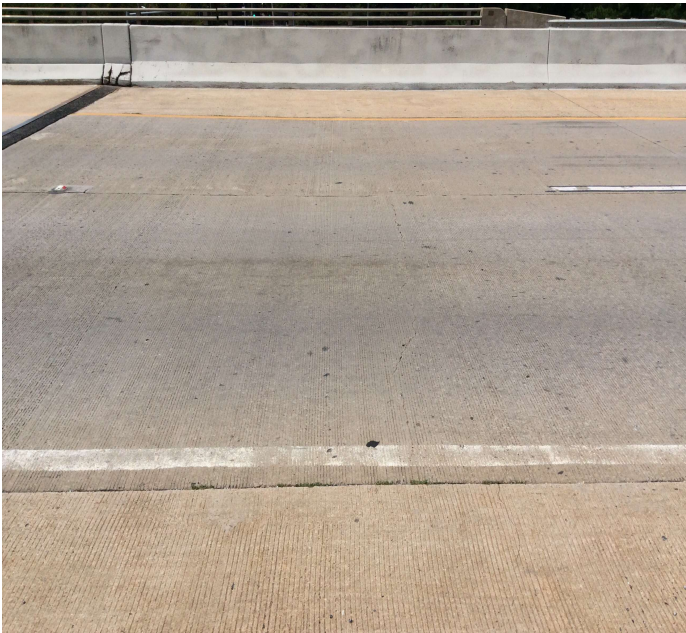
Approach slabs have minor settlement.

PHOTO 1 Description East approach slab.

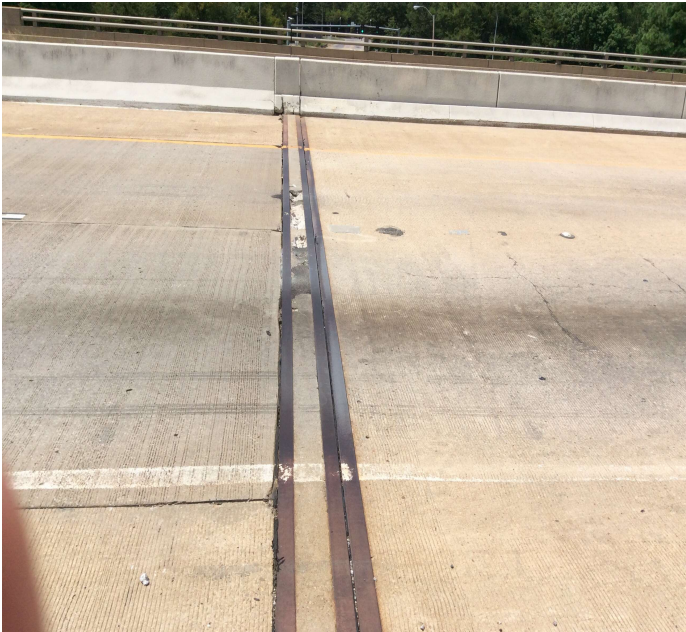
PHOTO 1 Description

The top of the West abutment backwall is approximately 1/2" higher than the bridge deck and appears to be slightly leaning away from the bridge deck.

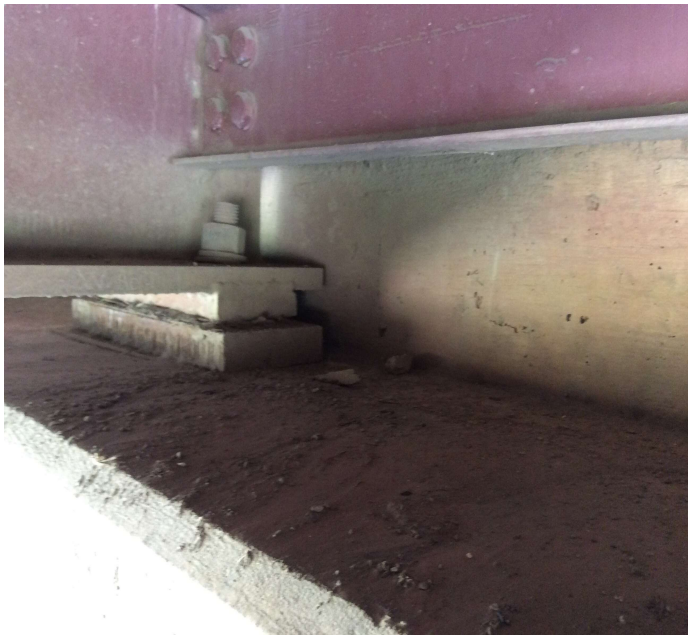
The bearings have a failing paint system with pack rust in the bearing devices in locations.

PHOTO 1 Description Bent 1. Beam 3. Bearing

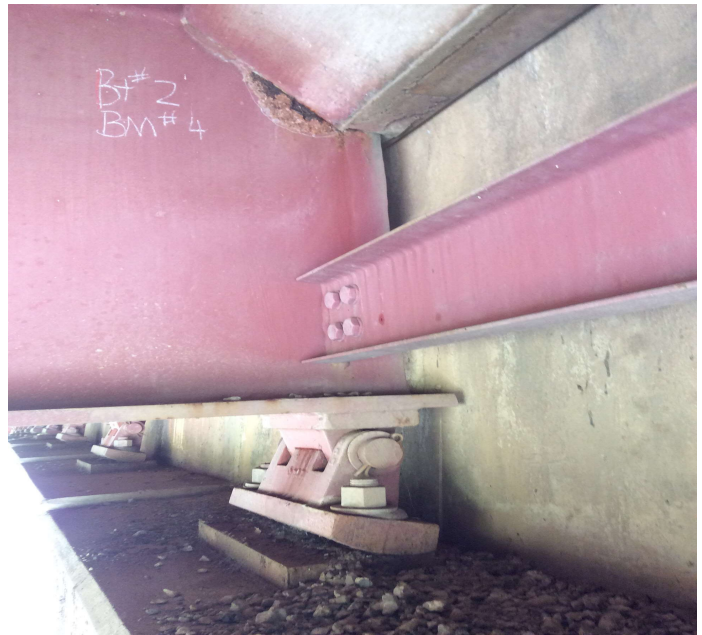
The armored expansion joints have areas of active corrosion with flaking rust adjacent to the top flanges of the exterior beams visible from the undersurface. The web of beam # 4 over the north abutment has active corrosion with flaking rust in the upper portion of the web at the juncture of the deck haunch.

PHOTO 2 Description Bent 2. Beam 4.

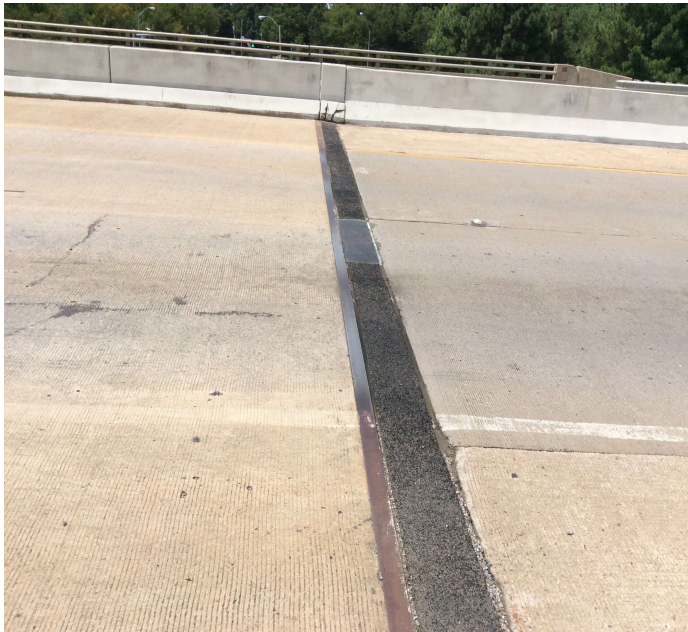
The base of the median parapet has spalling with exposed reinforcing steel at the north and south bridge ends.

PHOTO 1 Description Bent 2. Top of backwall

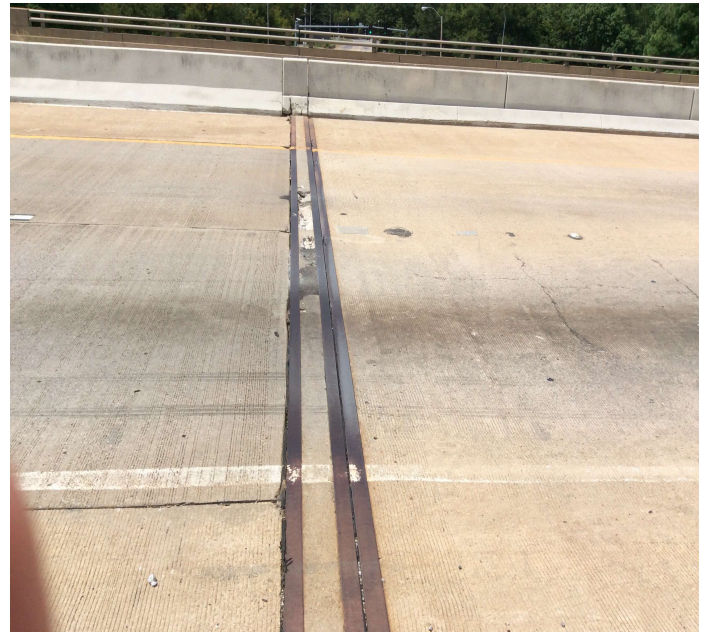
PHOTO 2 Description Bent 1. Top of backwall is breaking apart
